**CAT Report 1916
issued March 2023**

**Archaeological excavation at Duncan's Gate, Upper
Castle Park, High Street, Colchester, Essex,
CO1 1UN: June 2022**

**CAT project ref.: 2022/02d
ECC code: ECC4775**

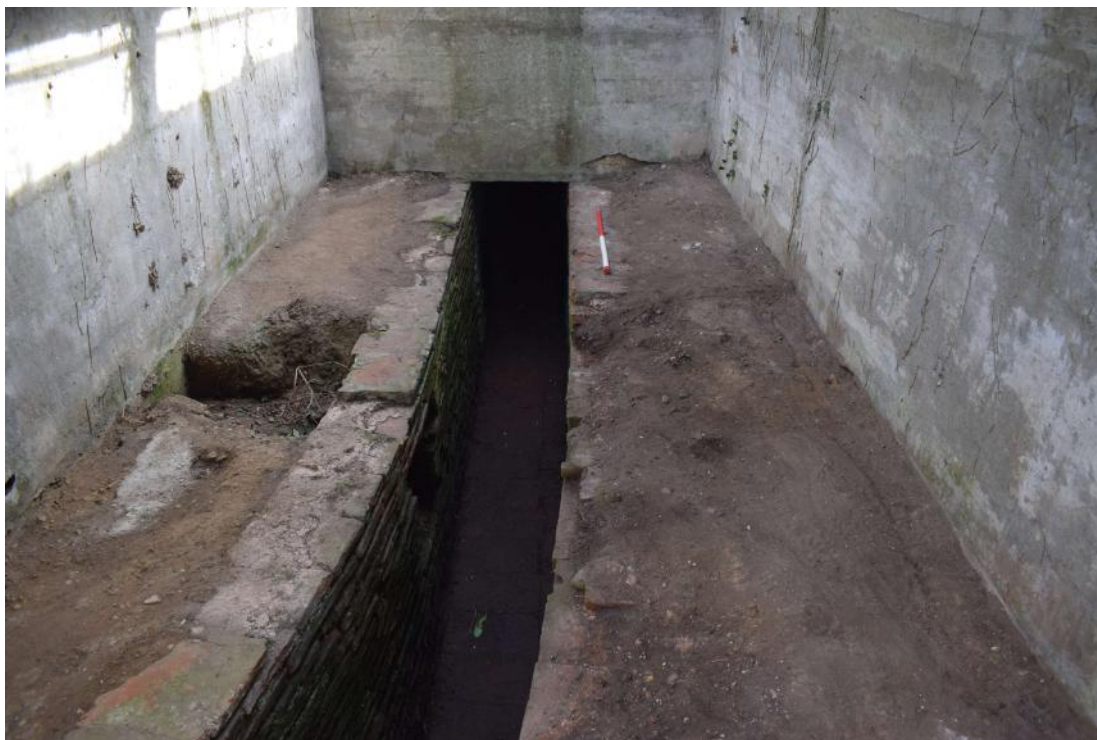
The stretch of drain recorded is approximately 6m long and accessed via a concrete inspection chamber. The walls are 1.4m at their tallest and are constructed from Roman bricks (brick

dimensions: 210-420 x 290 x 40mm) bonded with mortar. The base of the drain is laid with large red tiles (tile dimensions: 280 x 450mm). At the northern end, the drain is 0.63m wide while at the southern end it is only 0.48m wide. In the western wall of the drain is an opening, measuring roughly 0.45m by 0.55m, and located 0.56m from the base of the drain. See Figs 3-4 for images of the eastern and western walls of the drain.

Photograph 1 Interior of drain, looking north north-east.

The Roman drain cleaned and recorded for this report was first excavated by P M Duncan in the mid-19th century and then re-excavated in the early 20th century by Hull. The walls of the drain are constructed from Roman bricks and the base laid in large tiles.

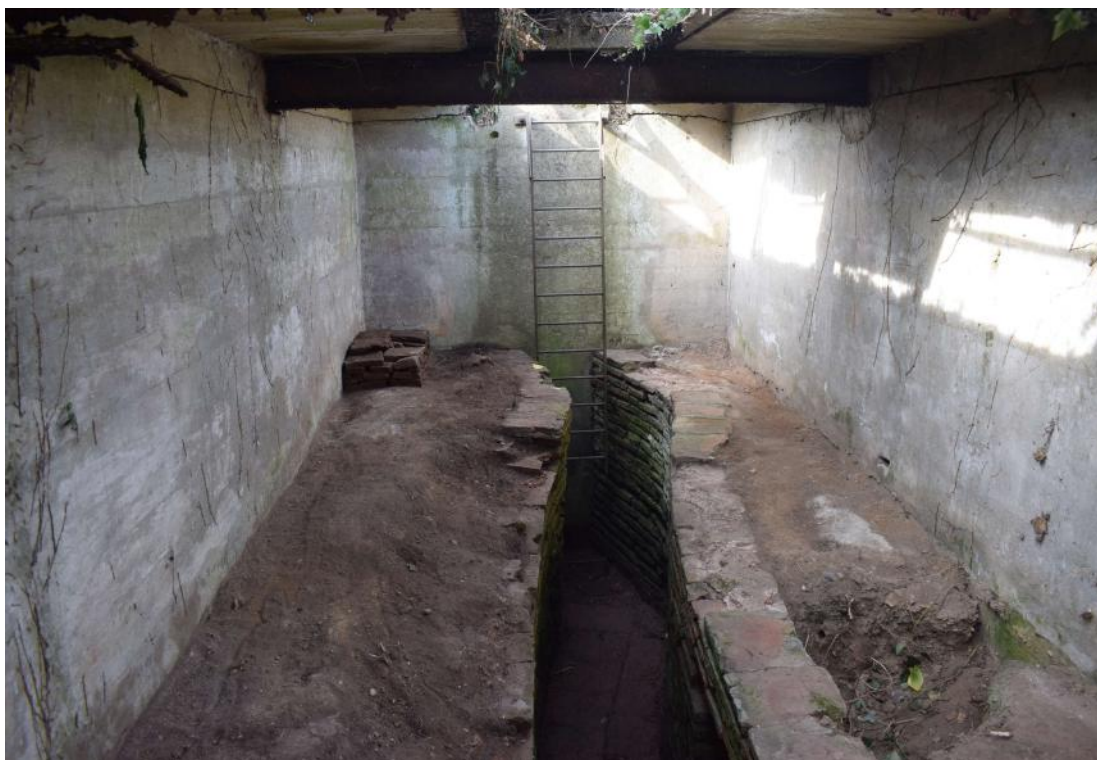
Photograph 2 Interior of drain, looking south south-east.

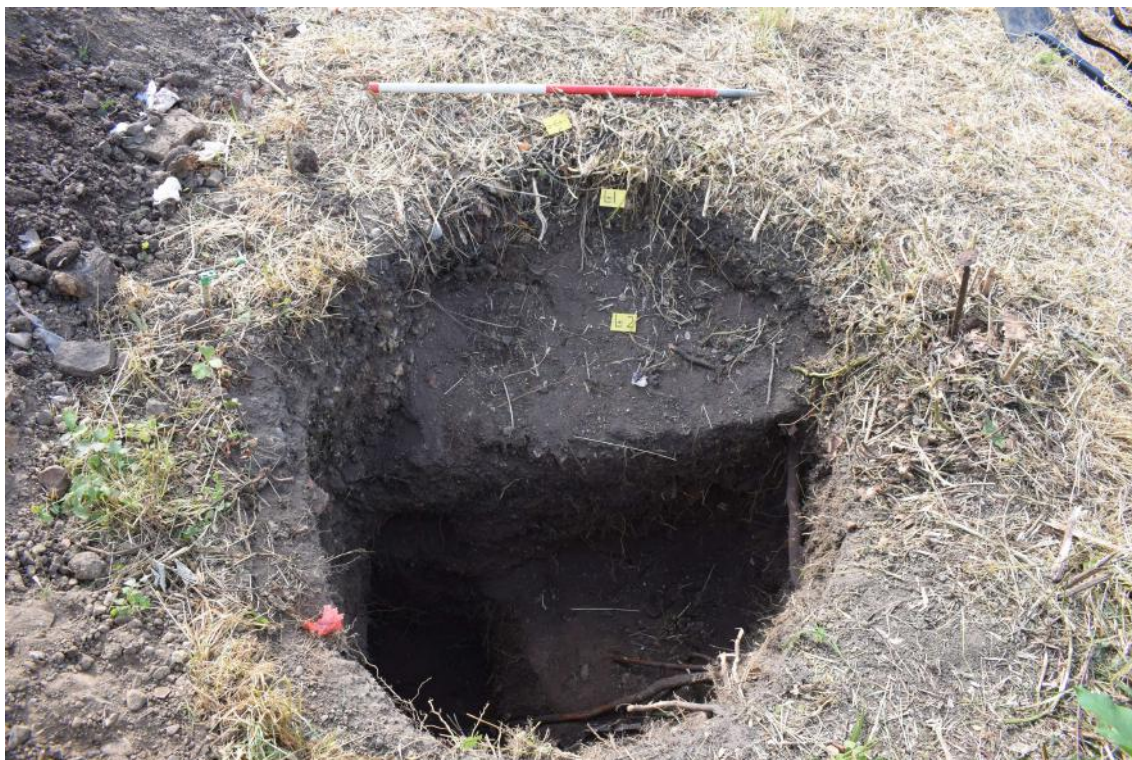
The sunken feature was dug to a depth of roughly 2m before excavations ceased due to health and safety concerns. It was excavated through a layer of modern topsoil (L1, dry, mid grey/brown sandy silt) into a layer of modern made-ground (L2, dry, mid grey/brown sandy silt with occasional stones). The fill was extremely loose with frequent rooting. A number of modern finds were observed throughout the removed soil.

Photograph 3 Sunken feature excavation, looking south-east.

The sunken feature was investigated to a depth of 2m but only modern layers were encountered. Using historic imagery (courtesy of Google Earth) a tree can be seen in the location of the sunken feature on images from 2006 and earlier. After 2009, the tree has been removed. The most plausible explanation for the sunken feature is a backfilled modern tree-throw and as the earth has settled a depression has formed.

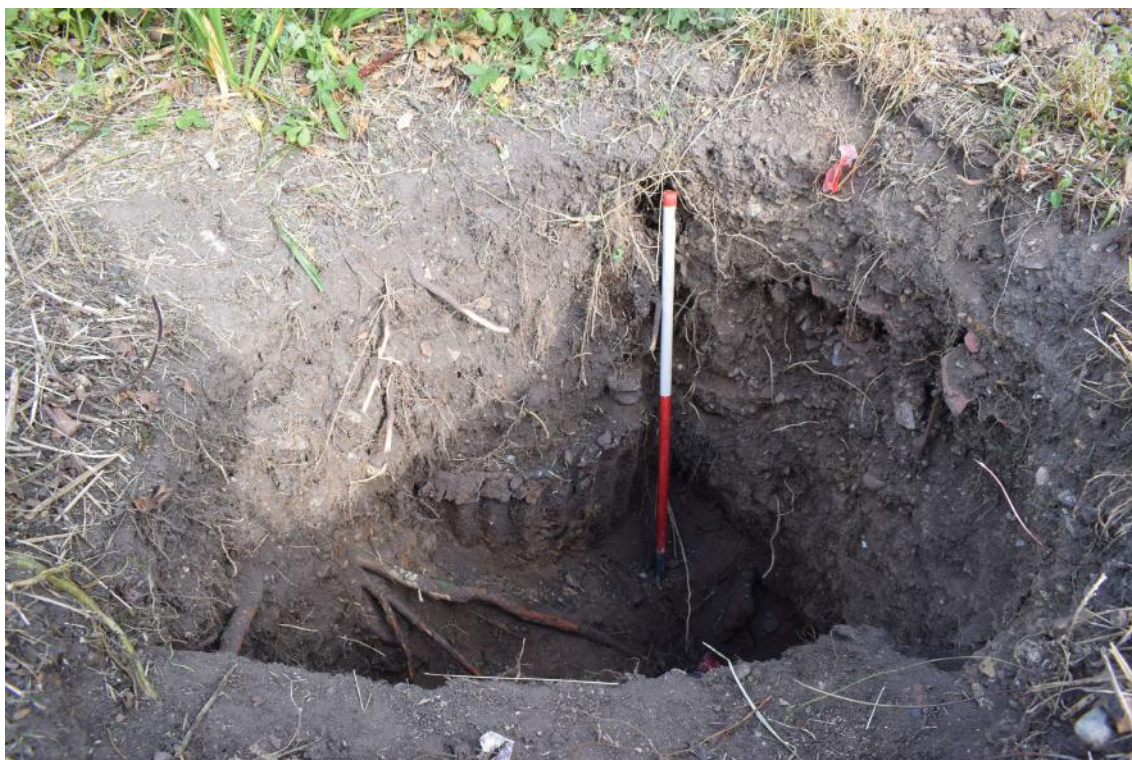
Photograph 4 Sunken feature excavation, looking north-west.

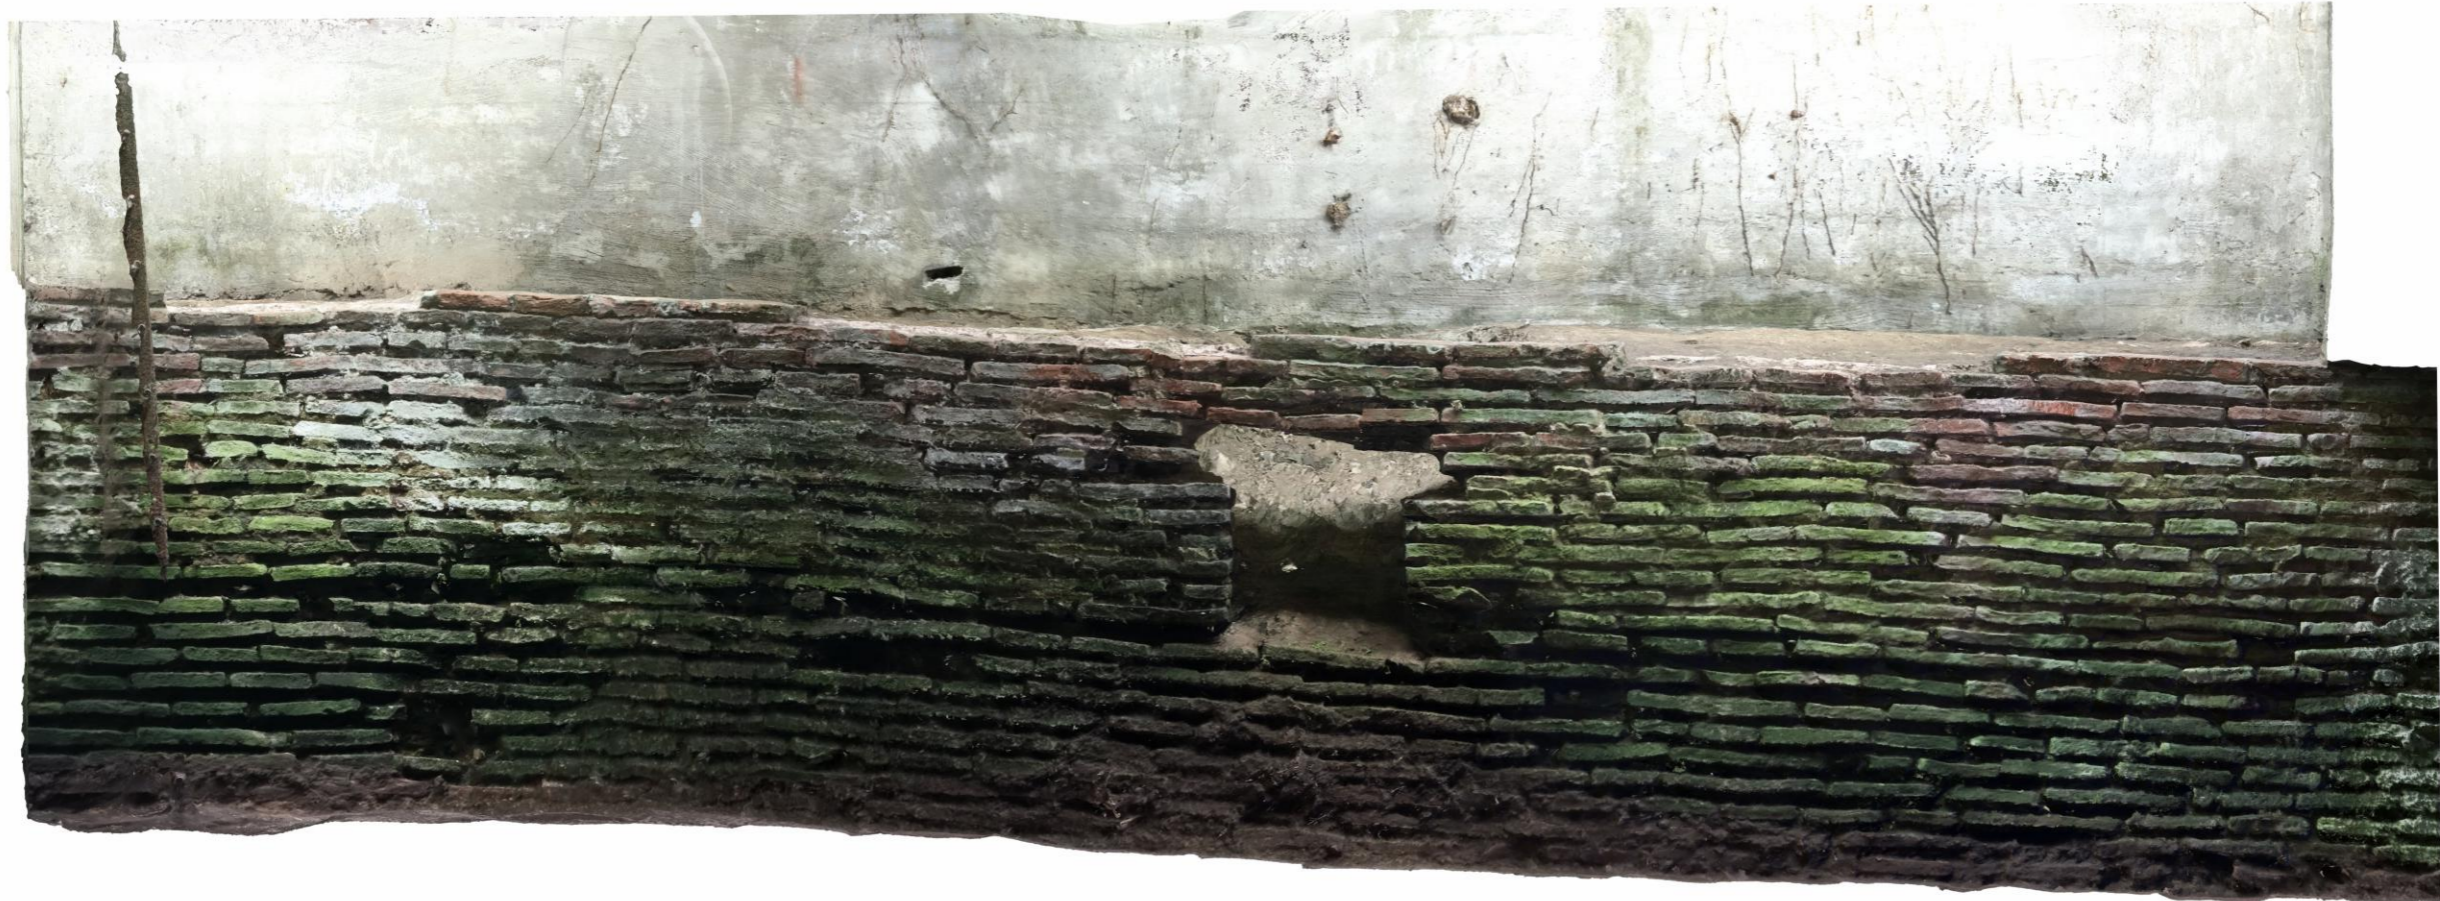
Fig 4 Western wall of drain.

On the western wall of this stretch of the drain is a rectangular opening. It is one of several openings on the western wall of the drain that were previously identified by Hull. His description is as follows:

It is assumed the openings are junctions where smaller culverts (possibly from private residences) emptied in to the larger drain, but previous excavations have found no evidence of the direction or nature of the conduit employed for these off-shoots. No evidence of the iron staple identified by Hull remained.

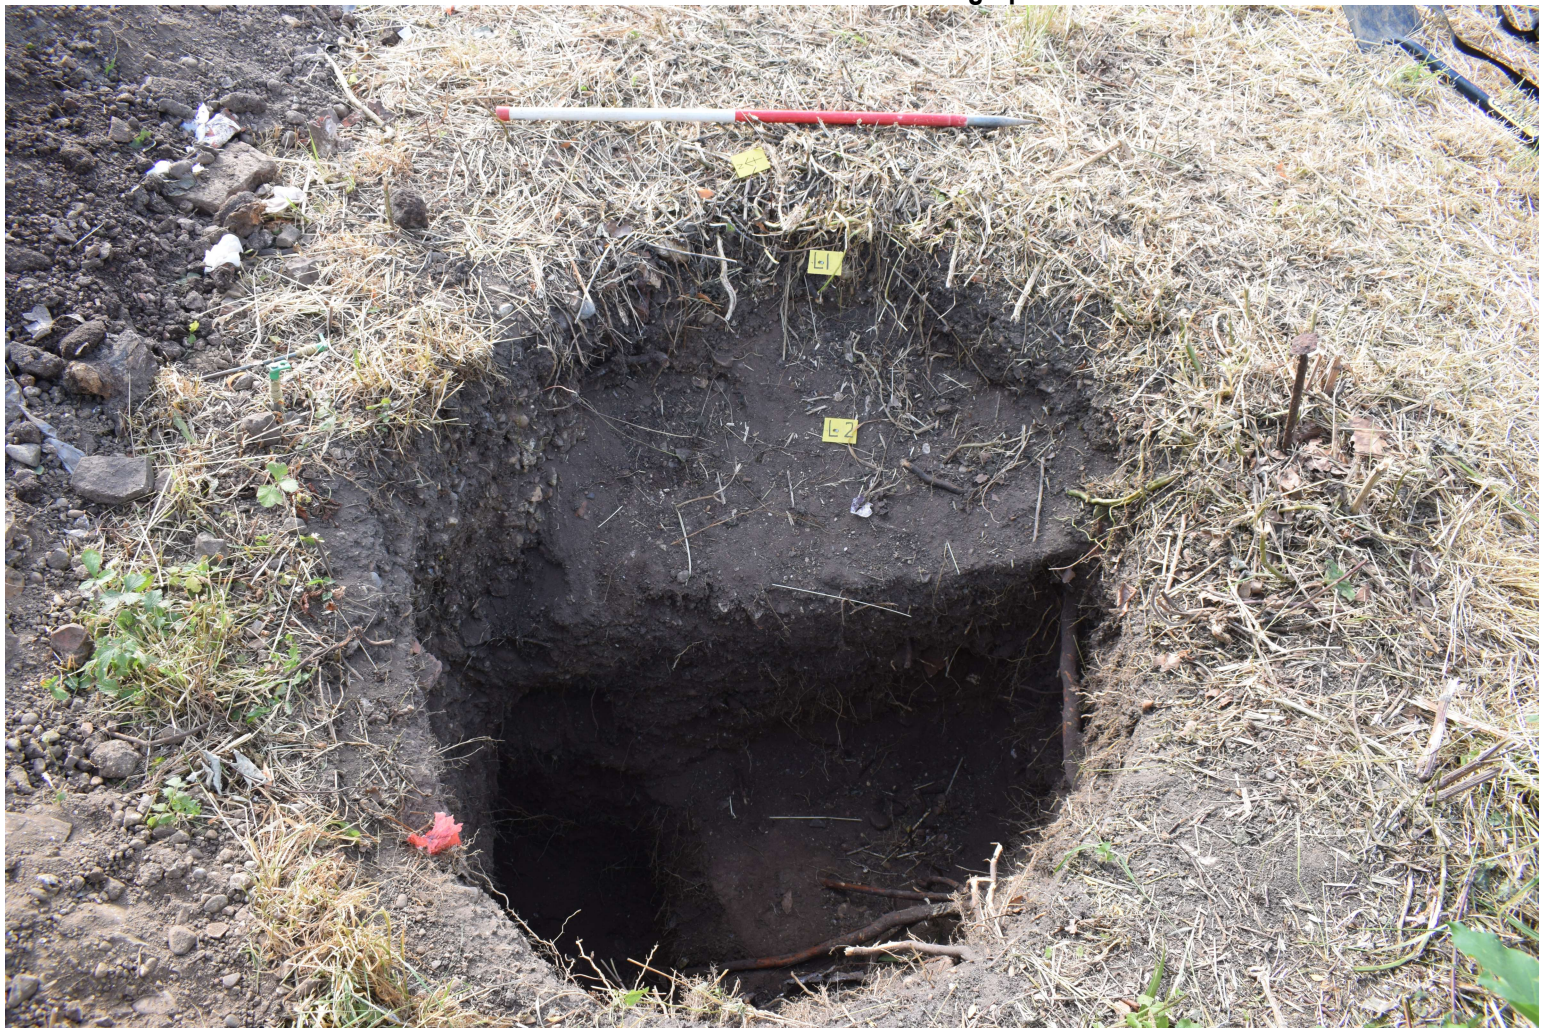
001

Filename	Description
ECC4775_PhotoGraph_001.jpg	Sunken feature excavation - view south-east
ECC4775_PhotoGraph_002.jpg	Sunken feature excavation - view north-east
ECC4775_PhotoGraph_003.jpg	Sunken feature excavation - view north-west
ECC4775_PhotoGraph_004.jpg	Sunken feature excavation - view north-west
ECC4775_PhotoGraph_005.jpg	Sunken feature excavation - view north
ECC4775_PhotoGraph_006.jpg	Sunken feature excavation - view north-east
ECC4775_PhotoGraph_007.jpg	Sunken feature excavation - view south-east
ECC4775_PhotoGraph_008.jpg	Interior of drain - view north north-east
ECC4775_PhotoGraph_009.jpg	Interior of drain - view north north-east
ECC4775_PhotoGraph_010.jpg	Interior of drain - view north north-west
ECC4775_PhotoGraph_011.jpg	Interior of drain - view south south-west
ECC4775_PhotoGraph_012.jpg	Interior of drain - view south south-west
ECC4775_PhotoGraph_013.jpg	Interior of drain - view south south-west

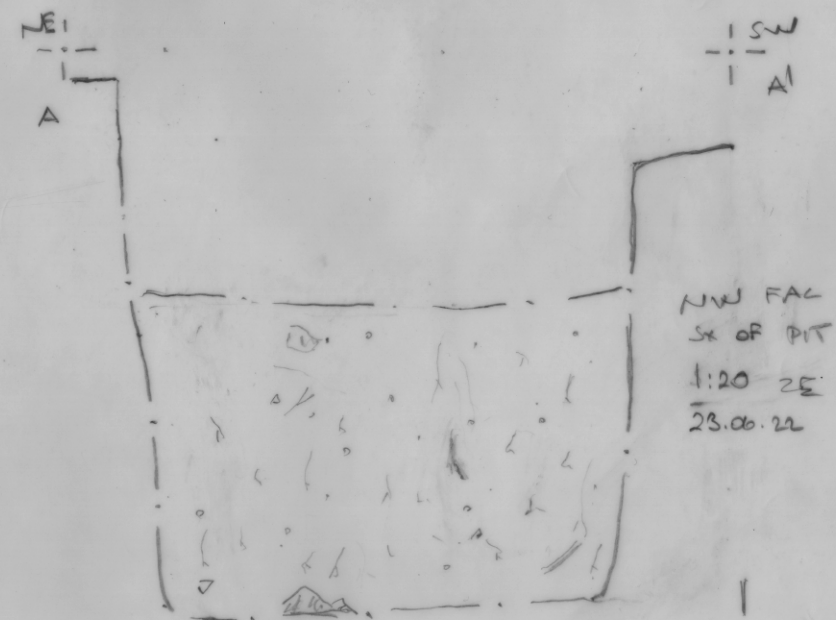
NW FAC
 SK OF PIT
 1:20 ZE
 23.06.22

MID GREY BROWN
 VERT LOOSE / SOFT
 SILTY SAND.
 HEAVILY ROOTING ACTION
 OCC. SMALL STONES +
 RARE CBM FRAGMENTS
 FREE. MODERN INCLUSIONS
 ? MODERN MADE UP GROUND
