**CAT Report 1802  
September 2022**

**Historic building recording of a cart lodge at  
Purley Farm House, Purley Lane,  
Coggeshall, Essex CO6 1TH**

**CAT project ref.: 2022/02m  
ECC code: CGPF22**

**NGR: TL 85640 24696**

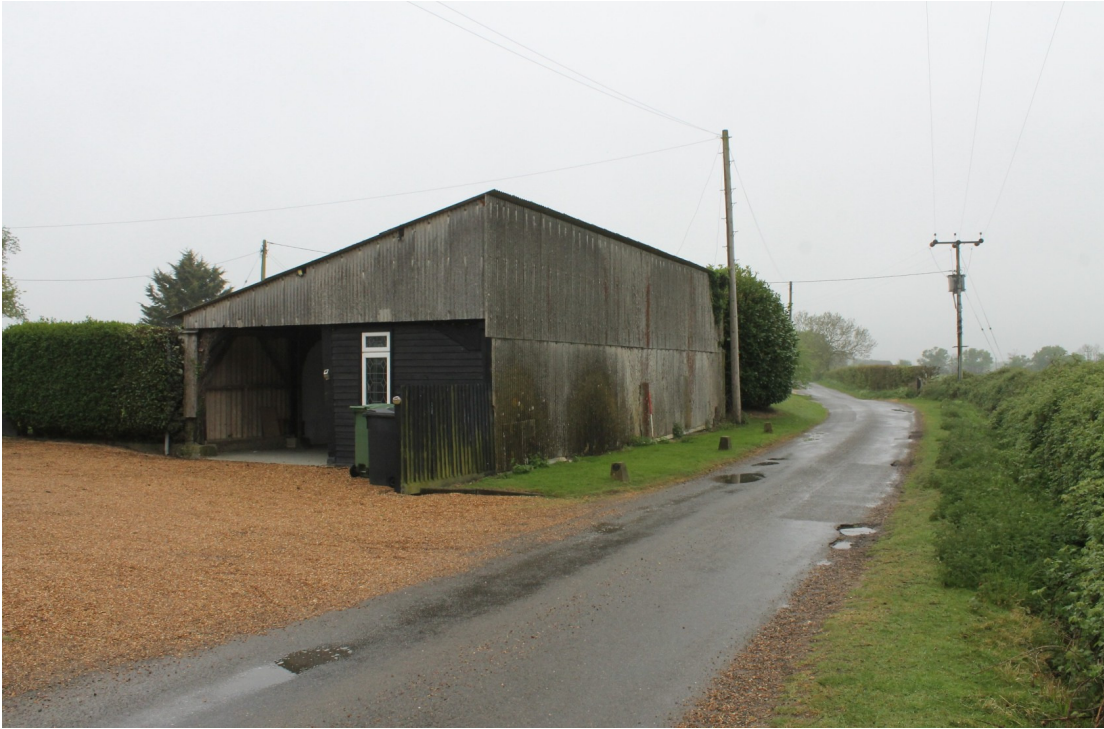
**Photograph 1** North and east elevations – view south-west.

The building lies parallel to Purley Lane, but set back a short distance from the road with the northern elevation a featureless façade of corrugated asbestos sheeting (Photograph 1).

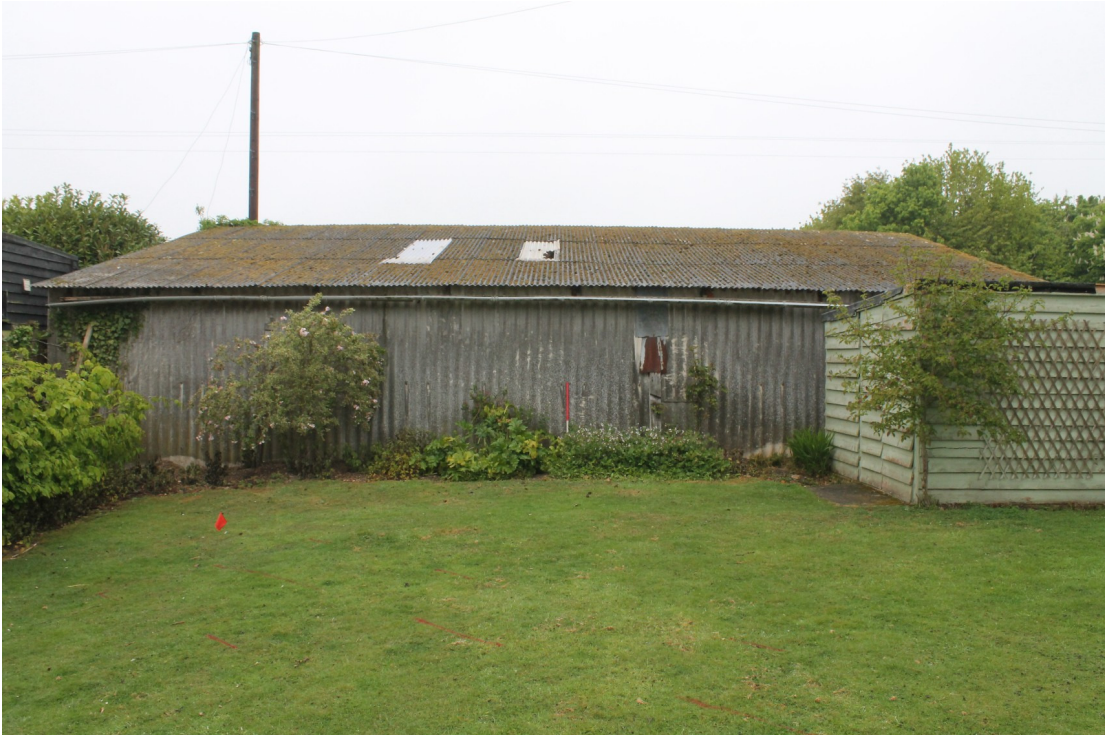
**Photograph 2** South elevation – view north.

The south elevation is also featureless and fully clad in corrugated asbestos sheeting (Photograph 2). It was not possible to access the western elevation during the recording but it is assumed that this is also featureless and clad in corrugated asbestos.

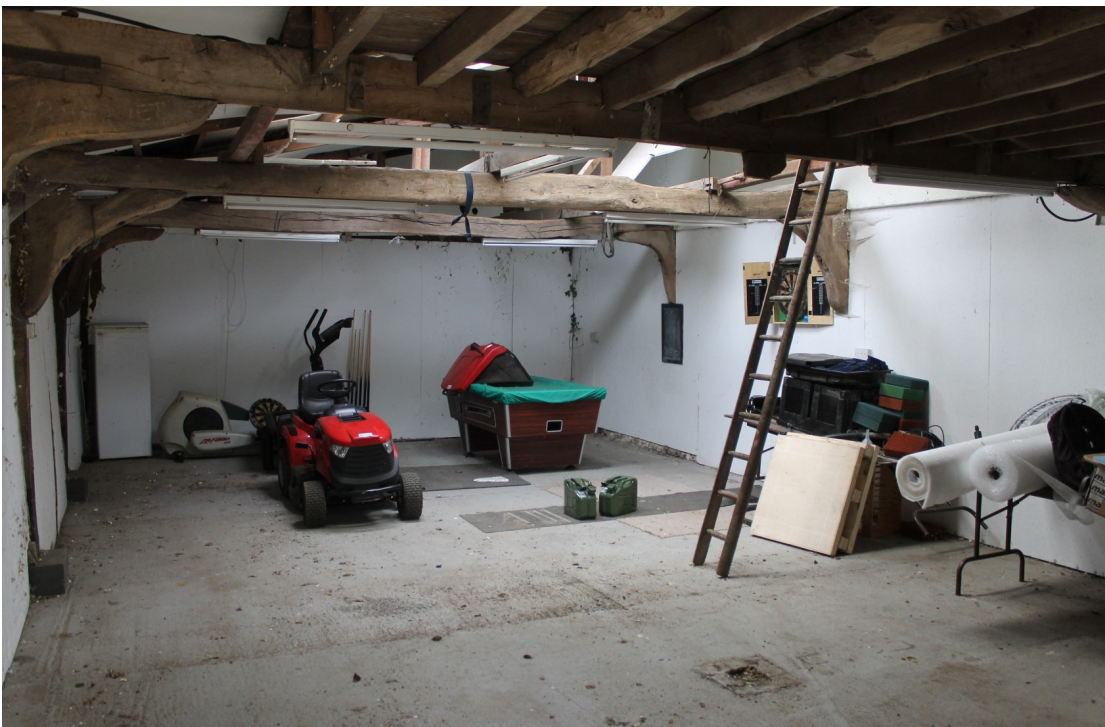
**Photograph 3** Interior of the cart lodge with the north wall to the right – view north-west.

The building consists of five roughly equal-sized bays, which have been labelled B1-B5 from west to east (see Fig 2). The floor of the building is modern concrete and the majority of the timber-frame has been concealed behind sheets of modern OSB (Photographs 3 and 4) although the tie-beams (T1-T4 on Fig 2) and supporting knee braces are visible as are the posts on the south wall. The exposed timbers are a mix of hardwood and softwood and comprise both hand-sawn and machine-cut timbers, including many which are re-used.

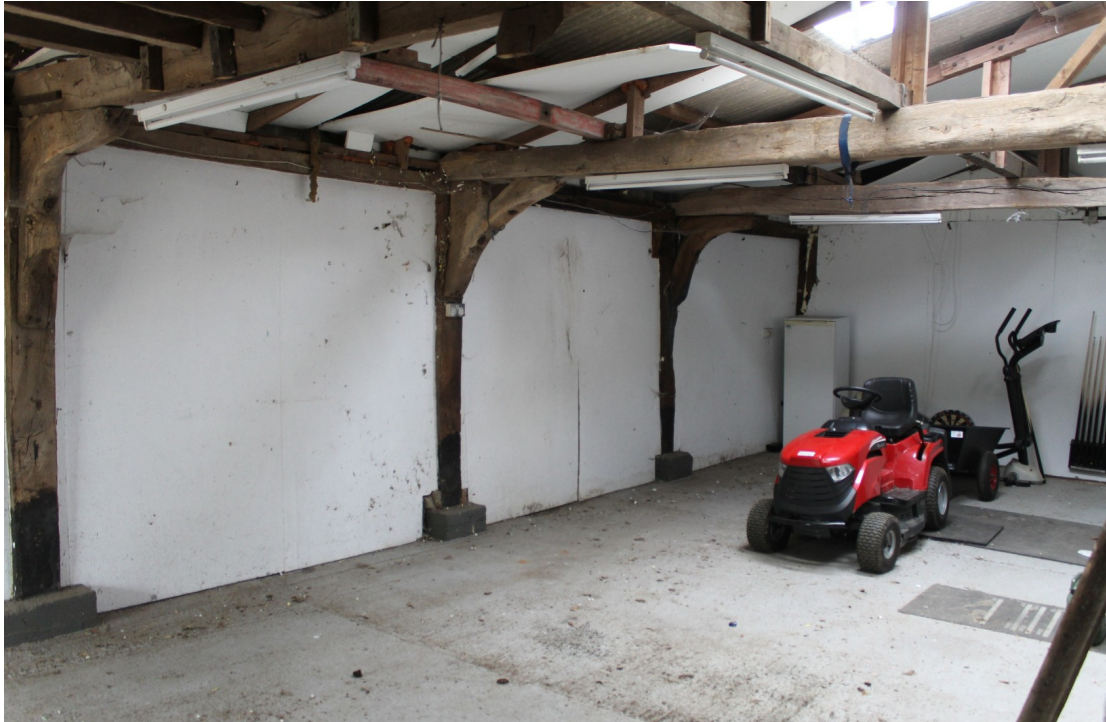
**Photograph 4** Interior of the cart lodge showing the south wall with its exposed posts and protective concrete shoes – view south-west.

The corner and intermediate posts in this wall each have a protective concrete shoe around their bases, a common feature of cart lodges designed to protect the posts from damage, although this is clearly a later addition. A concrete plinth has been inserted between the shoes.

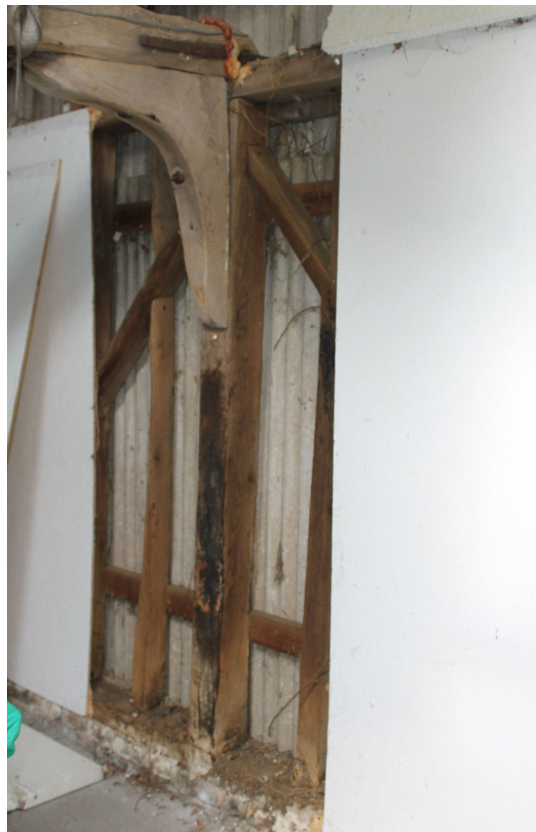
**Photograph 5**  
Exposed timber-frame  
of the north wall.

A section of the OSB sheeting was removed from each of the north, south and west walls to look for evidence of the original framing. This revealed a brick plinth present below the frame of the north and west walls, which also partly survives on the east wall and comprised two courses of brick with dimensions of 230mm x 110mm x 65mm laid in Flemish bond.

On the north wall the brick plinth supports a sill beam with dimensions of 90mm x 150mm from which rise straight, machine-cut intermediate posts and studs with through-bracing. The braces fall from the head of the posts to the sill-beam and comprise both machine-cut and hand-sawn timbers. Batons are attached to the posts and studs on to which the external asbestos cladding is affixed. A wall-plate is carried on the heads of the intermediate posts (Photograph 5).

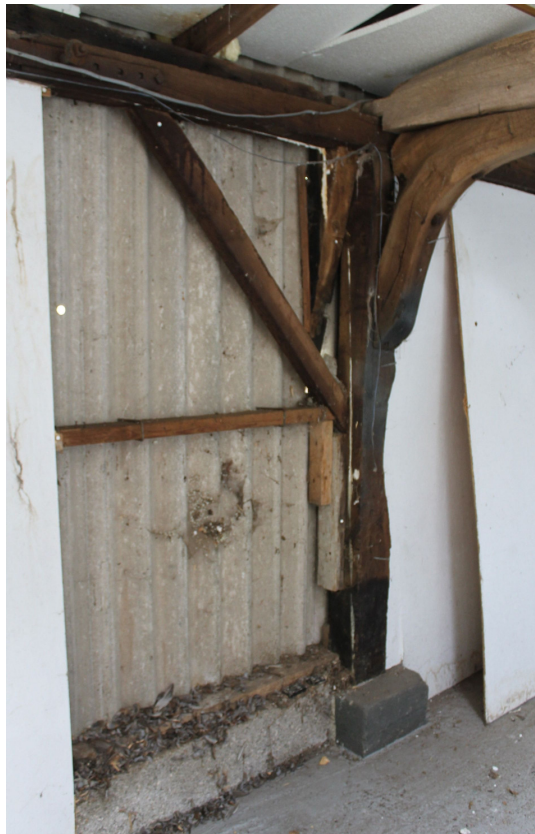
**Photograph 6**  
Inserted frame to the cart lodge openings on the south wall.

On the south wall the removal of the OSB sheeting did not expose any further original timber-framing other than the posts that were already visible. The spaces between the posts have been blocked by the insertion of inclined struts and a girding-beam. The inclined struts rise from the post to meet the wall-plate while the girding-beam is supported by a central post. The external asbestos cladding is attached to these posts (Photograph 6).

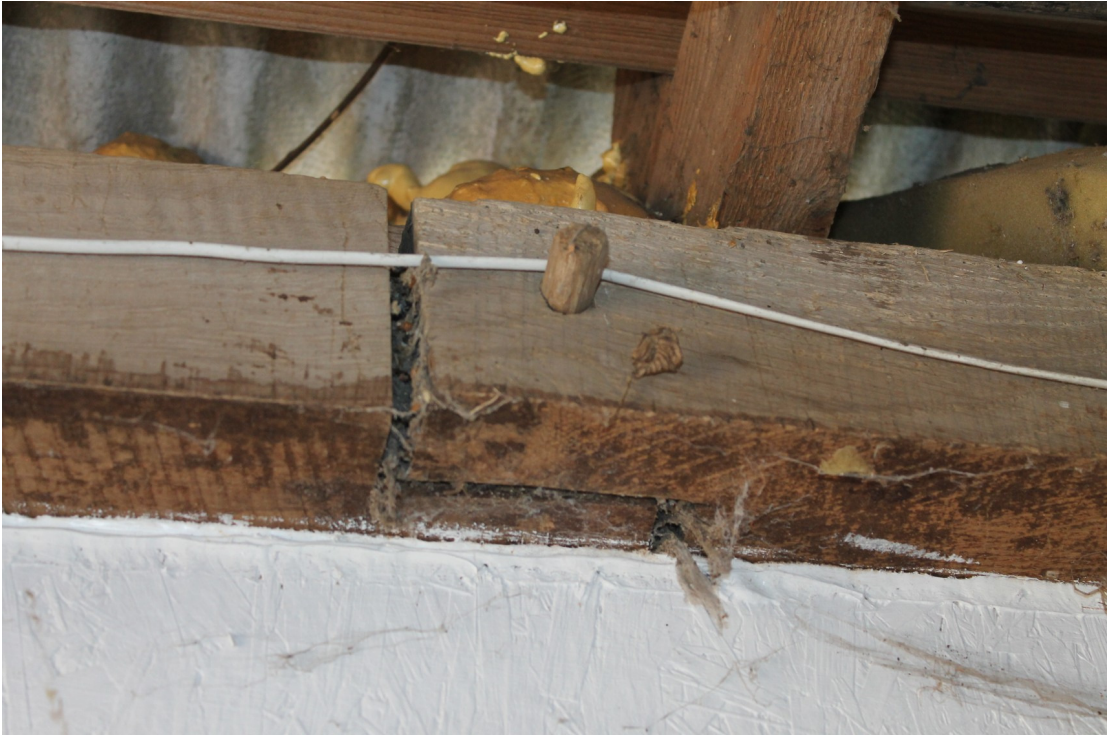
**Photograph 7** Face-halved and single-pegged scarf joint in the wall plate of the south wall.

On the wall plate of the south wall, two face-halved and single-pegged scarf joints were identified on the wall-plate, one in bay 2 and one in bay 4 (Photograph 7).

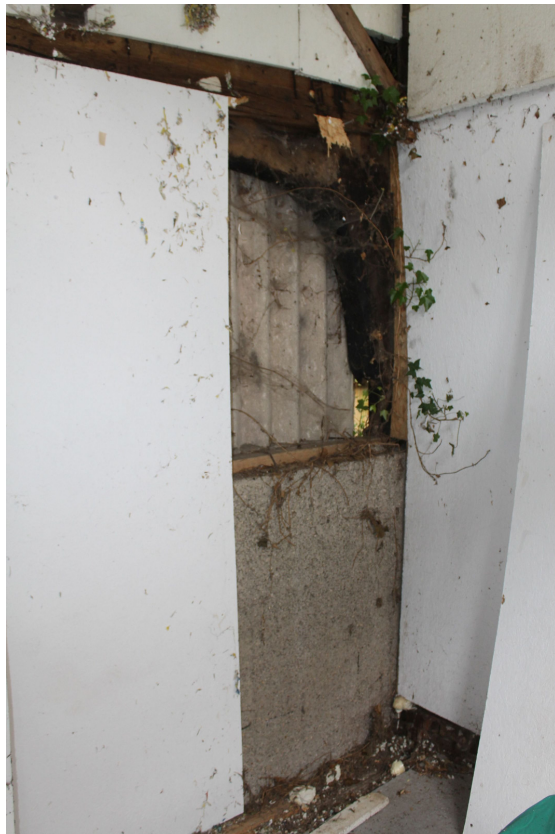
**Photograph 8**  
Inserted breeze block wall to west end of the cart lodge.

When the OSB sheeting was removed from the west wall, this exposed a half height wall of breeze blocks and no indication of the original framing (Photograph 8). No mortices were observed in the underside of the gable tie-beam or indeed in the underside of the eastern gable tie-beam. This suggests that either both gable tie-beams are replacements or that the short sides of the cart lodge were open to the elements.

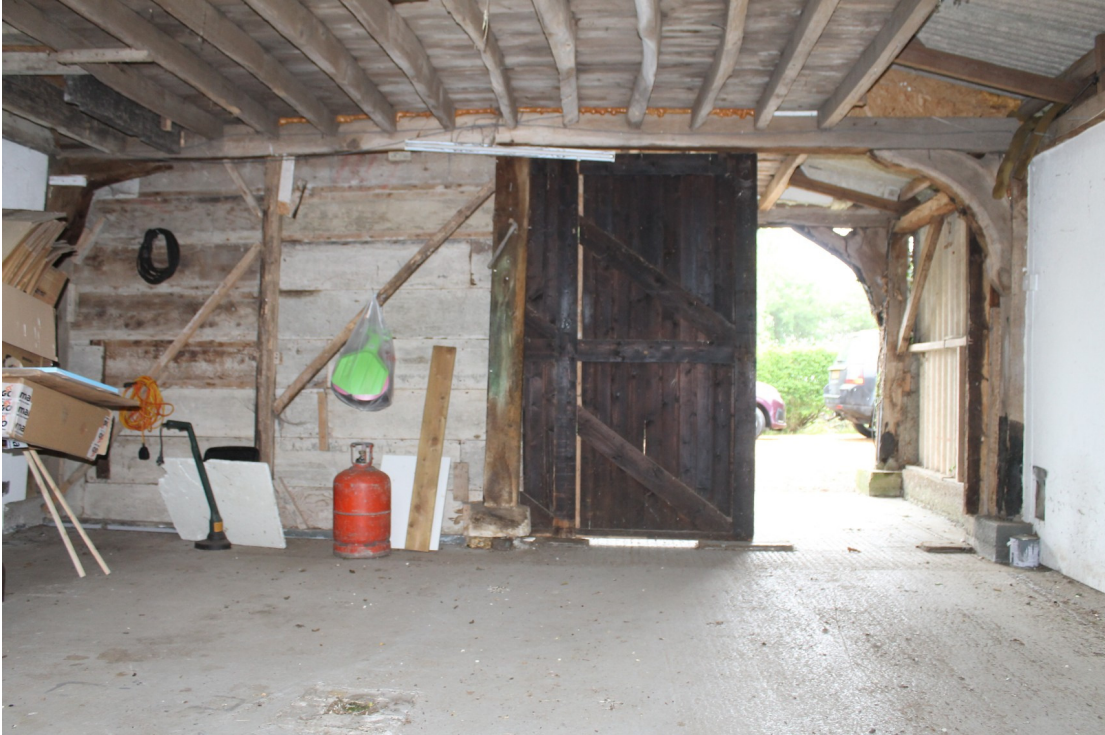
**Photograph 9** Inserted dividing wall between bays B4 and B5 with the loft above.

Bays B1-B4 are open, while bay B5 contains a recessed entrance way and a small inserted office. This has been created by the insertion of a wall between bays B4 and B5 directly below tie-beam T4 which is constructed from 300mm wide timber planks and has an opening for a large sliding door (Photograph 9). This divides the recessed entrance way and

office from the rest of the building. The construction method used on the east and south walls of the office is concealed. The southern wall contains a pair of uPVC French doors and the eastern a uPVC window. The raised floor of the office is covered in modern laminate flooring.

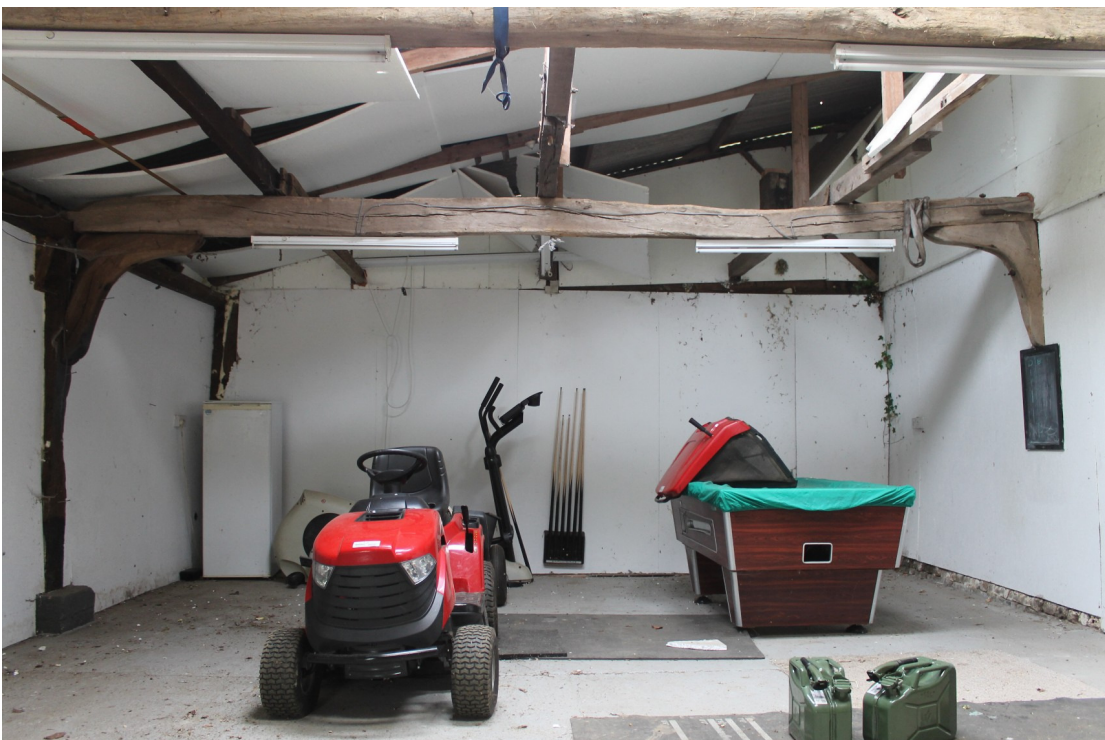
**Photograph 10** Tie-beam T1 with knee braces – view west.

The intermediate posts support large section straight tie-beams (T1-T4 on Fig 2) with dimensions of 160-175mm x 200mm high, which are supported by knee braces at each end (Photograph 10).

Three longitudinal timbers sit directly on top of the western gable tie-beam and tie-beams T1-T3 acting as a kind of purlin (see Photograph 10). These are formed from scrap timber, crudely spliced together and include a pair of waggon shafts over bay B3 (Photograph 16) and a door post over bay B2. After tie-beam T3, these timbers end and are replaced with the

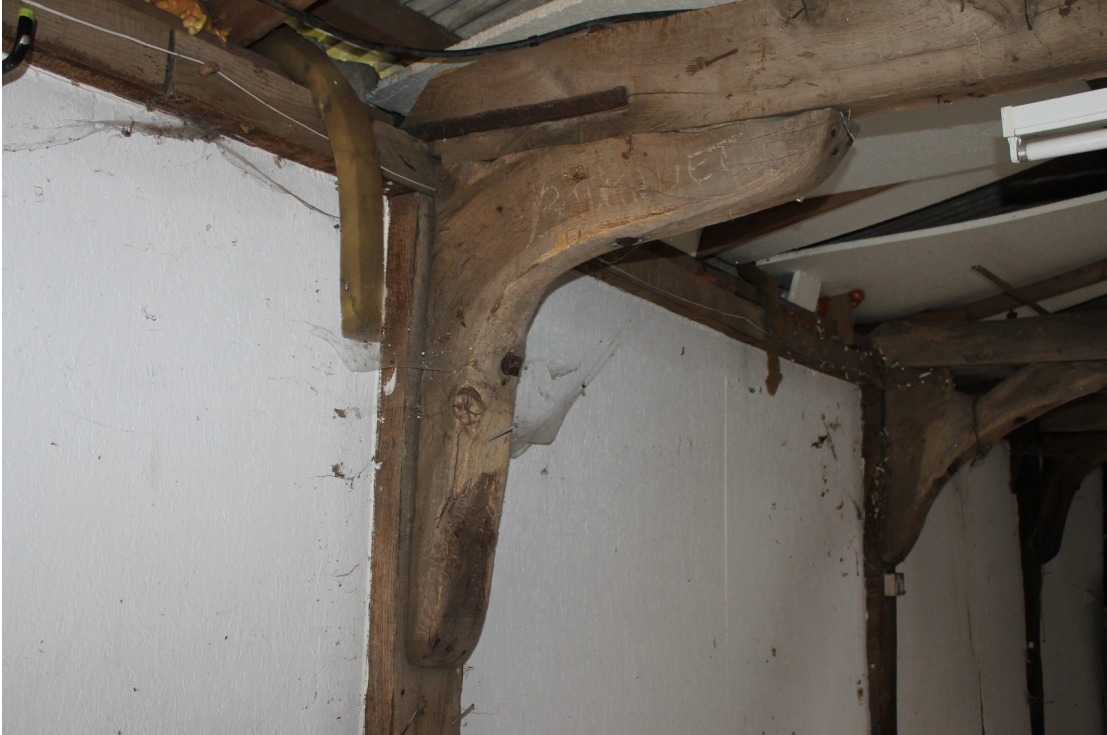
**Photograph 11** Knee brace at south end of tie-beam T3 showing iron bolts to the post and tie-beam and the iron staple at the end of the tie-beam – view south-west.

The knee-braces are attached to the intermediate posts by a single bolt and three iron nails and to the tie-beams in an identical fashion. A single iron staple is found on the opposing faces at each end of the tie-beams (Photograph 11) and a single carpenter's mark in the form of an incised 'II' is located on the west face of tie-beam T3 (Photograph 12). The tie-beams and knee braces are all re-used from an earlier building.

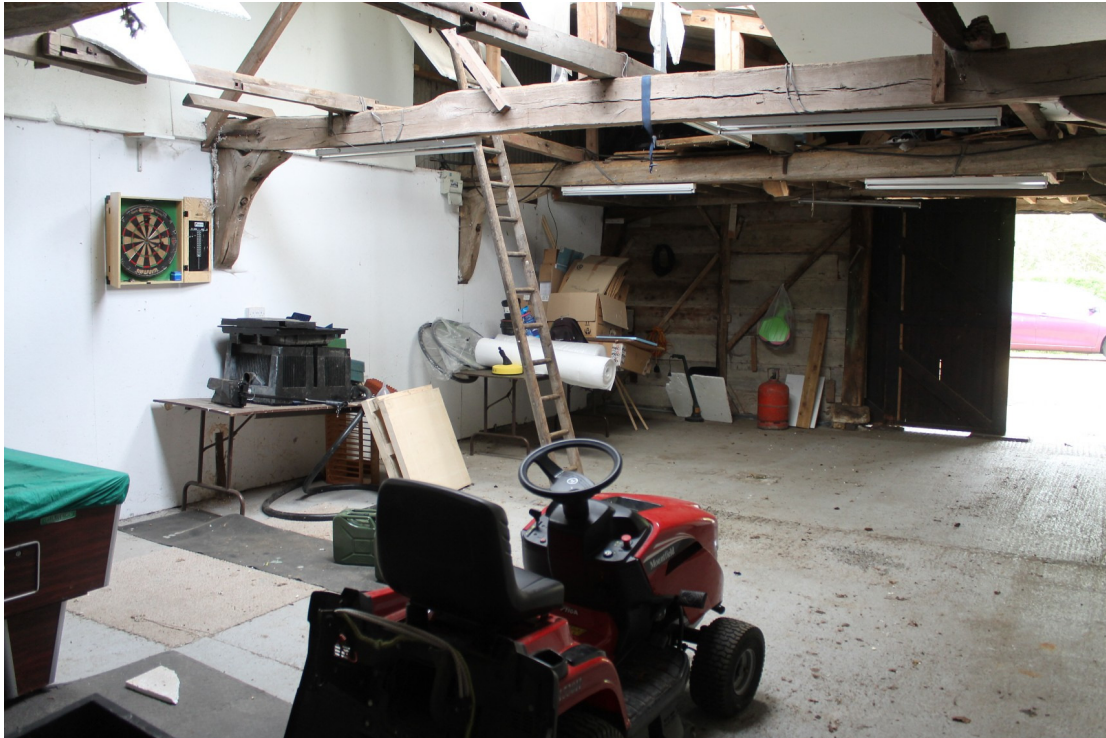
**Photograph 13** Inserted loft above bays B4 and B5, accessible only by ladder – view north-east.

Located above bays B4 and B5 is a loft, carried on eleven timber joists, which are notched in to tie-beams T3, T4 and the eastern gable tie-beam (Photograph 13). Most of the joists comprise machine-cut timbers but a few are formed from split tree trunks. Several of the joists also display empty mortices, indicating they are re-used timbers. The joists start 1.10m in from the wall plates on each side and this suggests that, although the loft is probably not an original feature, it was inserted when the cart lodge had its original gabled roof with the reduced width a result of the restricted space formed by the triangular shape of the roof configuration.

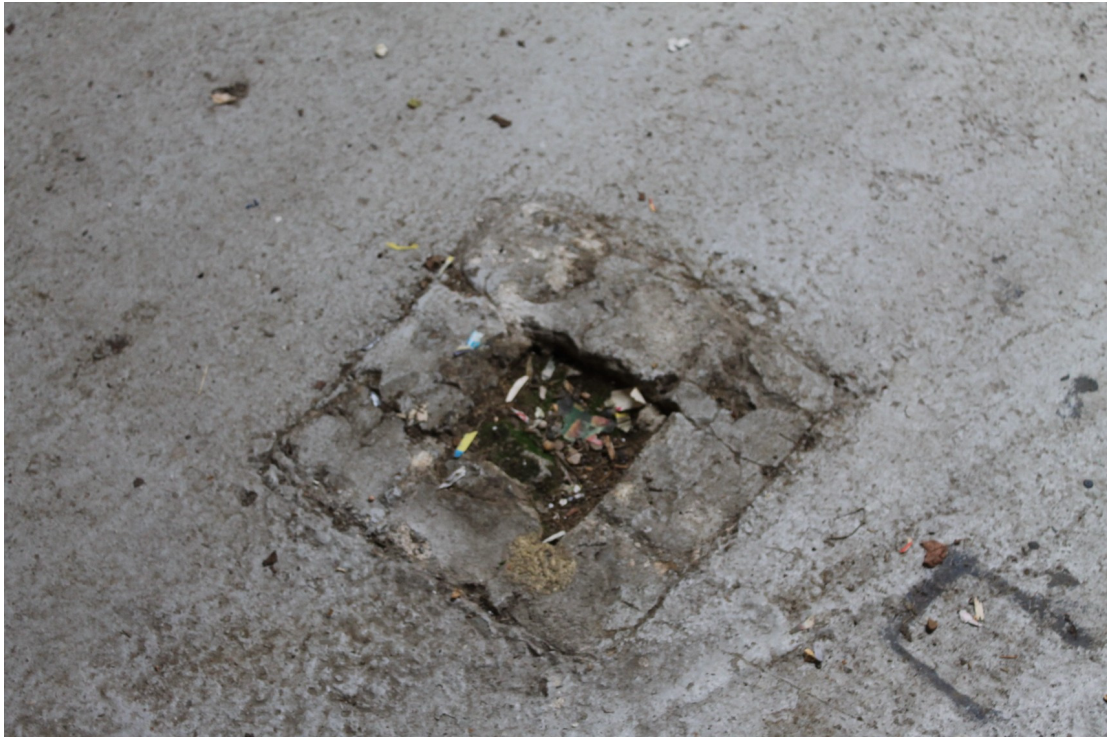
**Photograph 14** Scar in the concrete floor from the removal of the inserted post below tie-beam T3, which provided support for the loft.

Additional support for the loft is provided by three posts inserted below the centres of tie-beams T3, T4 and the eastern gable tie-beam (see Photograph 9). The post below tie-beam T3 has been removed at some point but the remains of the post can be seen below the tie-beam (see Photograph 12) and a scar in the concrete floor corresponds to its position (Photograph 14). It is likely that the carpenter's mark observed on tie-beam T3 corresponds to the insertion of these posts rather than the framing of the cart lodge itself. The inserted post below tie-beam T4 has either been affected by rot at some point or was never sufficiently long enough when inserted, as the foot of this post sits on a timber pillow which is, in turn, carried on a pair of bricks (Photograph 15).

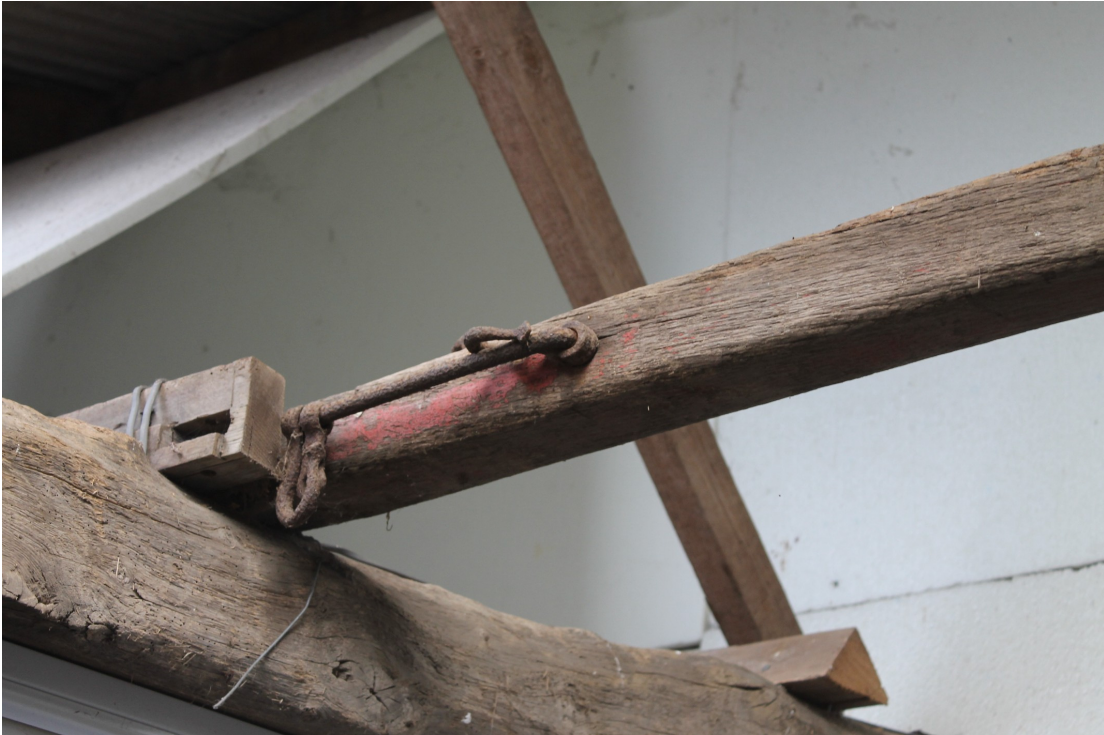
**Photograph 16** Waggon shaft (complete with harness attachment) fixed to a section of door post to form a crude longitudinal purlin supporting the struts of the modern roof.

joists for the floor of the loft. From these lower purlins, randomly-located struts rise to the meet the rafters. A pair of inclined struts rise from the northern-most end of tie-beam T2.
