**An archaeological watching brief at  
Shenfield Hall, Hall Lane,  
Shenfield, Essex**

**March 2002**

**CAT Report 181**  
April 2002

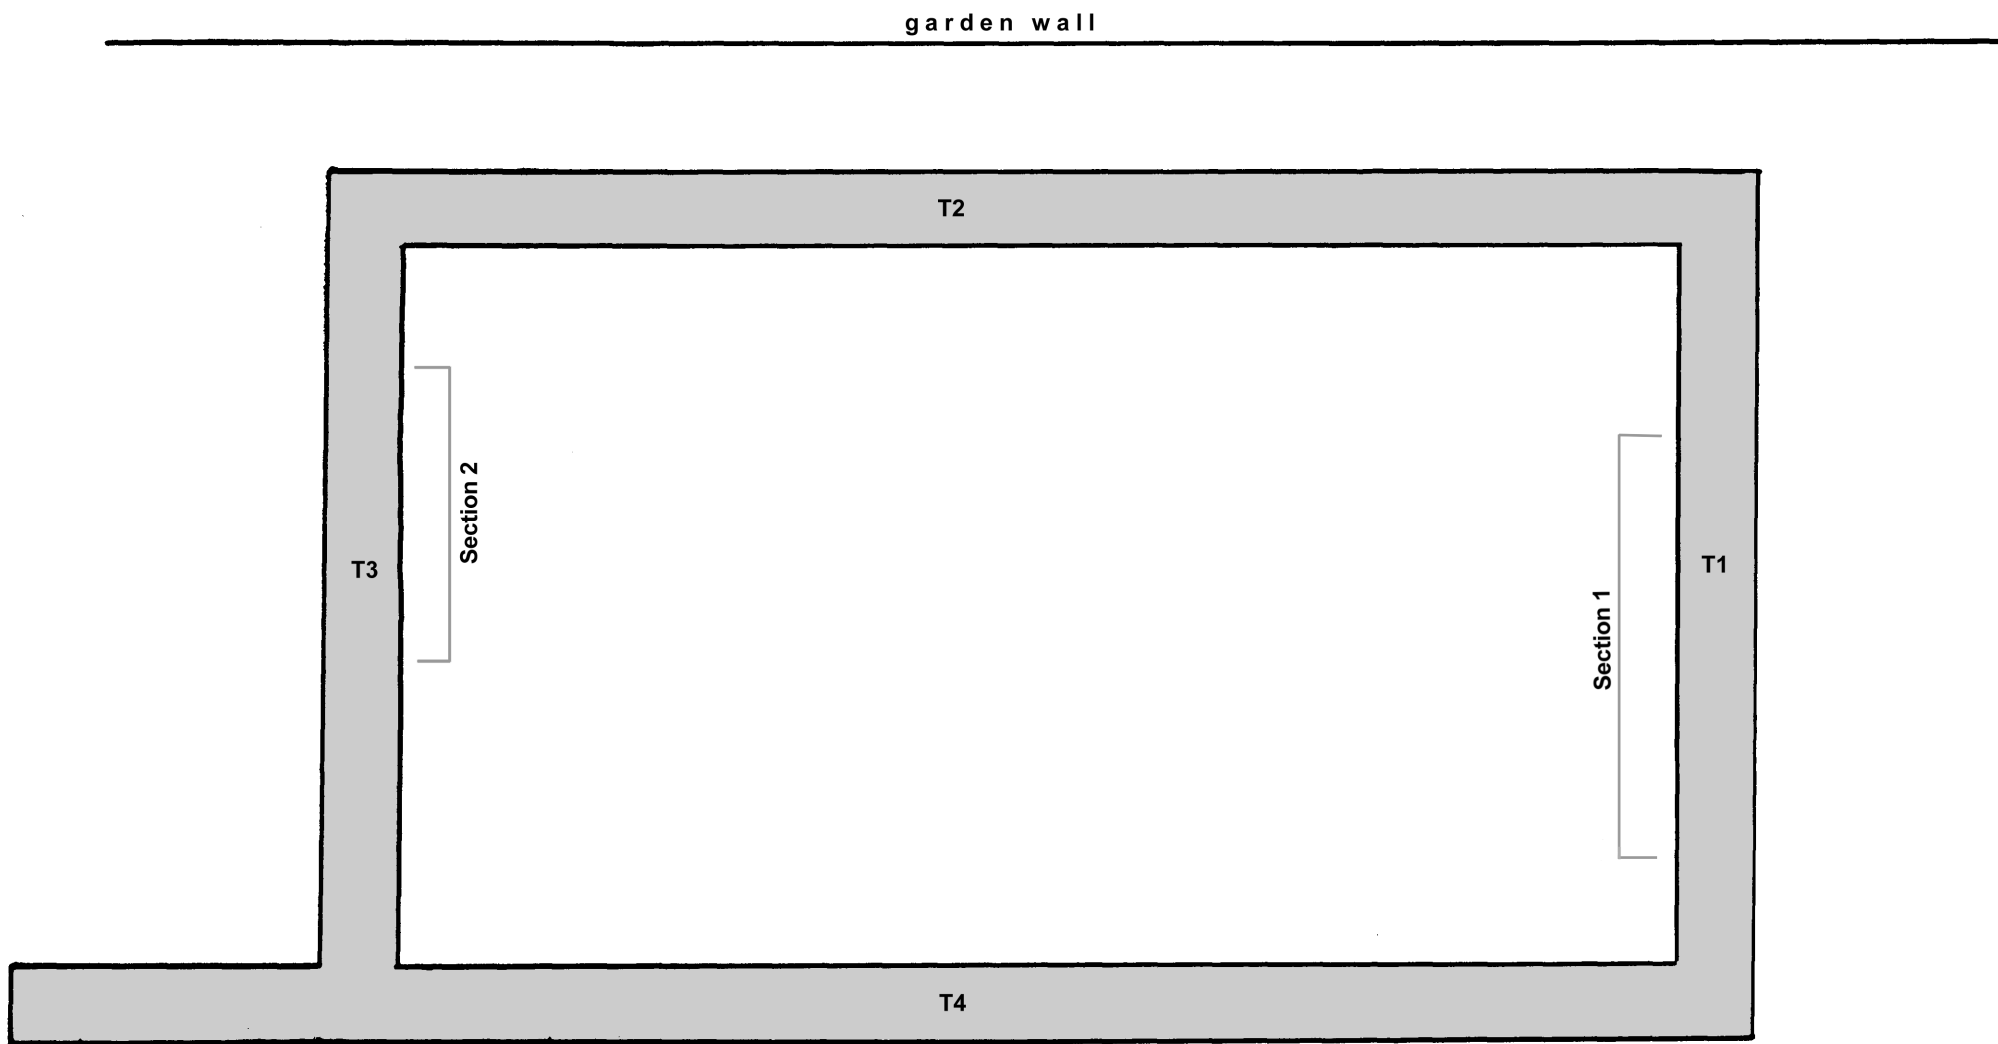
Fig 2 Plan of foundation trenches for garage and workshop,  
scale 1:50.

All four foundation trenches (T1-T4) cut through the tarmac surface of the yard (Layer or L1) and its base of concrete, stone and modern brick (L2). These layers sealed L3, which was a mixed layer of dark brown and light brown silty clay containing modern brick and pieces of drain-pipe.

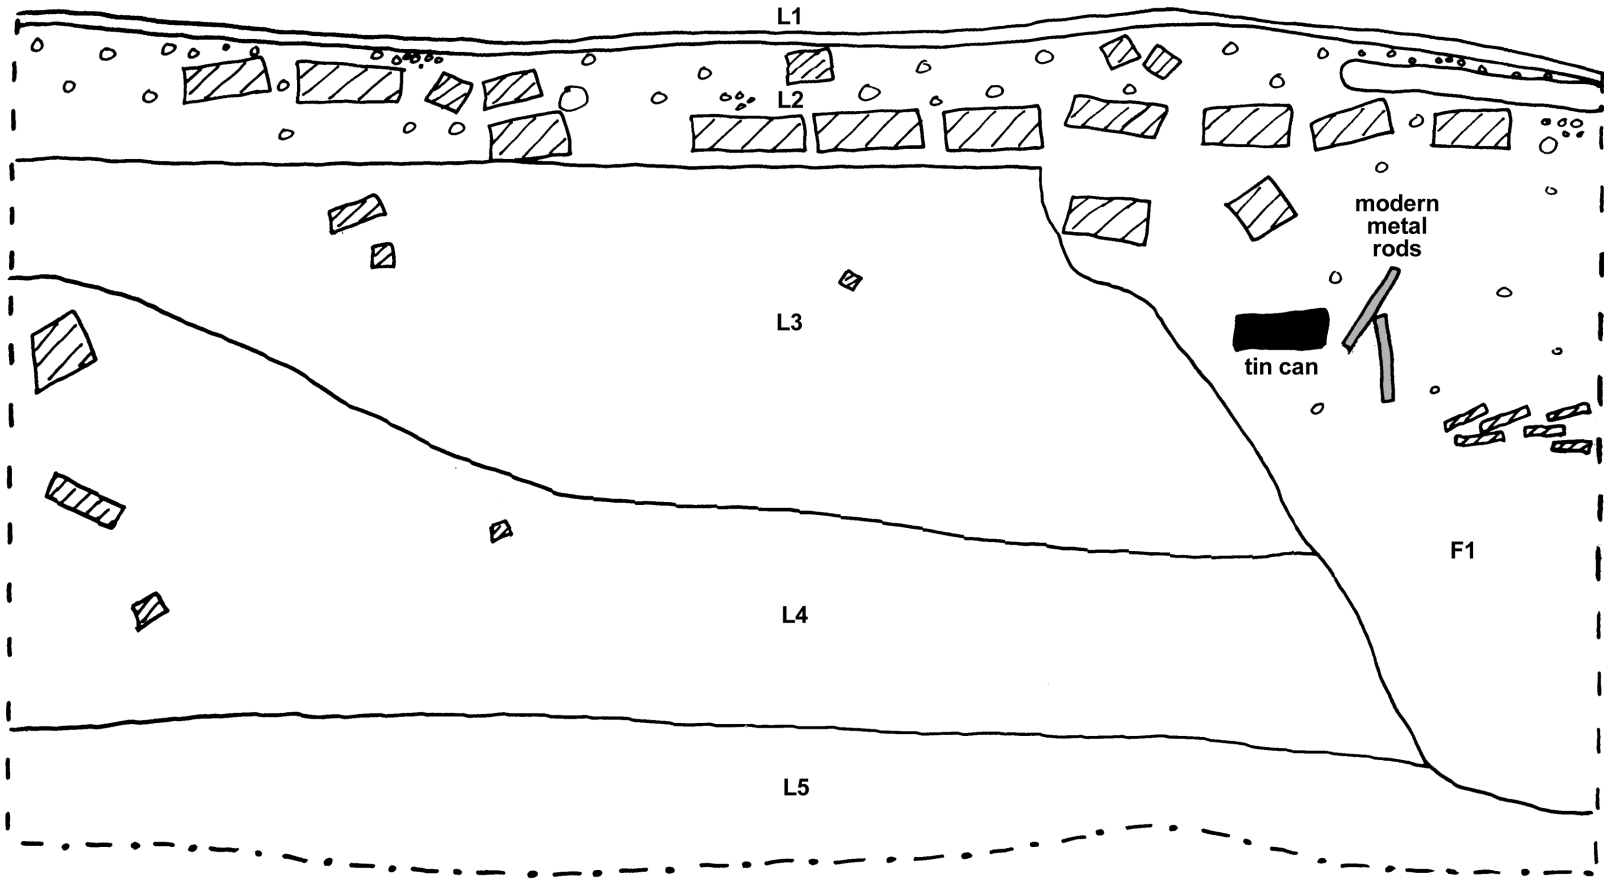
Fig 3 Section drawing of T1, Section 1;  
scale 1:15.

In the most easterly trench (T1), L3 overlay a dark brown sandy silty clay containing modern brick (L4). Natural light brown sandy silty clay was reached at between 1.2m and 1.3m below ground-level in this trench. L3 and L4 are modern material which was laid to level out the ground before the surfacing of the yard. A deep modern pit (F1) was exposed in the west-facing section of T1, cutting through L3 and L4. It was filled with modern brick, peg-tile, modern tin cans, metalwork and concrete (Section 1, Fig 3). This pit was also observed in both sections of the northern trench (T2).

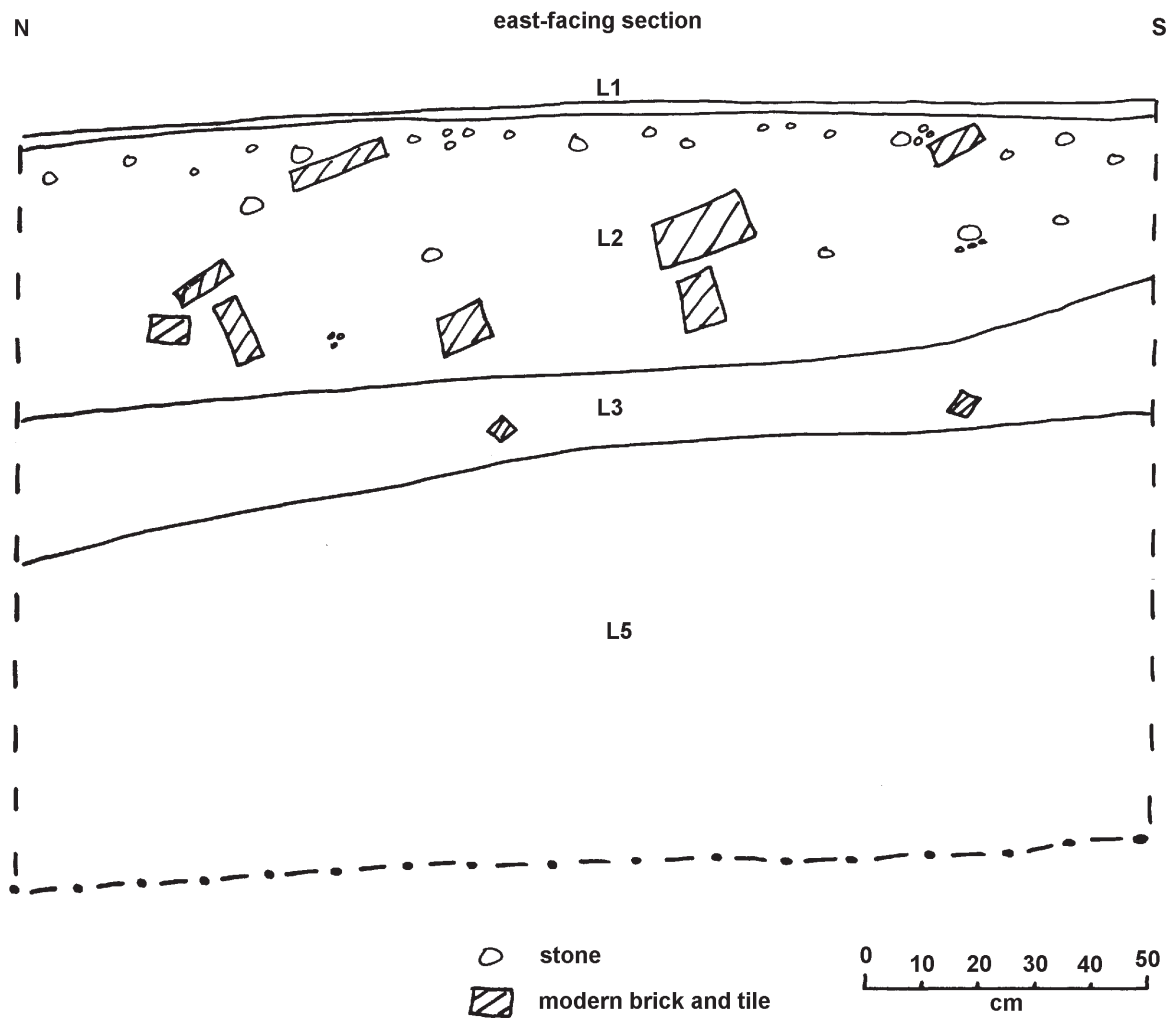
**Fig 4** Section drawing of T3, Section 2;  
scale 1:15.

In T3, the western trench, the section drawing shows the modern L1-L3 sitting on top of the natural silty clay which sloped down from south to north, thus demonstrating the levelling out of the slope (Section 2, Fig 4).
