**Archaeological building recording at  
Tubbeswick, Mill Road, Mile End,  
Colchester, Essex  
May 2011**

**report prepared by  
Chris Lister**

**on behalf of  
Mersea Homes**

**CAT Report 595**  
June 2011

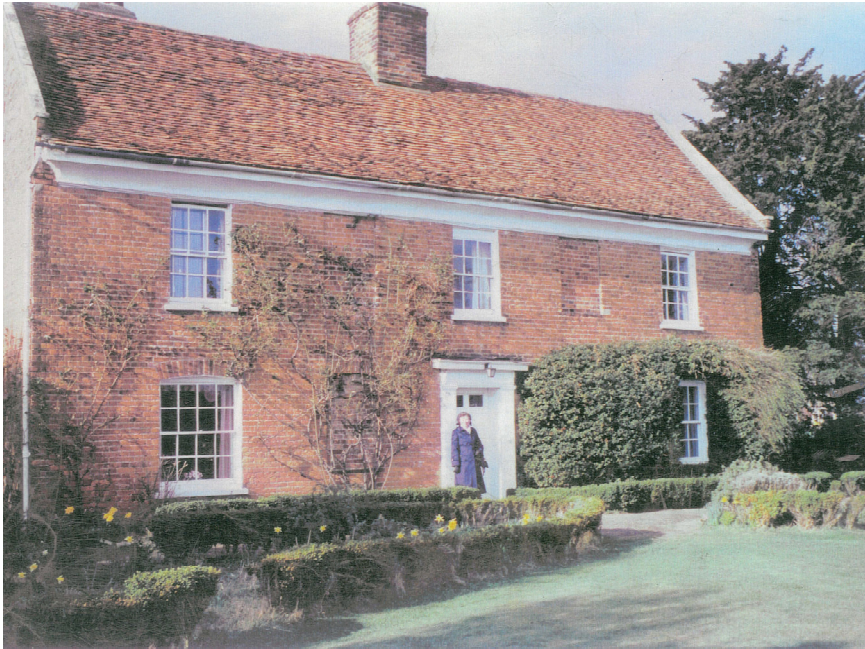
The south elevation (Plates 1, 3) was two storeys of red brick laid in Flemish bond with a five-window range to the upper floor and a centrally-aligned door in the ground floor. The elevation was symmetrical through this doorway and the brick chimney stack along the ridge line of the peg-tile roof. The central door had six panels, the upper two being glazed, set within a timber doorcase with a flat protruding hood. One bricked-in window under a segmental arch and with a brick sill was to either side of this with one eight-over-eight unhorned sash with stone sill to each of the outer window bays. The first floor alternated between three six-over-six unhorned sashes with stone sills and two bricked-in windows with brick sills. One brick (left of the first floor west window) bore an inscription 'HDF/1752' (Hannah Defoe). Below the eaves was a concave plaster cornice (Plate 7).

**Plate 1: Tubbeswick Farm south elevation prior to the 2009 fire.**

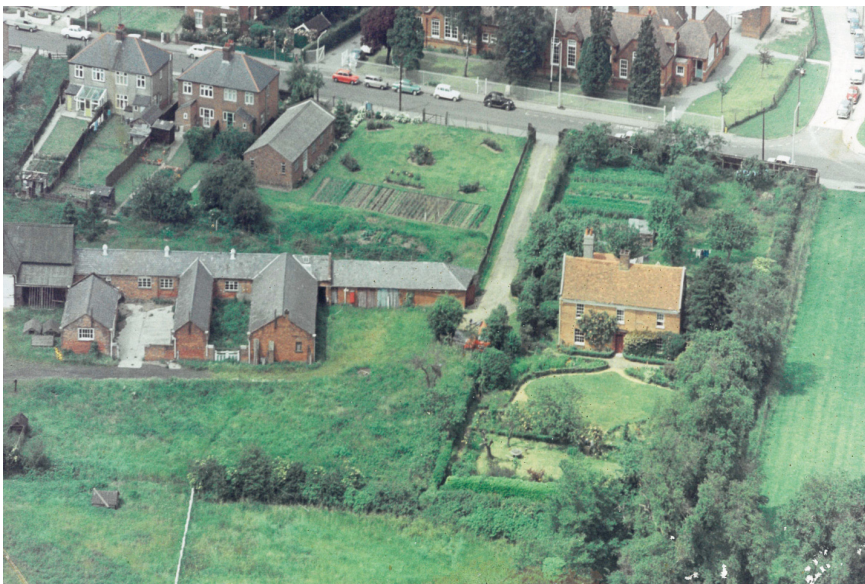
By the time of the 1875 Ordnance Survey 1st edition map, Tubbeswick appears unchanged in form from its appearance at the time of the building survey (Illustration 3). Although the name (having lost an e) shows signs of etymological evolution the map clearly shows the full double range plan form along with the lean-to extension to the east. The formal garden layout to the south of the house can also be made out as can lines of trees (presumably an orchard of some type) to the north of the property. Outbuildings to the west of the farmhouse can be observed, including a long ranged building that could be interpreted as stables. These outbuildings and garden features can be observed on an aerial photograph dated to the early 1970s (Plate 2).

Although the land to the north-west has been developed, this photograph (Plate 2) clearly shows a length of continuity at Tubbeswick stretching from at least the mid 19th century through to the latter half of the 20th. That continuity had come to an end by 1986 (Illustration 4) after the disposal of the outbuildings to the west for redevelopment purposes. At this point, the surrounding grounds at Tubbeswick were reduced in size to the approximate 0.35 hectare rectangle of land which contained the structure as surveyed.

**Plate 2: aerial photograph of Tubbeswick Farm showing farm buildings to the west.**

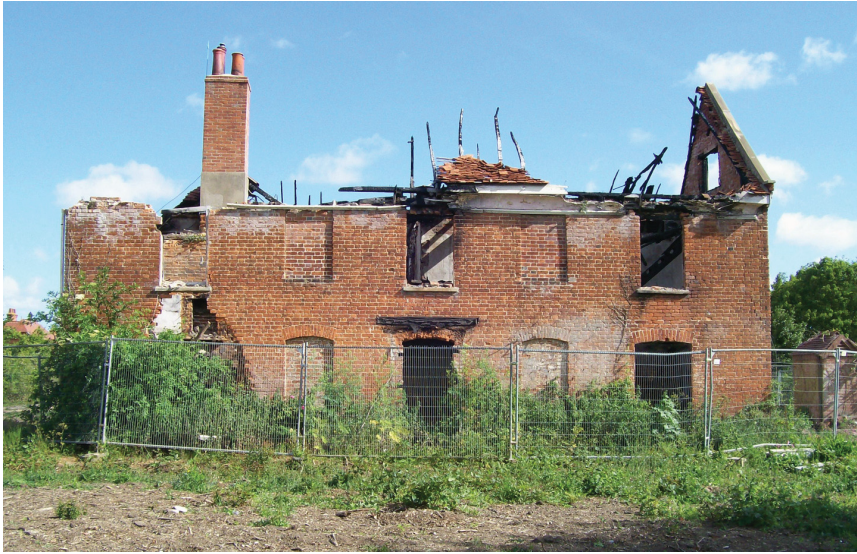
**Plate 3: south elevation.**

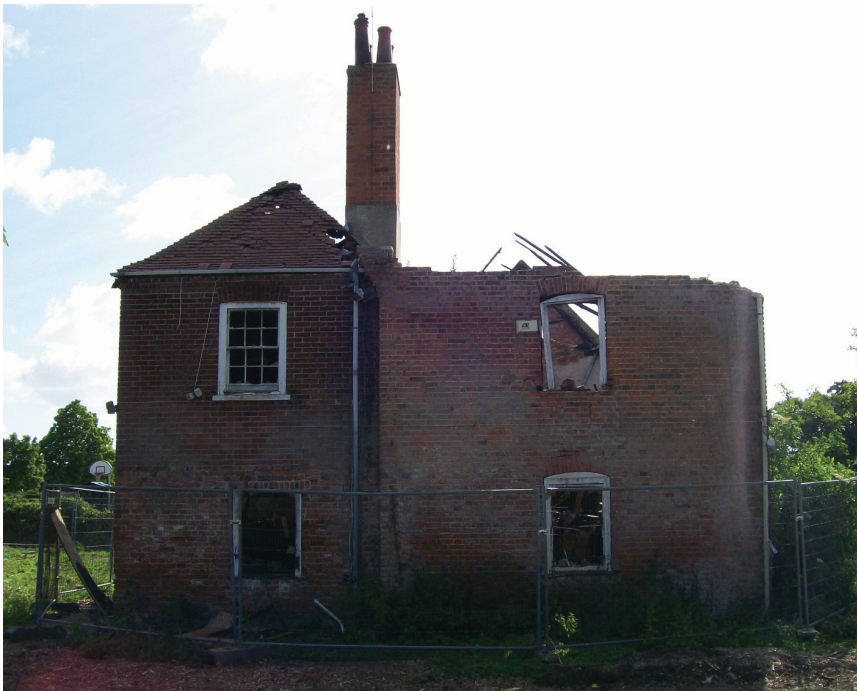
The west elevation of the Main House was of two storeys of red brick laid in Flemish bond with a high gable containing attic space (Plate 4). There was one six-over-six unhorned sash window with segmental arches and stone sills to each floor, with a segmental-headed casement with glazing bars to the attic above. The north range was recessed from the Main House with the ground floor being of red brick laid in Flemish bond and having a non-centrally located six-over-six unhorned sash window with wooden sill. Three courses above this window a second storey had been built or rebuilt. This was laid in stretcher bond (suggesting cavity walling) and had a hipped roof of machine-made tile. A six-over-six unhorned sash window with segmental arch and stone sill was centrally located within this upper floor (Plate 8).

**Plate 4: west elevation.**

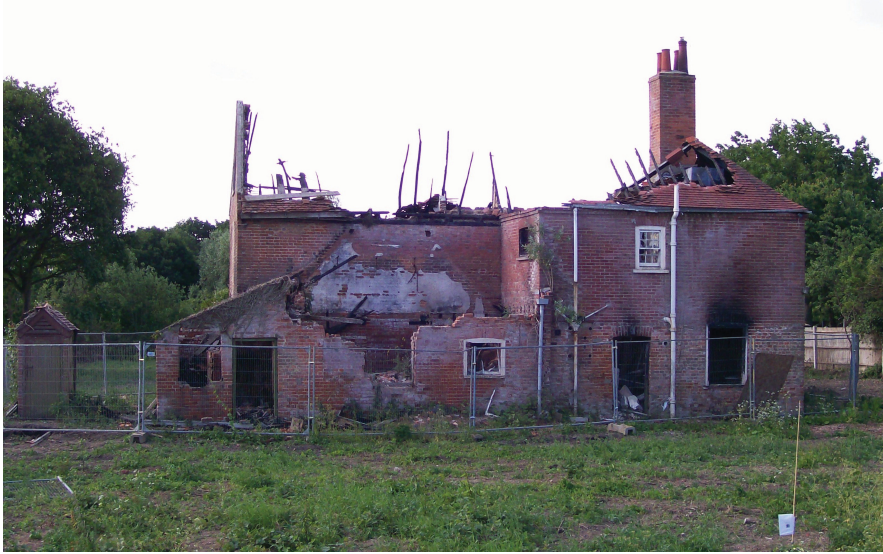
The north elevation comprised three structures (Plate 5). The west structure was recessed from the rest of the range and was two storeys in height. The ground floor was of red brick laid in Flemish bond with an eight-over-eight unhorned sash window with wooden sill and segmented arch to the west and a plank door to the east. Immediately to the east of this door was a bricked-in window with eight glass bottles in a rough X set into the brickwork (Plate 9). The upper floor was a second storey that had been built or rebuilt. This upper floor was laid in stretcher bond and had a hipped roof of machine-made tile. A six-over-six unhorned sash window with segmental arch and stone sill was located just to the east of the centre of the wall. A chimneystack rose from the main wall plane behind this second storey. The central structure of the north range was a single storey with a high gable (rising higher than the eaves of the Main House) of red brick laid in Flemish bond roofed in slate. The high gable incorporated attic space with a centrally located casement of twelve lights with glazing bars. To the west was a two-over-two horizontally sliding sash with a wood sill and segmental arch. This was mirrored to the east by a bricked-in window that had been truncated by a replacement two-over-two unhorned sash window with wooden sill and segmented arch. Attached to the east side of the central structure was a single storey lean-to of red brick laid in Flemish bond. This had a shallower pitched slate roof and projected east from the north range. A plank wood door was to the west and a casement with glazing bars to the east. The concave plaster cornice below the eaves of the Main House could be observed to the east and west of the gable.

**Plate 5: north elevation.**

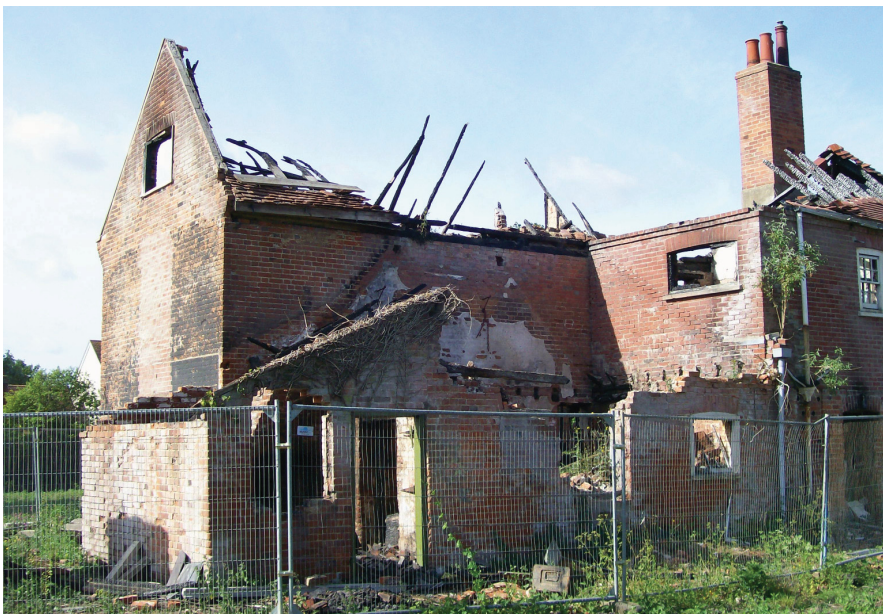
The east elevation comprised the Main House to the south and elements of all three of the structures forming the north range (Plate 6). The elevation of the Main

House was of red brick laid in Flemish bond. The central area where windows were present in the east elevation was taken up by brick infill from ground level up to the eaves. Either side of this infill the brickwork had been painted black. Centrally located within the high gable was a segmental-headed casement with glazing bars that admitted light to the attic. At the north end of the east elevation a plain red brick wall projected. This formed the external wall of the lean-to. Above this could be seen the slate covered roofs of the north range. Obscured by the high gable of the central structure, the east face of the second storey to the west contained a long, shallow casement with glazing bars.

The rest of the north range was clearly constructed after the Main House. With the fire damage exposing the interior, it could be seen that the central structure with its high gable and slate roof was built up against the north wall of the Main House, cutting through the plaster cornice (Plate 6). The slate rather than peg-tile roof covering and the fact that purlins were used in the construction, when they were not in the roof of the Main House, indicates that the two were not contemporary. It is likely that the central structure was added in the 19th century. The large fireplace at the east end hints that the structure may have been added to increase the domestic capacity of the kitchen to the west, possibly as a pantry or scullery. This probably reflects the changing attitudes to dining from the Georgian to Victorian periods or (perhaps more likely, considering the Victorian-looking outbuildings of the rest of the farm), the expansion in the number of people working on the farm and being fed from the farmhouse. The attic space above this pantry may either have been additional servants' quarters or storage. This is represented as Phase 2 on Figure 7.

**Plate 6: the east elevation (oblique angle).**

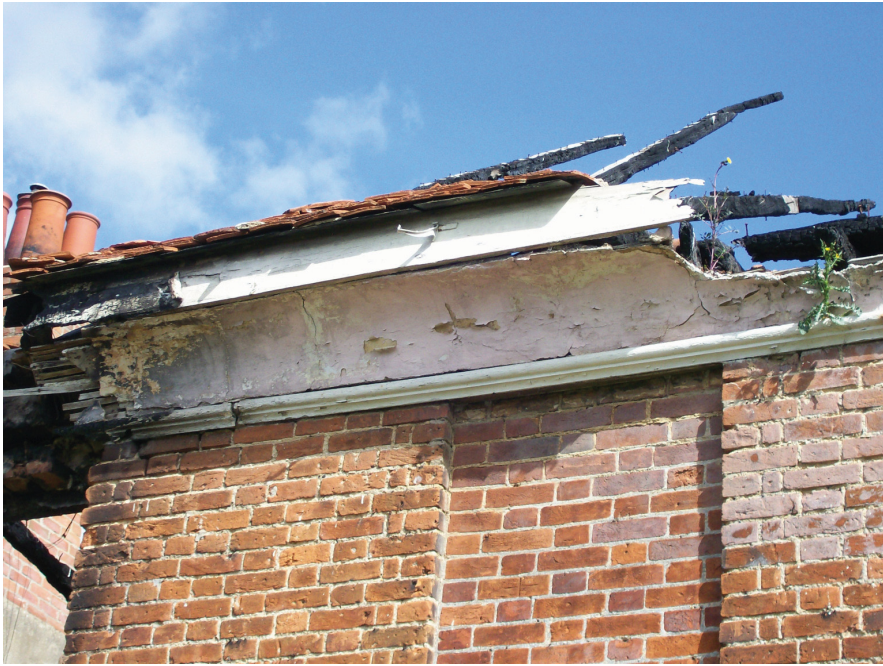
**Plate 7: detail of the plaster cornice and eaves.**

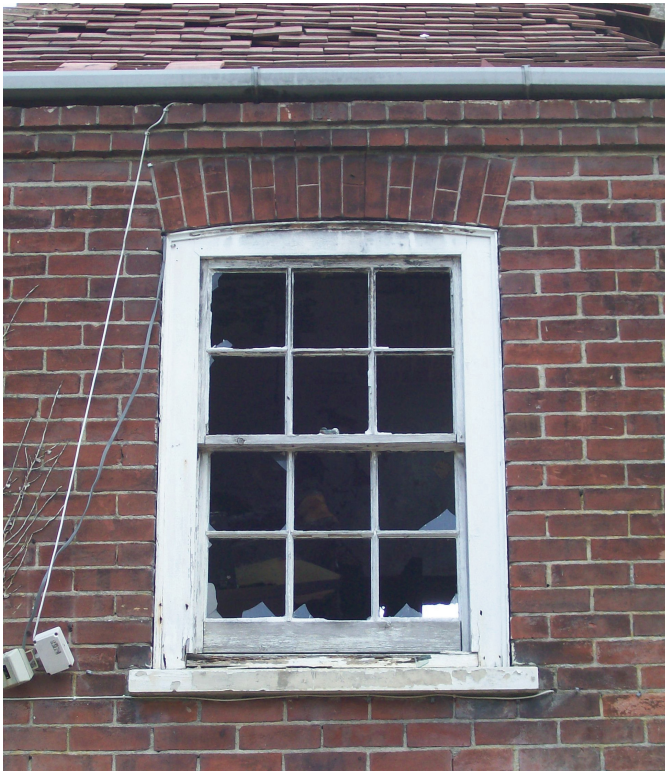
**Plate 8: west elevation upper-storey sash window.**

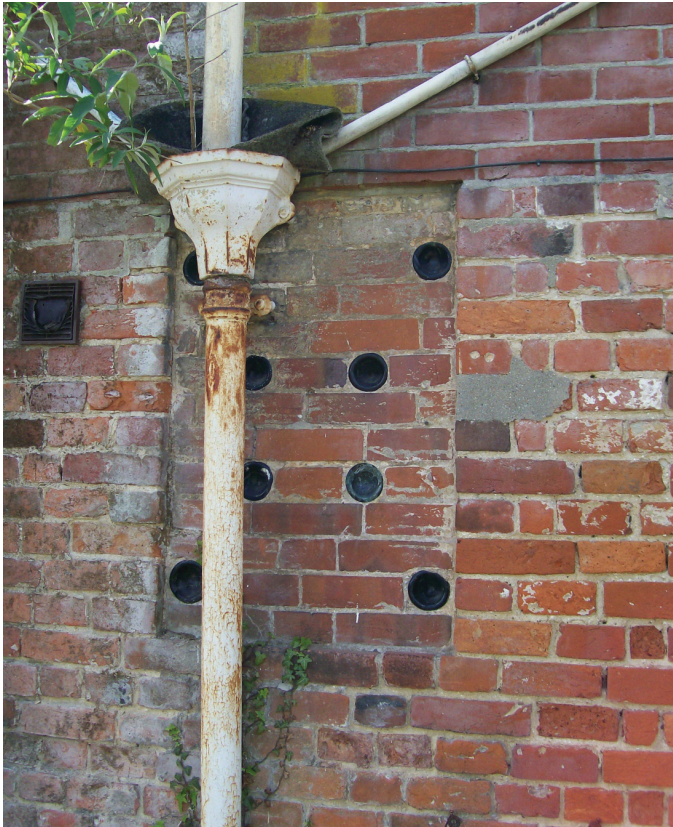
enlarged and dropped at the same time as those in the south elevation. The small bricked-in window to the east of the kitchen door was probably a late alteration. The bottle bases interspersed through the infill appear to be wine or beer bottles of early 20th-century design, although this cannot be confirmed.

**Plate 9: north elevation, detail of bricked-in window and bottle bases.**

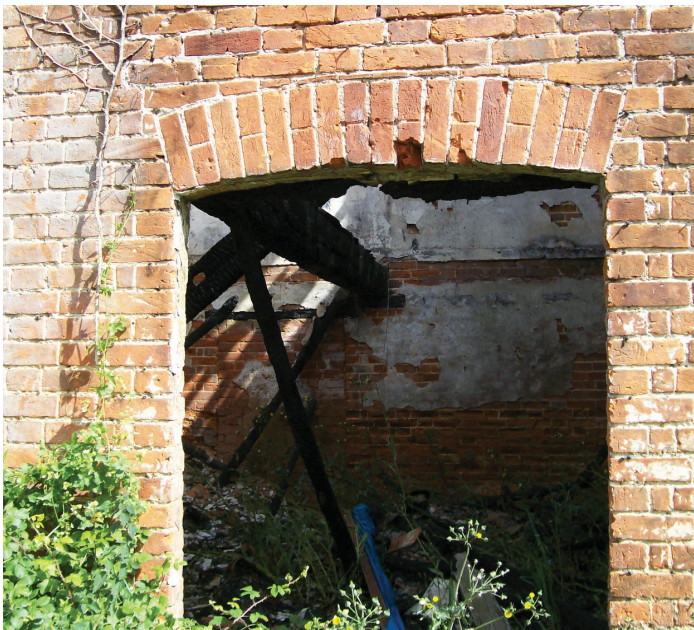
**Plate 10: south elevation, east ground-floor room, showing oak bridging beam and blocked-in window.**

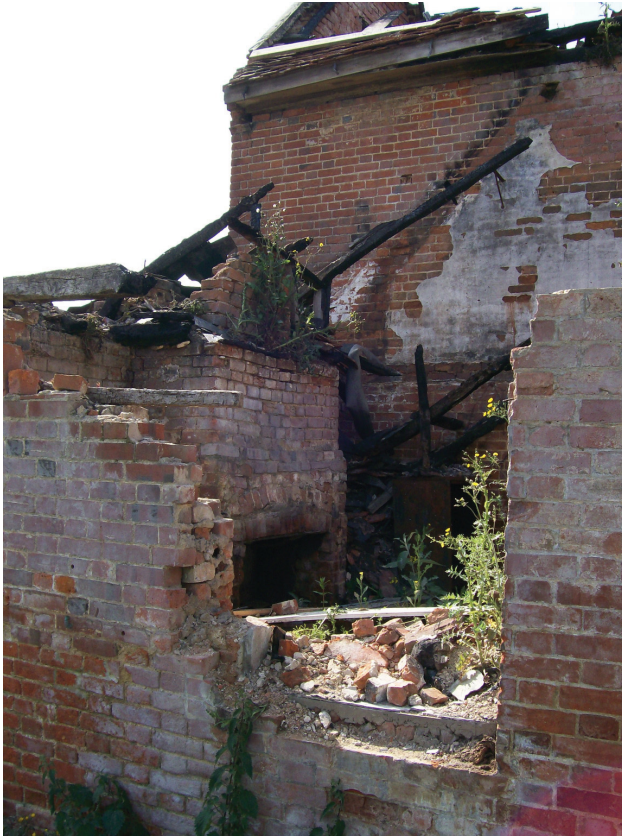
**Plate 11: north elevation, showing pantry fireplace.**

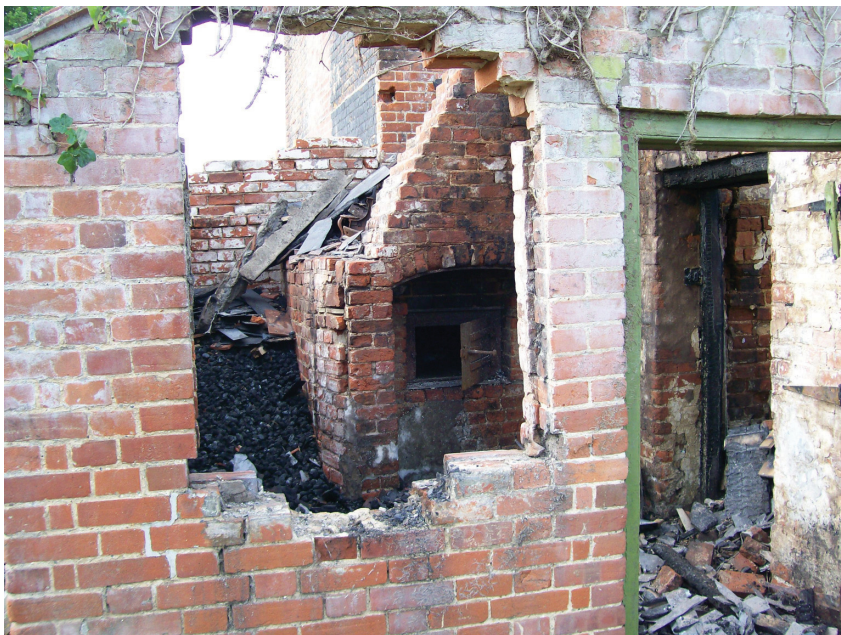
The brick lean-to at the east end of the pantry is a later addition (Phase 3 on Figure 7). This could clearly be seen in the change in the pitch of the roofline and in the discrepancy in the height of the brick course with that of the pantry. The large brick furnace in this lean-to suggests that this was a boiler room providing hot water to the house. The map evidence (Illustration 3) dates this structure to the 19th century. The out-house to the east of the lean-to is probably of 20th-century construction.

**Plate 12: north elevation - boiler room, showing furnace.**
