**Archaeological building recording at the Hope Inn,
16 High Street, Tollesbury, Essex
May 2011**

**report prepared by
Chris Lister**

**commissioned by Plater Claiborne
on behalf of Mr Robert Cannon**

CAT Report 592

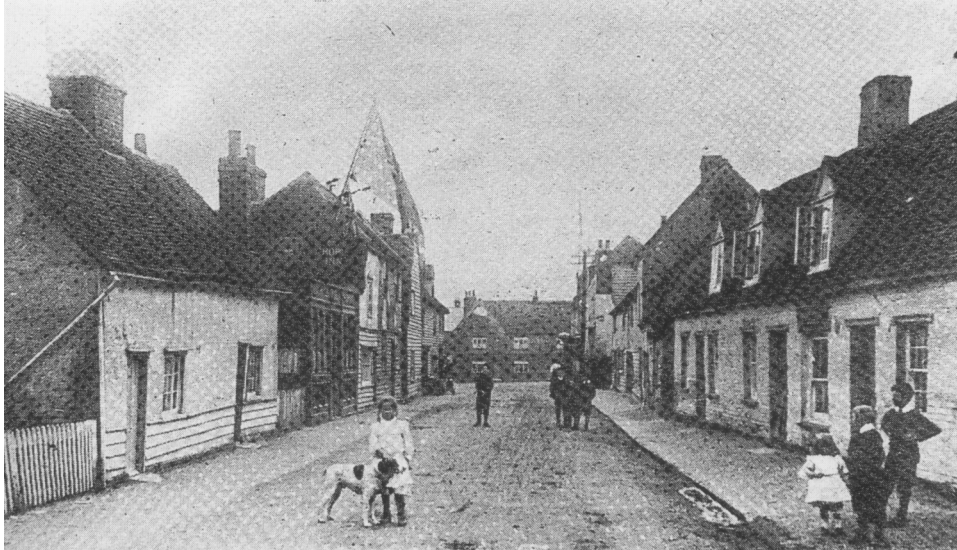
Plate 1 The Hope Inn before 1910.

captained HMS Defence at the Battle of Trafalgar (Lovell, 1991). Although Sir George had no direct connection to Tollesbury, the village has a strong maritime tradition (compare other former public house names in Tollesbury such as the Plough and Sail, the Hoy [a small, one-masted vessel] and the Ship Ahoy), and it is highly likely that this is for whom the inn was named. Indeed, the size of the flag flying from the pre-1923 Hope Inn (pictured below) is reminiscent of those displayed by ships o' the line of Sir George's day.

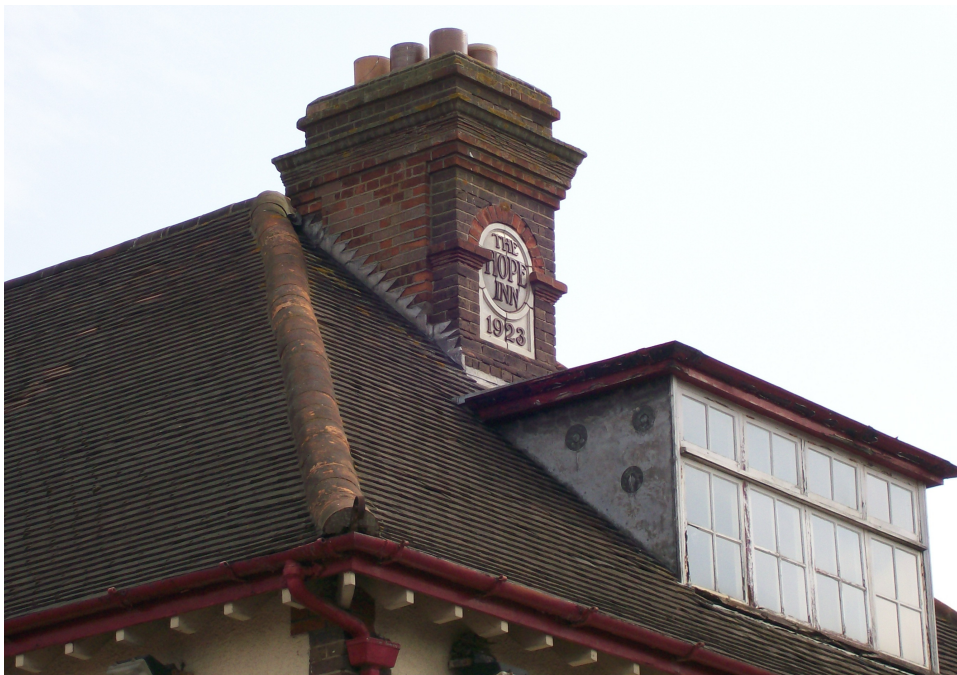
Plate 2 Glazed plaque showing date of construction.

Continuity of name did not extend to the actual structure itself, however. Sales particulars attributed to 1922 (found at the Inn by the current owner) suggest the inn's owners sold the property and that the new owners demolished the structure in favour of a more modern building. Direct proof that the Hope Inn was constructed in 1923 can be seen in the form a glazed plaque on the chimney of the south façade that clearly gives the date.

The south elevation has a protruding wooden porch, the supporting braces for which are carved wooden latticework, surmounting a doorway opening on to the High Street (Appendix Plates 1,2). This is flanked by two large windows with splayed arches of creasing tiles and glazed red brick sills. The wooden-framed windows each have three ranges comprised of six non-opening lights with a three light hung-casement window above. On the first floor there are similar sized windows with concrete sills and less ornate splayed arches of creasing tiles. These are wooden framed with three ranges of six lights, the outermost ones being casements, with three ranges of three lights above, the central one being a hung-casement. In between these is an arched dummy window with a concrete sill and a surround of creasing tiles. Above the eaves is a dormer window of four ranges of four lights, each with two lights above. Here the lower outer ranges are casements and above the two central are casements. To the rear of the dormer rises a red chimney with six flues. This has a glazed plaque on its south face recording the name and date of the Inn (Plate 2).

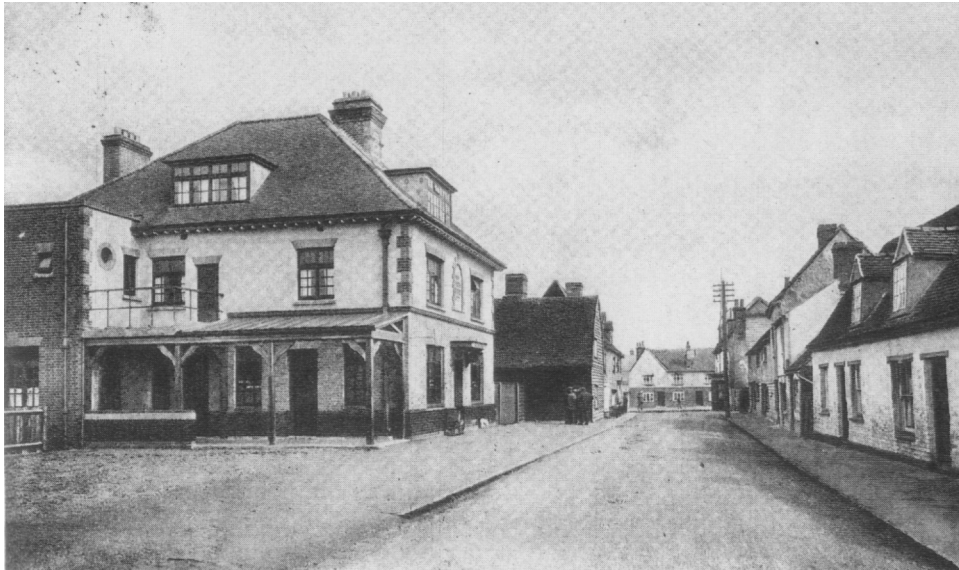
Plate 3 The Hope Inn, 1925.

Externally little changed in the nine decades of the Hope Inn's existence. The only major changes to the exterior came with the addition of a single storey extension at the north-west corner of the north wall in the 1950's and the removal of the veranda on the west side (see Plate 3) and its replacement with a plank-clad extension in the 1970's (see Plate 4).

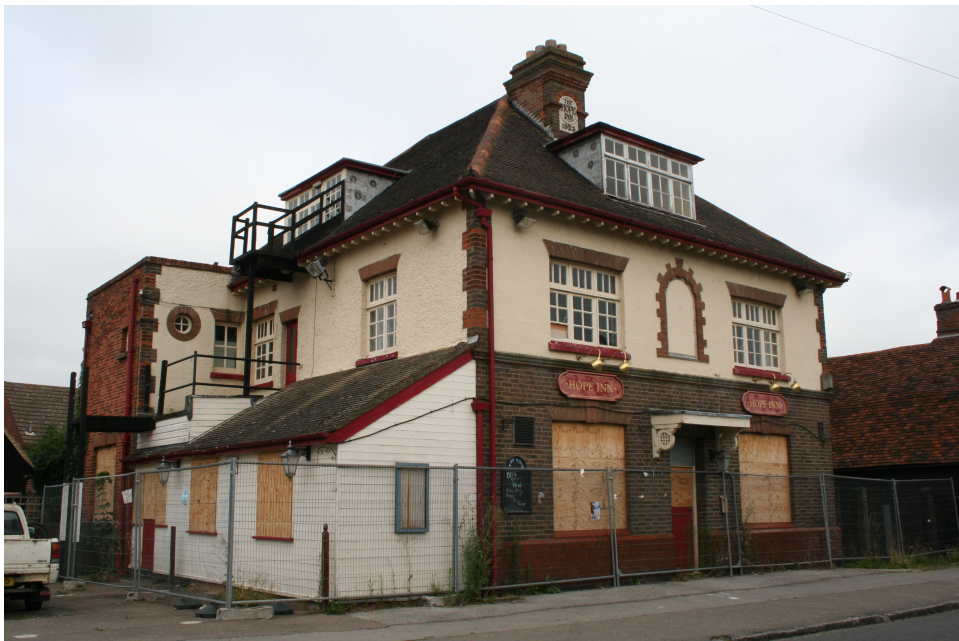
Plate 4 The Hope Inn 2011.

The west elevation (see Plate 4) has had significant alterations made to the ground floor. The removal of the veranda and its replacement with the plank-clad extension necessitated the removal of a door and two windows from the west wall (which remain as archways). The façade of this extension has two windows, each two ranges of six lights with two lights above. A pitched roof is above this part of the extension. North of this the roof is flat to provide a fire escape from the first floor (this is part of an external wooden fire escape from the dormer on the second floor). Below the flat roof is a doorway flanked by two windows of two lights each. The first floor is unaffected by alteration and has two windows of two ranges of six lights with two ranges of three lights above each. Of these the southern window has upper and lower casements on the south side, whilst of the northern window only the upper lights are casements. The northern window is situated hard against the projecting wing and north of the aforementioned doorway that leads out on to the flat roof. As can be seen in Plate 3 this doorway has always provided access on to a flat roof, previously that of the veranda, although it is not possible to say if this was originally intended as a fire escape. Both windows and doorway have splayed arches of creased tiles. Located above the doorway is dormer window identical to those on the south and east sides.

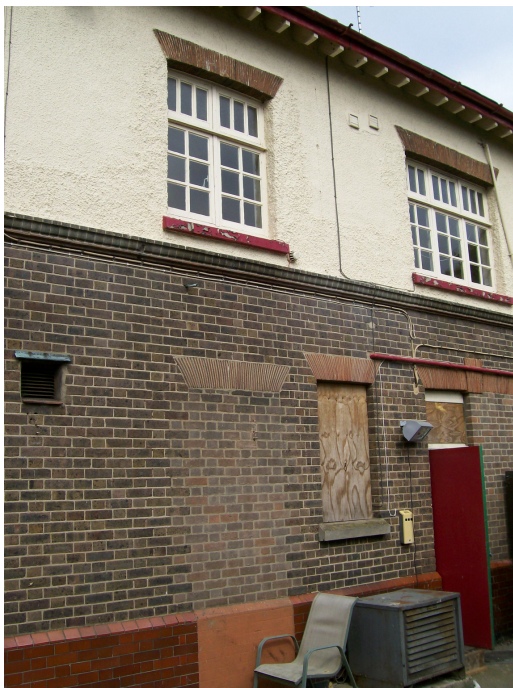
The east elevation has a large ground floor window of the same type as the south elevation, a fire door and two other windows. This large window is one of two flanking a centrally located door. Both the door and the window (to the north) have been infilled with brick. The fire door has been cut through the infilled north window. A small window has been inserted to the north of this. Both the original windows have the same ornate splayed arches of creasing tiles associated with the south elevation, with the infilled door and a contemporary window just north of this having less ornate arches. The first floor has identical windows as those of the south elevation, positioned above the large lower storey windows with a two range wooden framed window positioned above the infilled doorway. Above the eaves is a dormer identical to the one on the south elevation.

Plate 5 The east elevation showing the blocked door and window.

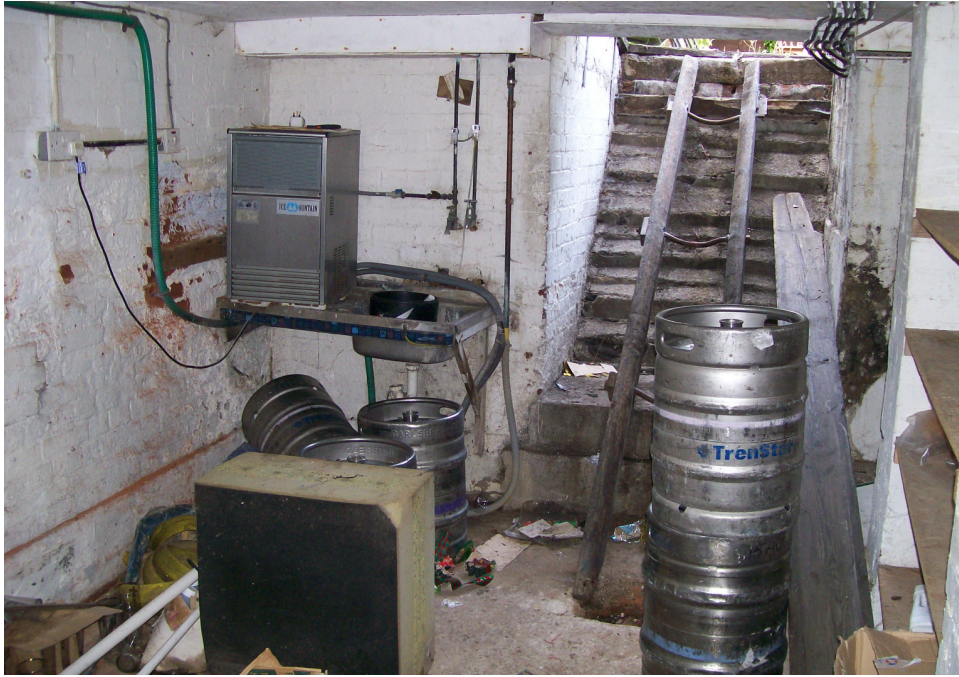
The cellar (Fig 2) has two access points, one from behind the bar area (down a flight of stairs) and one from outside at the rear of the Inn. This is where draymen would deliver barrels and crates of beer. Barrels were slid down a specially constructed ladder (Appendix Plate 5) and then moved to the barrel store beneath the saloon bar. Although the earlier Hope Inn may have had a cellar there is no clear indication that this has survived. As the entire building was rebuilt it is logical to assume this included the excavation of a brand new cellar. However, the dog-leg plan of the cellar could indicate the barrel store was associated with the earlier Inn and that the 1923 rebuild took advantage of an existing hole in the ground. If this is the case then extensive rebuilding took place in the cellar as the brickwork of both parts is continuous and shows no sign of jointing.

Plate 6 The cellar hatch and barrel ladder.

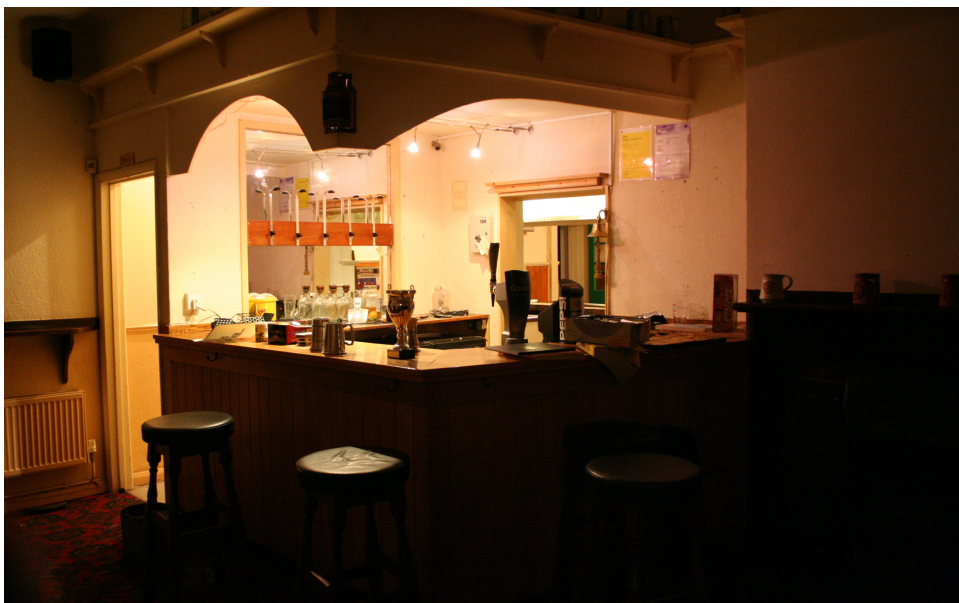
The lounge bar occupies the south-west quadrant of the ground floor and was expanded in the 1970's to encompass the area previously covered by the veranda.

Plate 7 The lounge bar.

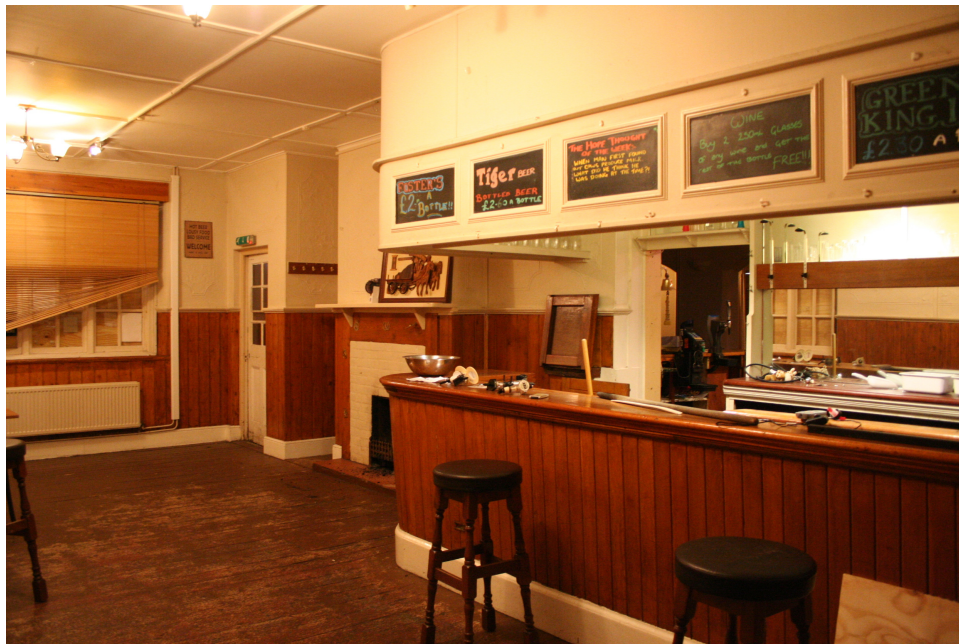
Plate 8 The saloon bar.

The saloon bar has exposed wooden floorboards with tongue and groove wooden panelling to the walls to a height of 1.4m. Above the dado rail the walls are plastered. Both panelling and plasterwork cover the blocked doorway in the east wall so cannot be original. A fireplace with a tiled hearth and a smaller grate than that in the lounge bar is located slightly north of the southern entrance (Appendix Plate 15). The long bar dominates about one quarter of the saloon bar and has an overhanging glass store. Both original entrances have an expanse of square black and white encaustic tiles instead of floorboards. Those by the blocked entrance lead north to a corridor off which the modern conveniences are located in the north-east quadrant.

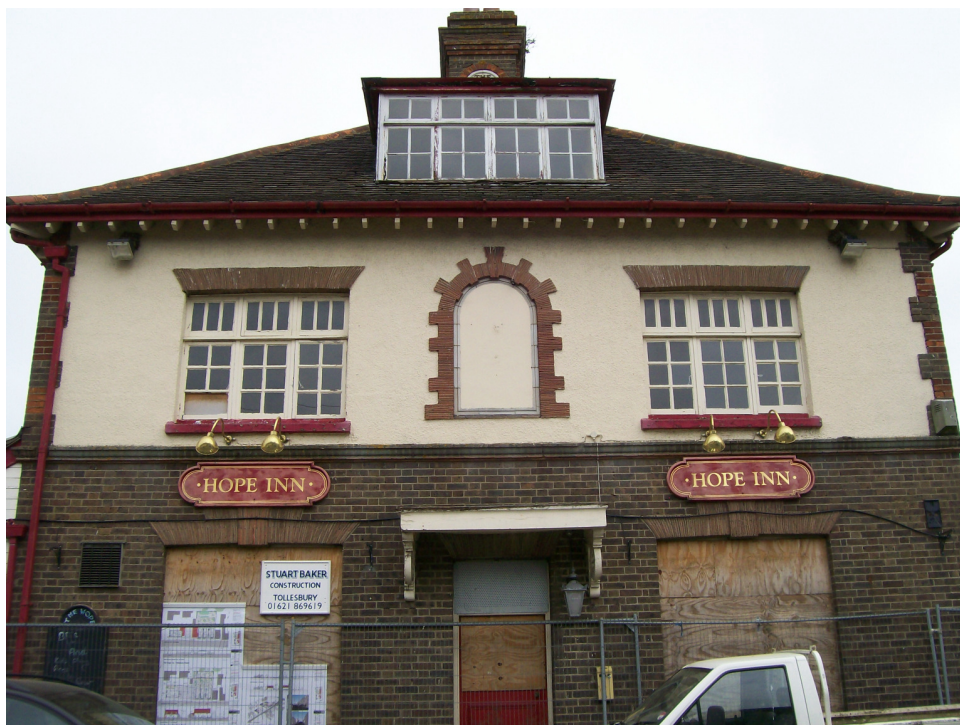
Appendix Plate 1 The south elevation.

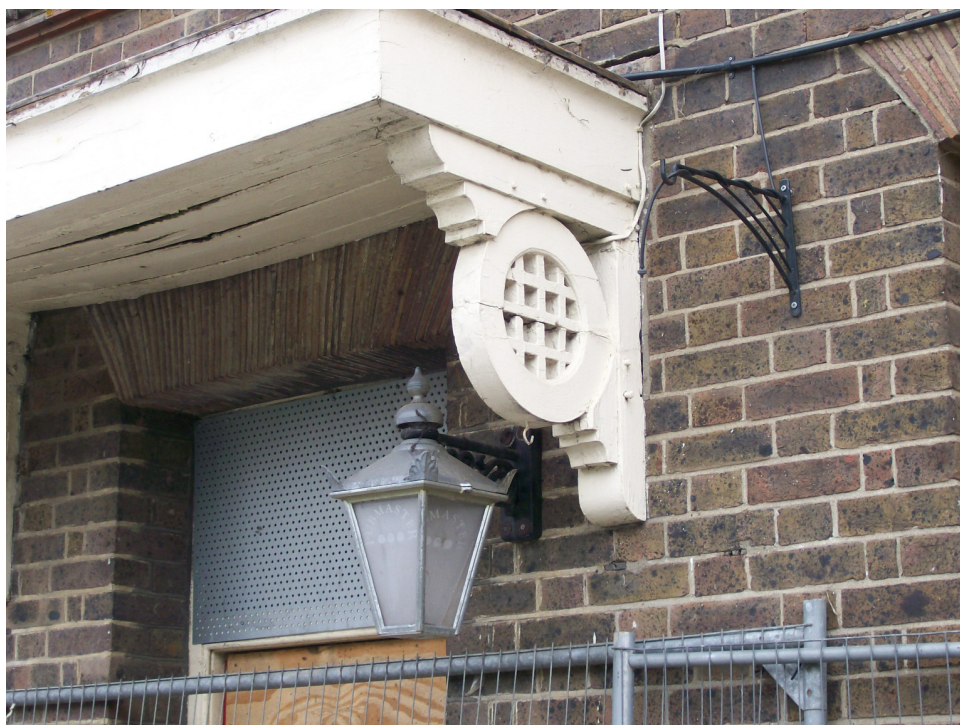
Appendix Plate 2 Detail of porch brace on south elevation.

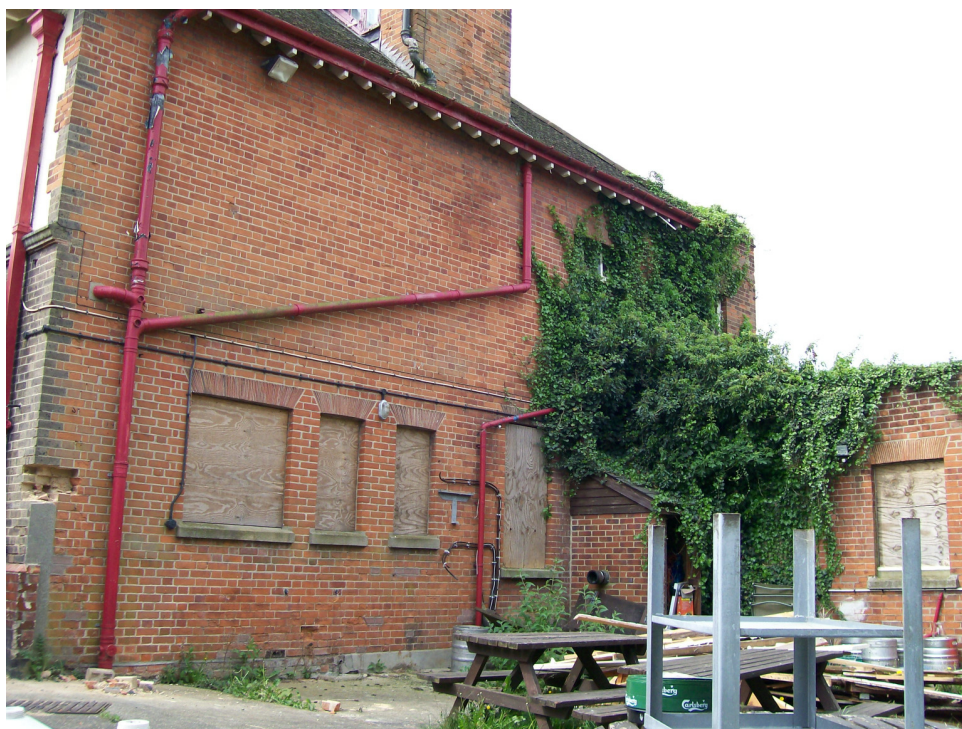
The north elevation (Appendix Plate 4) is of red brick laid in a Flemish bond. On the ground floor are four windows. One, taller than the others, shares the same height as those to the south and west although this is narrower, only having two ranges of three lights with two lights above. Below this window is the access to the cellar. The other three windows form a short range at the north-east corner, the outer being wider than the other two. All four windows have concrete sills and splayed arches of creased tiles. The first floor has two windows; the westernmost (technically part of the projecting wing) has two ranges of four lights with two lights above, whilst the one further east has two ranges of six lights with three above. Projecting through the roof above the eaves is a centrally located chimney with four flues. Attached to the south side of this chimney is a small dormer with triangular lights to the east and west.

Appendix plate 4 The north elevation.

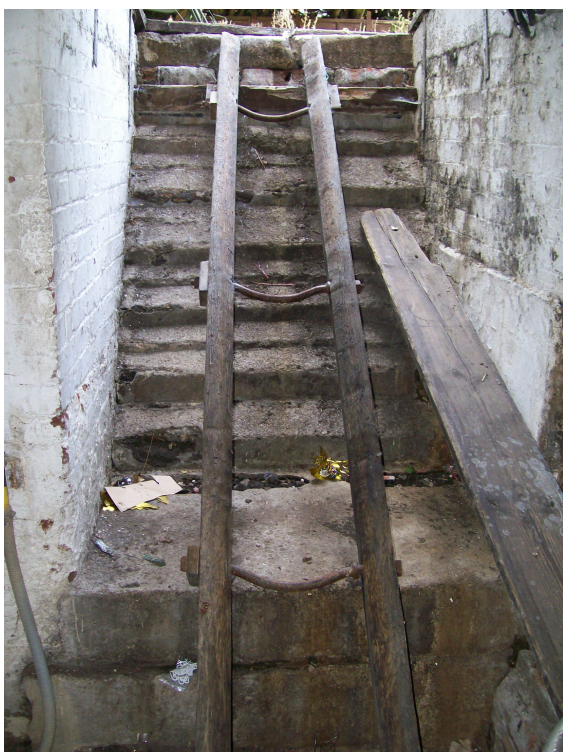
Appendix Plate 5 The barrel ladder.

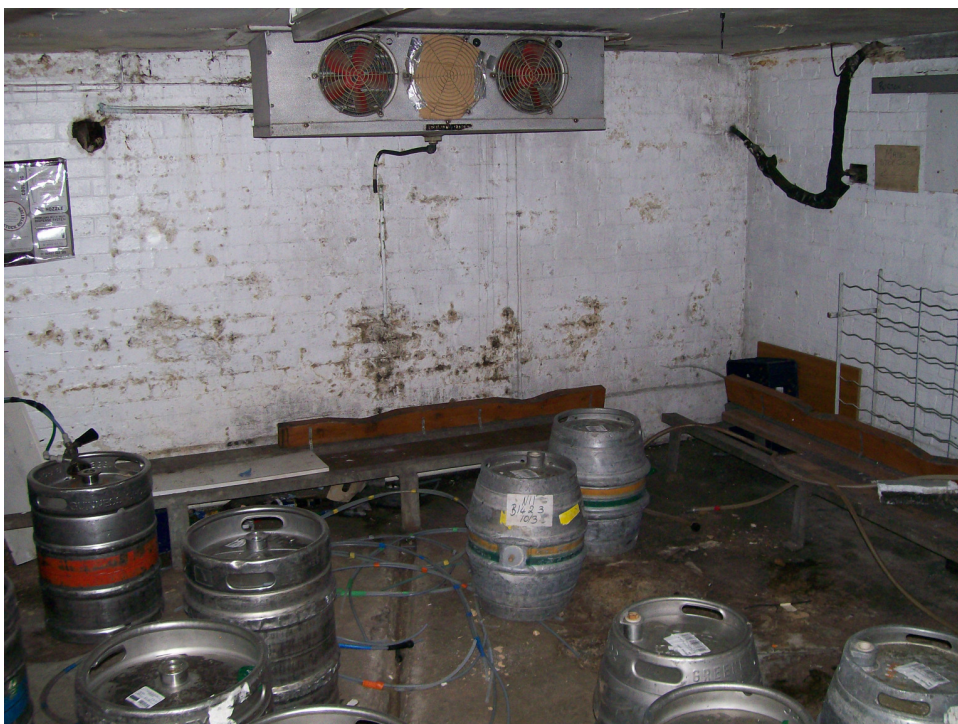
The brick-lined and concrete-floored cellar was designed to keep beer at a cool and constant temperature, as well as providing a secure location for the Inn's reserves of beer and liquor (Appendix Plate 6). At the base of the internal access to the cellar is a recess cut into the wall with a side-opening casement of four lights. This would appear to be for borrowed light, although it should be noted that as the upper opening of the light-well would have been under the wooden veranda the efficacy of this feature could be called into question (Appendix Plate 7).

Appendix Plate 6 The barrel store.

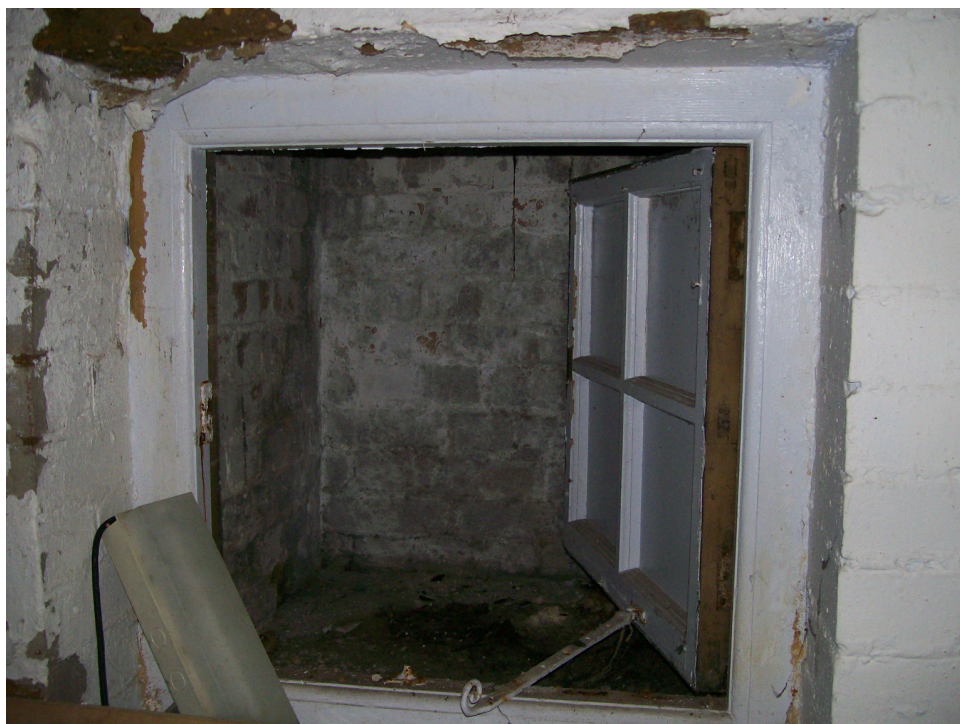
Appendix Plate 7 The lightwell.

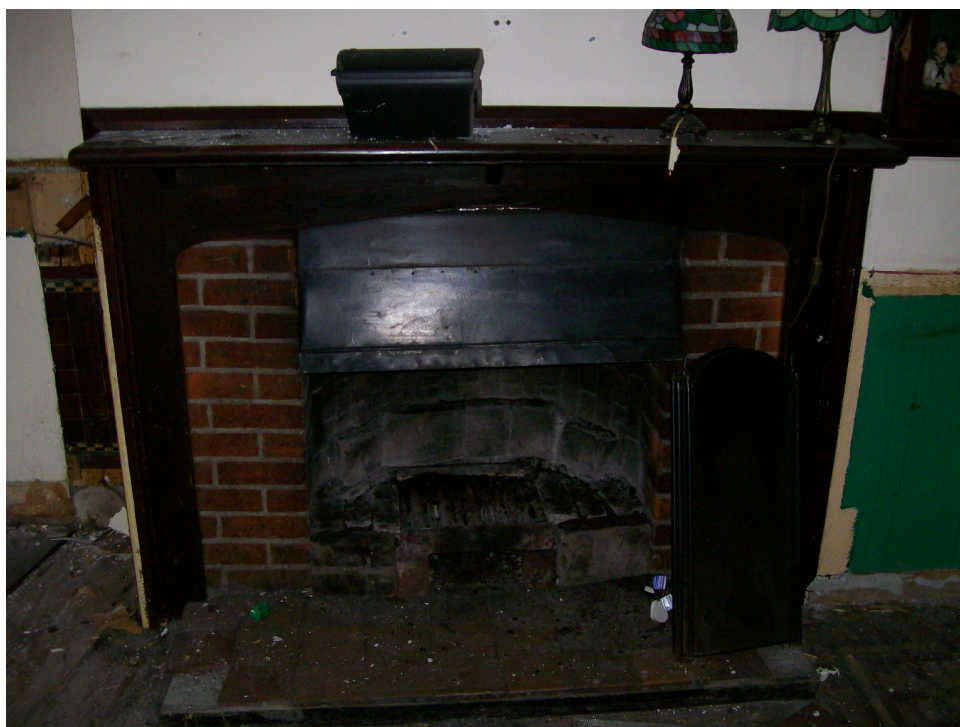
A large brick fireplace with a metal hood in the east wall would have been the focus point of the room (Appendix Plate 8). The original floor was a repeating pattern of black and red rectangular encaustic tiles with a surrounding border of red, black and yellow tiles (Appendix Plate 9). Although later access was through the door in the extension's west wall, the original entry would have been through the doorway in the west wall opposite the fireplace (now an arch [Appendix Plate 10]). The bar in its final position is not original - this is evident from signs of a wall since removed and tiles on the wall that are obscured by the current bar (Appendix Plate 11), but is probably not too far from its original position. The lines of symmetry adhered to in much of the building suggest the bar in the lounge might have looked similar to that in the saloon bar next door. The removed wall is in line with the north edge of the floor tiles and probably formed the dividing wall to the hallway and stairwell leading to the upper floors. The door (marked A on Fig 3) is a heavy external door with a porthole light that can be made out on Plate 3 (see also Appendix plate 12). Above this is a window of six small lights, identical to that over the main door in the south wall. What is currently the private door to the upper floors (directly at the base of the stairs) was once a window (again see Plate 3) and the stairs turned three risers up into the hallway (as the remains of a newel post [Appendix Plate 13] attest to) instead of being straight as they are now, and probably were open to the south side as they are on the first floor (Appendix Plate 14).

Appendix Plate 8 The lounge fireplace.

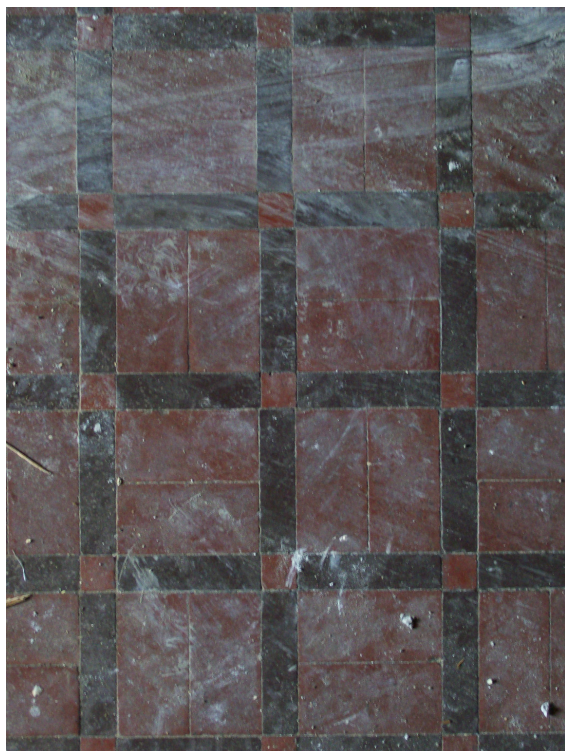
Appendix Plate 9 Detail of original lounge floor tiles.

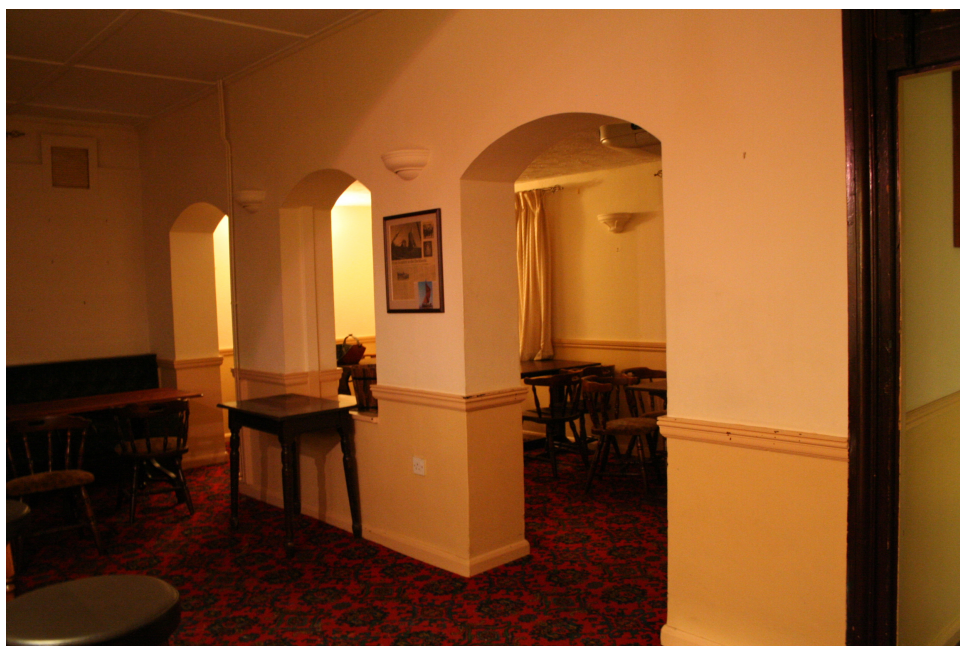
Appendix Plate 10 The extension to the lounge cut through the original west wall.

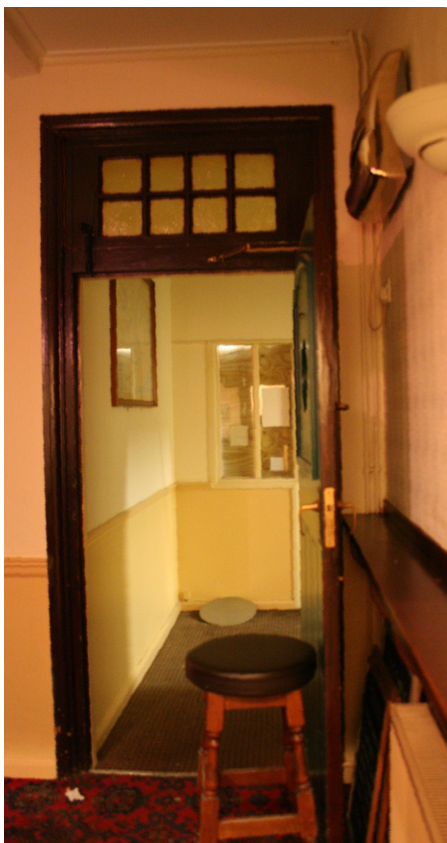
Appendix Plate 12 Original external doorway in west wall.

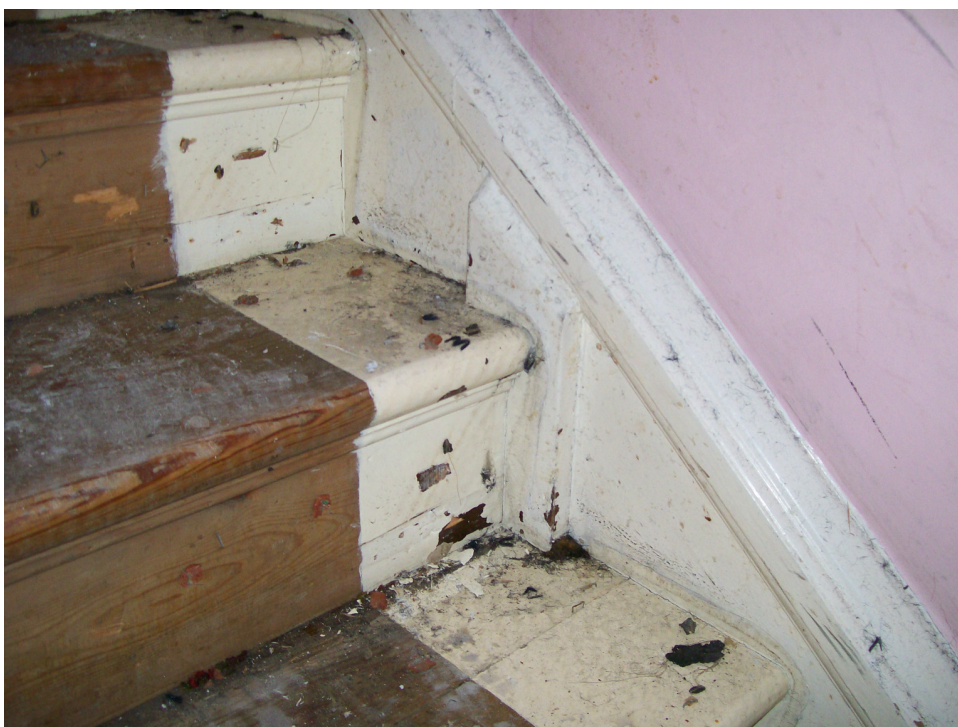
Appendix Plate 13 Groundfloor stairs with remains of original newel post.

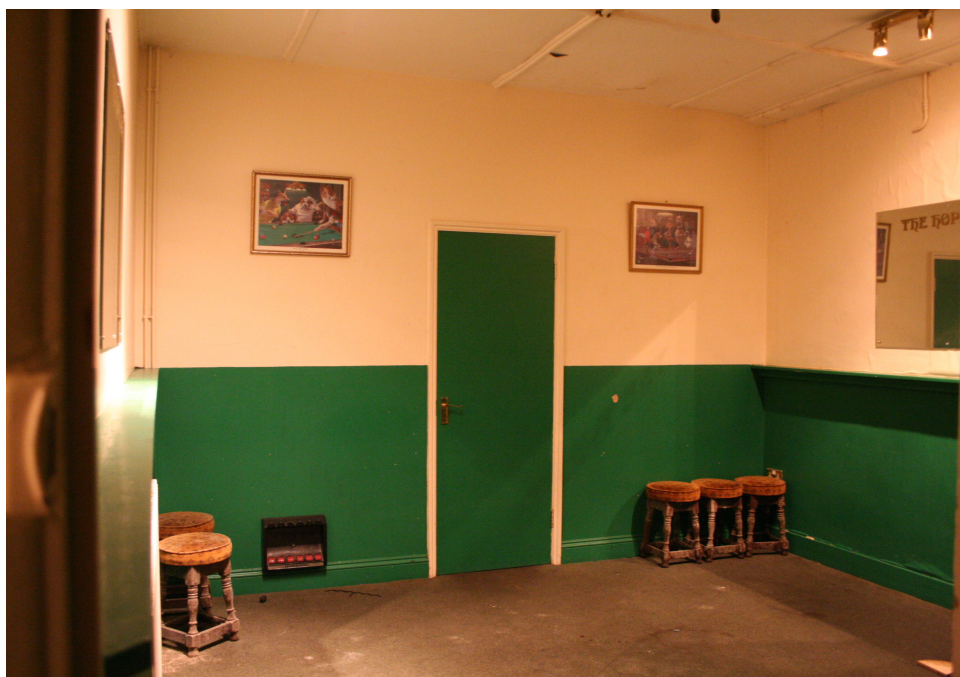
The north-west quadrant of the Hope Inn, the “back room”, was latterly used as a games room (pool) but was originally much larger (Appendix Plate 16). The dividing wall to the west is a later addition and the removal of this opens up the room significantly. The room has three modern access points, one from the bar and toilet area, one from the modern kitchen and one from the modern entranceway in the west wall. The first is probably original, the second is highly likely to be an original backdoor to the land behind the Inn and the third is probably an original window (this can be seen on Plate 3 but is partially obscured). The presence of a fireplace at the east end of the room (converted to a cupboard) and the large window at the west end suggest this was a bar or area of comparable size to that of the lounge or saloon. There is a recess to the north of the fireplace (converted to a cupboard) that has white and brown glazed tiles to half its height and an arched roof that is 20cm lower than that of the main ceiling (Appendix Plate 17). The glazed tiles and the potential for access to the rear of the property (garden and cellar access) suggest this may have been a kitchen.

Appendix Plate 16 The "backroom".

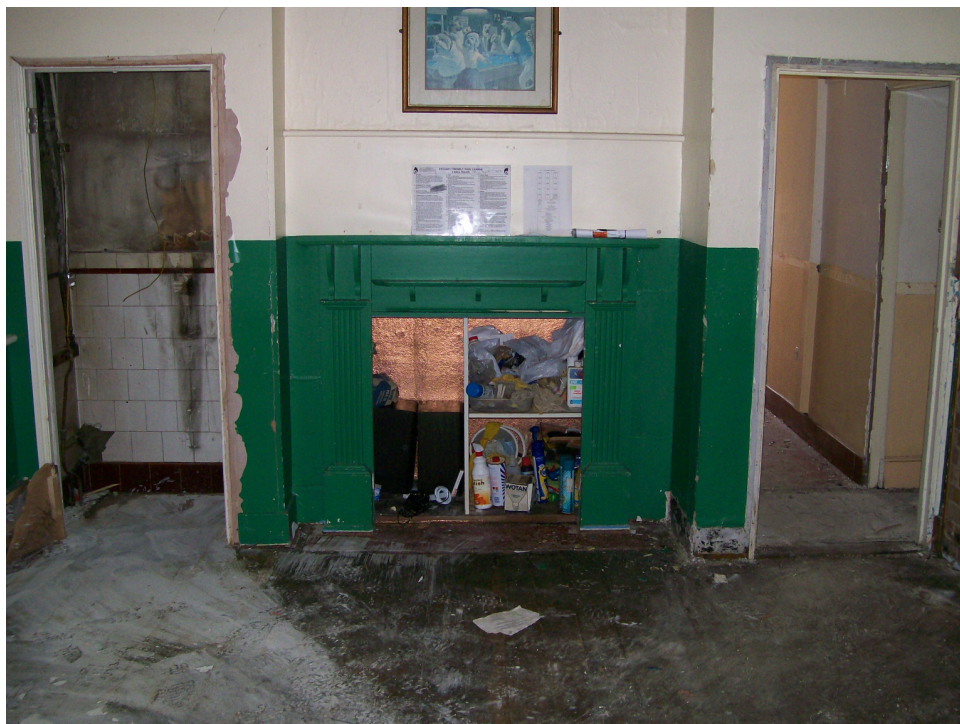
Appendix Plate 17 The “backroom” detail of fireplace and original tiling.

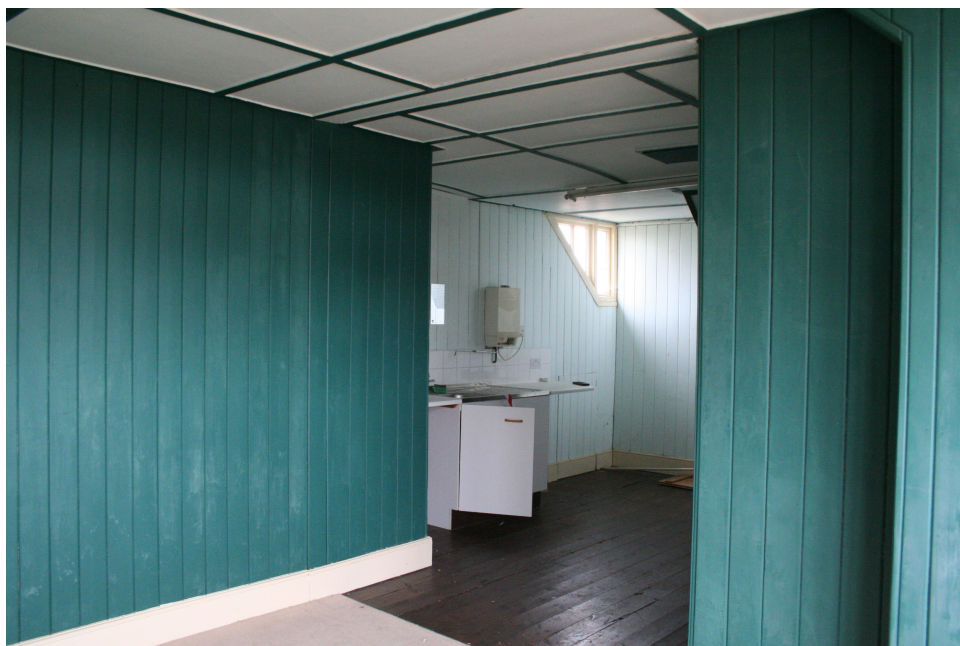
The second floor is comprised of three attic spaces opening off of the landing (Fig 5). That to the south has the chimney rising centrally through the room with a fireplace on the south face. The east attic was originally divided from the one to the north by a wooden wall which has been removed to convert the east and north attics into a larger space (Appendix Plate 20). Probably at the same time the western part of the north attic was partitioned off and converted to a bathroom and toilet. The north attic had a fireplace and two ranges of three triangular lights in the sides of the small dormer constructed to the south of the north chimney (Appendix Plate 21). Each of the three attics was walled with floor to ceiling tongue and groove panelling.

Appendix Plate 20 East attic showing removed dividing wall to north attic.
