Historic Building Recording at Harlow Town Park, Essex

June 2014

CAT Report 781
July 2014

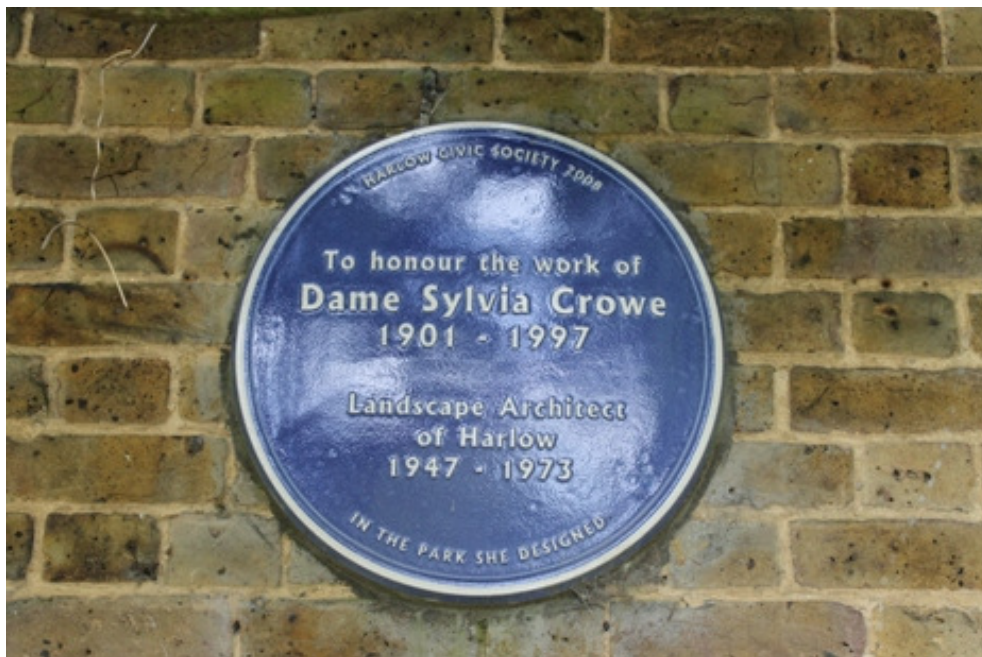
Plate 1 Commemorative blue plaque on north wall of Spurrier's House - view south-east

Spurrier's House is located at the north-west end of Spurrier's Core, a linear arrangement of buildings aligned north-west to south-east (Figs 1 & 2). Constructed in the early 1860s from yellow stock brick laid in Flemish bond, the building comprises a main two-storey rectangular range with a hipped slate roof and a smaller two-storey range to the south, also with a hipped slate roof. On the south side of this there is a single-storey service wing with a hipped slate roof. On the north elevation is a blue plaque (Plate 1) commemorating the work of Dame Sylvia Crowe, principal designer of Harlow Town Park.

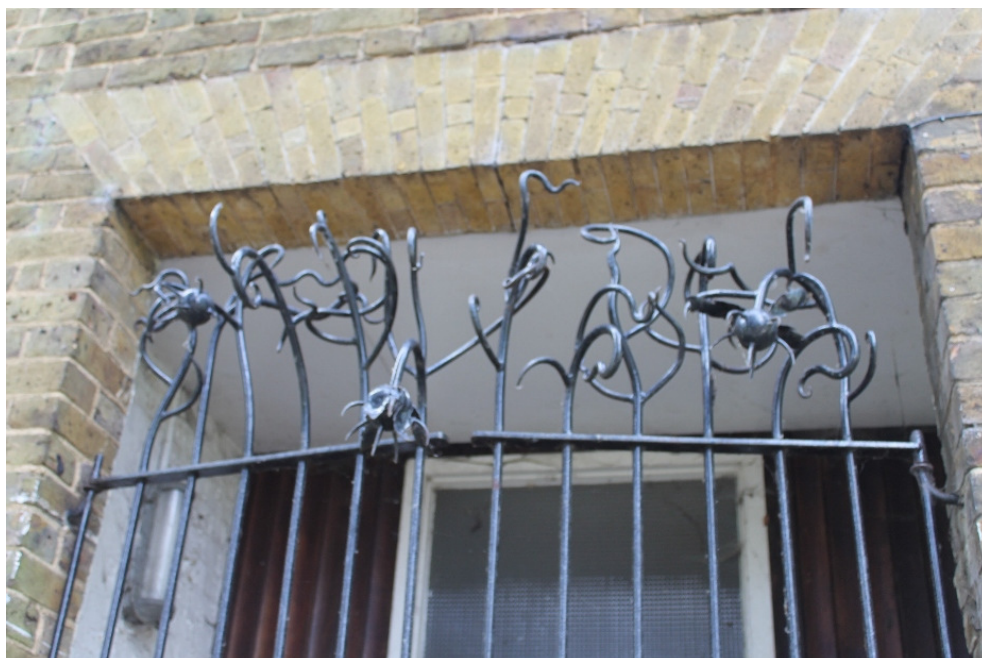
In keeping with the strong tradition of public art in Harlow, the security bars installed by Harlow District Council on the ground floor windows and doors have aesthetic qualities, wrought in the shape of plants with flowering seed pods (Plate 2).

Plate 2 Detail of wrought iron security bars in the shape of seed pods - view south-east

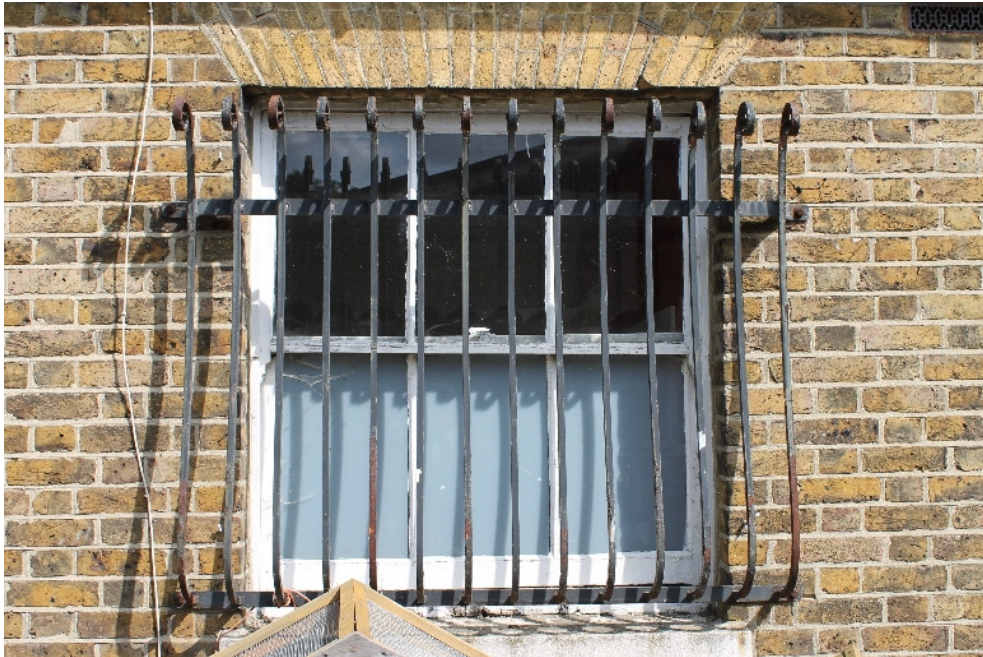
The security bars covering the windows on the service wing at the rear of the building are also more than merely functional, although not as ornate as those on the

public sides of the house (Plate 3). They are, however, more ornate than the gates over the rear entrances and it may be concluded that this represents a chronology for the security features of the building which became progressively plainer over time.

**Plate 3 Detail of wrought iron security bars on extension to Spurrier's House
- view north-west**

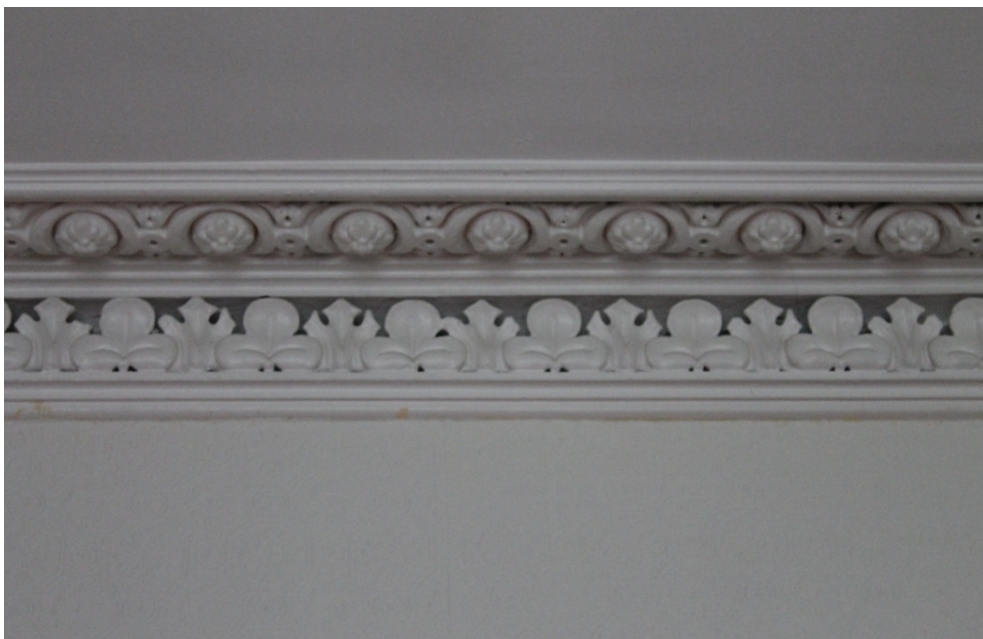
As part of the regeneration programme, the ground floor of Spurrier's House is to be renovated, retaining original features such as the plaster moulding and removing later alterations which detract from the historic integrity of the building (Plates 4 & 5). Included in these works will be the conversion of the basement.

Plate 4 Detail of decorative plaster moulding in Spurrier's House

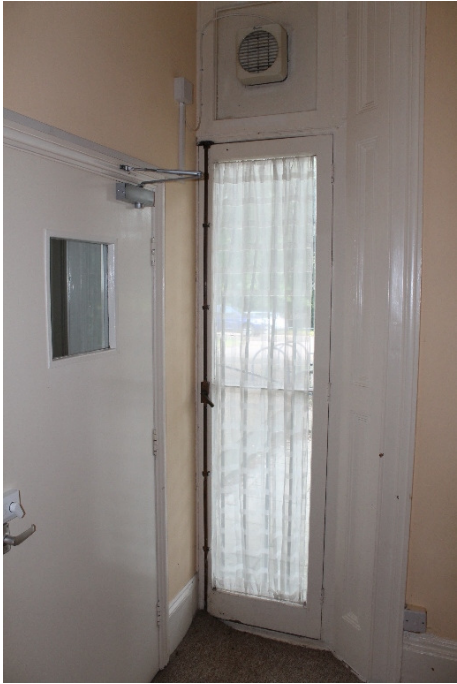
Plate 5 Original French doors of Spurrier's House truncated by inserted stud wall - view north-west

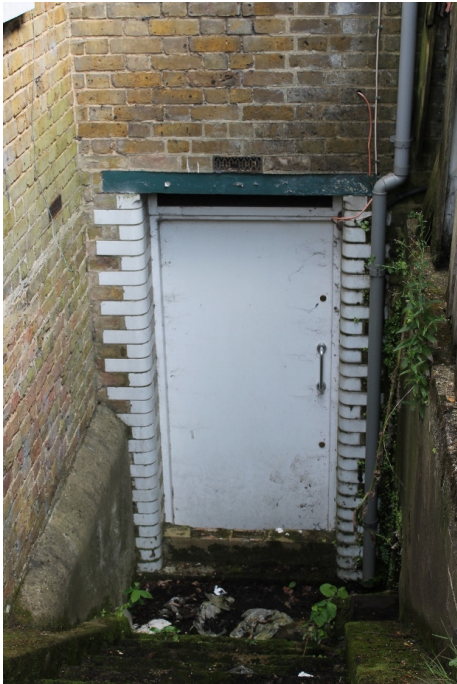
The basement of Spurrier's House has two entrances, one external (Plate 6) and one internal (Plate 7). The external entrance is down a flight of steps beside the single-storey service extension and has a door surround formed of white-glazed brick.

Plate 6 Basement entrance to Spurrier's House - view south-east

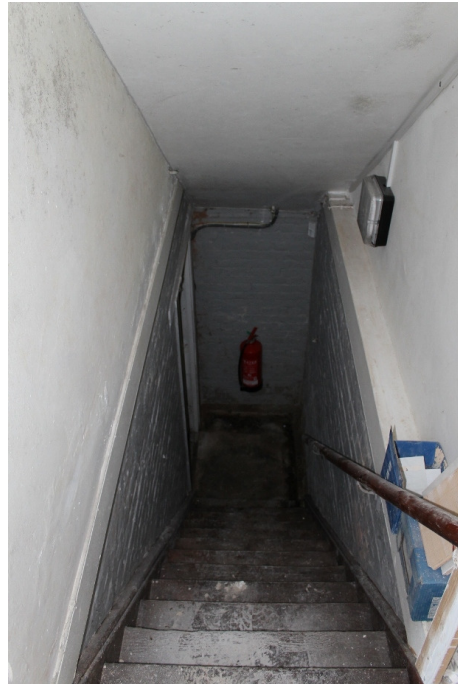
Plate 7 Internal staircase to basement of Spurrier's House - view north-west

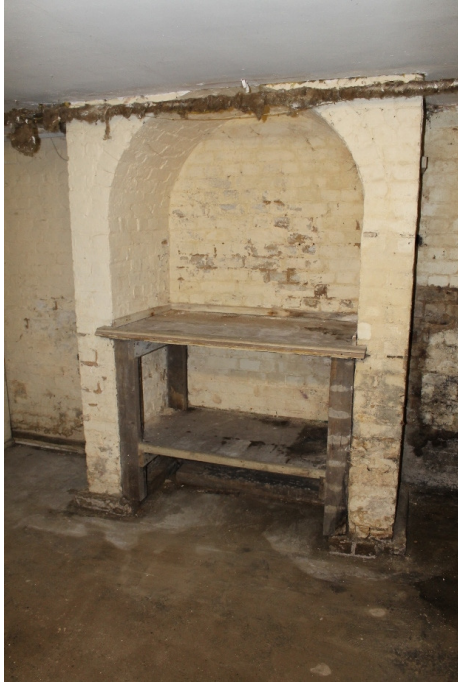
Although the basement has been used as a storage area since the building was acquired by HDC it retains several original features. These include a brick arch (the purpose of which is uncertain, but which may have been an area for keeping wine; Plate 8), a recess lined with white-glazed tiles/bricks and with an iron and glass light grill above it, probably fulfilling a scullery function (Plate 9) and the carcass of a wooden sideboard, probably original to Spurrier's House and relocated from the dining room upstairs (Plate 10).

Plate 8 Original brick alcove in basement of Spurrier's House – view south-east

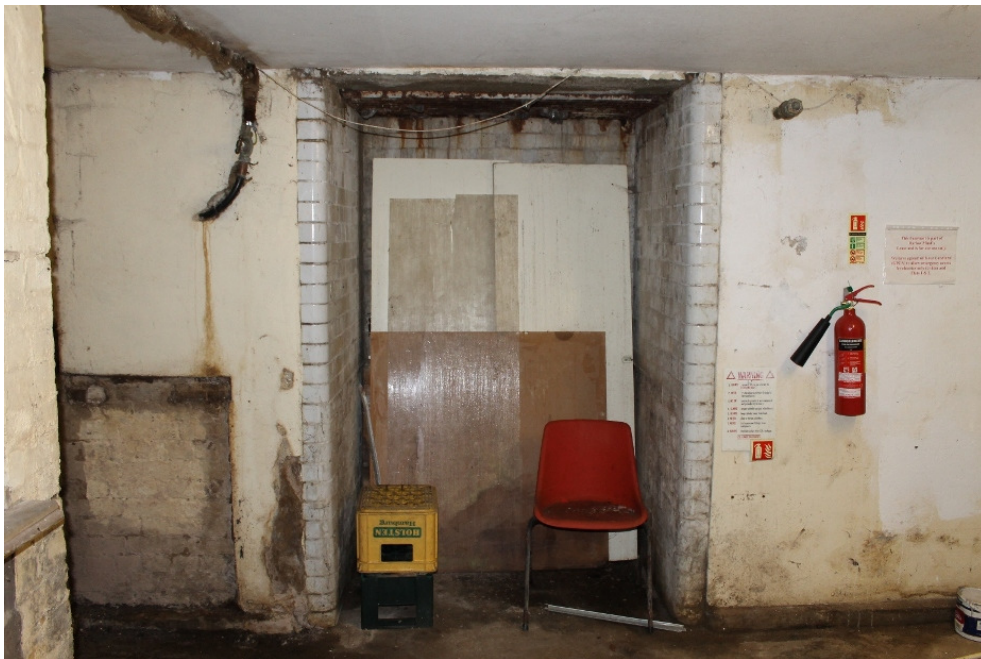
Plate 9 Tiled recess in basement of Spurrier's House, possibly a scullery area - view south-west

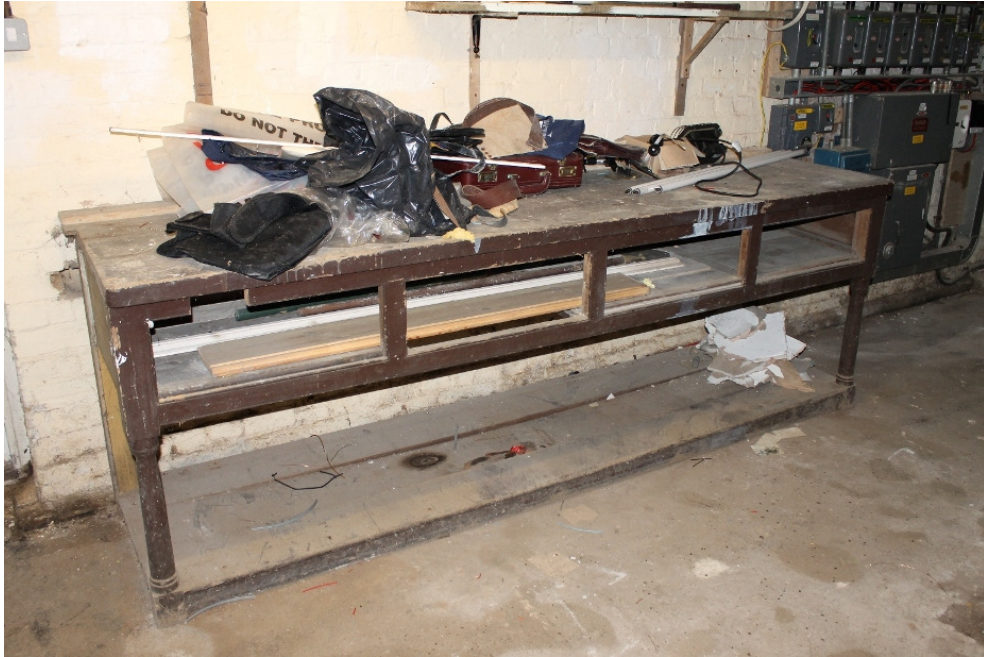
Plate 10 ?Original sideboard, possibly from the dining room of Spurrier's House - view north

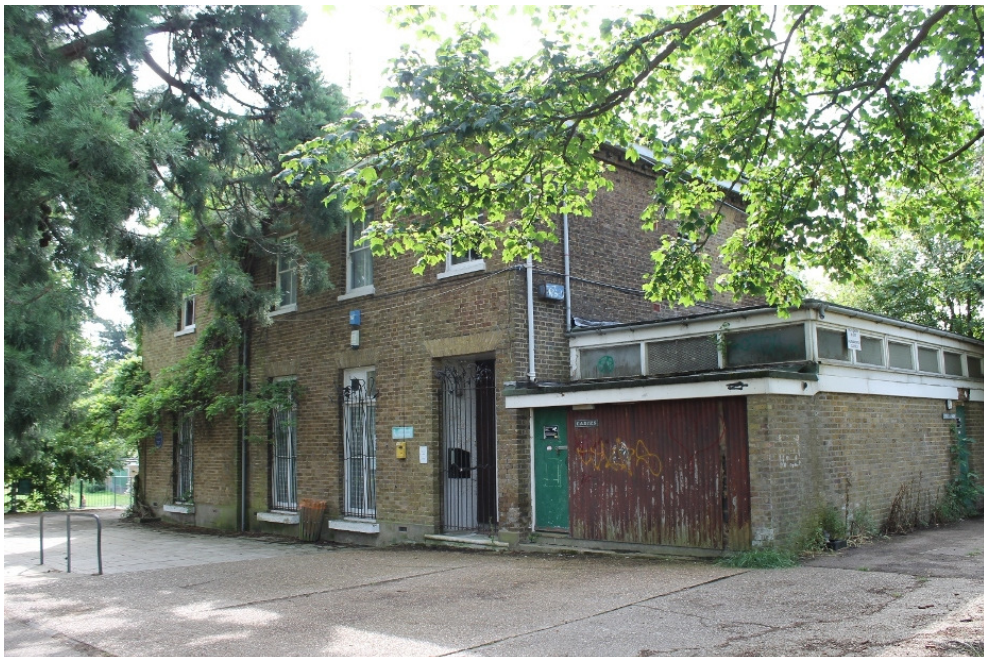
The original stables to Spurrier's House were incorporated into Pets Corner in 1966 and it is probable that this was when the toilet block was constructed against the west side of Spurrier's House. The toilet block is a single-storey, flat-roofed structure of yellow stock brick laid in stretcher bond (Plate 11), although the north elevation containing the entrance to the Ladies' toilets is formed from vertical plank cladding. The flat roof has a continuous range of narrow windows just below the eaves, providing additional illumination to the interior of the toilets.

Plate 11 Spurrier's House with 1960s toilet block attached - view south-east

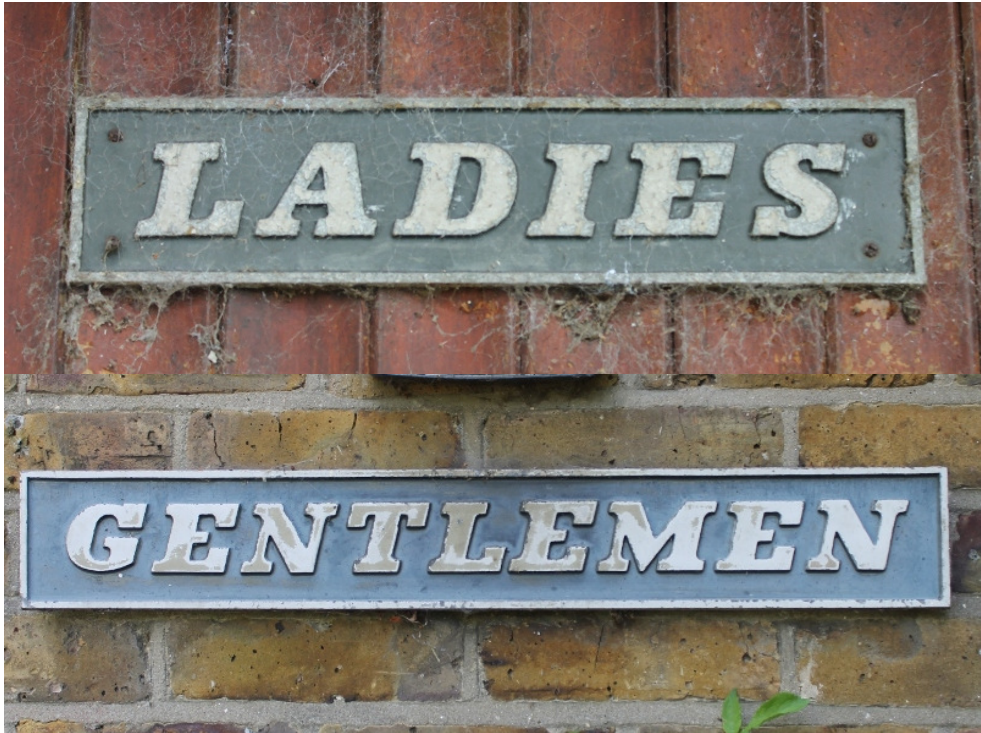
Both the Ladies' and Gentlemen's toilets have the original signage, executed in a typical 1960s font (Plate 12).

Plate 12 The original 1960s signage on the toilet block at Spurrier's House

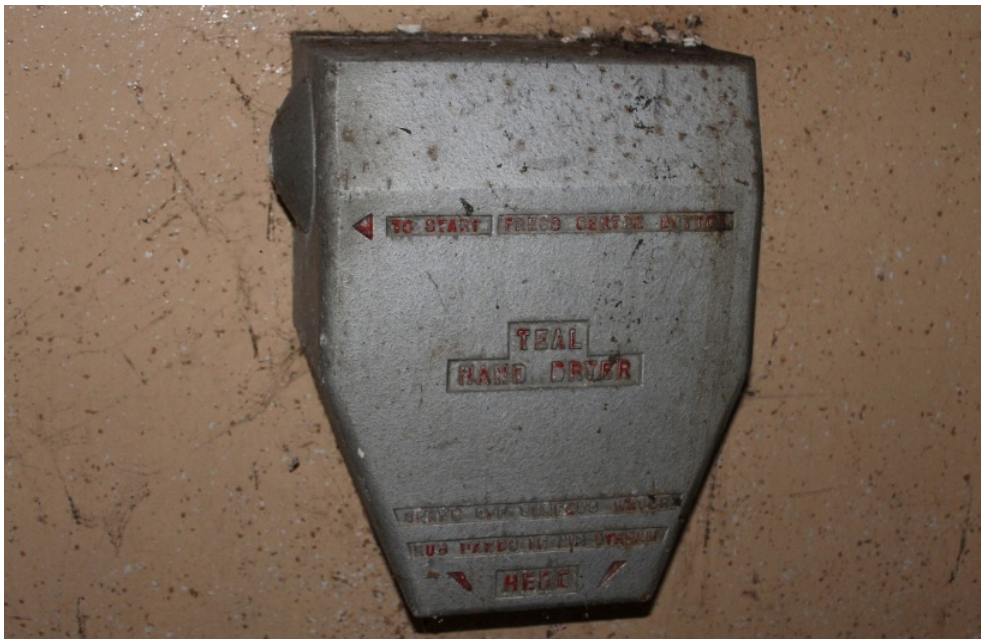
It was not possible to access the Ladies' toilets but examination of the Gentlemen's facilities showed the interior to be relatively basic in layout and design with plain, utilitarian WCs and urinals, a stark contrast to the ornate fixtures and fittings that would be encountered in a Victorian or Edwardian example. One interesting feature was the original 'Teal' electric hand-drier (Plate 13).

Plate 13 The original 1960s 'Teal' hand-drier in the toilet block at Spurrier's House

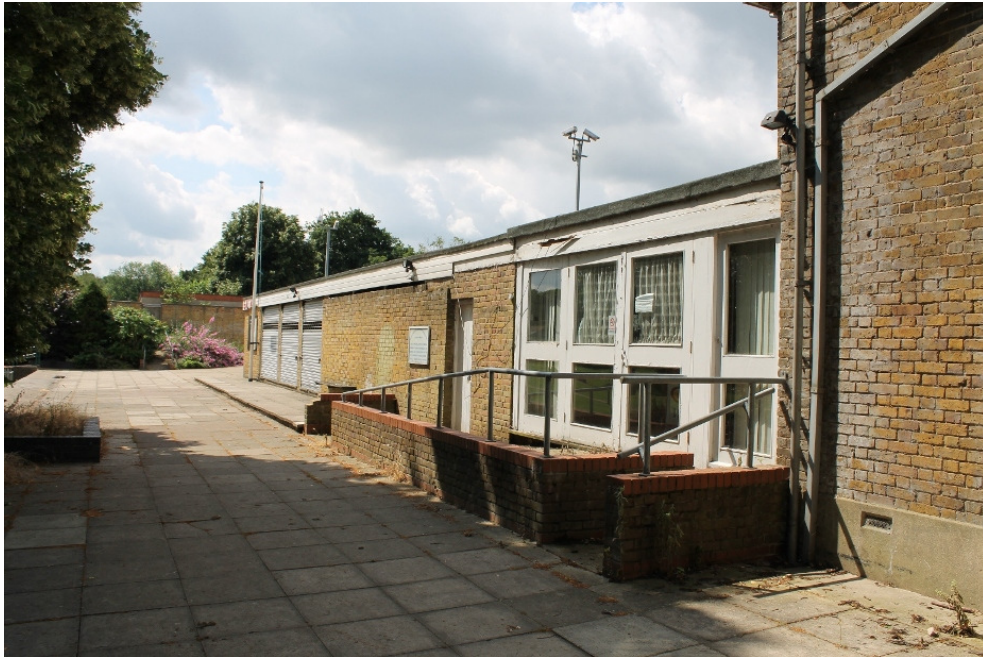
An additional extension was built in 1971 at the south-east corner of the main range to house the Town Museum and a drinks dispensary (Plate 14). This was a flat-roofed structure, constructed from yellow stock brick in an attempt to blend in with Spurrier's House.

Plate 14 Spurrier's Core with Spurrier's House to the right and the cafe extensions - view south

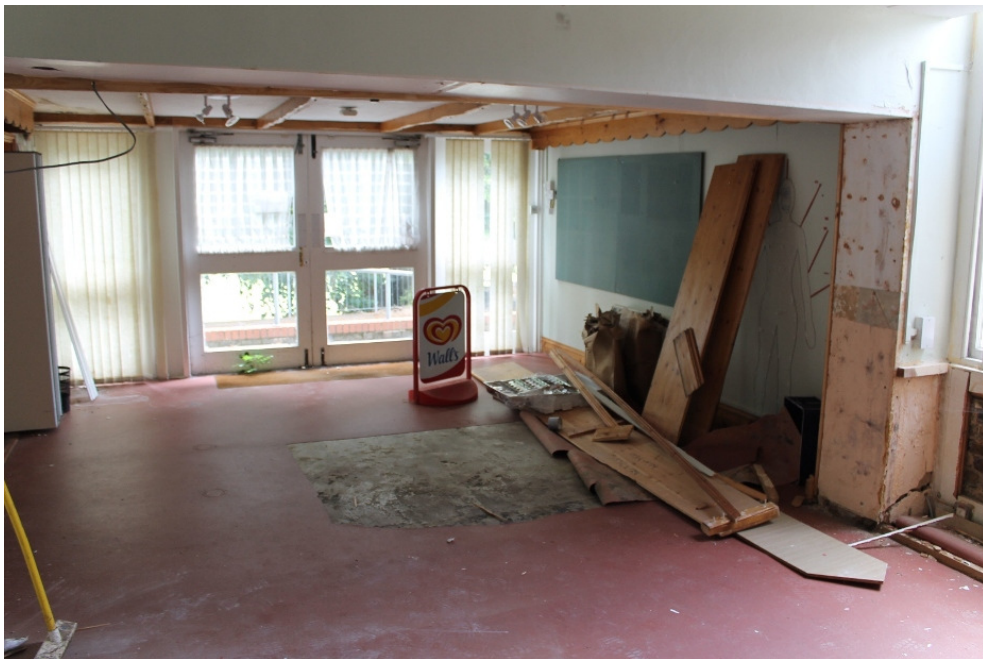
The construction of Spurrier's Core removed a large section of the ground floor wall of Spurrier's House (Plate 15). The drinks dispensary was fitted out with exposed roof beams in an unsuccessful attempt to make the building appear older than it is.

Plate 15 The interior of the 1971 extension to Spurrier's House showing the width of the Victorian brickwork - view east

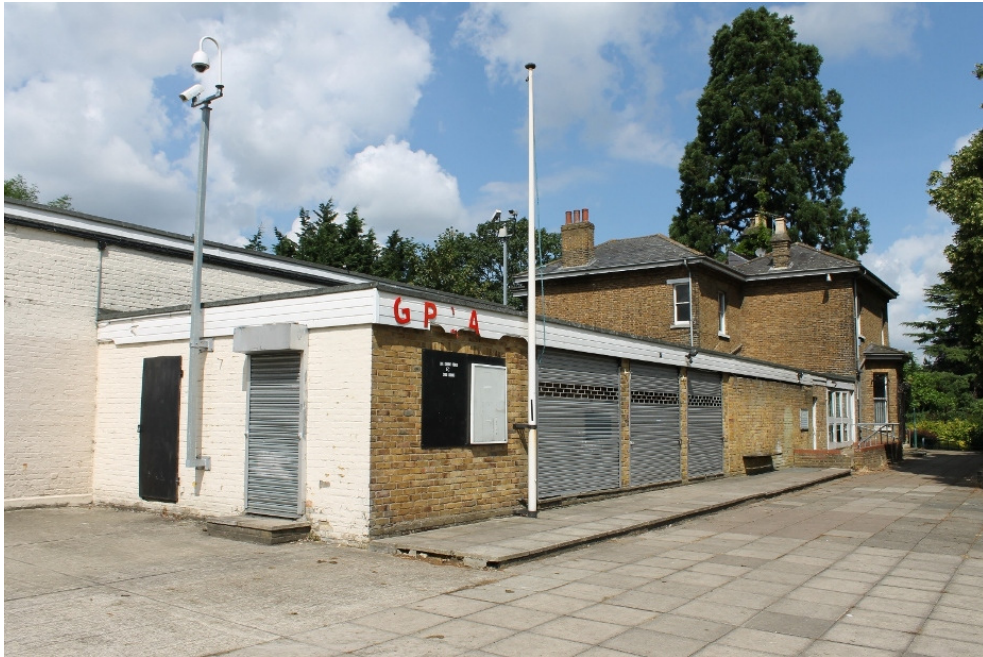
In 1973 the size of the drinks dispensary was deemed inadequate and a long, single-storey extension was built against the exterior of the east stable block to house a much larger café (Plate 16), whilst the Town Museum was moved to Passmore House. The whole of this new development became known as Spurrier's Core.

Plate 16 Spurrier's Core with Spurrier's House to the right and the cafe extensions - view south

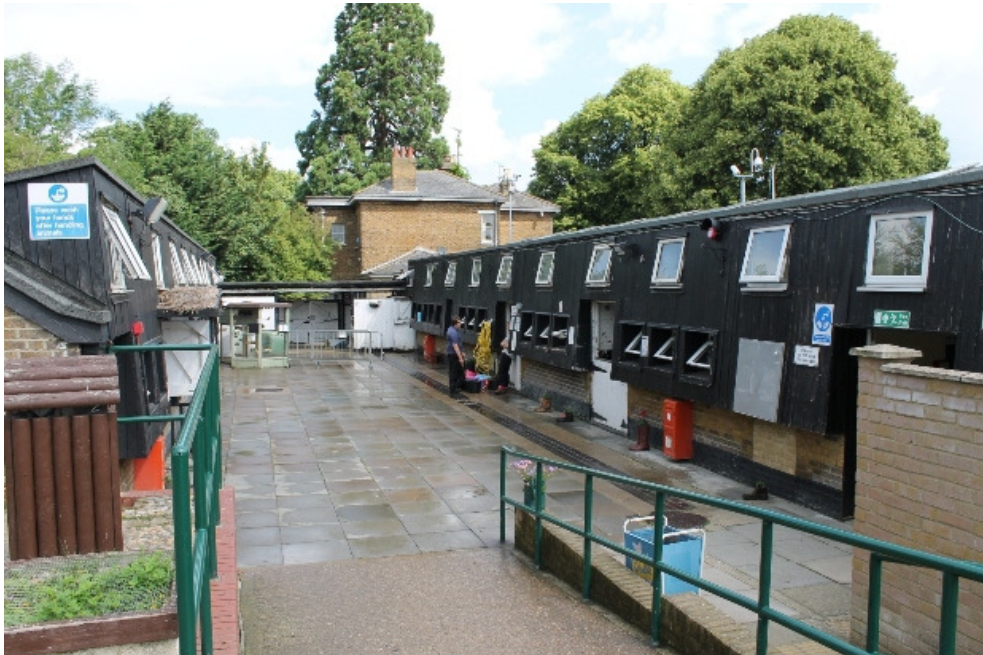
Pets Corner comprises two distinct areas, arranged in a linear pattern aligned north-west to south-east, along with a collection of paddocks to the west of the zoo. The northernmost of these areas comprises the original stable blocks for Spurrier's House (Plate 19) separated from the rear of Spurrier's House by the original Victorian stable yard gates (Plate 20).

Plate 19 Pets Corner stable blocks with Spurrier's House in the background – view north

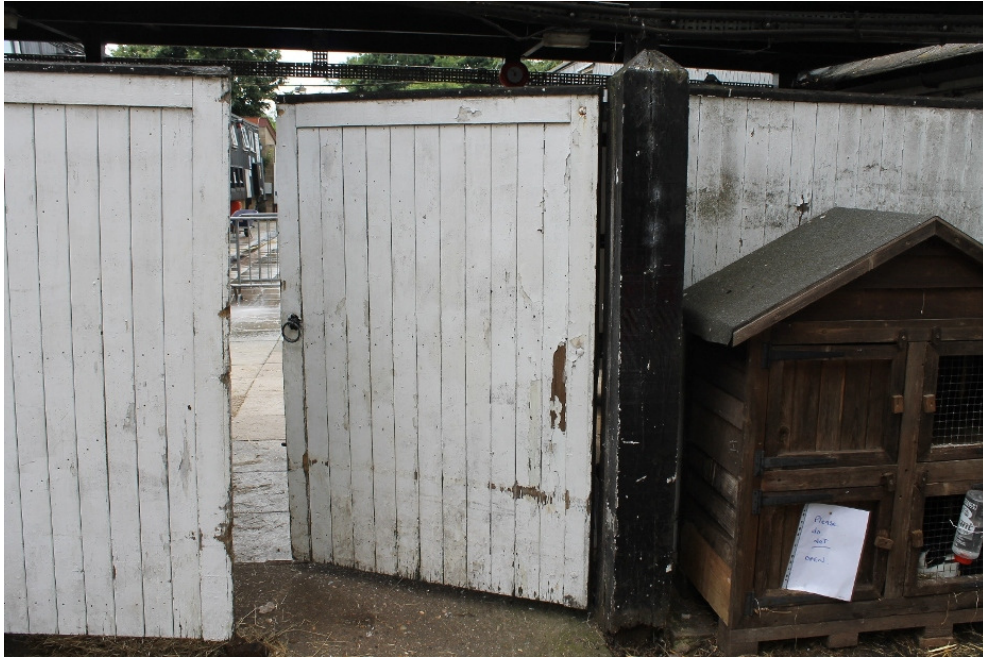
Plate 20 Original stable yard gates of Spurrier's House, now the rear access to Pets Corner - view south-west

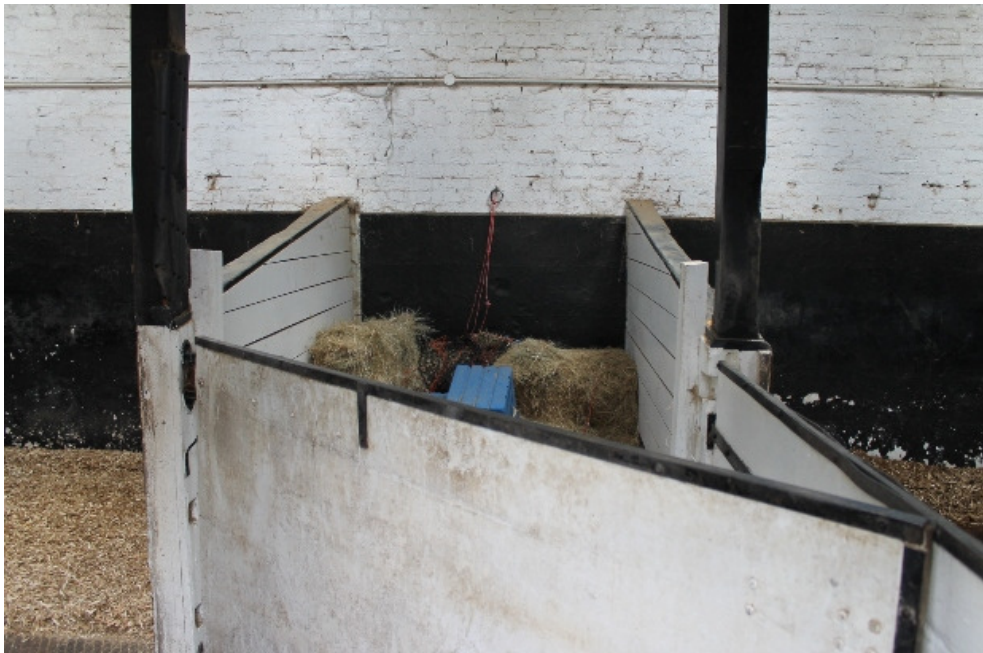
The stables have been extensively modernised, either in 1966 but probably more recently as the current stables have high roofs and double-glazed windows. Despite these alterations many original features have survived, including a drainage gully formed by Staffordshire blue bricks (probably original – but possibly later), tethering rings and stall divisions (Plate 21).

Plate 21 Original stall dividers in the stable block - view north-east

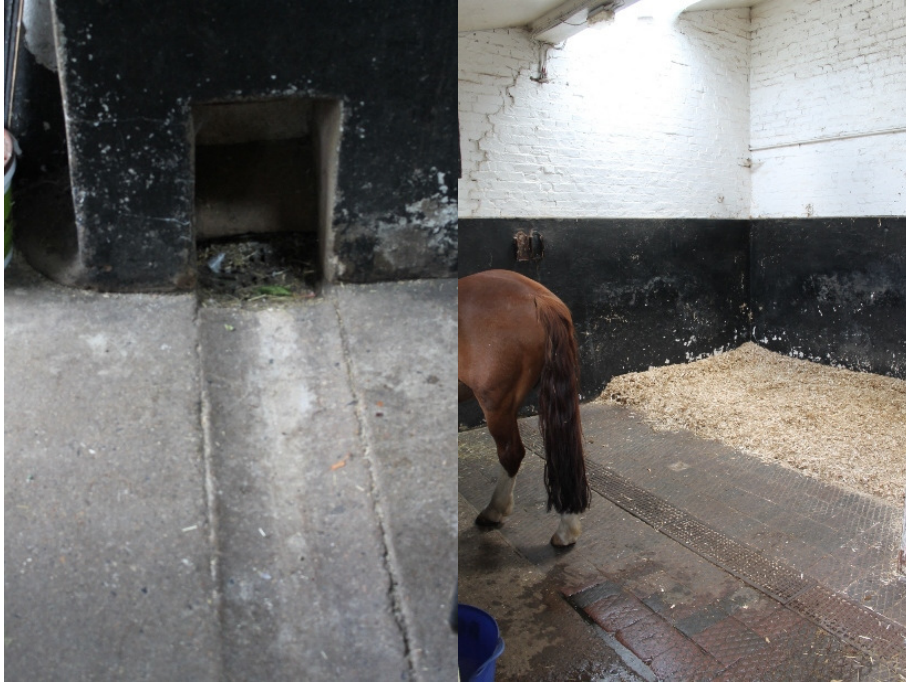
In addition to these features the internal drainage gullies and floor surfaces of the original stables have survived (Plate 22).

Plate 22 Original drainage gullies and floor surface in the former Spurrier's House stable block

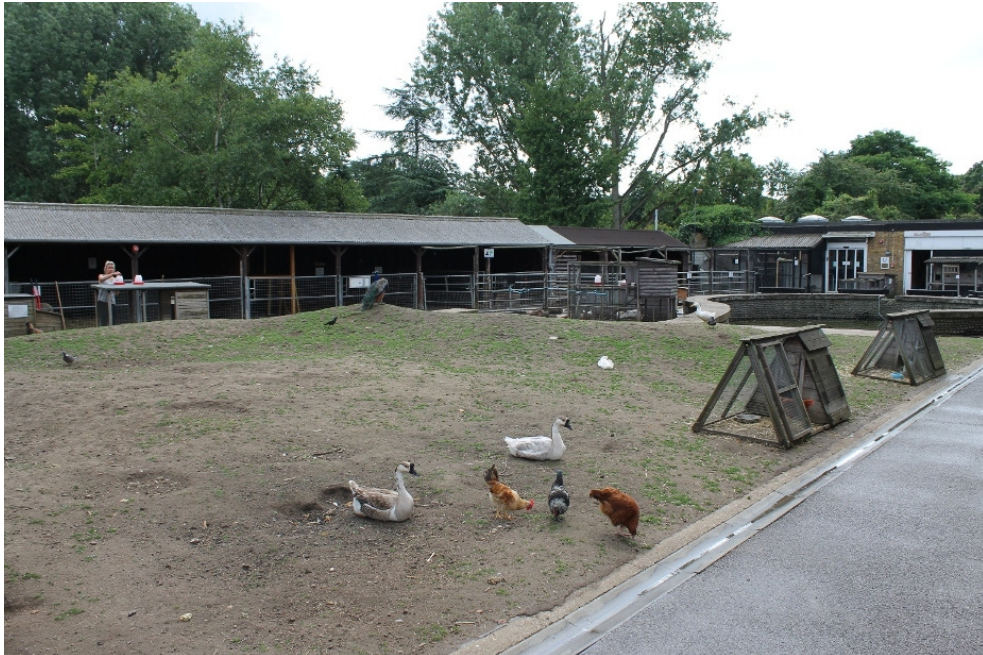
The southern part of Pets Corner dates to 1966 and consists of open-fronted shelter sheds/pens arranged around a green with a brick Aquarium at the south end (Plate 24).

Plate 24 Pets Corner with the open stables and Aquarium block in the background - view south-east

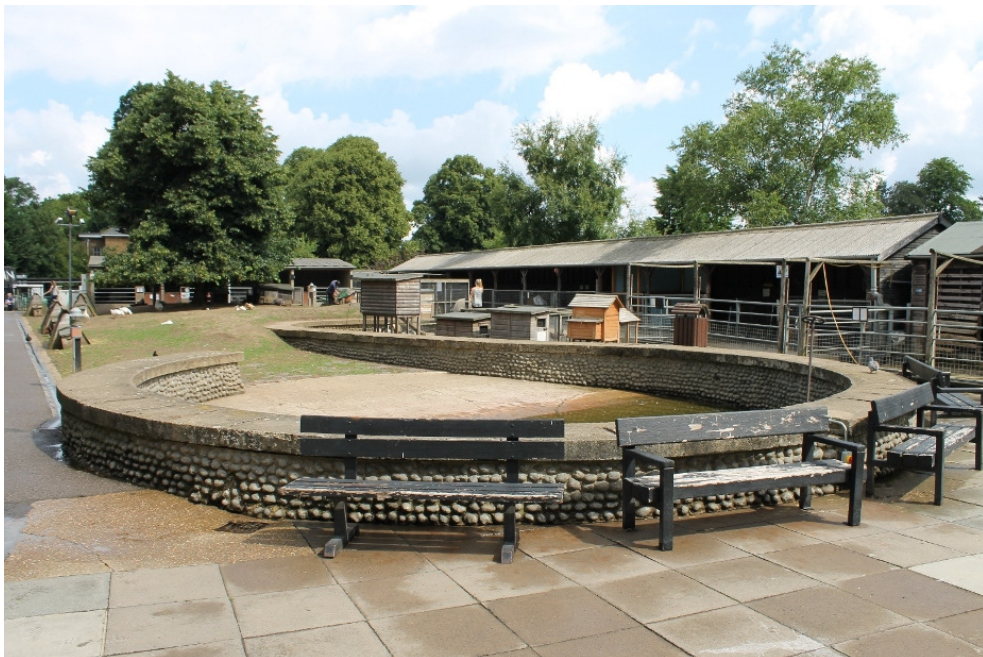
To the south of the green is a low S-shaped structure, built from river cobbles capped with concrete slabs. The south end of this forms a duck pond (Plate 25) whilst the north end is embedded into the green, forming a small plaza filled with bird cages.

Plate 25 The interior of Pets Corner with the duck pond in the foreground and open-fronted shelter sheds to the right - view north

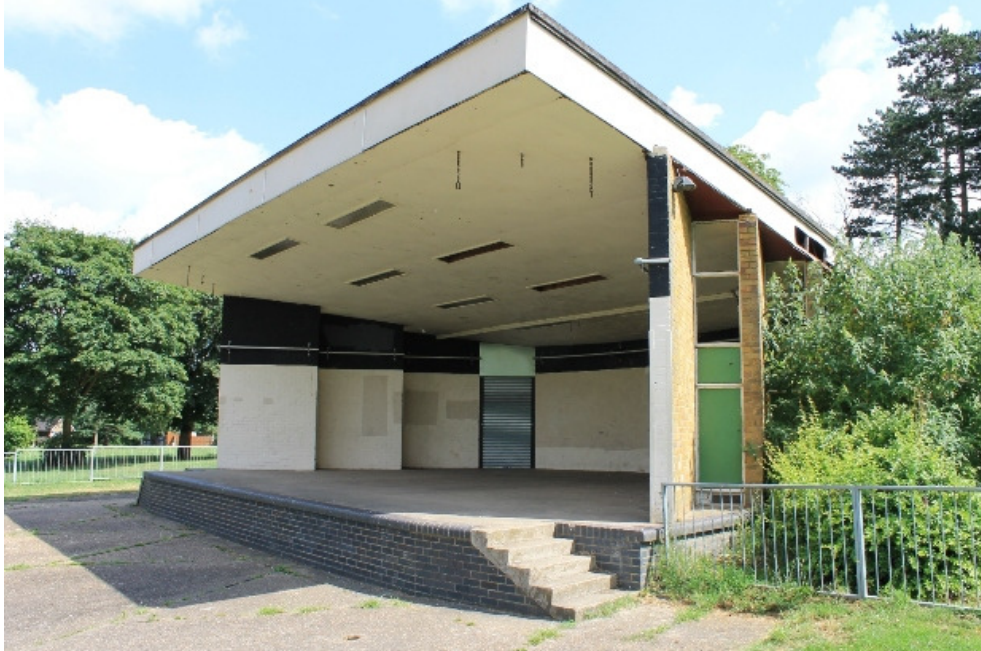
The Bandstand was built in 1973 and is a concrete and brick structure more akin to a theatre than a traditional bandstand. Like the other buildings of Spurrier's core it has been constructed of yellow stock brick in an attempt to blend in with the Victorian Spurrier's House. The Bandstand takes the form of a raised stage with funnelled sides and an overhead canopy (Plate 30).

Plate 30 The Bandstand with its raised stage and angled walls – view north

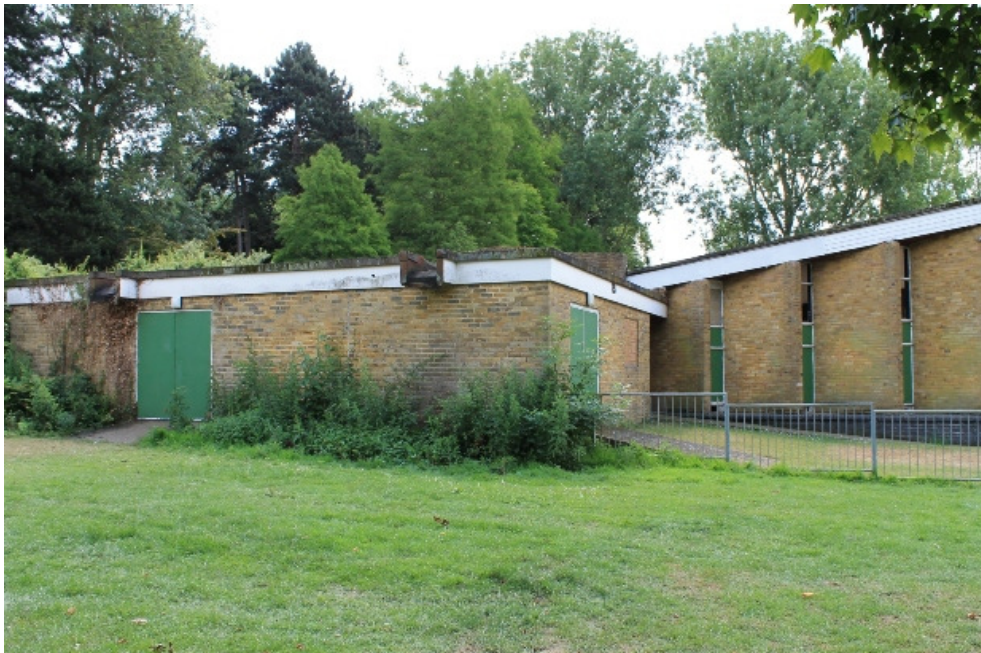
There is a single-storey, flat-roofed ancillary structure to the rear and the north, which housed the green room and dressing rooms (Plate 31).

Plate 31 The ancillary structure at the side and rear of the Bandstand, housing the green room and dressing rooms – view south-east

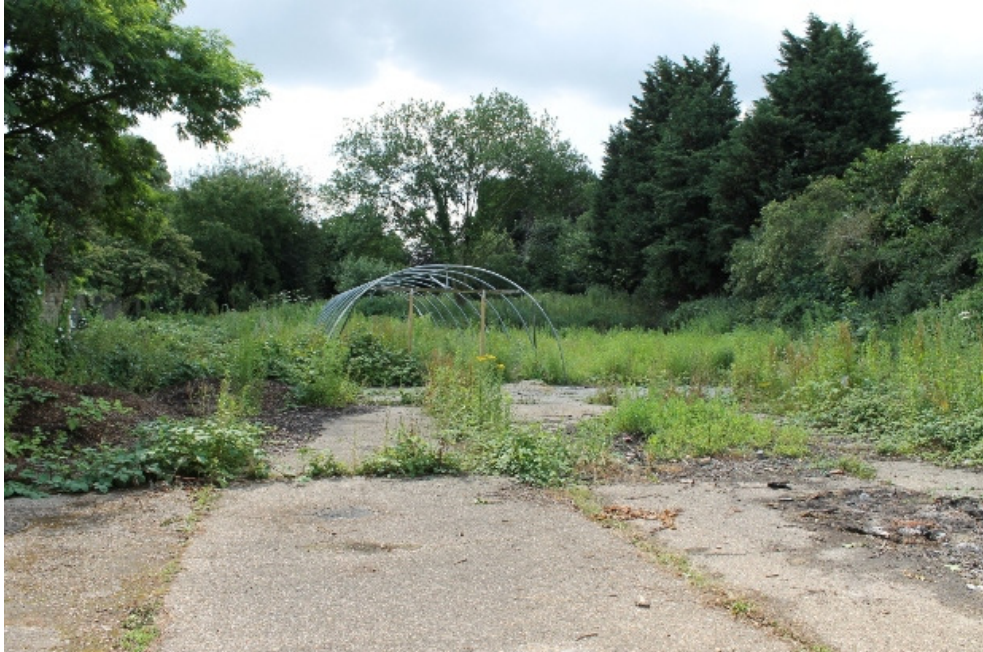
The nursery is located in the former walled garden of Spurrier's House and has been neglected for many years. The result is a wilderness (Plate 32) with some dilapidated structures that are all that remains of the gardener's office and potting sheds (Plate 33).

Plate 32 The Nursery, formerly the walled garden of Spurrier's House - view south-east

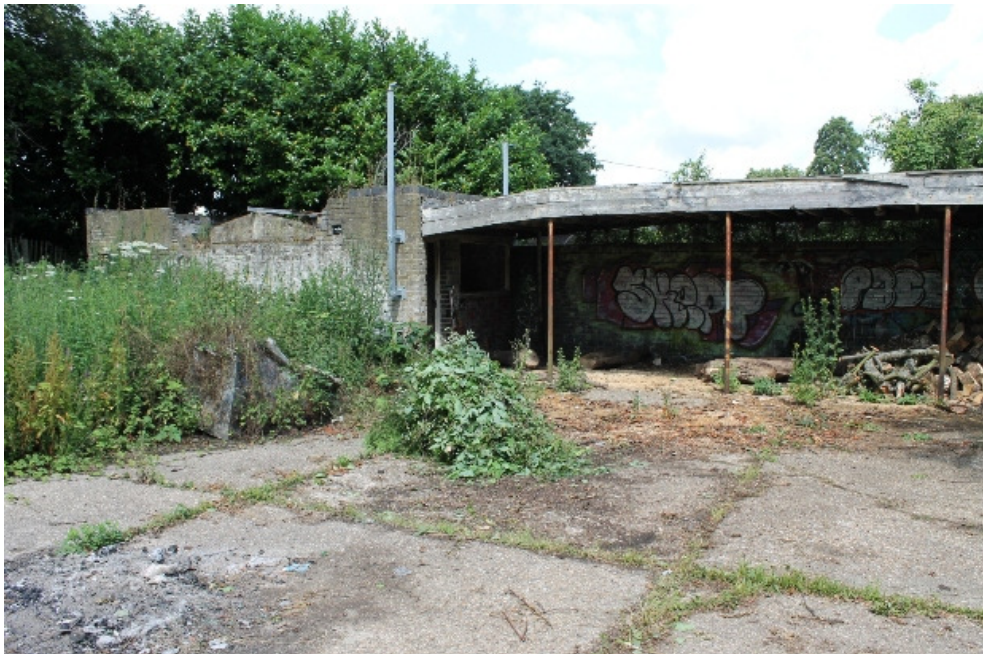
Plate 33 Remains of the gardener's office and an open-fronted shed in the Nursery - view north-west

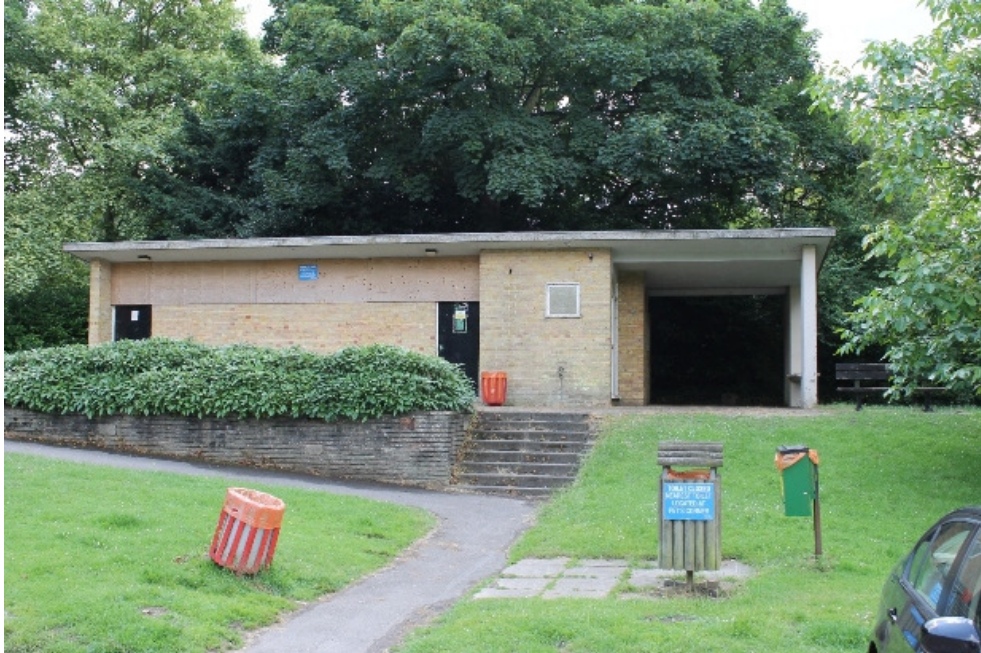
The proximity of the Greyhound toilets to the Bandstand suggests they were constructed to accommodate the increase in visitor numbers attending concerts in the park, either in 1973 at the same time as the Bandstand was built or shortly after. The toilets (named for the nearby public house which dates to at least 1810) occupy a low ridge on the south side of the car park (Plate 34).

Plate 34 The Greyhound toilets - view south

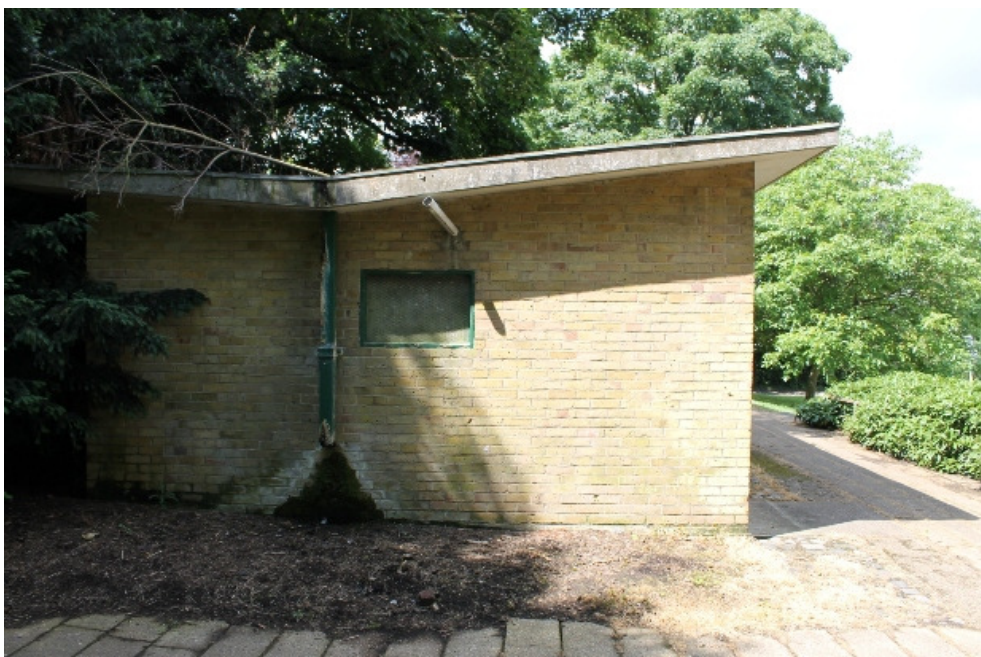
The toilets are constructed from brick and concrete and have an inverted roof designed to funnel rainwater to an integrated rainwater pipe at the east end of the building (Plate 35).

Plate 35 The Greyhound toilets with the integrated roof drainage - view west

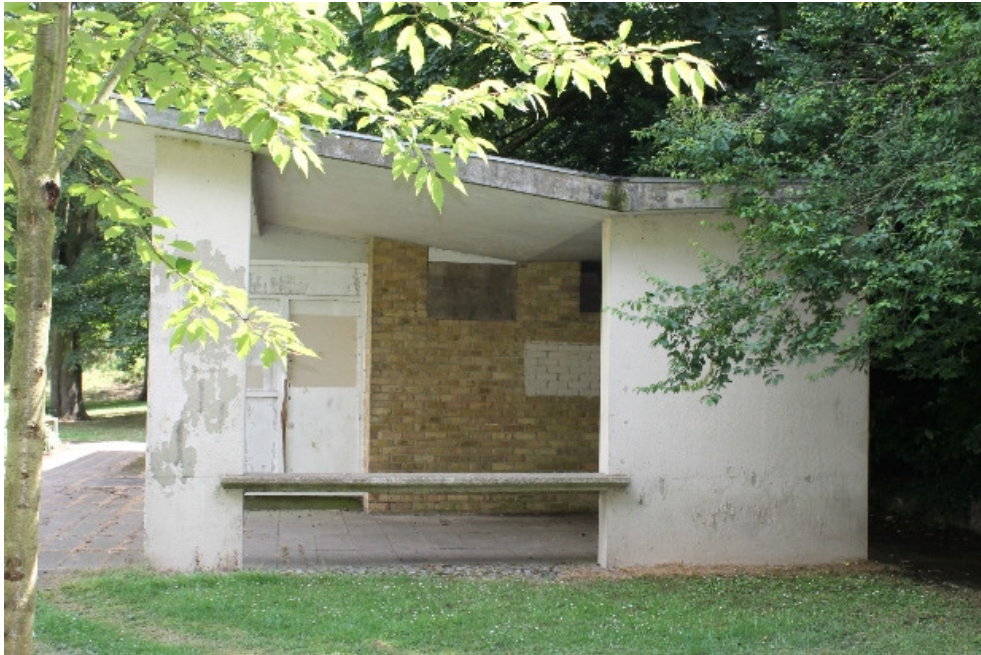
The west end of the structure has a projecting canopy supported on two different sized concrete piers, between which is a concrete bench (Plate 36).

Plate 36 The west end of the Greyhound toilets with the canopy over the bench held by the roof piers - view east

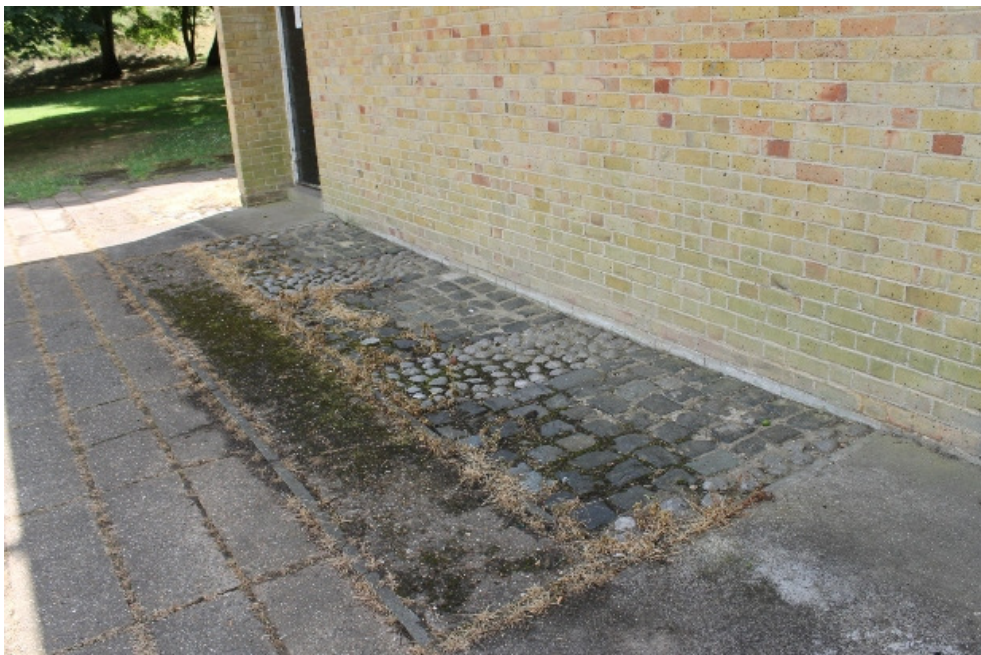
An area of hard-standing in front of the toilets has a tactile surface formed from granite setts and rounded cobbles, possibly an intentional reflection of the Pets Corner duck pond (Plate 37).

Plate 37 Tactile surface outside the Greyhound toilets, possibly recalling the duck pond of Pets Corner - view east

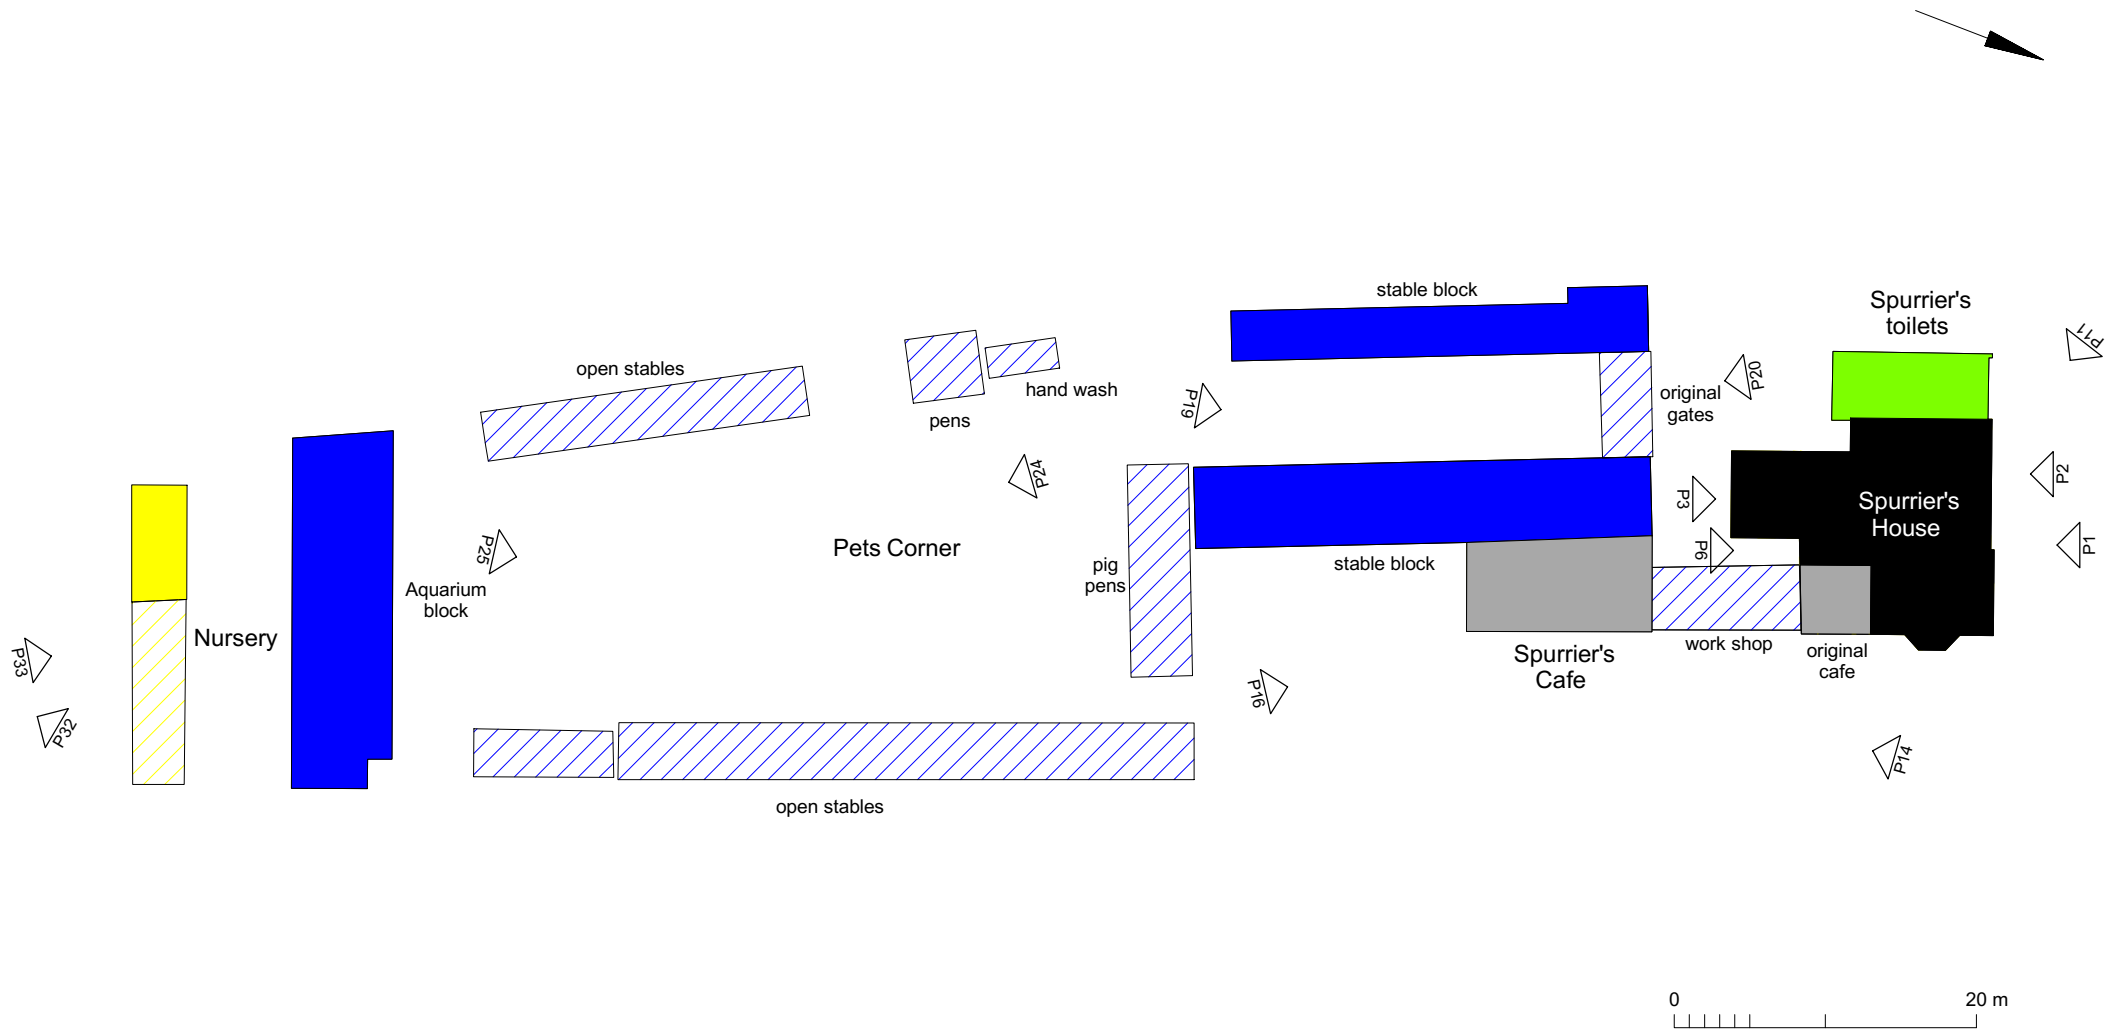
Fig 2 Spurrier's Core, showing the location and orientation of photographs included in this report.
