Historic Building Recording at Harlow Town Park, Essex

June 2014

CAT Report 781
July 2014

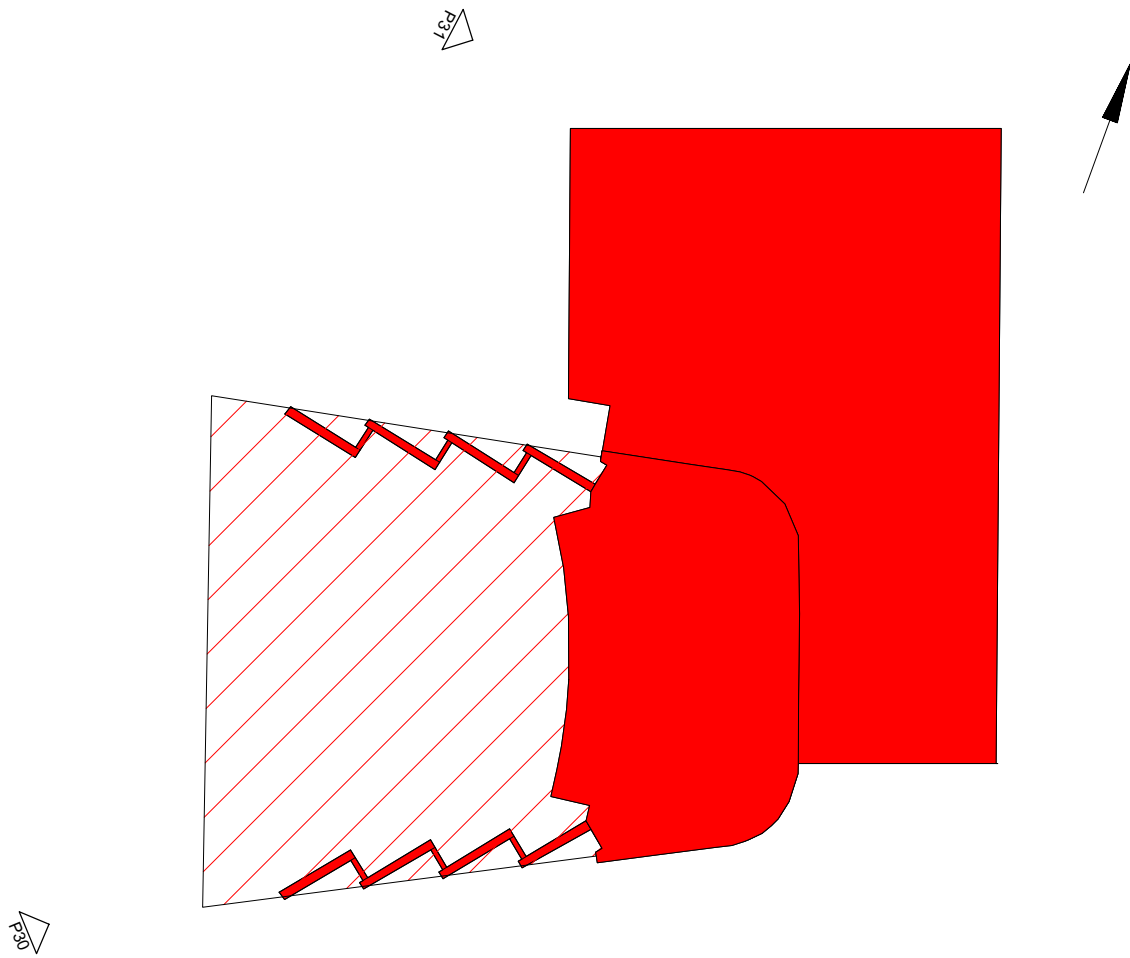
Fig 3 The Bandstand, showing the location and orientation of photographs included in this report.

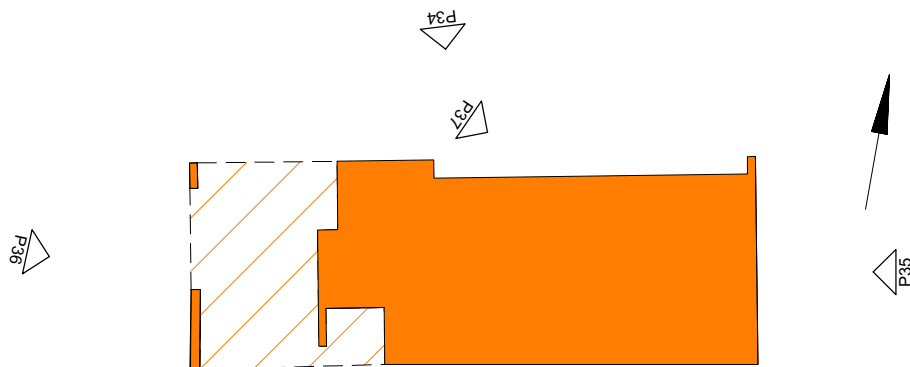
Fig 4 The Greyhound toilets, showing the location and orientation of photographs included in this report.
