# **Historic building recording of the former farmhouse at Howe Farm, Grange Road, Tillingham, Essex**

**February 2013**

**CAT Report 690**  
April 2013

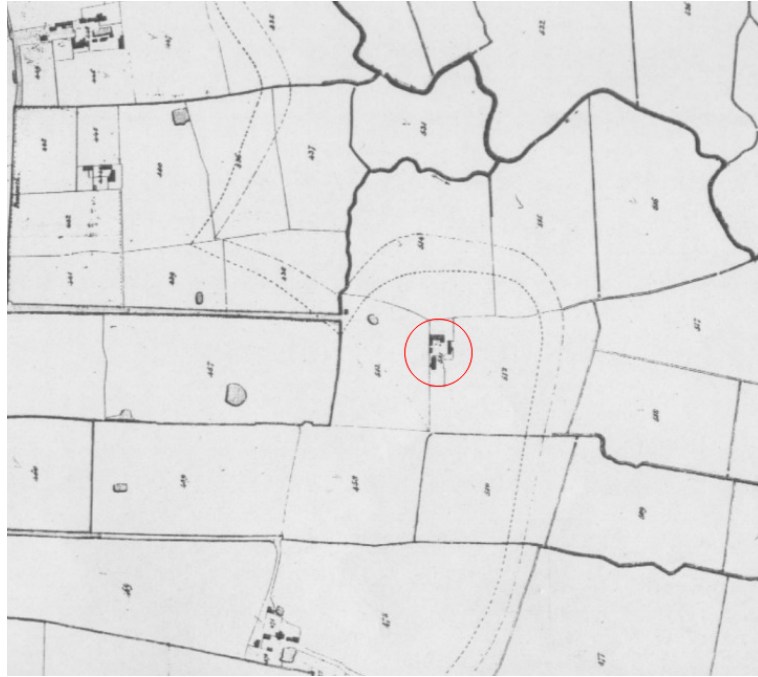
**Fig 2 1838 tithe map with Howe Farm circled (ERO D/CT 3613).**

The first cartographic reference to Howe Farm located in the records of the ERO is the 1838 tithe map for Tillingham (ERO D/CT 3613, Fig 2). The map shows the farmhouse as a north to south orientated, rectangular structure located on the south side of a loose courtyard formed by two barns and a smaller structure. In contrast to the Chapman and André map, the tithe map illustrates the effects of the programme of reclamation carried out in the previous centuries. The farms which previously occupied the marshlands are now shown with ordered field systems and drainage networks. This is the case with Howe Farm. The tithe award lists it as How Farm, owned and farmed by John Attenborough, and describes 120 of the 144 acres as being under arable cultivation. This reflects the changes in farming practice of Howe Farm, from its medieval origins as a dairy farm to a 19th-century producer of cereal crops, made possible by the draining of the marshes.

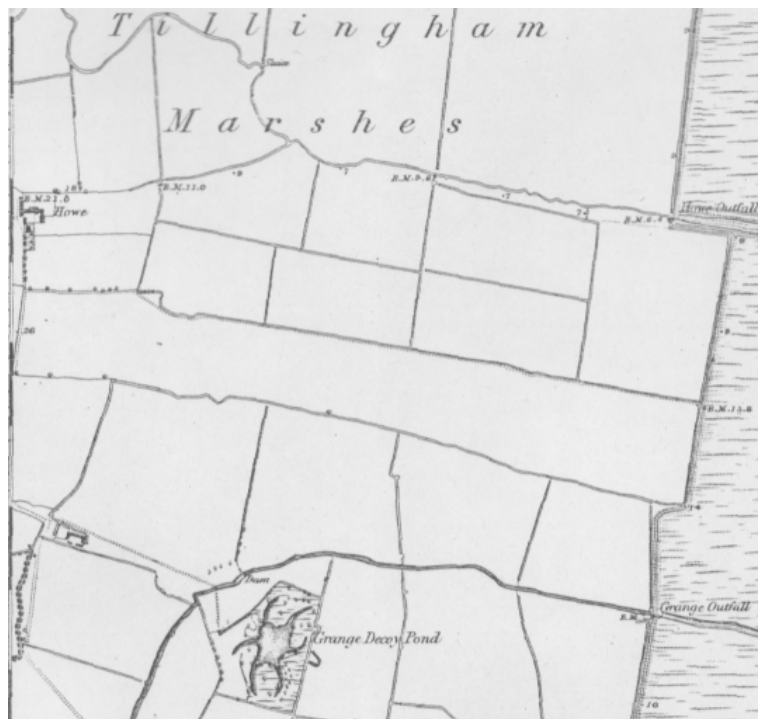
**Fig 3 1st edition 6" OS map, 1873 (sheet 64).**

The 1st edition 6" OS map of 1873 shows little change to the farm. The farmhouse appears the same and an additional structure has been added to one of the barns. The overall plan form of the farmyard appears to then remain unaltered until the 21st century.

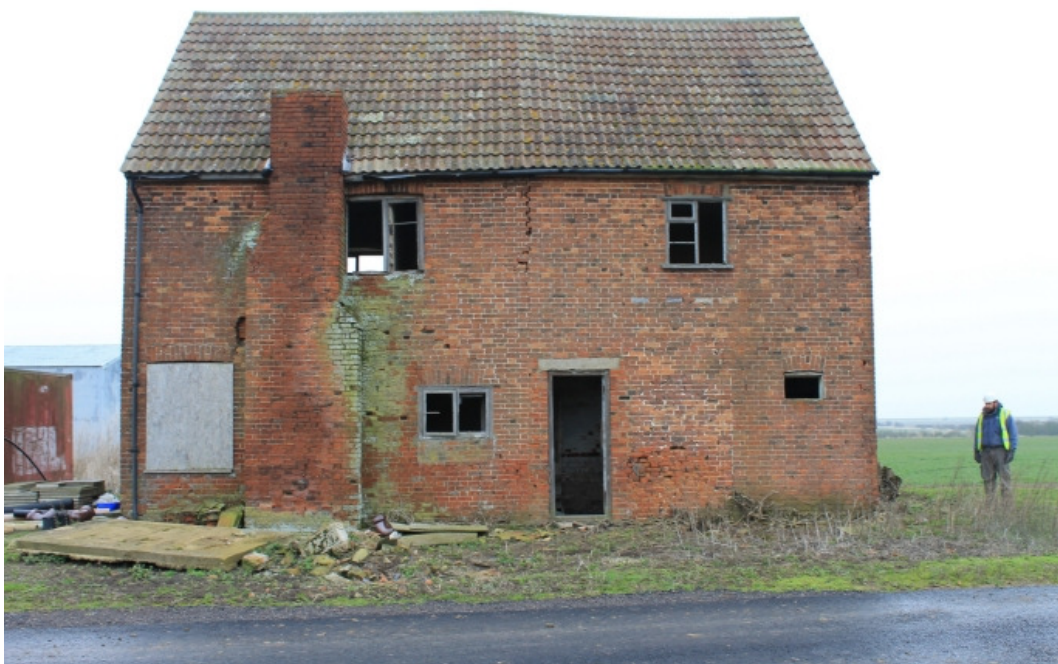
**Plate 2** West elevation – view east

The farmhouse is located on the east side of the farm track called Grange Road, with only a small strip of land separating the house from the road itself. The west longitudinal elevation (Plate 2) faces the road and has an external chimney stack, an off-centre doorway and three windows of unequal size in the ground floor and two mismatched windows in the upper floor (Fig 8). The ground floor window to the north is a sash window of eight over eight lights, with a shallow segmental brick arch above. At the other end of the west elevation there is a small wooden-framed window with a single light, surmounted by a shallow segmental brick arch. Both of these windows are original. Between these windows are an additional window and a doorway. The window is a wooden-framed casement of four lights and has replaced an earlier window. The opening for the original window has a shallow segmental brick arch but the inserted window is wider than this and also shorter. The doorway is also a later insertion and has a concrete lintel. Replacement brickwork to the right of this doorway indicates that the position of the original doorway was moved and was not as tall as the later insertion. The windows of the first floor both have shallow segmental brick arches and are replacement wooden casements of six lights, although no alteration to the surrounding brickwork has taken place.

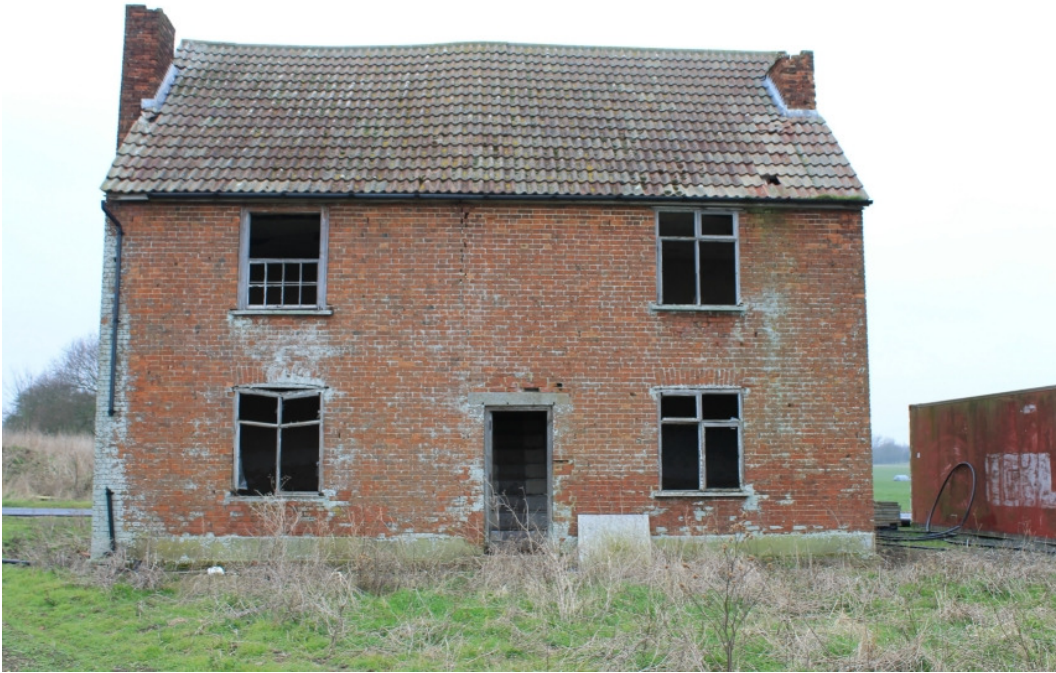
**Plate 3** East elevation – view west

The east longitudinal elevation (Fig 9) faces the marshes and should be considered the 'front' of the farmhouse. It has an off-centre doorway flanked by large windows to either side and two large windows on the upper floor (Plate 3). The ground floor windows are replacement wooden-framed casements and both are surmounted by flat brick arches. The doorway has a concrete lintel. Brickwork in the door surround indicates that this doorway has replaced an earlier entrance, probably lower in height than the later insertion. The windows on the first floor are directly in

line with those on the ground floor and are identical in size. The window to the south is the original sash window of eight over eight lights, whilst that to the north is a replacement wooden-framed casement. The tops of these window openings are directly below the eaves and there is no indication of any surmounting arch.

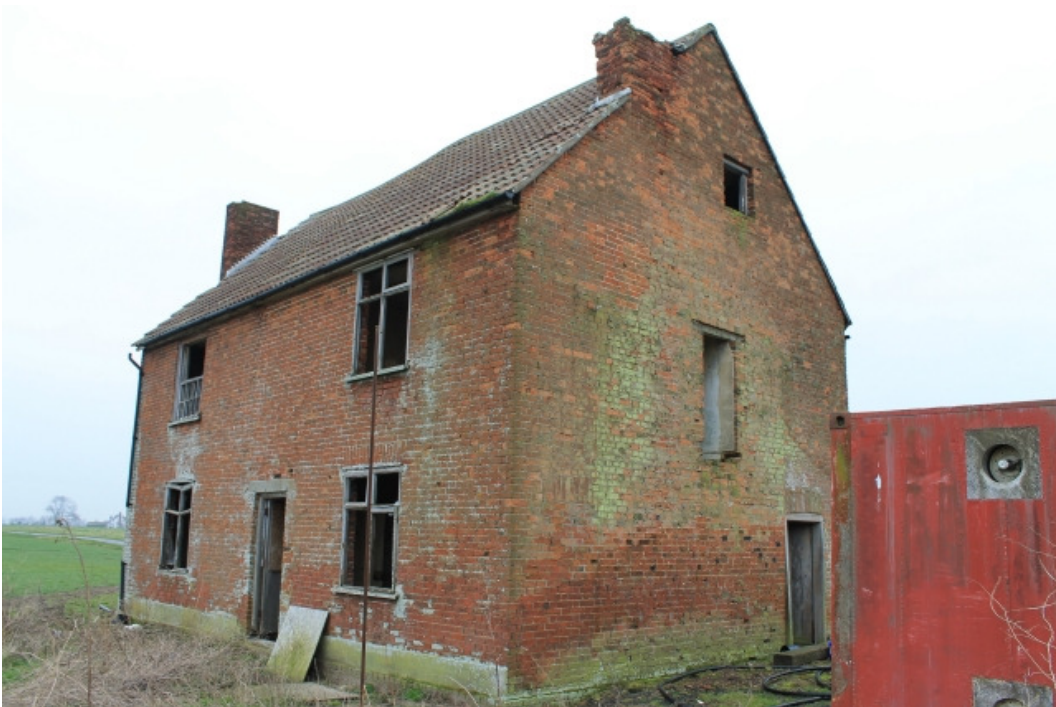
**Plate 4** North elevation - view south-west

The north elevation (Fig 10) has a doorway and blocked window on the ground floor, a doorway on the first floor and a window in the gable (Plate 4). An internal chimney stack rises from the gable edge. The blocked window on the ground floor is surmounted by a flat brick arch, whilst the doorway has a shallow segmental brick arch. The doorway is wider and shorter in height than the other external doors of the farmhouse and has a wooden vertical plank door with an iron latch (Plate 5). This is probably the original door. The doorway on the first floor is an oddity as it appears to open out onto nothing. It is clearly a later insertion and has a wooden lintel with a crude line of brick headers above. This doorway must have granted access to an outbuilding attached to the farmhouse and there is water staining on the brickwork that suggests a shape for this (Plate 6). The plan in the 1917 sales catalogue shows this outbuilding which was probably the brew-house and wash-house and must have been of wooden construction. Brewing and washing would have required access to water and the outbuilding was near to the pump. The window in the gable is a small rectangular opening with the same lintel of brick headers as the inserted door. The fact that it is off-centre to the gable, thus avoiding the apex of the extension, combined with the crude lintel, suggests it is a later insertion.

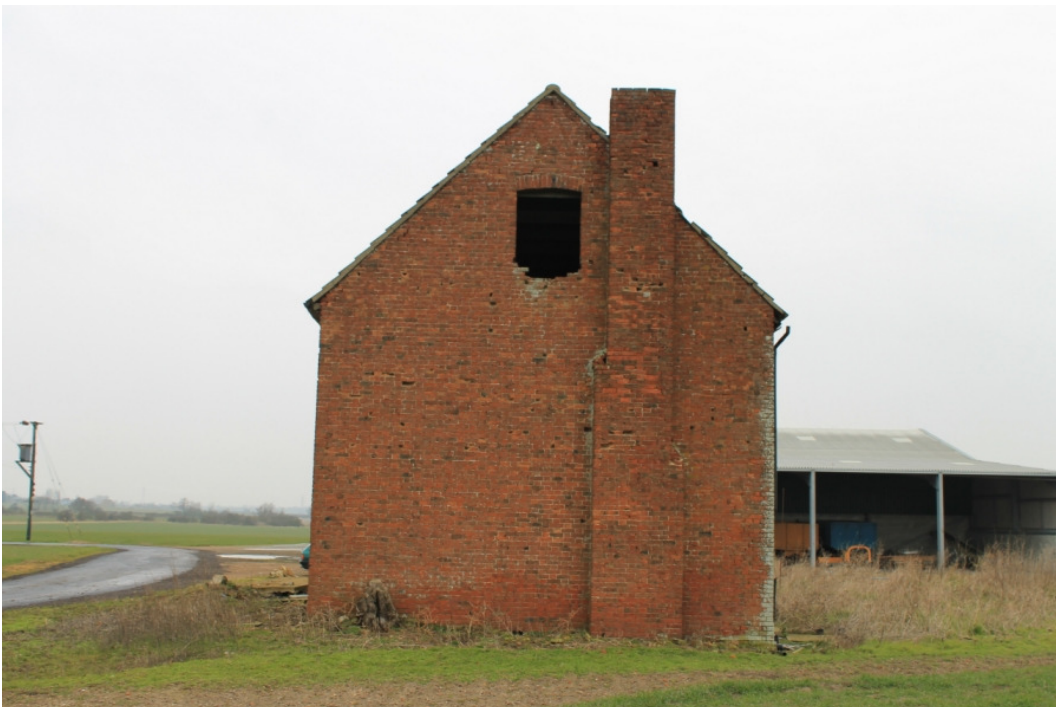
**Plate 7** South elevation - view north

The south elevation is plain brick apart from a centrally-located window opening in the gable (Fig 11). This has a shallow segmental brick arch, but no trace remains of the frame to identify what type of window was placed in the opening (Plate 7). An external chimney stack rises above the gable edge.

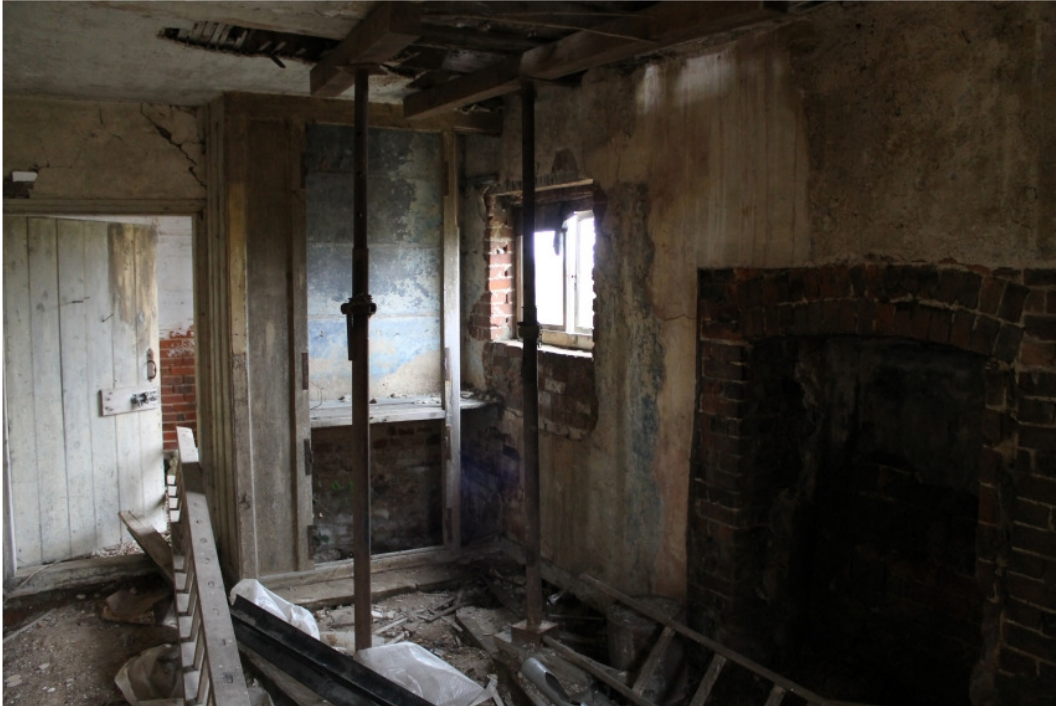
**Plate 8** Kitchen, with scullery through door - view south

The kitchen measures 5.5m x 2.6m and has three doors providing access to the yard/outbuilding, dining room and scullery (Plate 8). The west wall of the kitchen has a recessed fireplace which would have contained an iron range (Plate 9) and there is a fitted cupboard on the wall to the scullery (Plate 10). The doors to the scullery and yard/outbuilding are virtually identical in size and construction whilst the one to the dining room is a narrower traditional Victorian four panel door (Plates 11-13). The walls are plastered and the floor is of exposed earth with no trace remaining of the original floor covering.

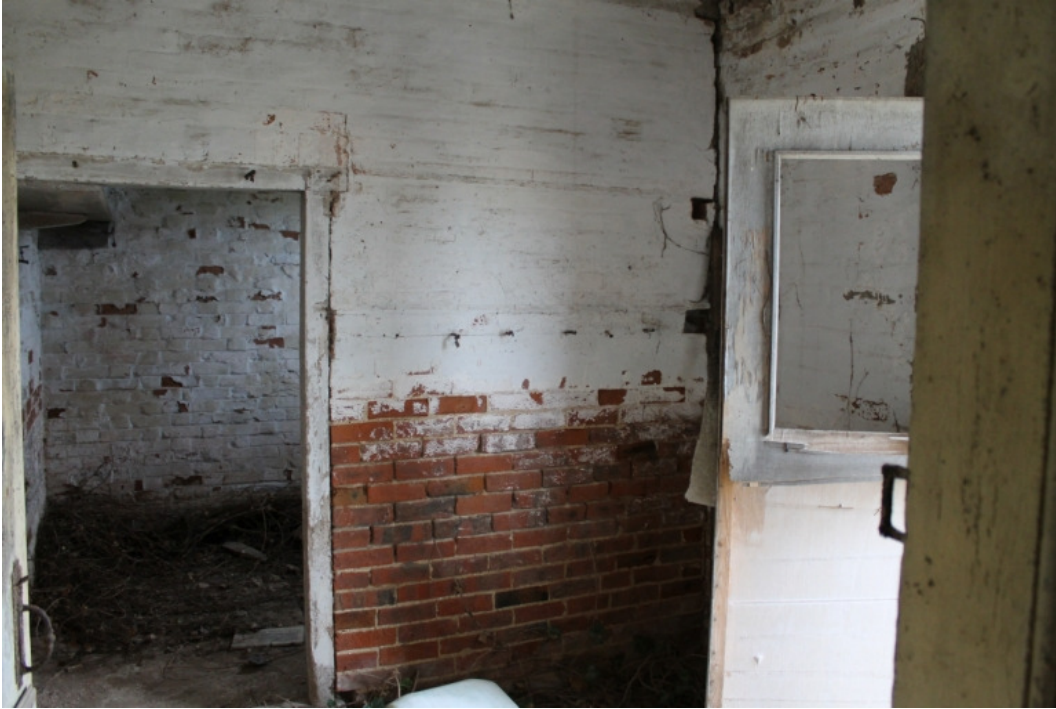
**Plate 14** Scullery, with inserted dividing wall and relocated doorway – view south

The scullery measures 4.6m x 2.6m and has been divided into two smaller rooms by the insertion of a brick cross-wall (Plate 14). The scullery has a door to the kitchen and a door to outside and a small high window. As mentioned above, the external door is a later alteration and was probably inserted at the same time as the cross-wall was installed. If a door of identical dimensions to the scullery and kitchen doors is placed against the join between the original brickwork and the replacement infill, it becomes clear that there was a door in the centre of the scullery wall (Plate 15). It is possible that this original doorway may well have had identical small, high windows on either side, one of which was totally removed by the insertion of the later door. The scullery walls are white-washed brick and there is a shelf in the room farthest from the kitchen. The ceiling is open to the joists of the first floor and there are iron hooks nailed to several of the joists, probably for the suspension of game (Plate 16). As with the kitchen, the floor was exposed earth with no sign of the original floor covering. It is possible that these two rooms were originally floored with flagstones or (more likely in this stone poor region of Essex) with ceramic tiles.

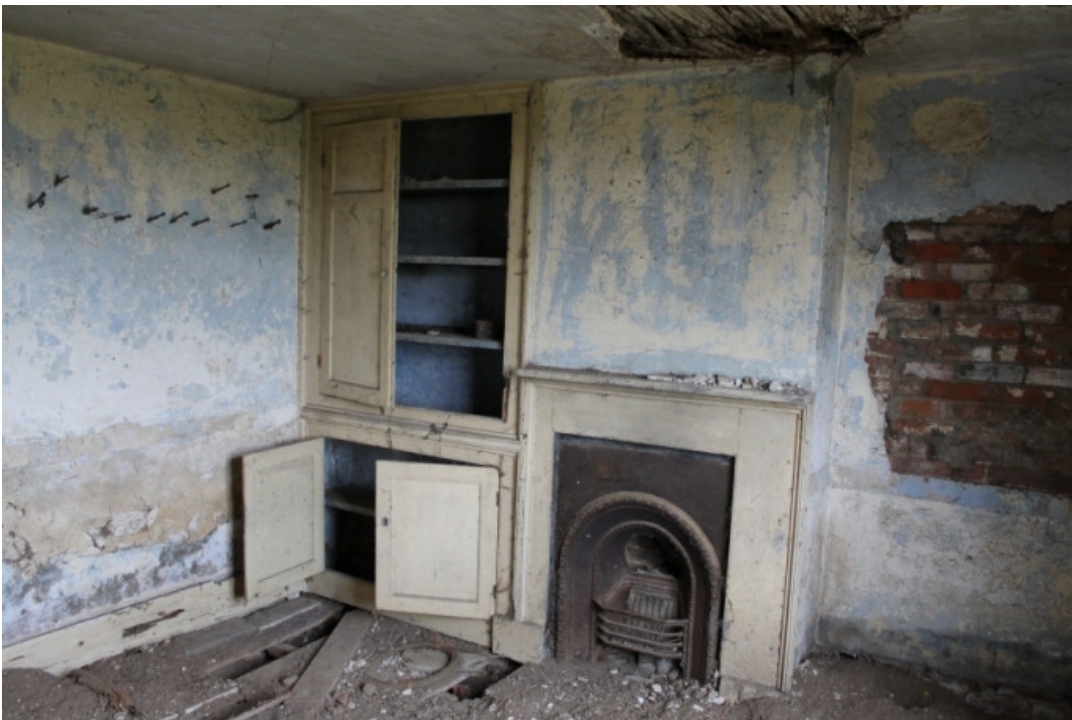
**Plate 17** Dining room with cupboards, early Victorian register grate and bricked-in window  
– view north-west

The dining room measures 4m x 3.75m and is finished to a higher standard than the kitchen and scullery (Plate 17). The walls are plastered, have skirting boards and there appears to have been a dado rail, although there is no indication of a picture rail. The floor is of joists with floorboards laid over. There is a chimney breast on the north wall with an early Victorian iron register grate and a simple wooden surround. To the left of the fireplace are cupboards; whilst to the right is a bricked-in window.

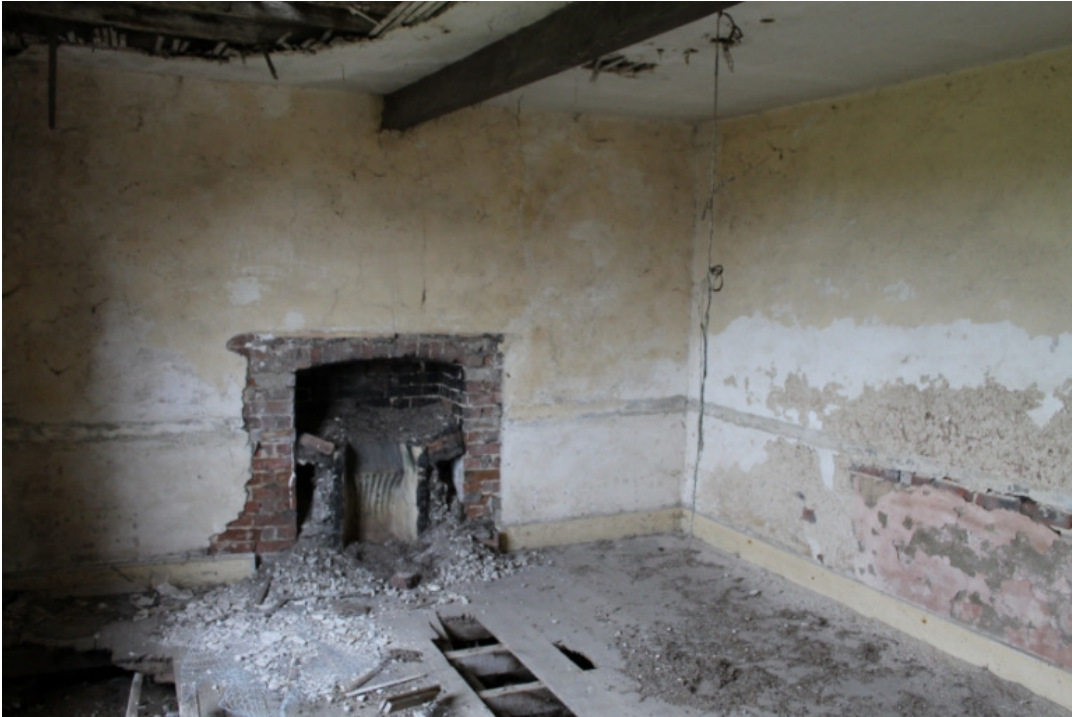
**Plate 18** Parlour with remains of fireplace and bridging beam – view south-west

Across the small hall is the parlour (Plate 18). This measures 4.6m x 3.75m and has plastered walls. The floor is of floorboards laid over joists and has skirting boards and there is evidence for a dado rail but not a picture rail. The ceiling is plastered but has an exposed bridging beam. In the centre of the south wall there are the remains of a fireplace. This appears to have been similar to that in the dining room, an iron register grate with a wooden surround.

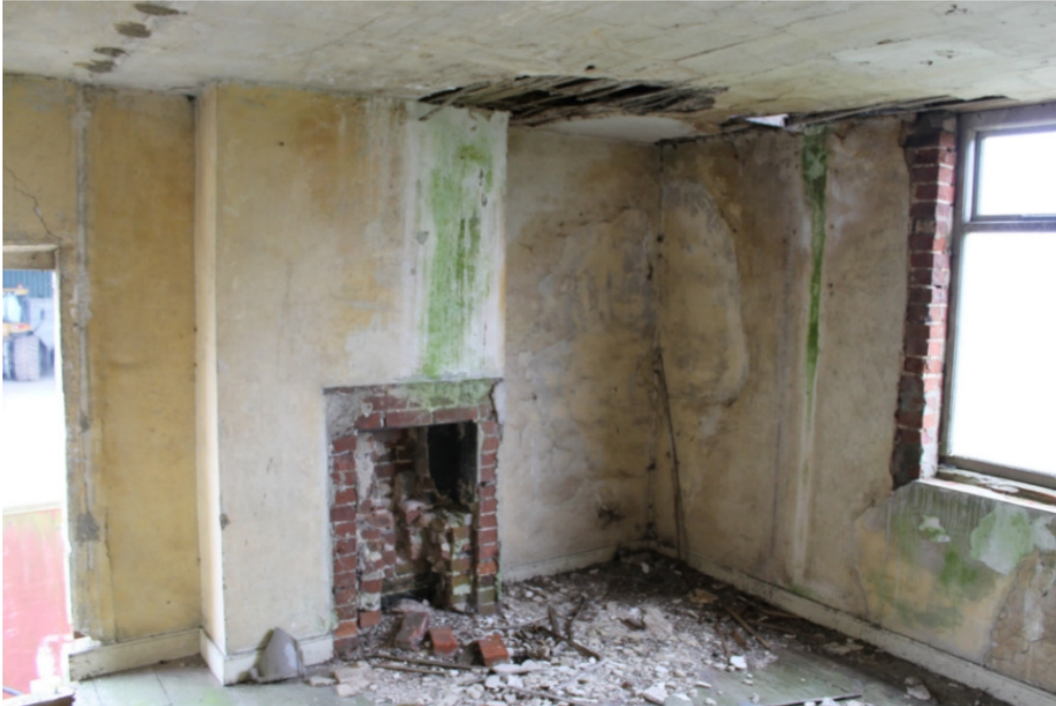
**Plate 20** Bedroom 1 with remains of fireplace and inserted doorway to outbuilding – view north-east

Bedroom 1 measures 4m x 3.75m and has a chimney breast on the north wall, although the grate and surround have been removed (Plate 20). To the left of the chimney breast is an opening in the north wall that once provided access to the outbuilding. There is a cupboard over the stairs (lacking its door) and a door in the west wall provides the only access to bedroom 3. Both the door to the landing and the door to bedroom 3 are traditional Victorian four panel doors.

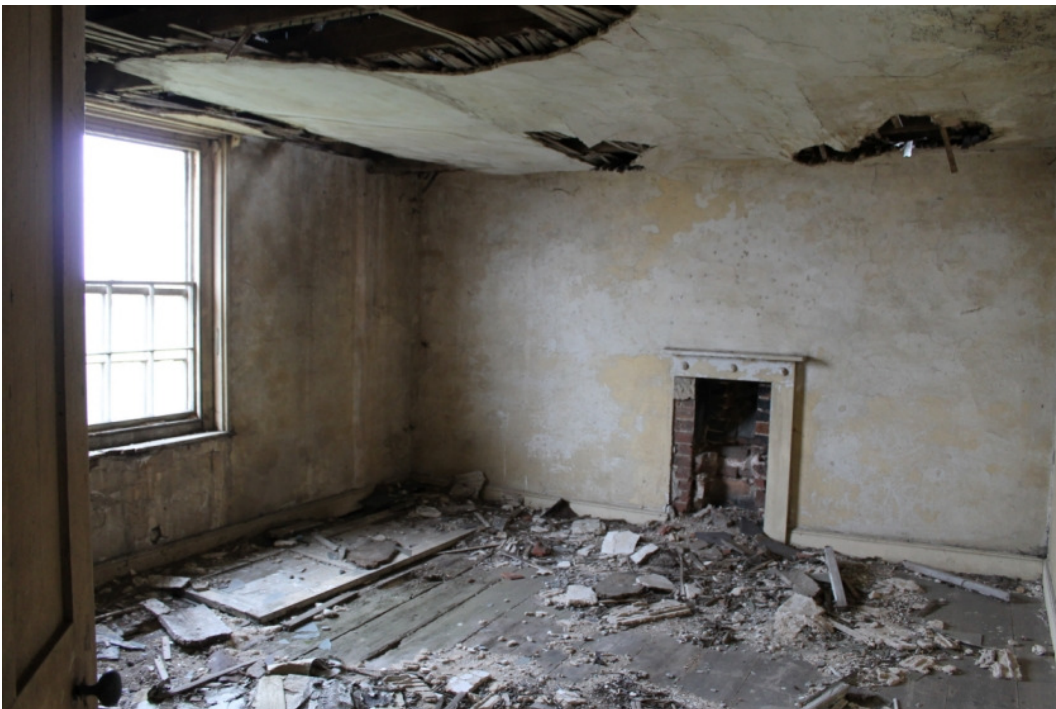
**Plate 21** Bedroom 2 with remains of fireplace and original sash window – view south-east

Bedroom 2 measures 4.6m x 3.75m and has a recessed fireplace in the south wall (Plate 21). Although the iron grate has been removed, a simple wooden surround remains in situ. The door to bedroom 2 is a traditional Victorian four panel door.

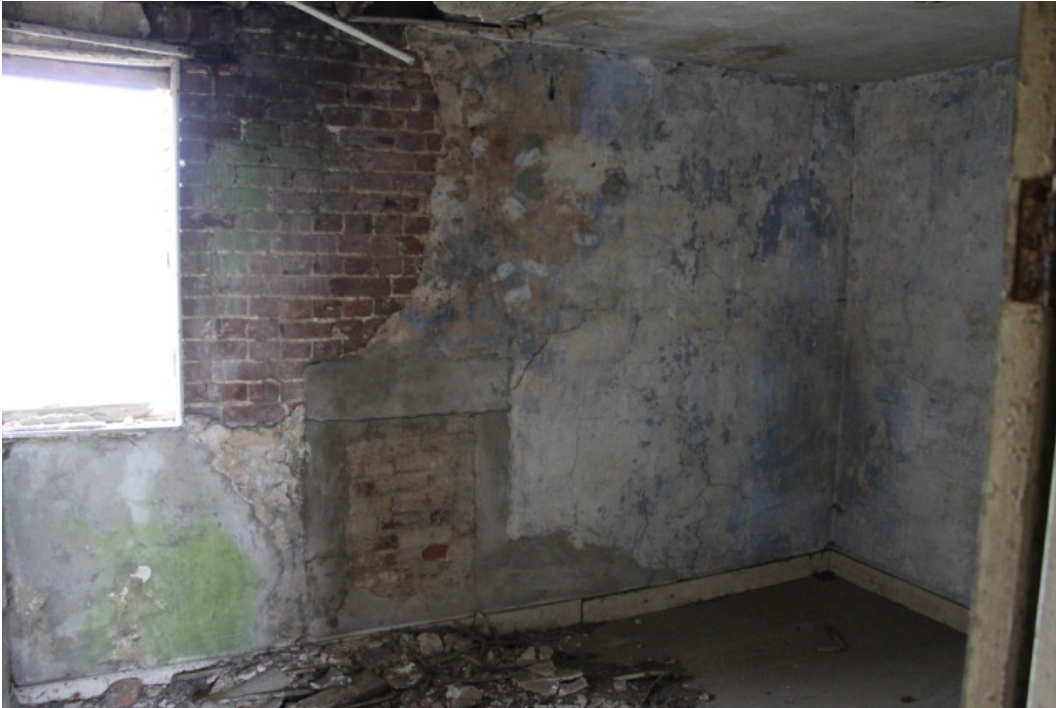
**Plate 22** Bedroom 3 with bricked-in fireplace – view south-east

Bedroom 3 (accessed from bedroom 1) measures 3.3m x 2.6m and has a bricked-in fireplace in the west wall (Plate 22). The south wall of this room is clearly a later insertion as it ends against the centre of the window. Without this inserted wall bedroom 3 would originally have measured 5.25m x 2.6m and would have been accessed from the door at the head of the stairs. This indicates the doorway from bedroom 1 is a later insertion.

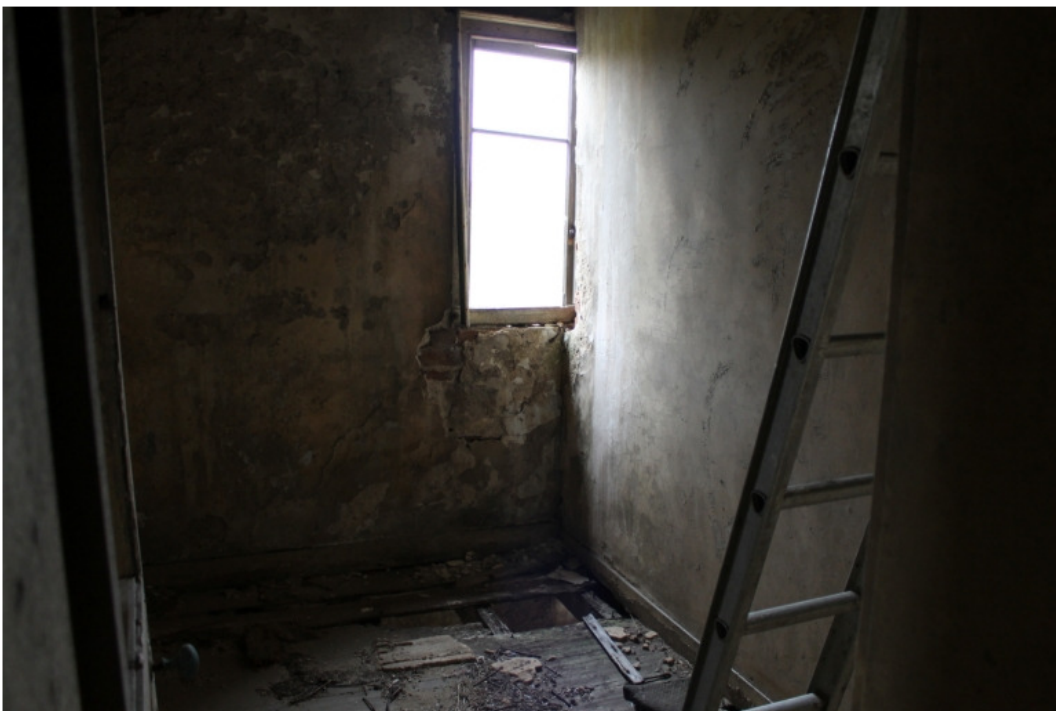
**Plate 23** Attic access with inserted wall to the right – view north-west

The attic access off the landing, once part of bedroom 3 (Plate 23) forms a small room 1.75m x 2.6m which provides access to the attic via a ceiling hatch, and the only access to bedroom 4 through a door in the south wall. No trace of any original stairs or attached ladder arrangement for the ceiling hatch was observed and it is assumed access was always via a ladder. The doors to the landing and bedroom 4 are both traditional Victorian four panel doors.

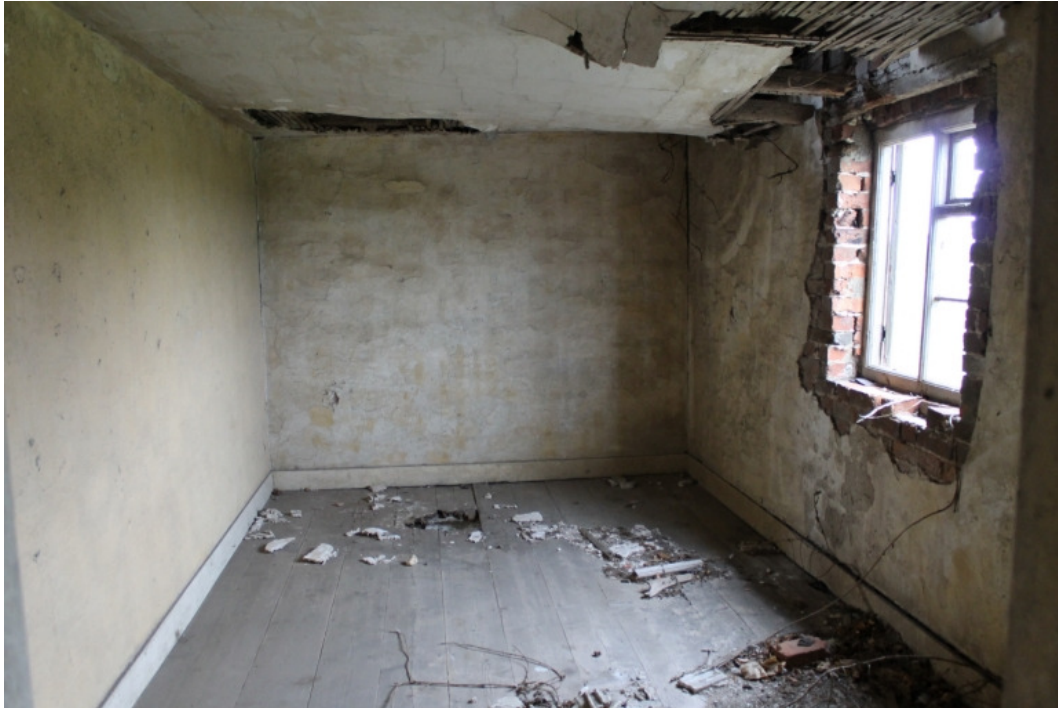
**Plate 24** Bedroom 4 – view south

Bedroom 4 measures 4.6m x 2.6m and has no features apart from the window in the west wall (Plate 24). There is no fireplace in bedroom 4 which suggests the original function of this room was not as a bedroom. This is reinforced by the information provided in the 1917 sales catalogue that states the farmhouse has only three bedrooms. One possible explanation for this is that bedroom 3 was intended as a children's bedroom and that bedroom 4 (opening off of it) was used as a nursery.

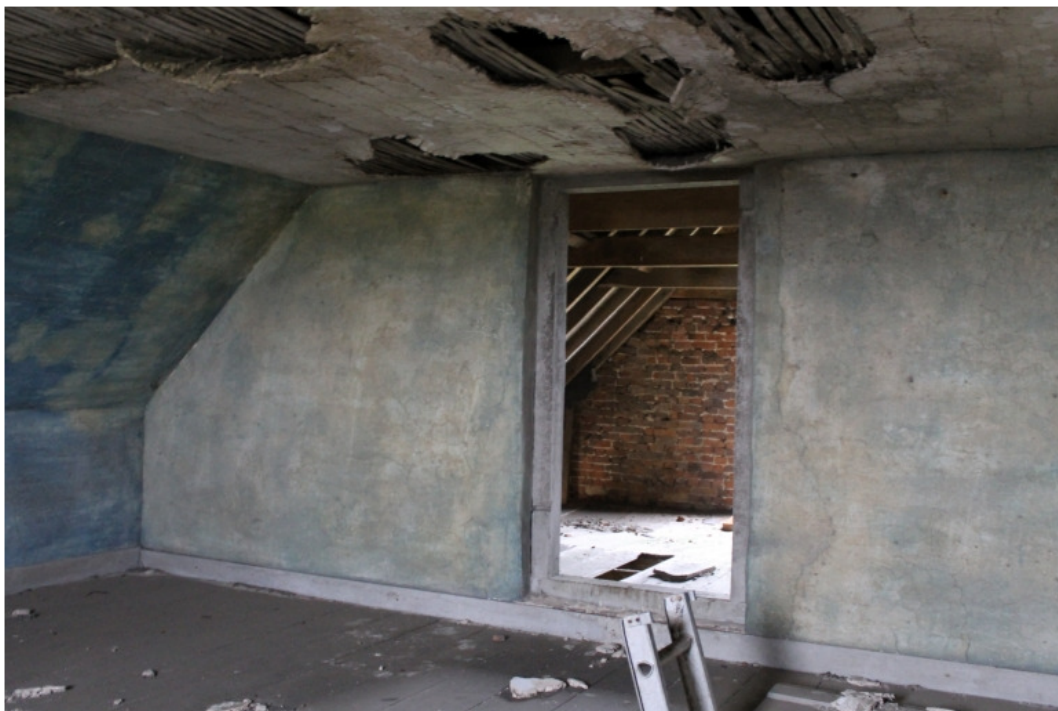
**Plate 25** Attic room 1 with attic room 2 visible through the doorway - view south-east

The attic is divided into two rooms (Fig 7). The larger of the two, attic room 1, measures 5.25m x 4.6m and has plastered walls and ceiling. Attic room 2 measures 4.6m x 4.6m and is open to the rafters. Both rooms have floorboards laid over the joists (Plate 25).

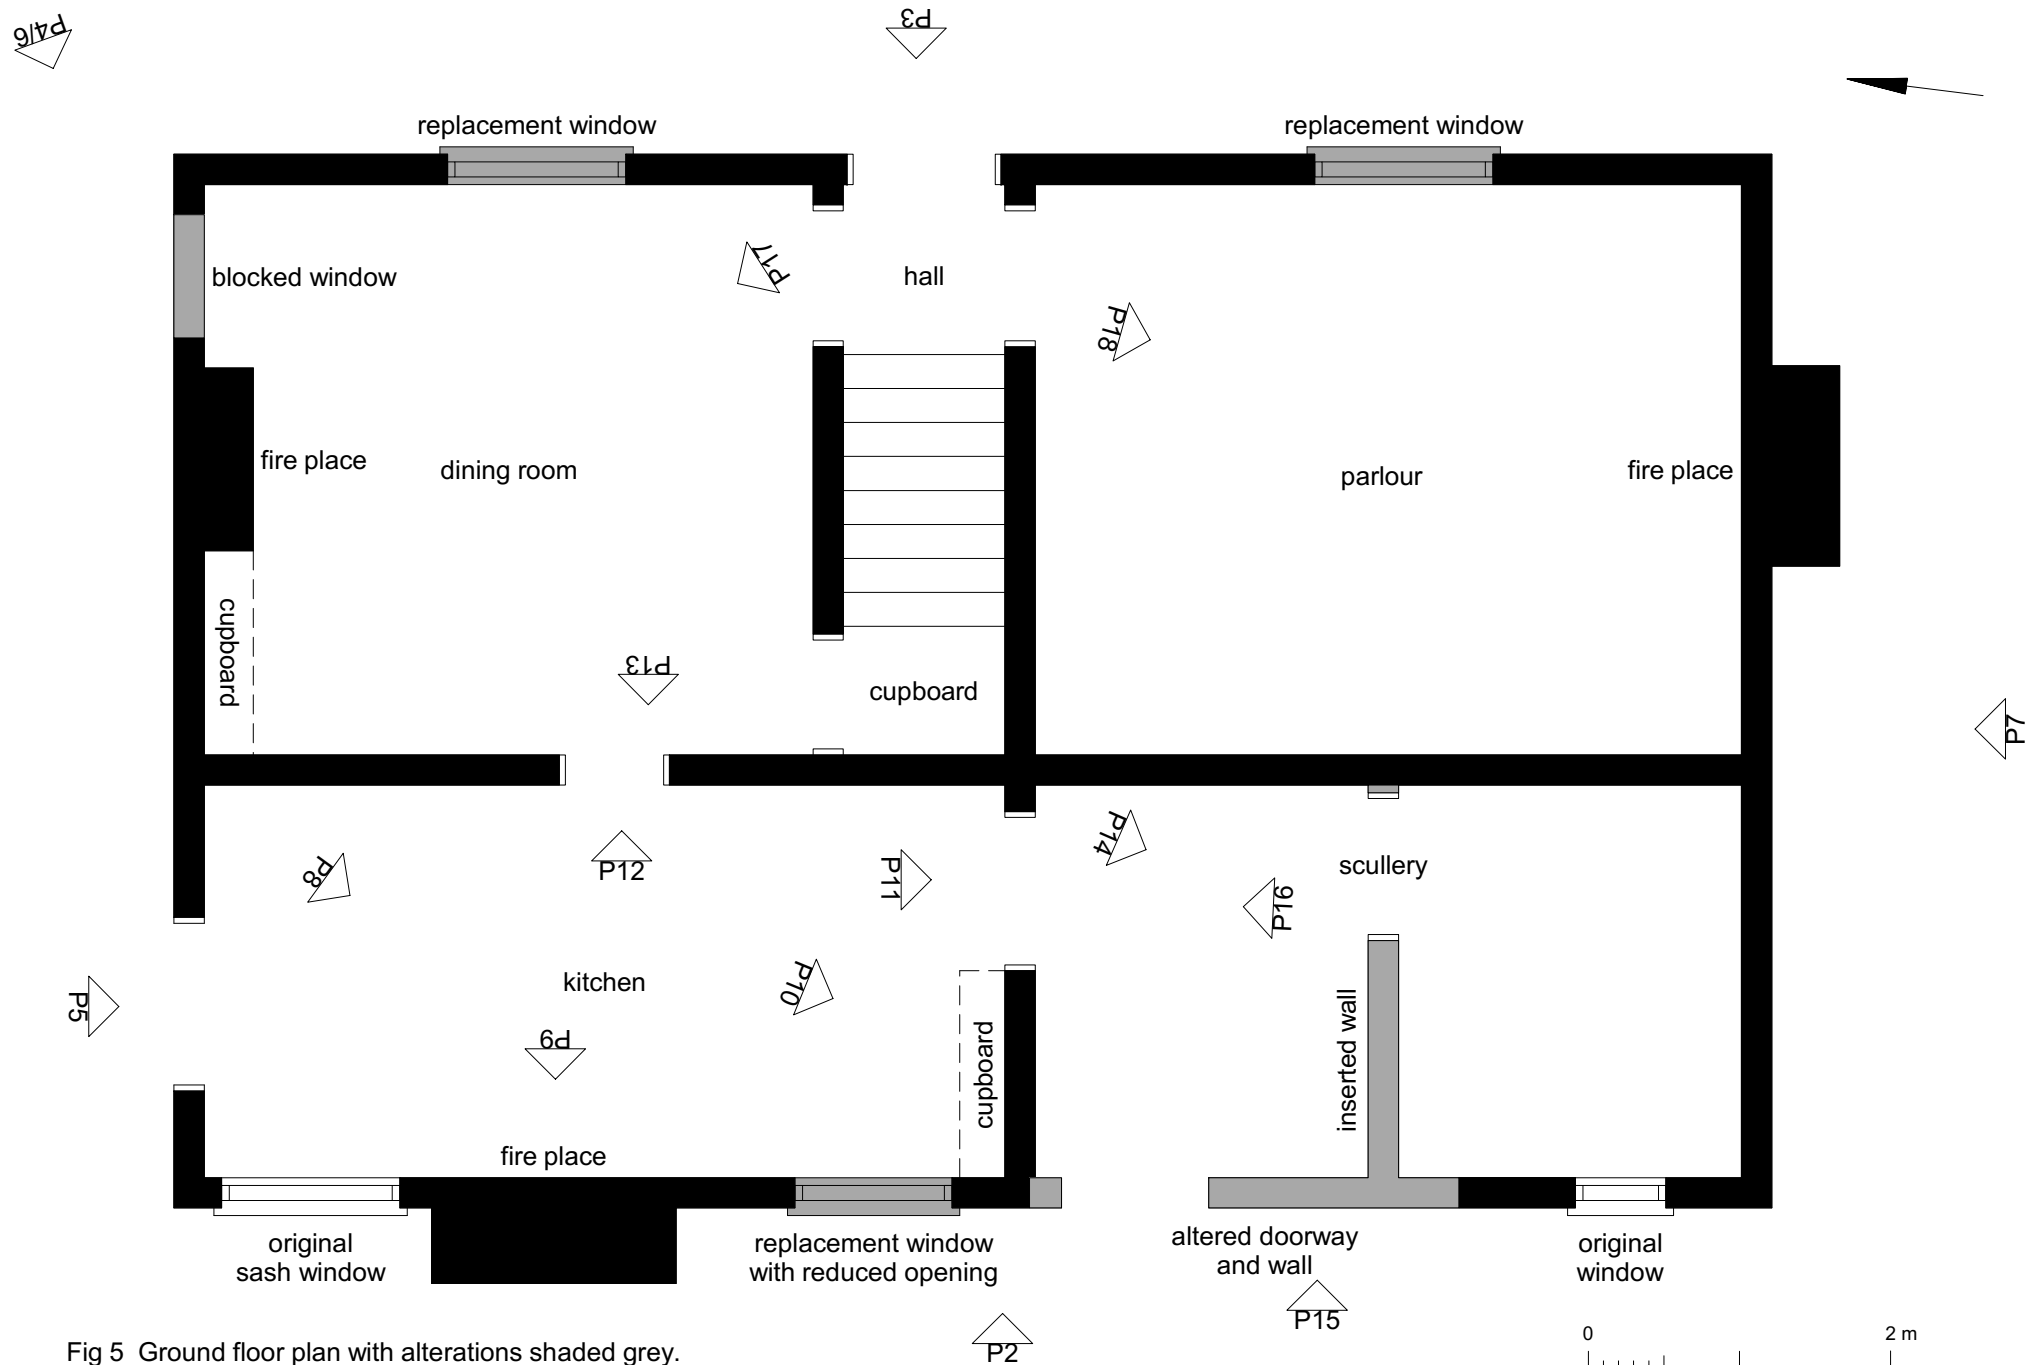
Fig 5 Ground floor plan with alterations shaded grey.

The ground floor is divided into four rectangular but unequally-sized rooms, comprising kitchen, scullery, dining room and parlour (Fig 5). A later inserted wall has divided the scullery into two rooms. The west side of the farmhouse contains the kitchen and scullery, whilst the dining room and parlour, either side of the front door and hall, are on the east side of the farmhouse, looking out over the fields to the marshes beyond.
