**Historic building recording
of a 19th-century house and workshop
off West Stockwell Street,
Colchester, Essex**

March 2013

CAT Report 691
August 2013

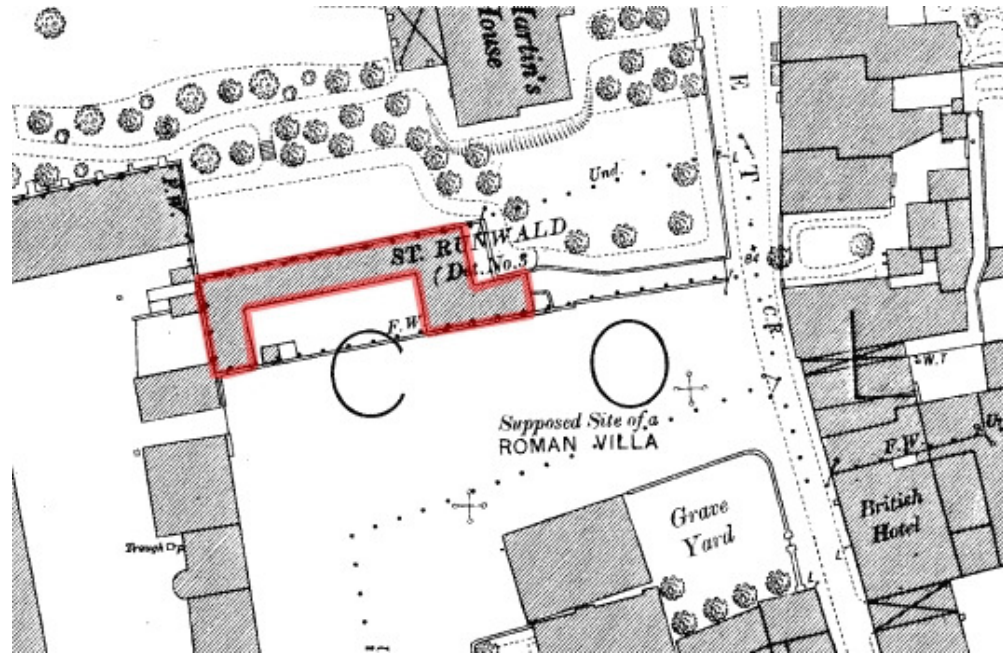
The 1st edition Ordnance Survey map of 1876 (Fig 2) shows a much-changed layout. The 1830 house is shown with substantial additions, including an L-shaped range extending to the west and a rectangular extension to the south which projects towards West Stockwell Street. The function of these extensions is unclear, although they may be the start of the conversion of the 1830 house from domestic to industrial usage. The long rectangular building to the south of the site has been removed

Fig 2 1st edition OS map, 1876.

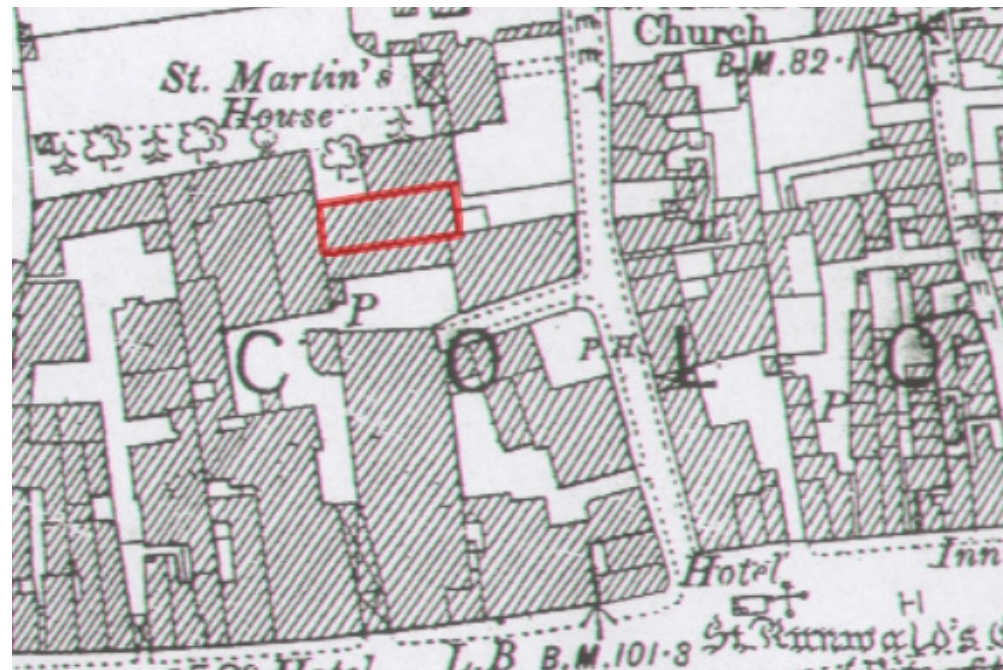
Fig 3 2nd edition OS map, 1897.

The 2nd edition Ordnance Survey map of 1897 (Fig 3) shows further change to the complex. The entire width of the property is occupied by a large building extending from the east side of the 1830 house to the west end of the plot. The extension that was projecting towards West Stockwell Street has been removed. The surrounding area has also been developed. To the north there is an extension to St Martin's House, whilst to the south, buildings have been erected along the length of the

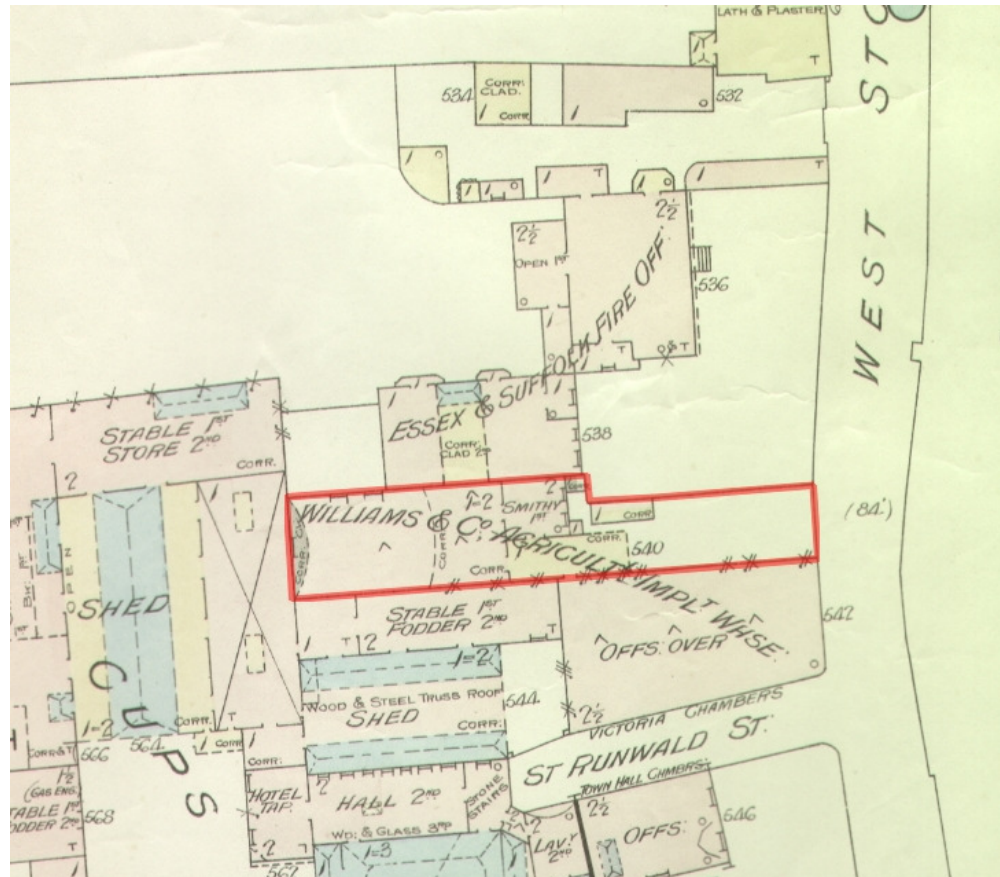
Fig 4 Insurance map, 1909.

The insurance map shows the 1830 house labelled as a smithy with the workshop extending from the west wall. South of the smithy, there is a rectangular structure that the map key indicates is constructed from timber. This equates to the covered yards. To the west of the 1830 house, the map shows a small rectangular wooden shed aligned along the northern boundary. On the map the complex is labelled as the 'Williams and Co Agricultural Implement Warehouse' and includes the ground floor of the 1883 Victoria Chambers, which, with its large windows, was probably used as a showroom.

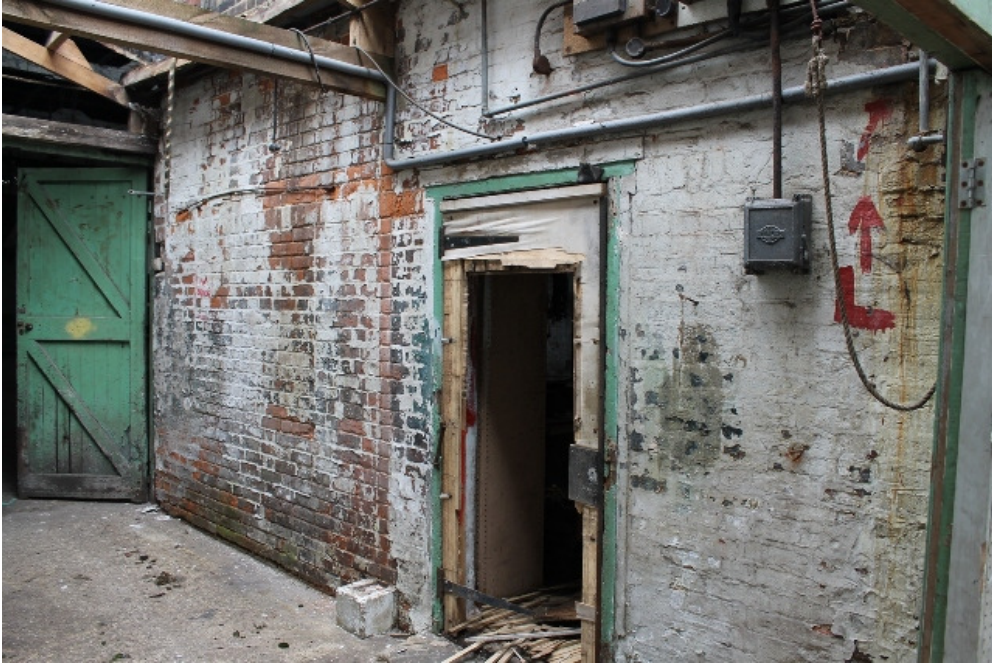
The south wall has a doorway partially inserted through a blocked window in the ground floor and a second blocked window towards the west (Plate 3). The first floor has been rebuilt in red brick with dimensions of 222 x 110 x 66mm laid in Flemish bond. This later wall includes an irregular-shaped window, which has subsequently been bricked-in (Plate 4). The gable has collapsed and been replaced with vertical sheets of corrugated iron.

Plate 3 South elevation of the converted 1830 house, showing the inserted doorway and blocked windows – view north-west

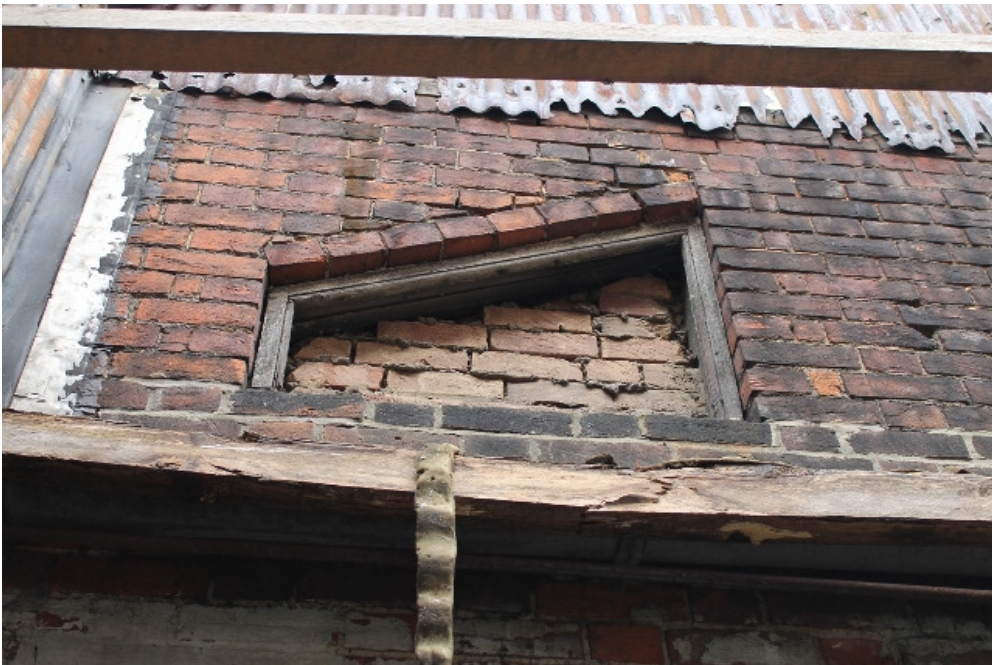
Plate 4 The rebuilt first floor wall of the converted 1830 house, showing the irregular-shaped window – view north

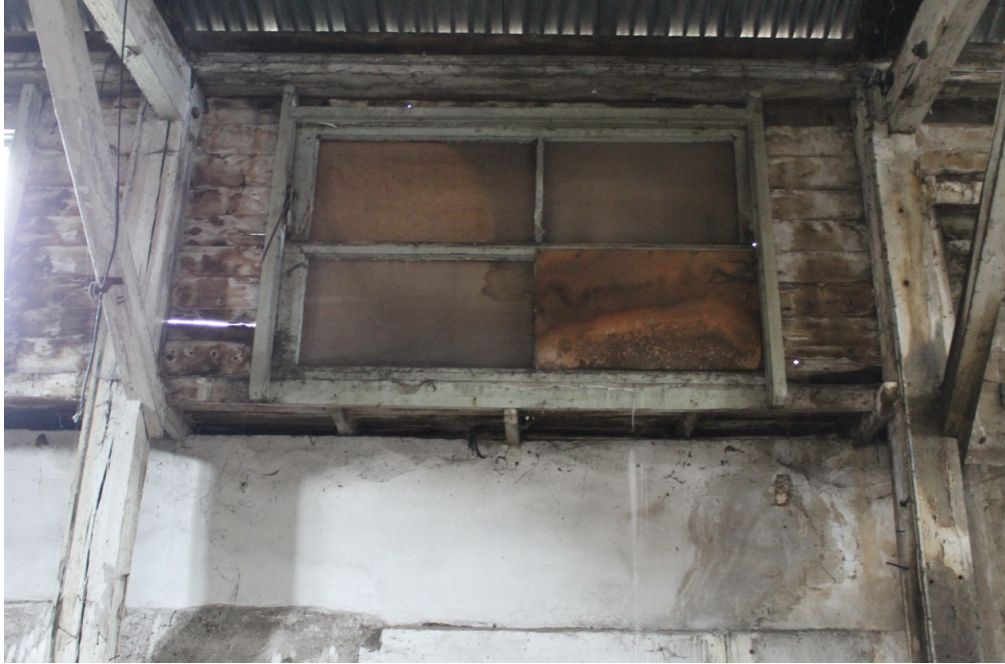
Plate 10 North wall of the workshop, showing the structure built on the adjoining property wall - view north

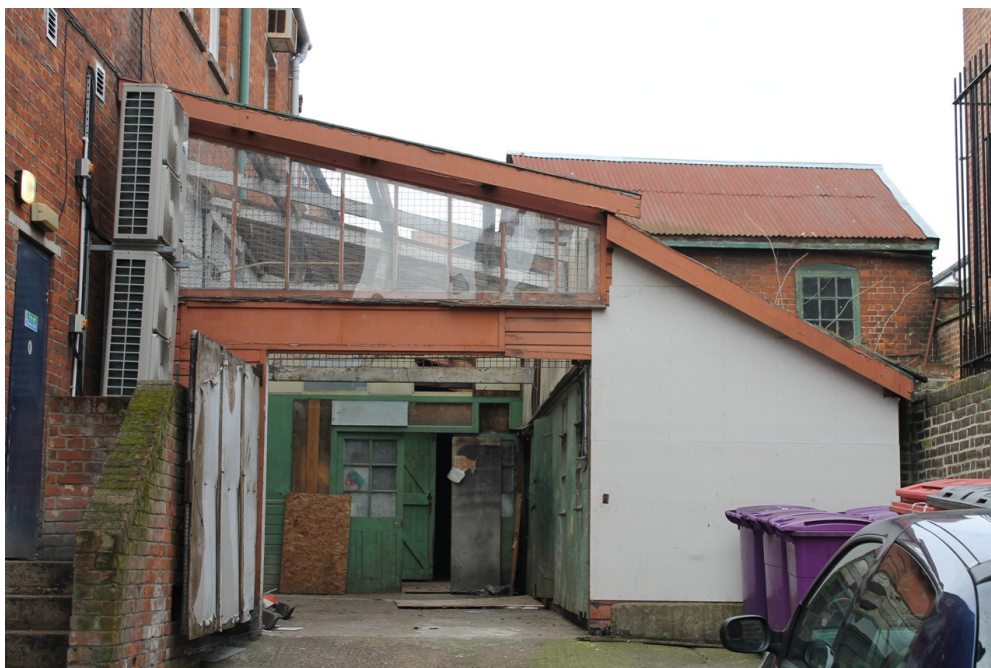
This structure is a single-storey, mono-pitch shed, constructed from timber and consisting of an office and a kitchen (Plate 12). This is a very simple structure that has been repaired several times and has had two metal-framed windows inserted into the south elevation (Plate 13).

Plate 12 The 20th-century mono-pitch shed - view west

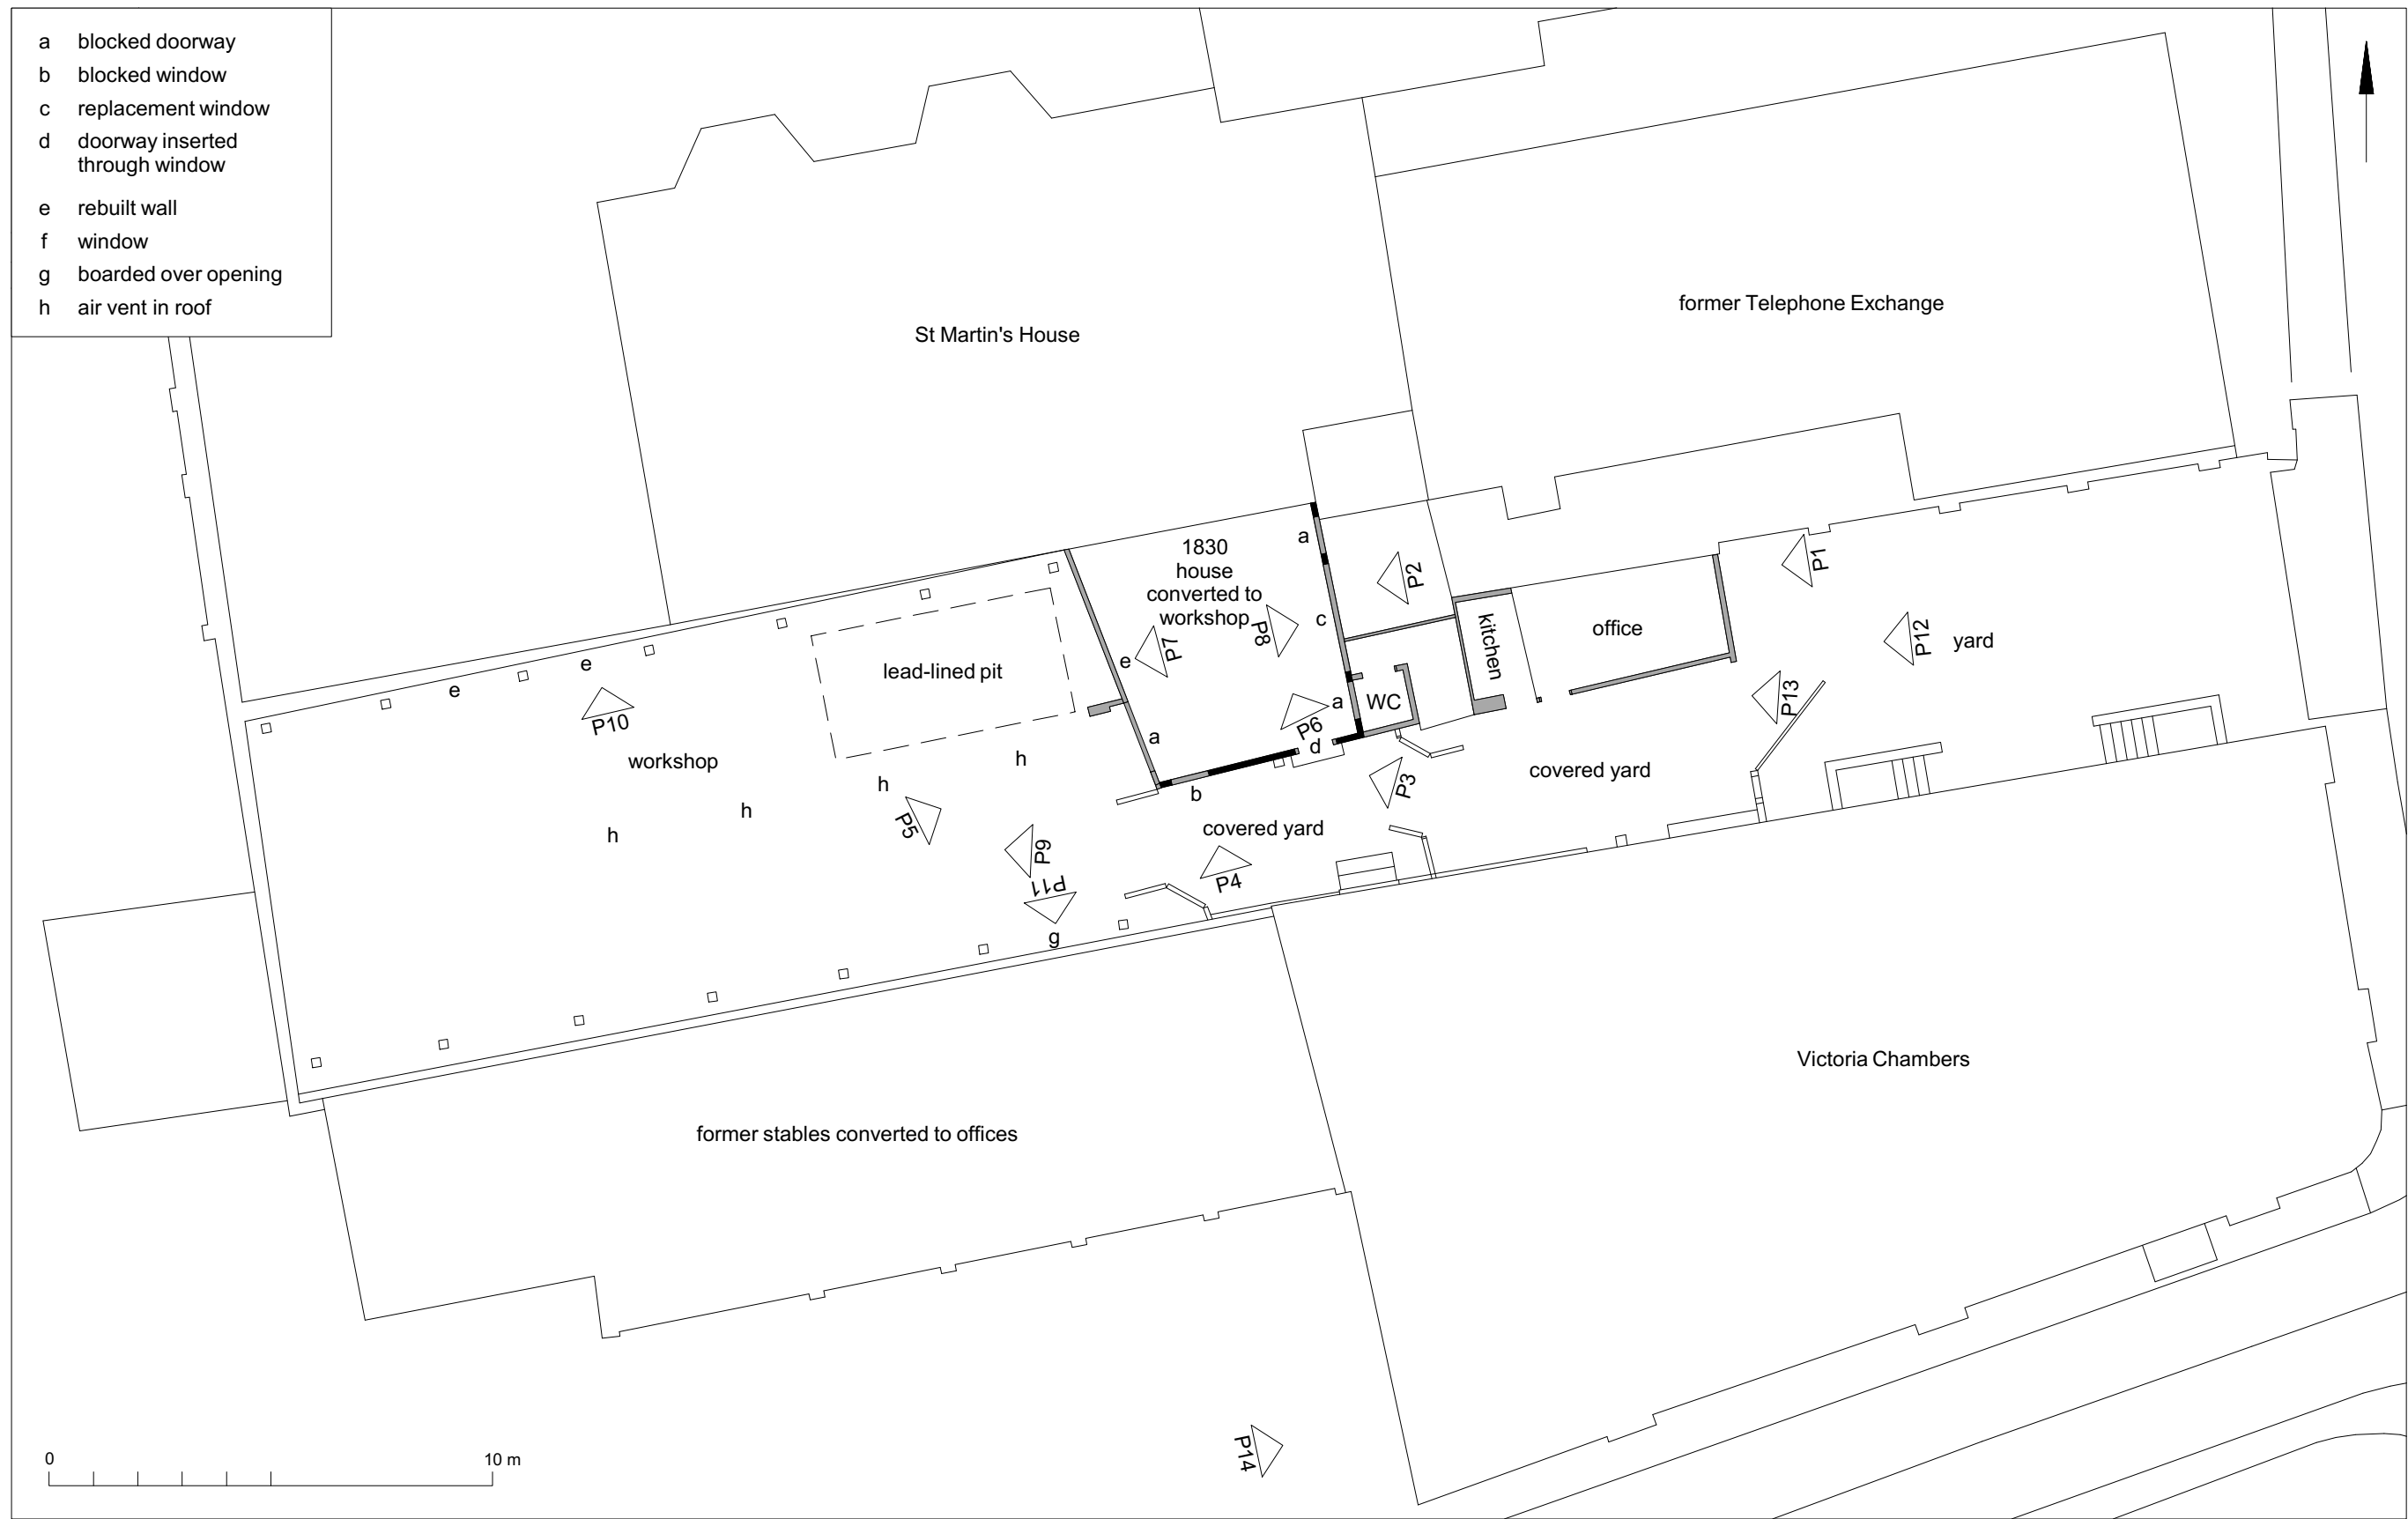
Fig 6 Plan of the site showing the location and orientation of photographs included in the report.

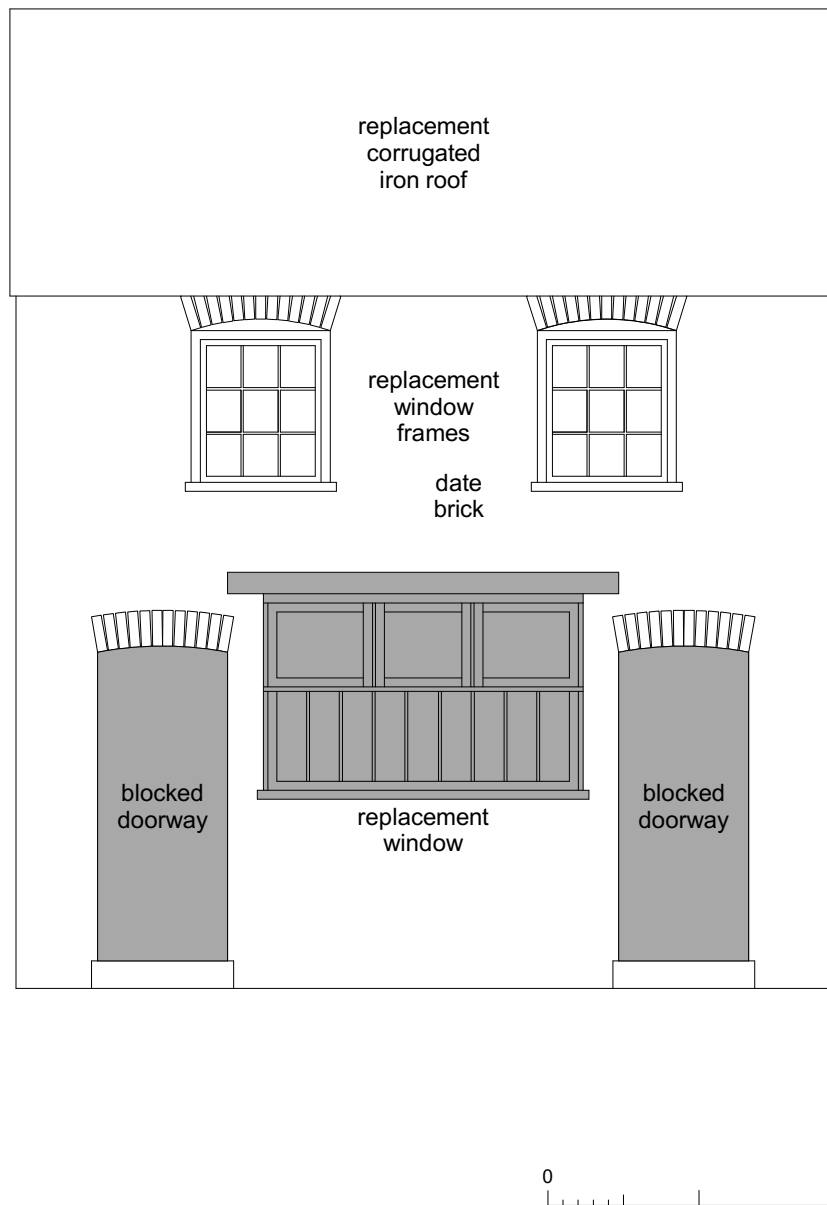
Fig 7 East elevation of the converted 1830 house, with later alterations shaded grey.

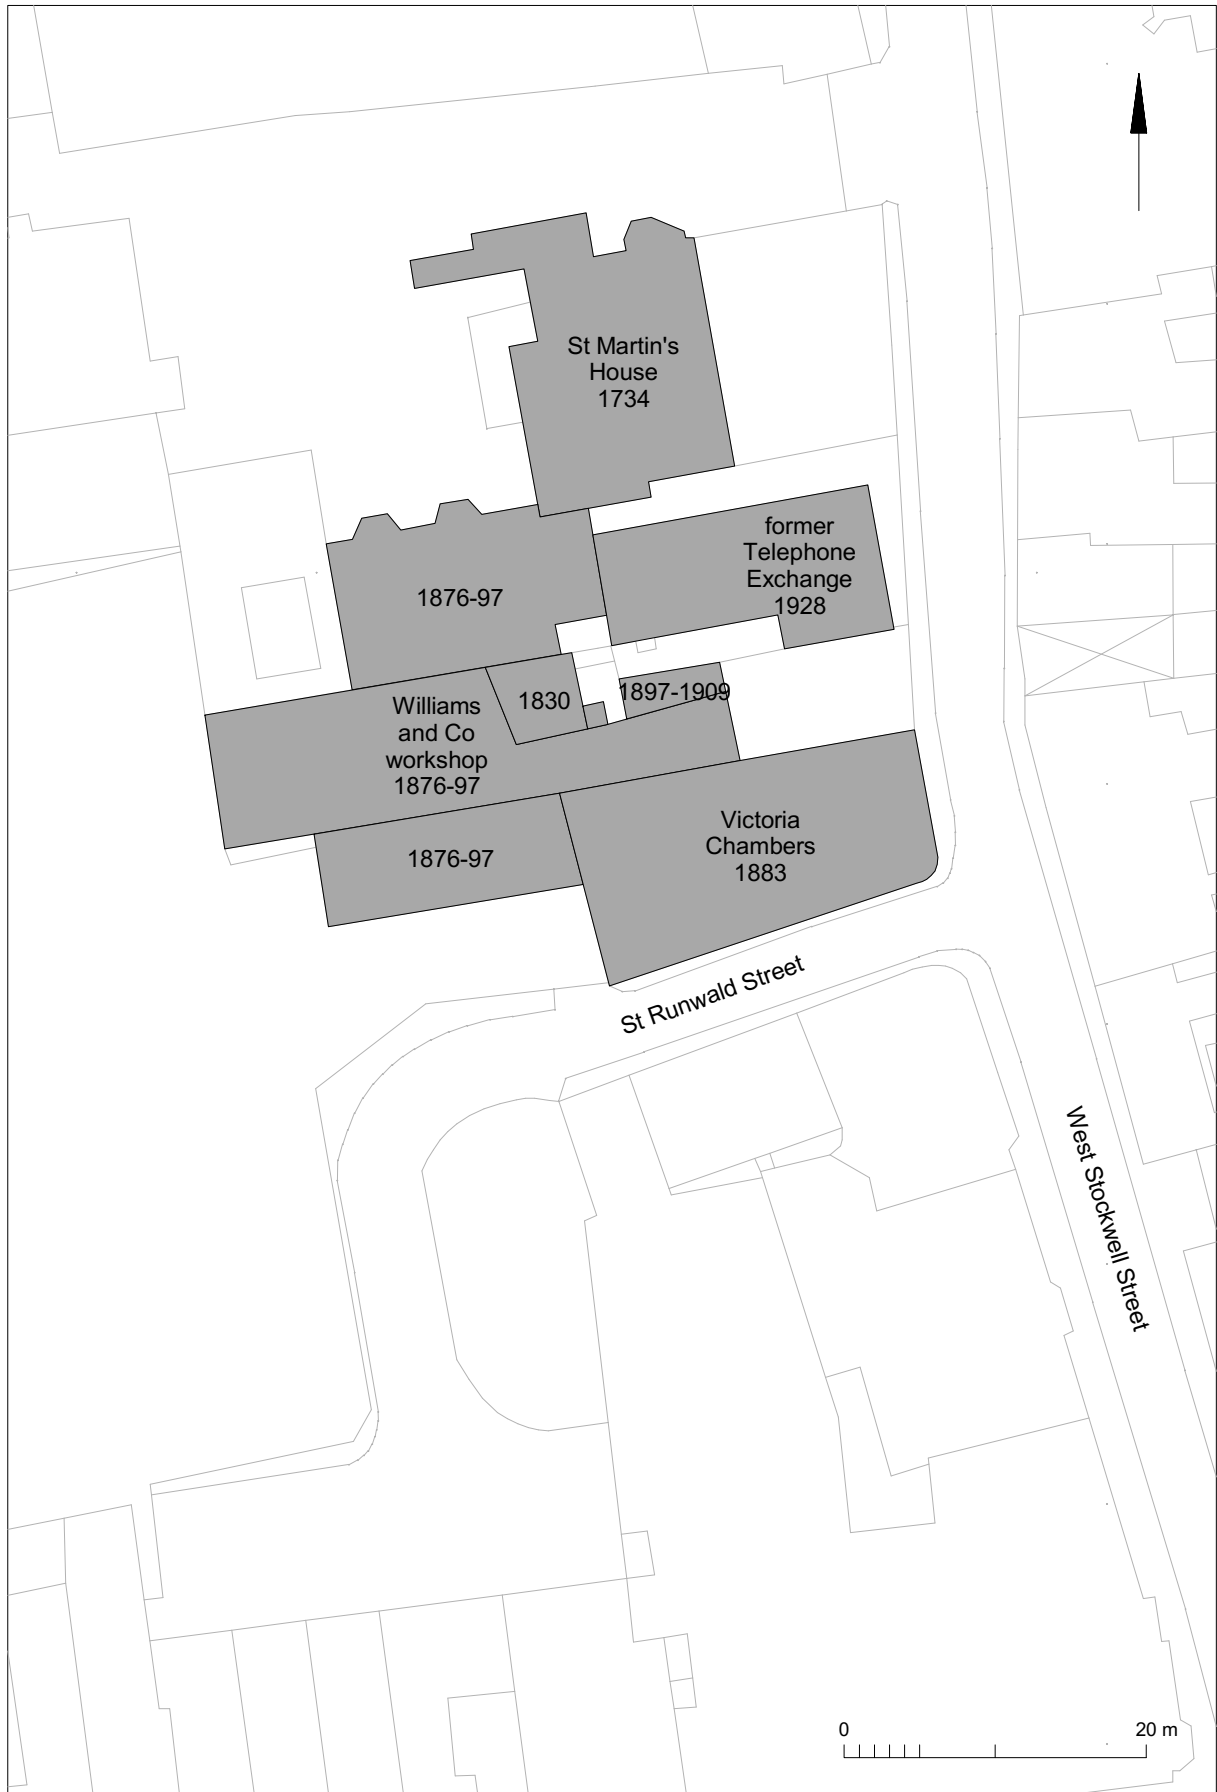
The complex has three distinct phases, although there have been many alterations to the structures throughout its history. The individual buildings are described in the following text by phase. The earliest phase (Phase 1) dates to 1830 and consists of the brick house. Phase 2 consists of the large workshop west of the 1830 house and dates to 1876-97. Phase 3 is the wooden shed to the east of the converted 1830 house and dates to 1897-1903.

Fig 8 Site phasing.
