**Historic building recording
at the decommissioned
Hyderabad and Meeanee Barracks,
Colchester, Essex
April 2013**

**report prepared by
Chris Lister**

**on behalf of
Taylor Wimpey**

CAT Report 711
September 2013

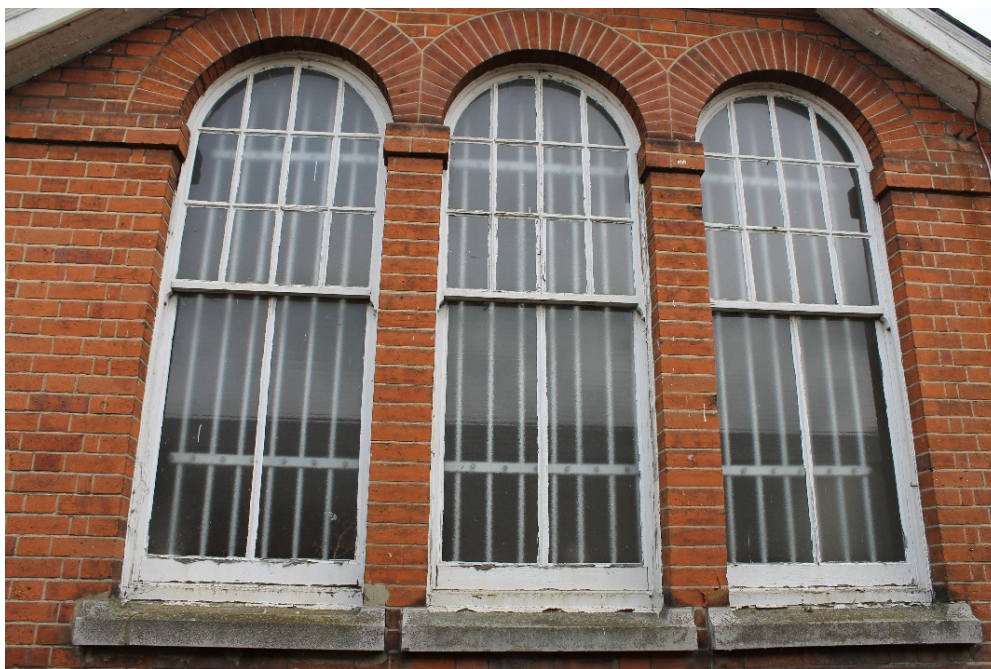
Plate 2 South elevation of the MEE 01, showing the original windows – view north-west (Ingram, 2000)

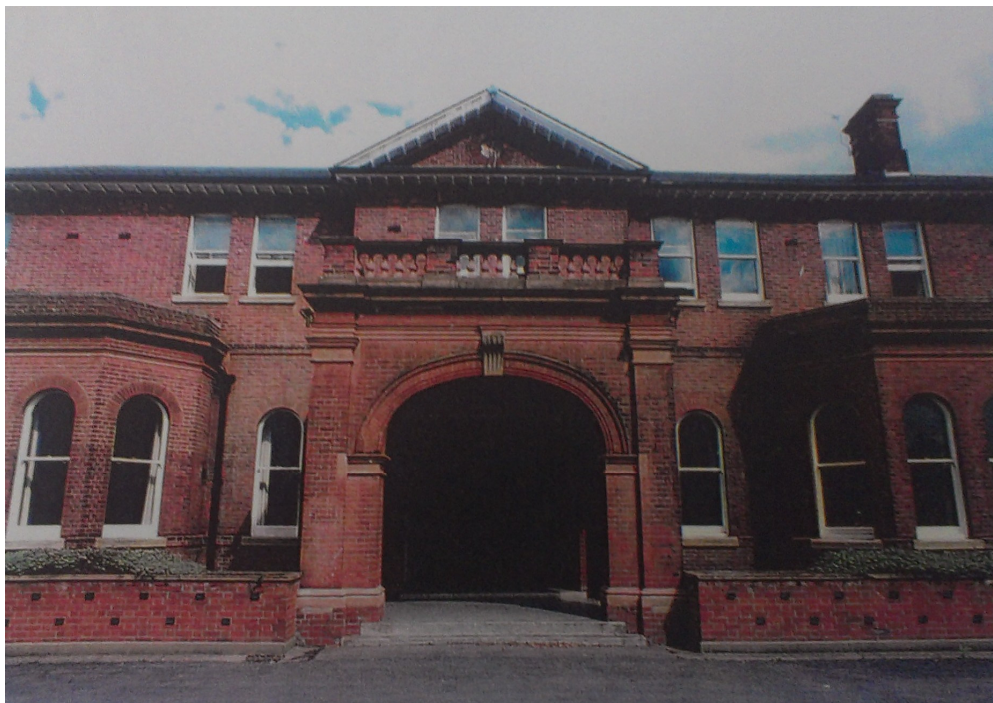
Plate 12 MEE 17, showing main range and northern service wing - view south-east
(Ingram, 2000)

The north wing is a combination of a single-storey extension from 1958-61 and a two-storey building rendered in concrete. The latter has a fully hipped roof and is the original living quarters for the Mess manager. In addition to the concrete render the original windows have been replaced with metal-framed versions.

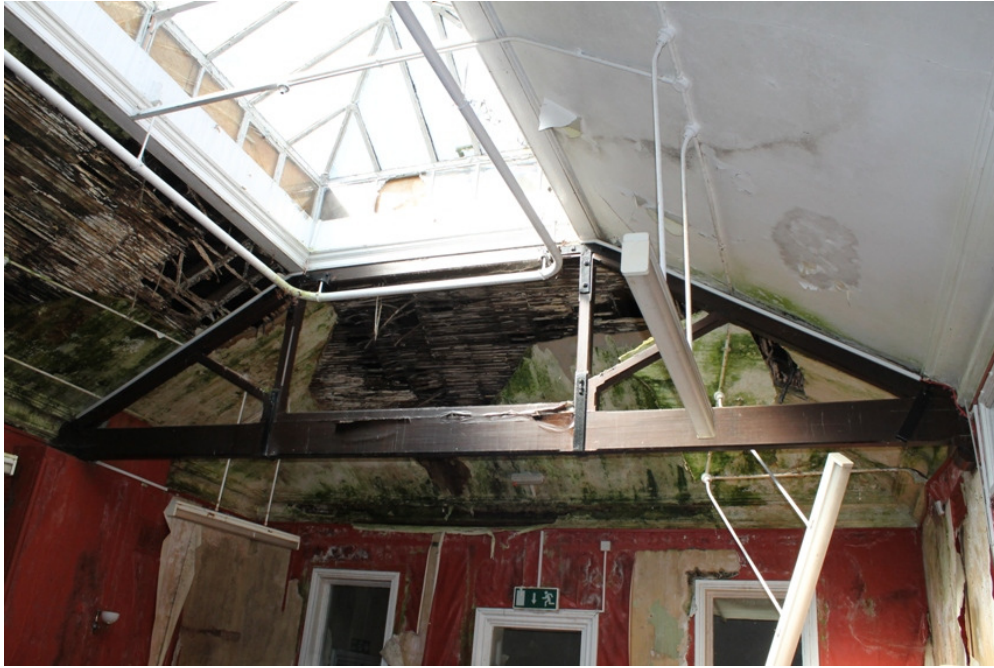
Plate 22 MEE 17 Billiard Room - view east

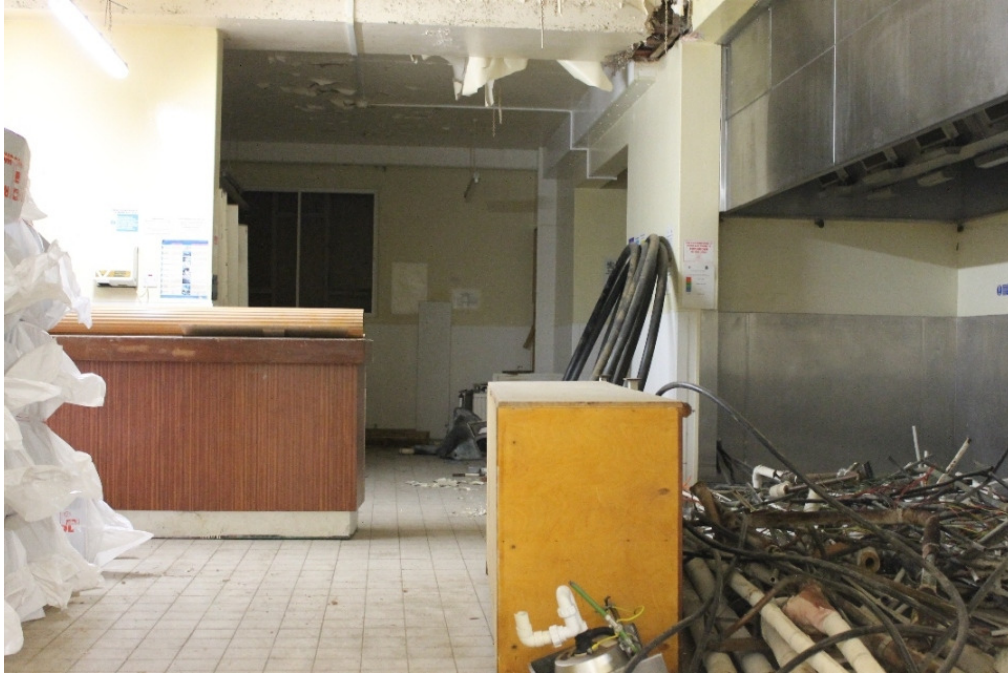
Plate 38 HYD 08 Mess Room, showing artificially lowered ceiling – view north-west

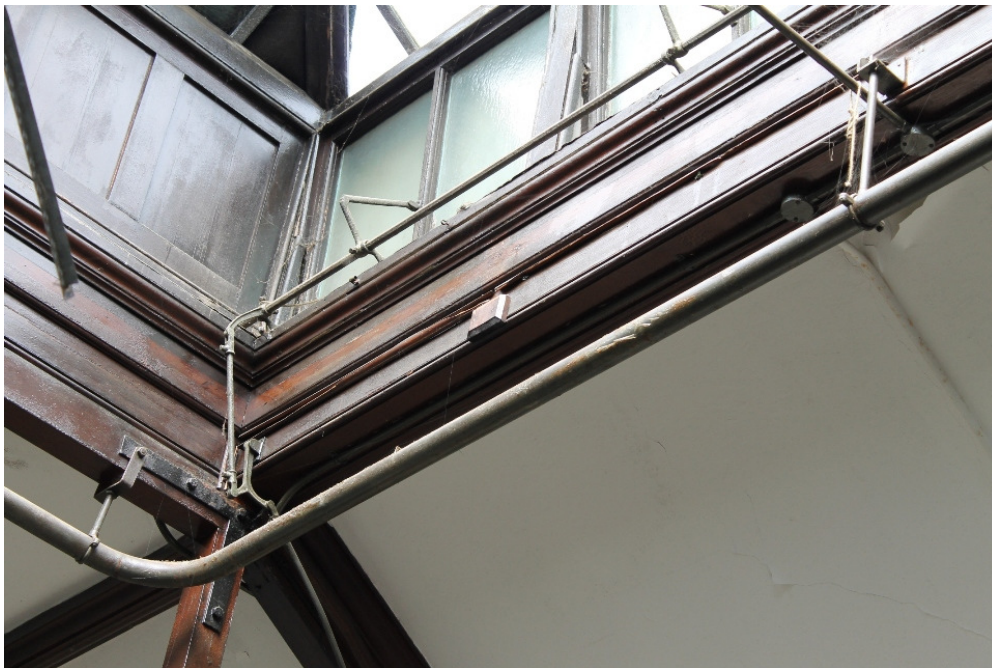
Plate 41 HYD 08 Billiard Room with parquet floor and queen post trusses – view east

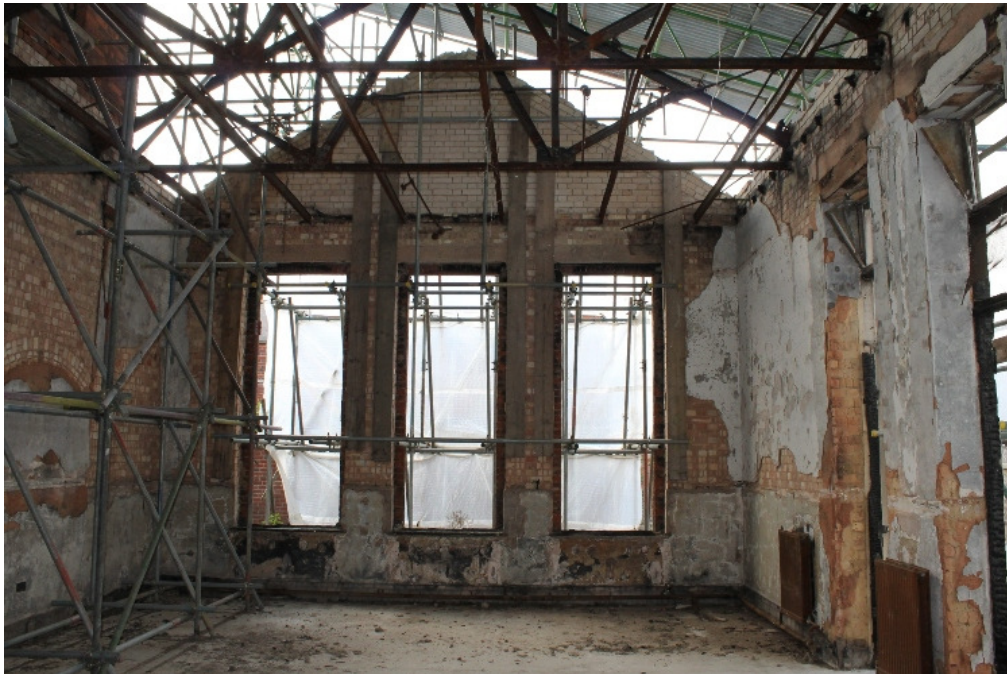
Plate 55 HYD 11 1938 interior, showing blocked windows of the 1904 structure – view east

The 1938 entrance is identical to the 1904 example apart from the iron work of the staircase, which is executed in an Art Deco style (Plate 54). It has doorways leading into the main range and the single-storey extension on the west side, labelled the Corporals' Restaurant on the 1946 plan. The main range is a large open room with a servery in the south wall, and is labelled as the Soldiers' Room on the 1946 plan. Due to the extensive fire damage it is possible to see the alterations to the west wall of the 1904 structure (Plate 55). Where the plaster has fallen away, it can be seen that the west wall is a mirror image of the east and that all of the windows were blocked when the 1938 extension was added.

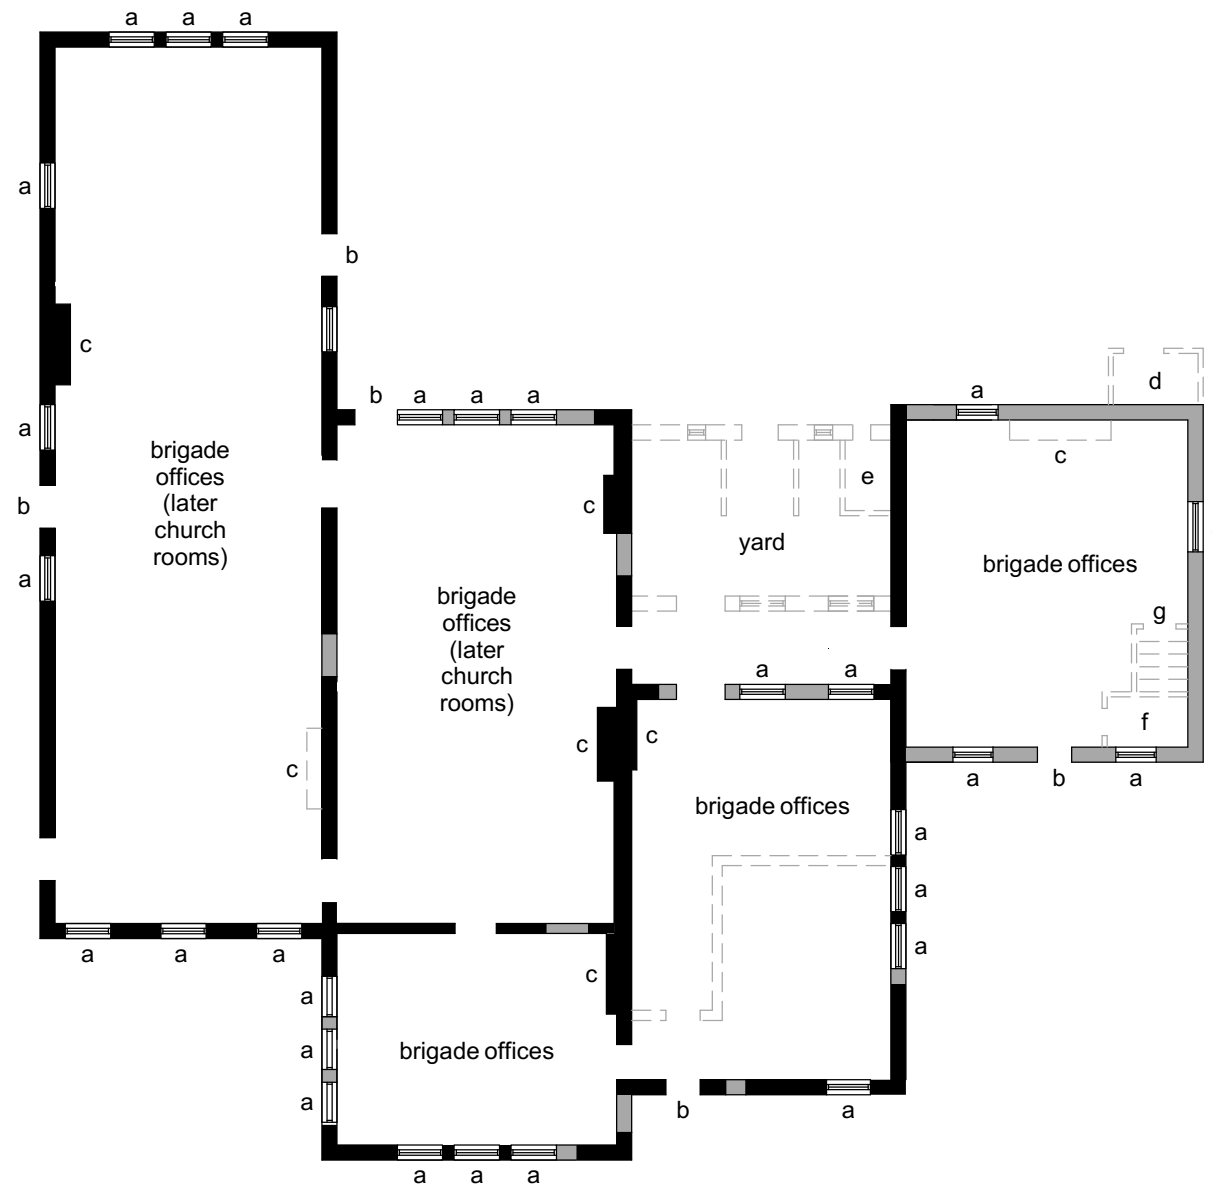
- a original window
- b original entrance
- c fireplace
- d WC
- e coal store
- f cupboard
- g stairs to cellar

Fig 24 MEE 01: original floor plan of the former Meeanee Barracks Brigade Offices, with surviving fabric shown black and removed/altered components shaded grey.

The square structure on the north-east corner of the building is a flat-roofed garage built of red brick with dimensions of 215 x 65 x 110mm laid in stretcher bond. The south wall is open but appears to have originally held folding doors. This structure has replaced an identical-sized building that was part of the Brigade Offices (Fig 24).

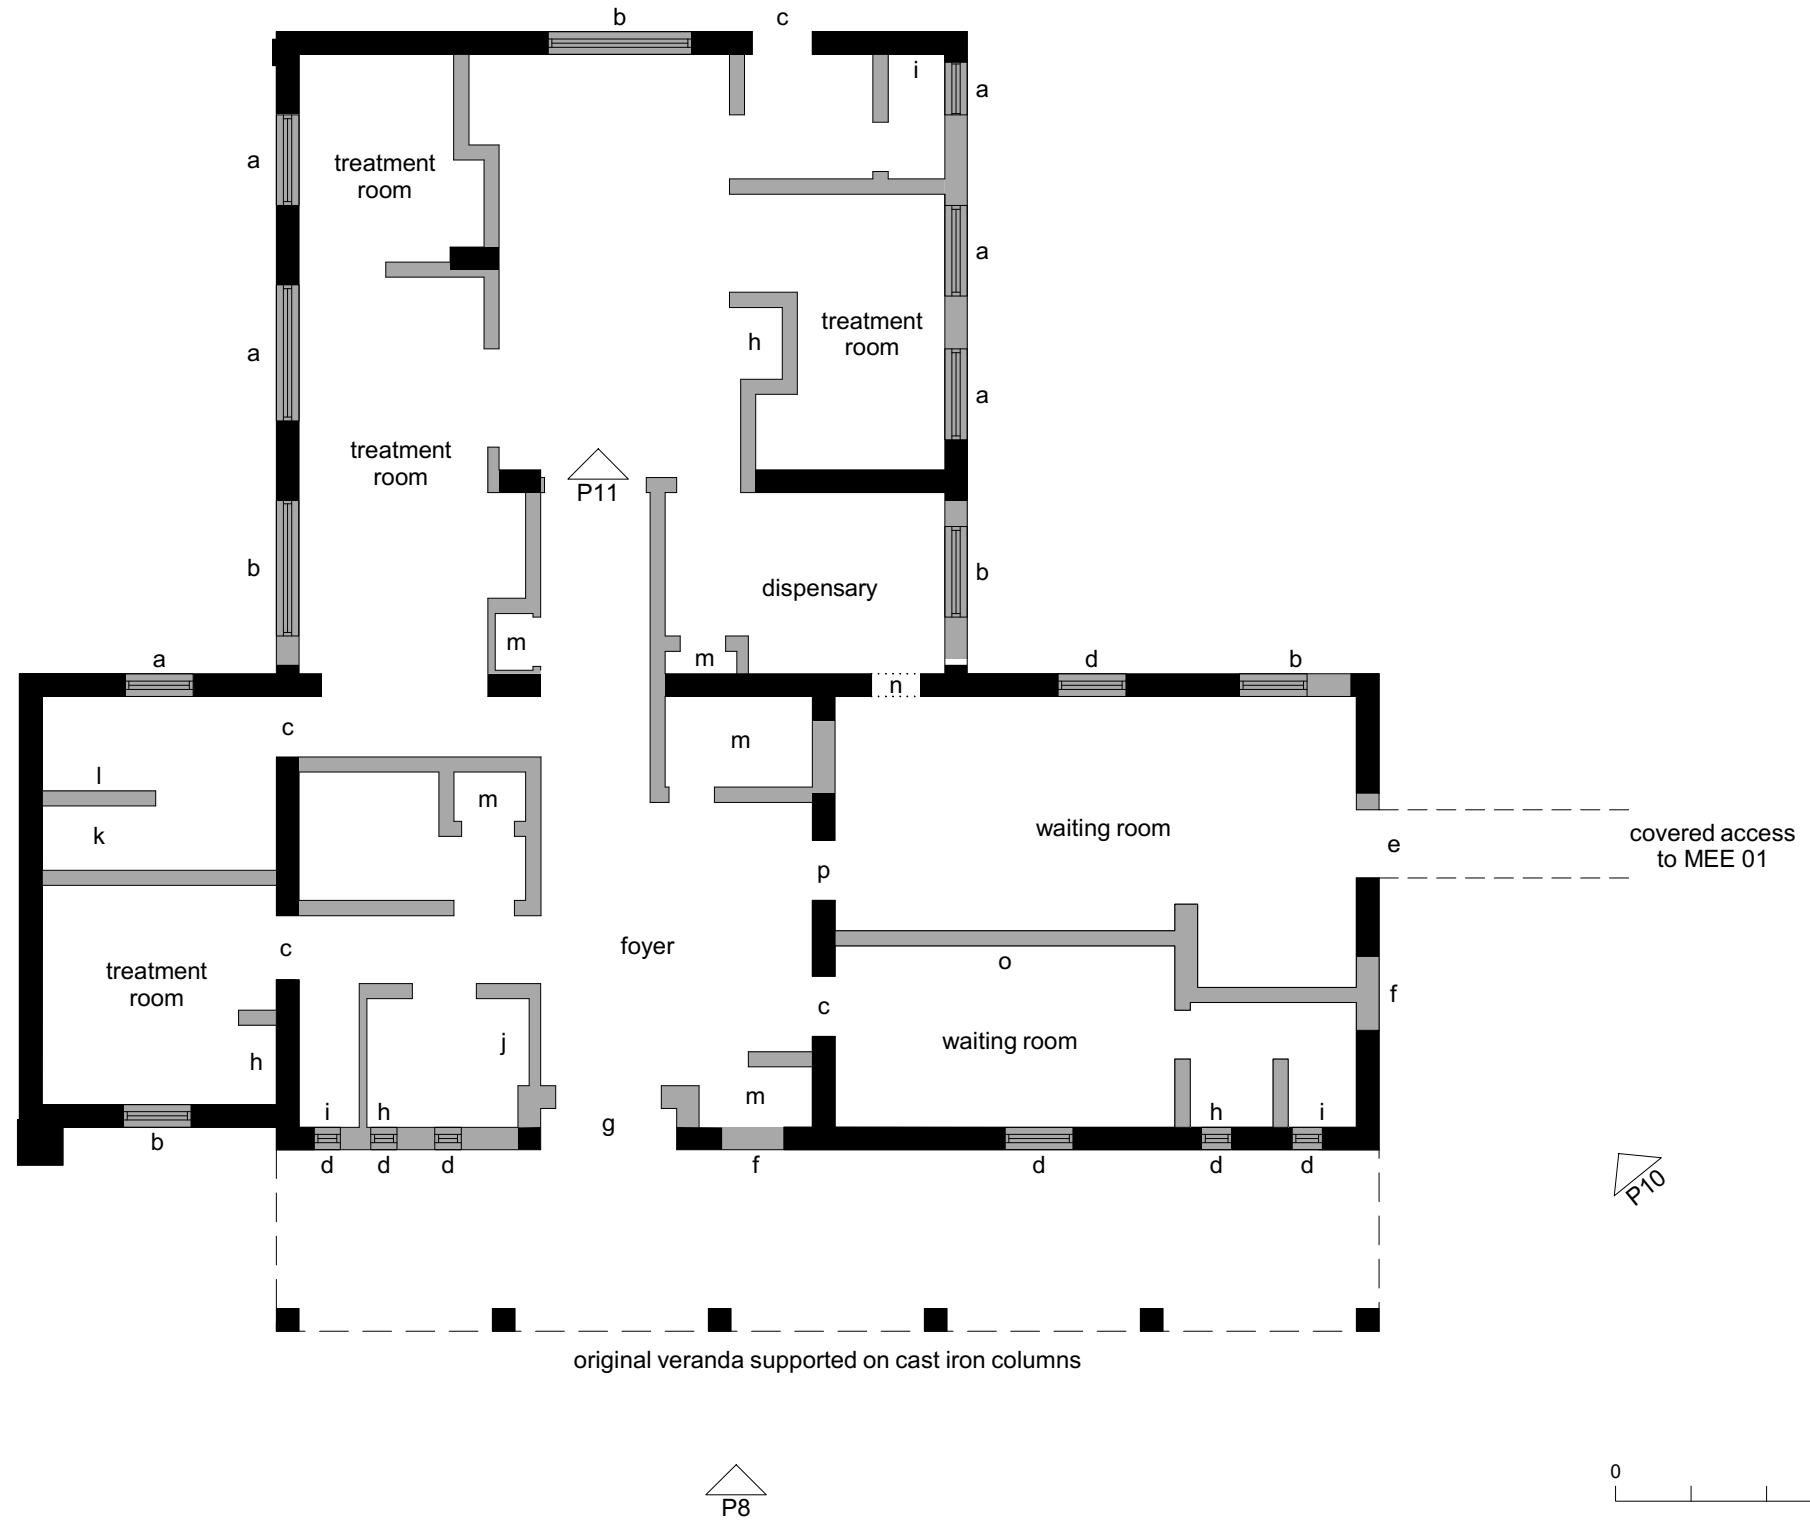
- a replacement window
- b doorway converted to window
- c inserted doorway
- d inserted window
- e window converted to doorway
- f blocked window
- g original doorway widened
- h sink
- i WC
- j urinals
- k shower
- l footbath
- m cupboard
- n inserted dispensary hatch
- o folding wall
- p doorway inserted through former fireplace

Fig 29 MEE 03: floor plan of the former Meeanee Barracks Guard House, with original fabric shown black and medical centre alterations shaded grey. The location and orientation of photographs included in this report are indicated by the numbered arrows.
