**Historic building recording
at Rectory Cottage, Rectory Road,
Tolleshunt Knights, Essex**

October 2013

CAT Report 734
October 2013

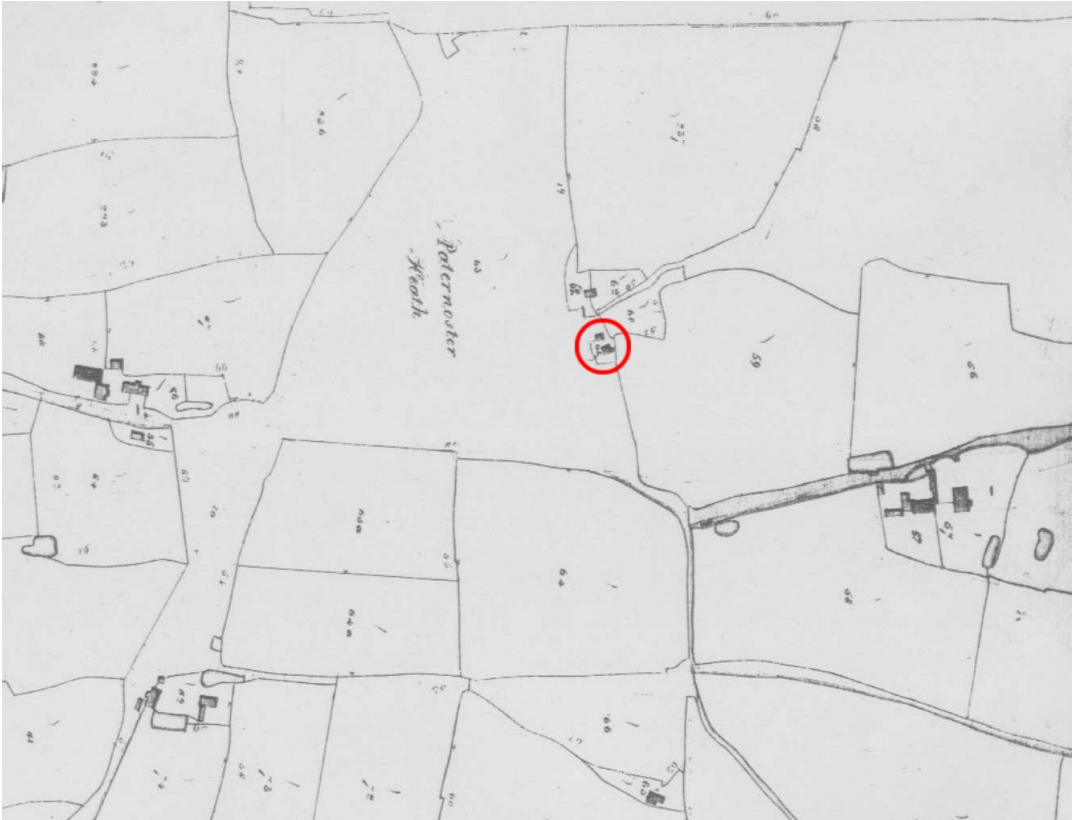
Fig 2 1840 tithe map with Rectory Cottage circled (ERO D/CT 365B).

The tithe award groups this property with the rectory, located to the south-east of the cottage in parcel 57. This was owned and occupied by the Reverend Charles William Cawardine, rector of the parish. White's Directory for 1848 records that, as the incumbent, Reverend Cawardine held 63 acres of glebe land, valued in 1831 at £493. The proximity of the cottage to the rectory (labelled 'Parsonage' on the Chapman and André map, but 'Rectory' on the later Ordnance Survey editions) combined with the very name of the cottage, suggest a connection with the rectory.

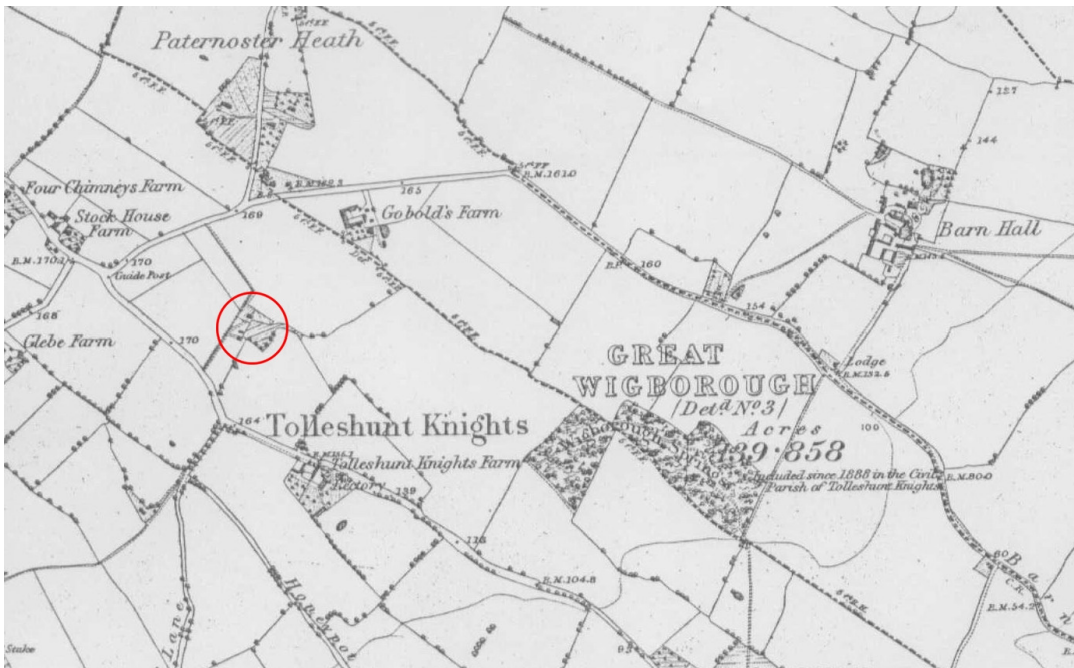
Fig 3 1st edition 6" OS map, 1881 (sheet 46) with Rectory Cottage circled.

The 1st edition 6" OS map of 1881 (Fig 3) differs little to the 1840 tithe map. The cottage appears in the same location, as does the outbuilding. The overall plan form of the cottage appears to then remain unaltered until extensions were added in the 20th century.

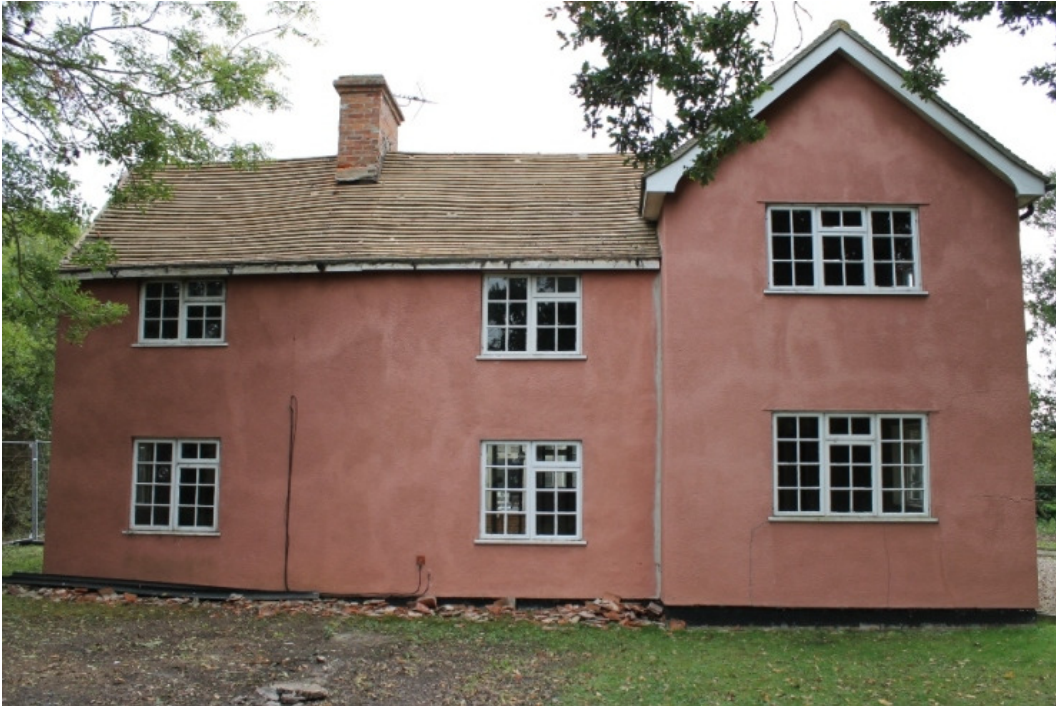
Plate 1 Rectory Cottage, with the 1979 extension to the right - view east

The original structure is rectangular in plan, aligned roughly north-south, measuring 7.5m x 3.65m, and comprises two storeys with a gabled roof of plain tiles (Plate 1). Much of the original structure has been obscured by the application of a modern render, painted pink, applied when the Phase 3 extension was built in 1979. Where the original structure is exposed, it can be seen that the building is timber-framed and has two bays. The frame is of hand-sawn oak with the corner posts having flared bases. No trace of a sill beam or plinth was observed due to the presence of a modern concrete floor, but if these elements exist they are below modern ground level.

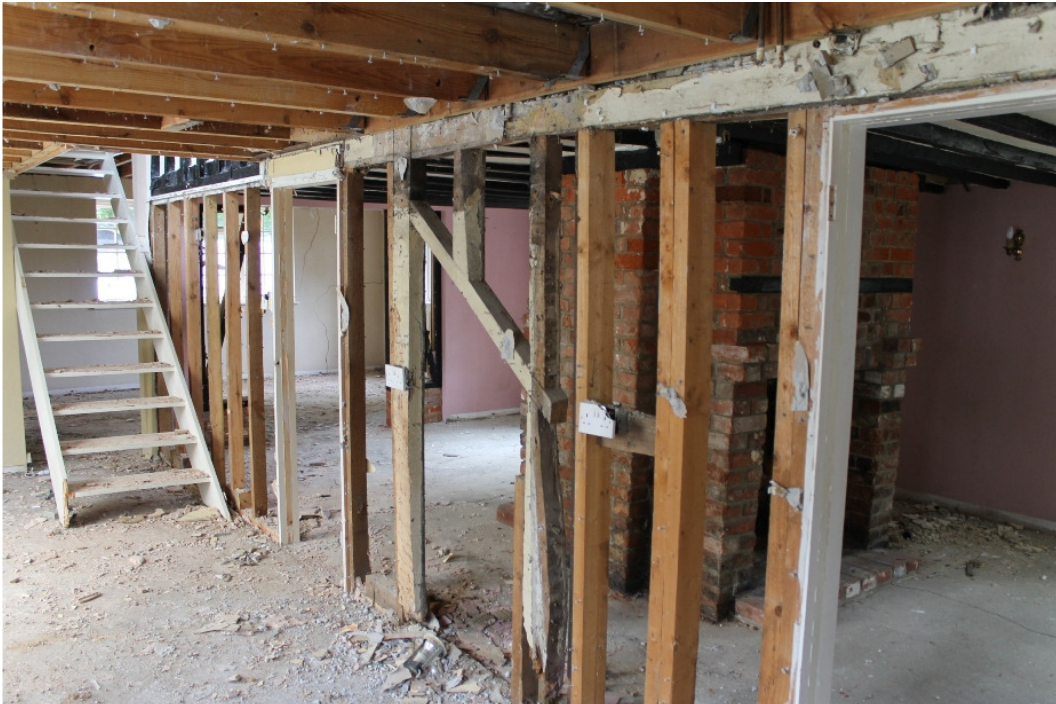
Plate 2 The exposed frame of the east wall, with the surviving girt, main post, studs and brace – view south-west

On the ground floor the frame is exposed only on the east wall (Plate 2). The corner posts and a central main post are original timbers and support the original girding beam, or girt, which is single-pegged to the posts (Plate 3). A straight brace falls from the main post and there are the remains of original studs above and below this (Plate 4). There is a chiselled carpenter's mark (II) on the main post at the joint with the south girt (Plate 3) and a scratched (II) where the brace passes through one of the studs (Plate 5). The remaining studs of the frame are modern replacements. The studs of the south wall have been removed entirely to provide access to the 1979 extension. The frame of the north and west walls is obscured by modern plasterboard, but a projection in the west wall suggests there are studs surviving behind. Modern timber casement windows have been inserted into these walls, although it is not possible to say if these are through original openings.

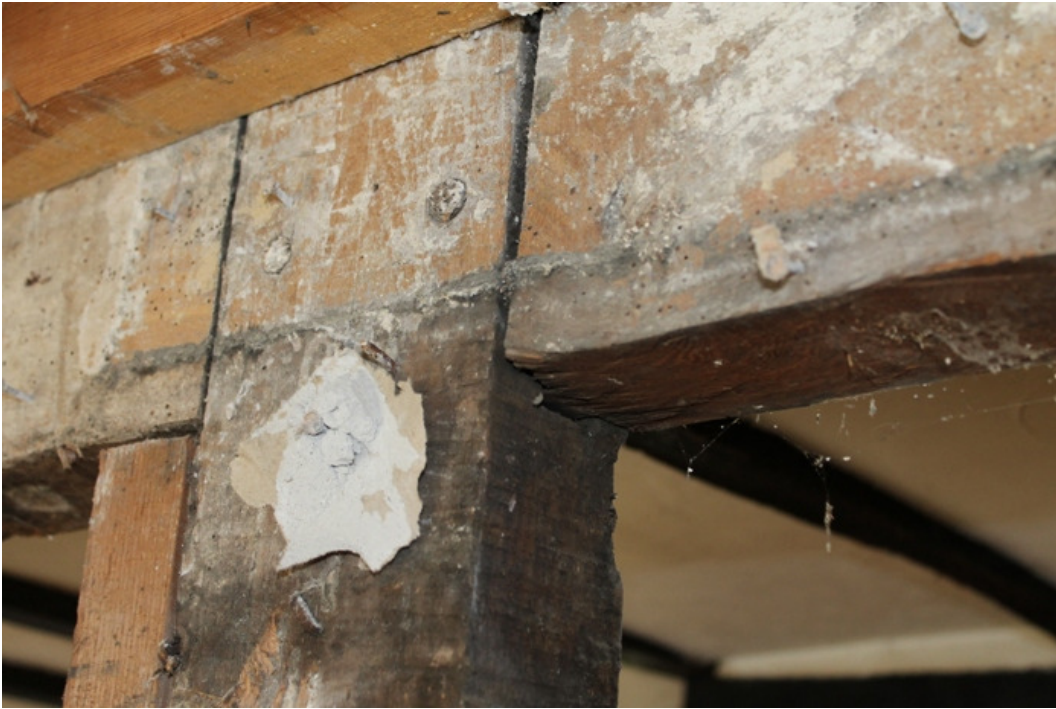
Plate 3 Girding beams single-pegged to main post, with carpenter's mark (II) at the top of the post – view south-west

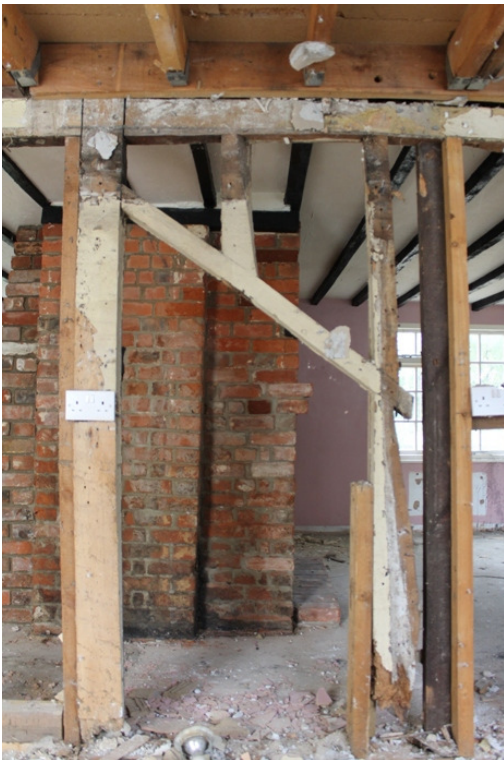
Plate 4 Surviving timbers of the east wall - view west

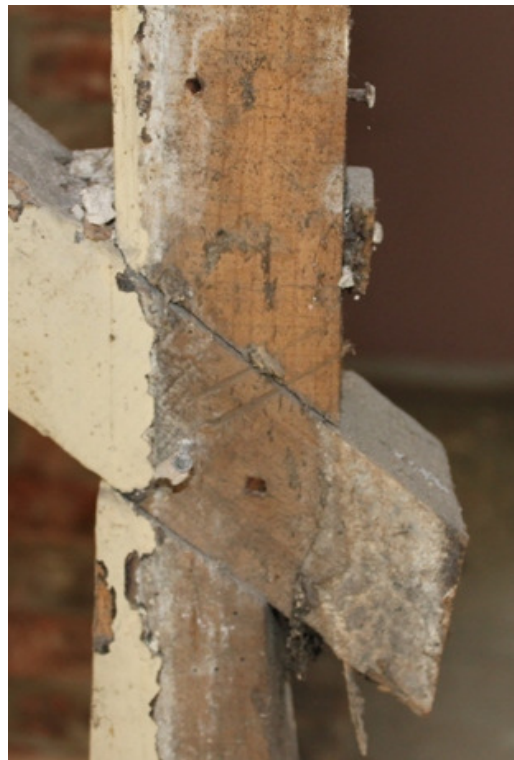
Plate 5 Carpenter's mark (II) on brace and stud – view west

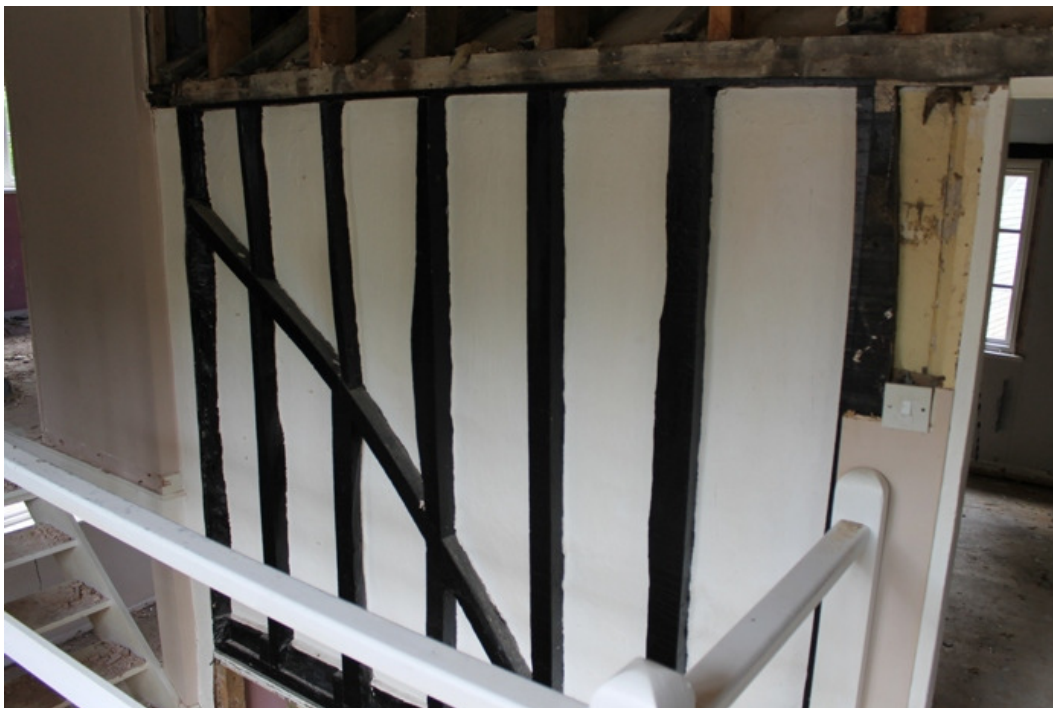
Plate 6 Surviving timbers of the first floor frame - view south-west

There is greater survival of original timbers in the frame of the first floor. In the east wall, nearly all of the original studs have survived (Plates 6, 7), exceptions being where studs have been removed to create doorways with the Phase 2 extension. Where this has occurred, empty mortices can be seen in the underside of the wall plate (Plate 8). The frame of the east wall of bedroom 3 has a lightly curved brace falling from the corner post and passing through the studs, terminating at the base of the fifth stud from the corner post. The lower end of a second brace survives, rising from the sixth stud to the central main post, although this has been truncated by the inserted doorway to bedroom 3. The studs are nailed to these braces. At the north end of the east wall, there is a straight brace rising from the corner post and terminating at the head of the fifth stud from the corner post. Removal of modern plasterboard in bedroom 3 shows that the frame of the north wall has been rebuilt below the wall plate. However, above the wall plate the gable has an original collar beam with studs above and below. The exterior of the gable is clad in lath and plaster (Plate 9). Exposure of the roof space also shows the survival of the original rafters, carried on clasped purlins supported by collars. The bases of the rafters have furring pieces nailed to them to lessen the slope of the eaves (Plate 10). Bedroom 3 has a tie beam spanning the structure (Plate 11). This is not part of a truss; it does not sit above the main posts, nor does it have principal rafters rising from it. Instead it sits on the wall plate in a shallow notch, abutting one of the common rafters (Plate 10). This is a result of the insertion of a chimney stack in the centre of the structure. The tie beam has been moved from its original position, central to the structure, and relocated to the immediate north of the inserted stack. To provide support for the tie beam, re-used timbers (possibly from an original dividing wall) have been inserted between the floor and the underside of the beam. The west wall has few original timbers below the wall plate. One further point of interest is the presence of diagonal wind braces nailed to the underside of the common rafters.

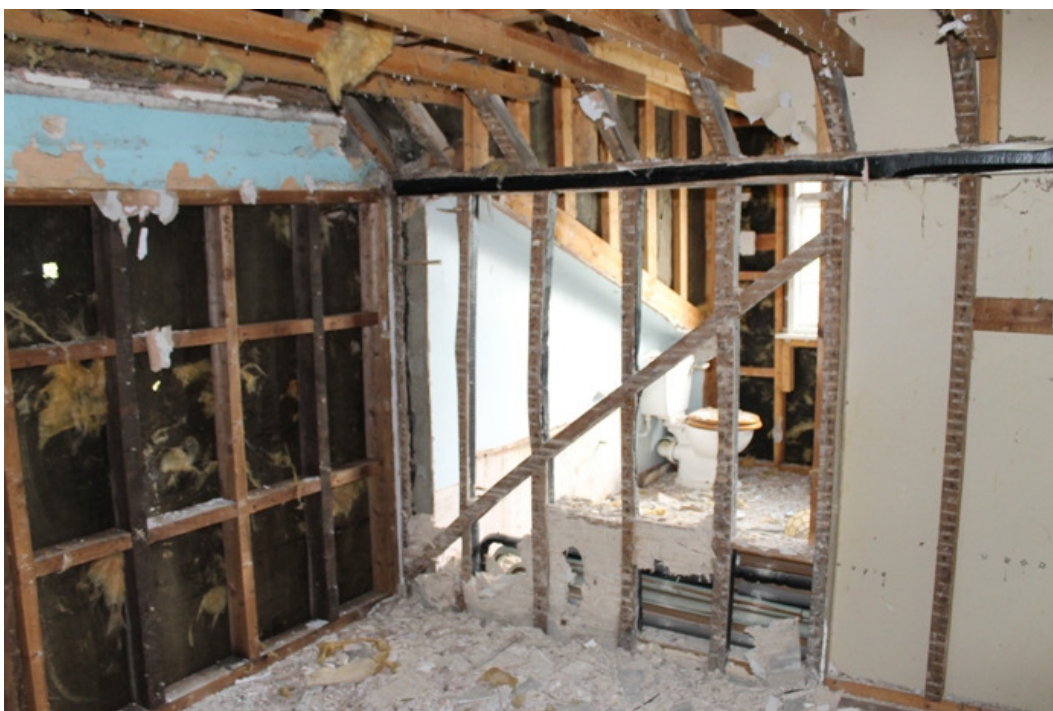
Plate 7 Surviving timbers of the first floor frame, with modern replacements to the left - view north-east

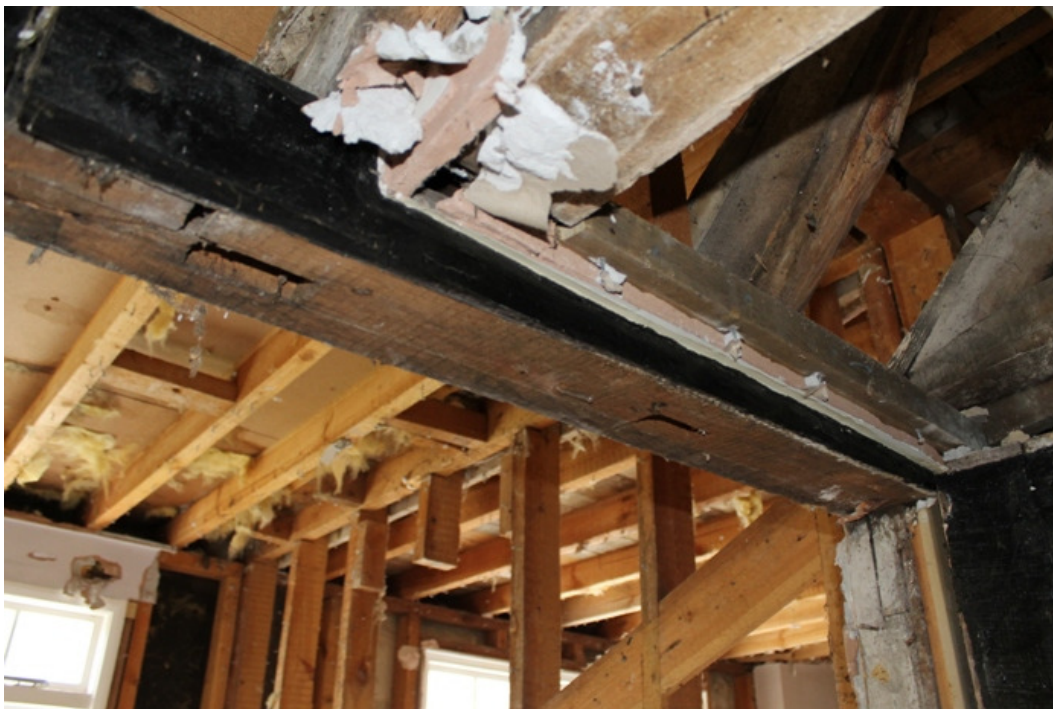
Plate 8 Mortices for removed studs in underside of wall plate with bladed scarf joint to the left – view south-east

are exposed in the ceiling of the living room, although they have been planed smooth and chamfered. The wall plate of the east wall has a bridled scarf joint located above the entrance to bedroom 4 (Plate 8).

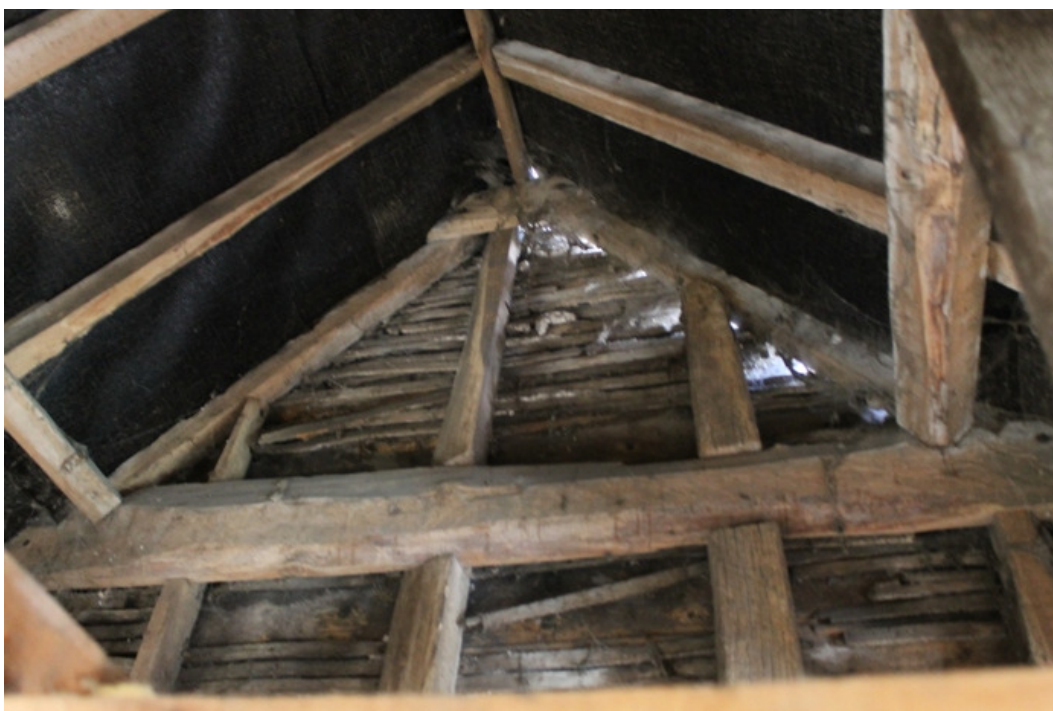
Plate 9 The interior of the north gable with original studs above and below a collar beam and the original purlins and rafters - view north

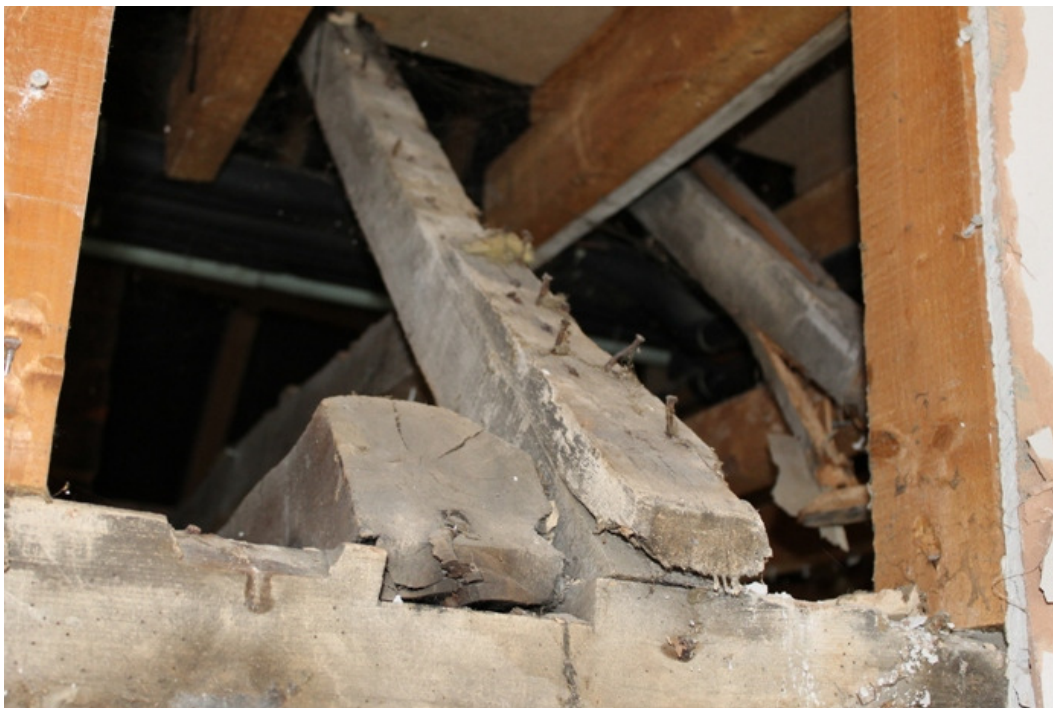
Plate 10 Original rafter with firing piece nailed to it and end of relocated tie beam – view north-west

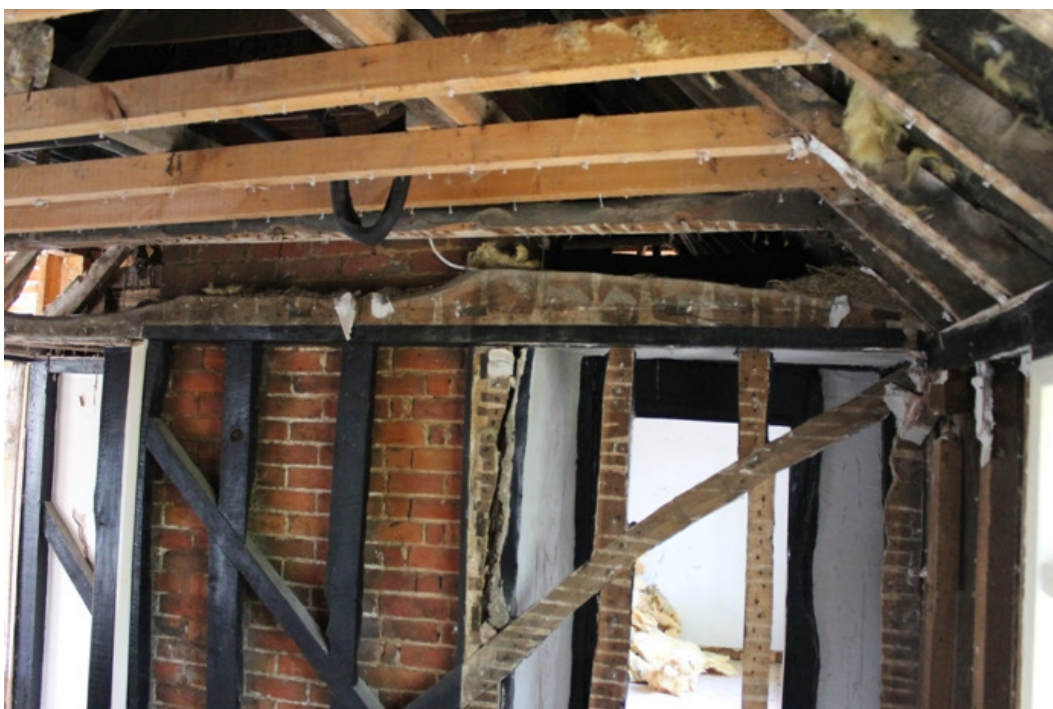
Plate 11 The relocated tie beam in bedroom 4 - view south

The flooring throughout the first floor of the Phase 1 structure dates to renovations carried out when the 1979 extensions were built but there is small area of flooring in the cupboard of bedroom 3 that is contemporary with the construction of the Phase 2 chimney stack. The construction of this chimney stack necessitated the relocation of the original tie beam.

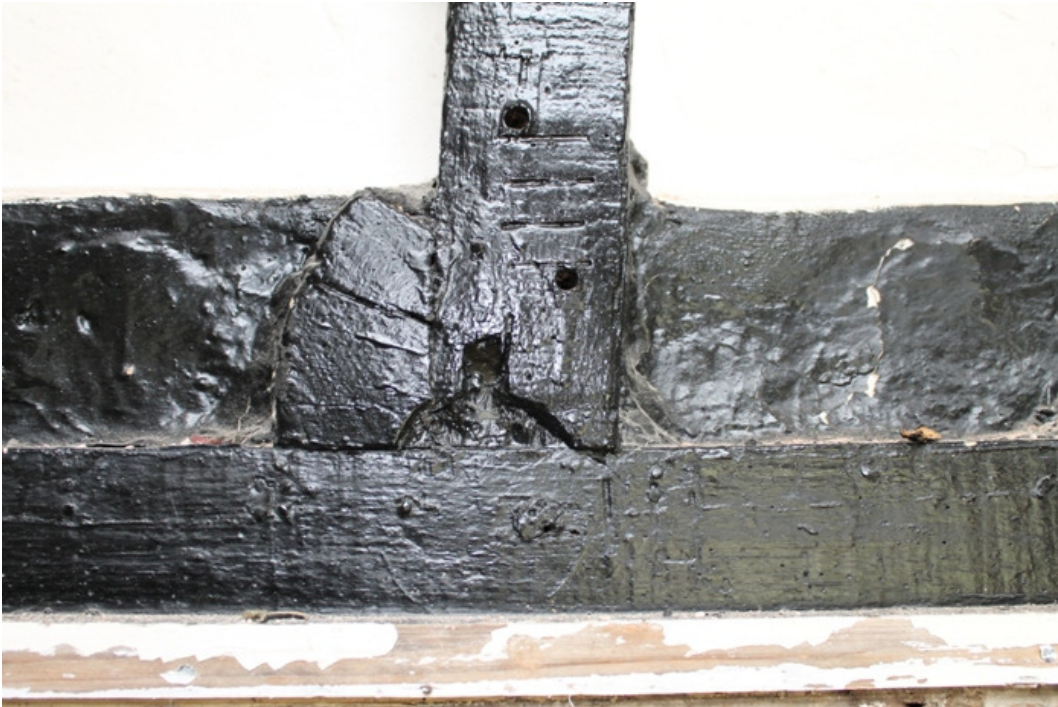
Plate 12 Example of a carpenter's mark (III) on the base of a stud in the east wall of the first floor frame, with the butt end of a floor joist carried on the girt - view west

Carpenters' marks are visible on the exterior of the east wall frame to bedroom 3. The bases of five of the studs each have a chiselled mark (I-V) ascending from south to north (Plate 12). There is also a scratched (III) across one of the junctions of the brace and studs. The exposed end of a floor joist abuts the base of each stud (Plate 12). These joists

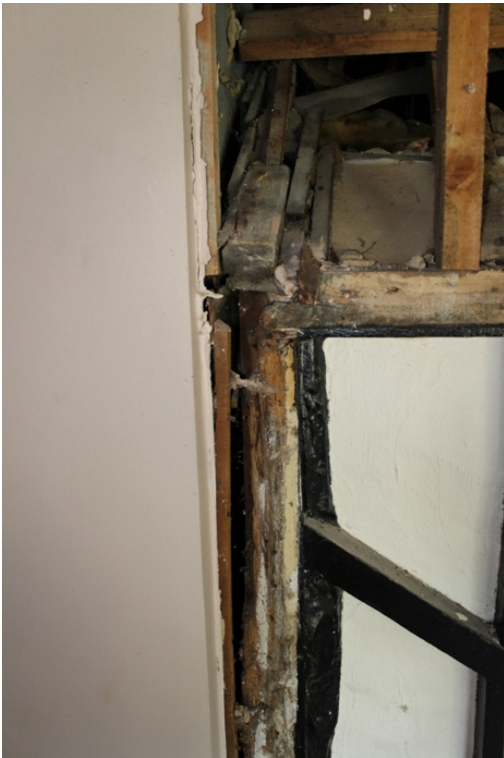
Plate 13 The south gable with 1979 extension to the left – view west

The south gable is preserved where the Phase 3 extension abuts the original structure (Plate 13). This shows that the exterior of the south gable was weatherboarded, although it was not possible to say if this was the original cladding or a later addition.

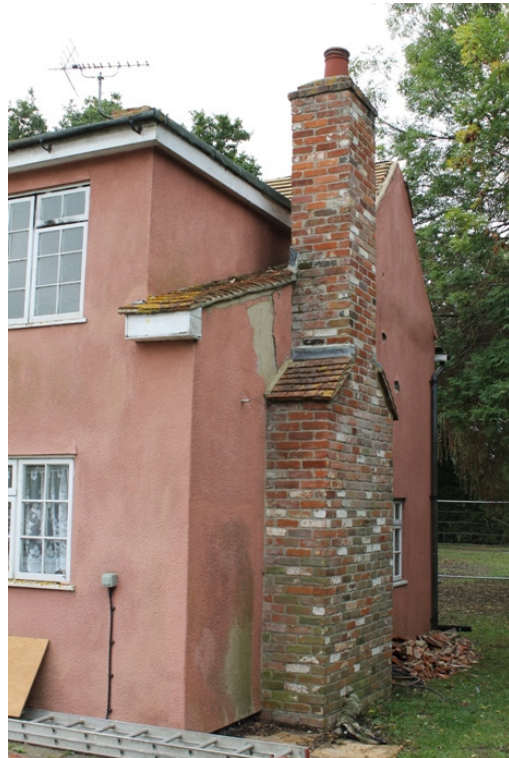
Plate 14 Phase 2 single-storey extension with the Phase 3 second storey extension above – view south-west

At some point in the 20th century, but prior to 1979, a brick-built single-storey extension was added to the east side of the original structure (Plate 14) and a chimney stack inserted through the centre of the cottage. The extension provided a kitchen to the cottage and included an external chimney stack on the north wall. This extension may have replaced an earlier/original kitchen area as there is no apparent hearth location in the Phase 1 structure.

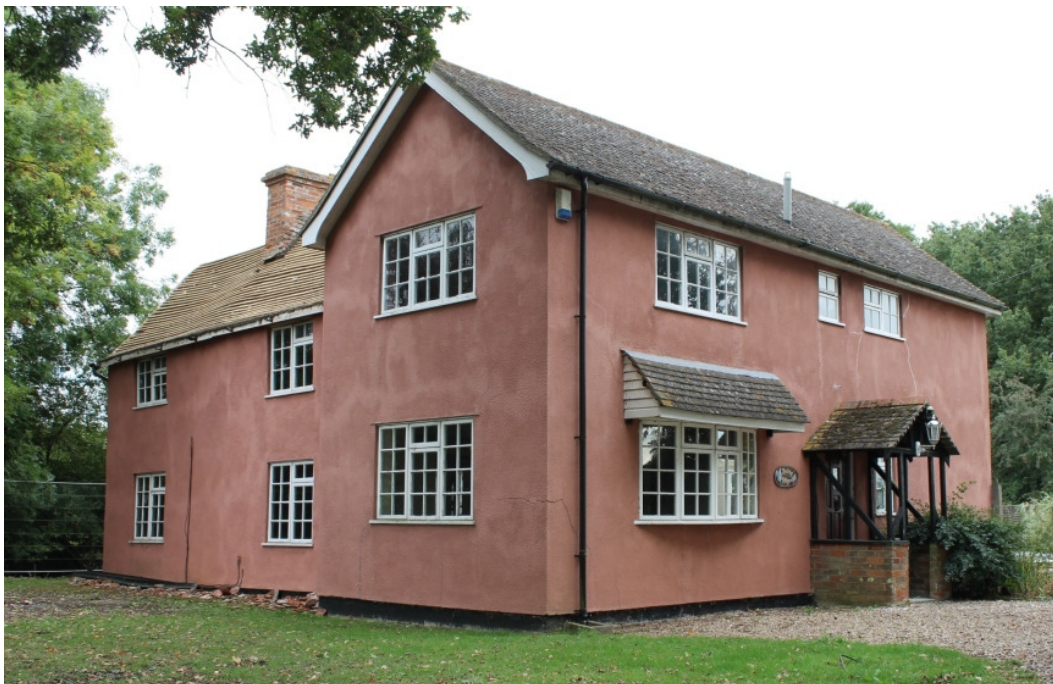
Plate 15 Phase 3 extension with the original structure to the rear – view north-east

In 1979 a block-built, two-storey extension aligned east-west was built onto the south ends of Phases 1 and 2, along with a timber-framed second floor above the Phase 2 extension (Plates 15, 16). On the ground floor, the extension removed the frame of the south wall of the original Rectory Cottage whilst, on the first floor, the frame and gable were completely obscured. Doorways from the extension above the kitchen cut through the framing of the original cottage's east wall.

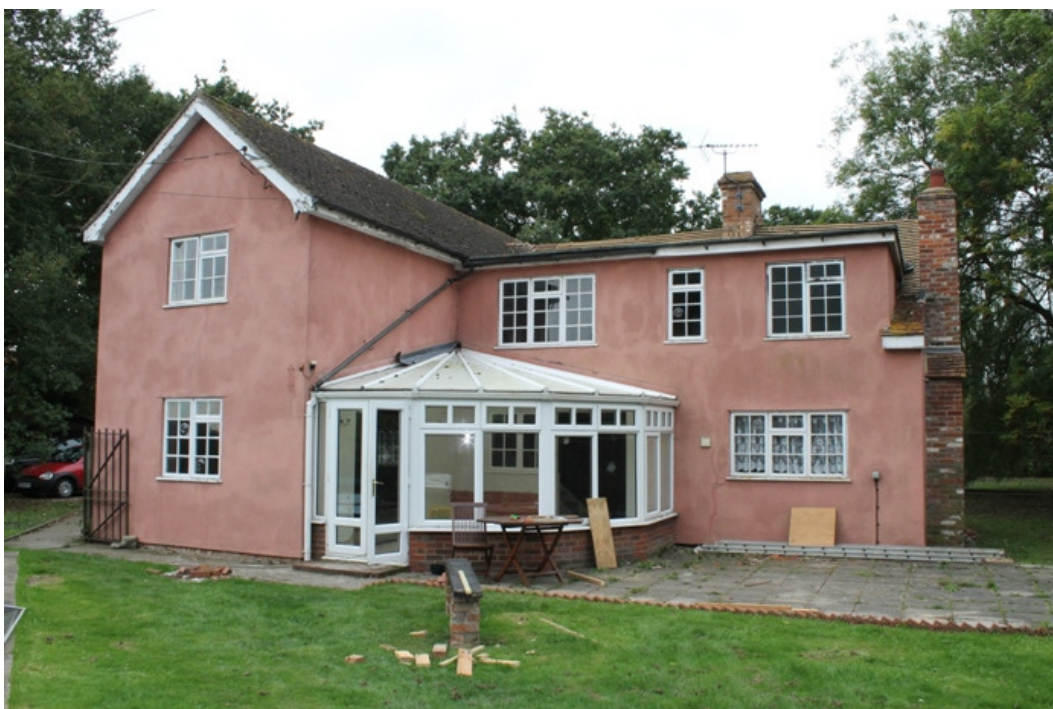
Plate 16 The Phase 3 extensions to the left of and above the Phase 2 extension, with the original structure in the background – view west

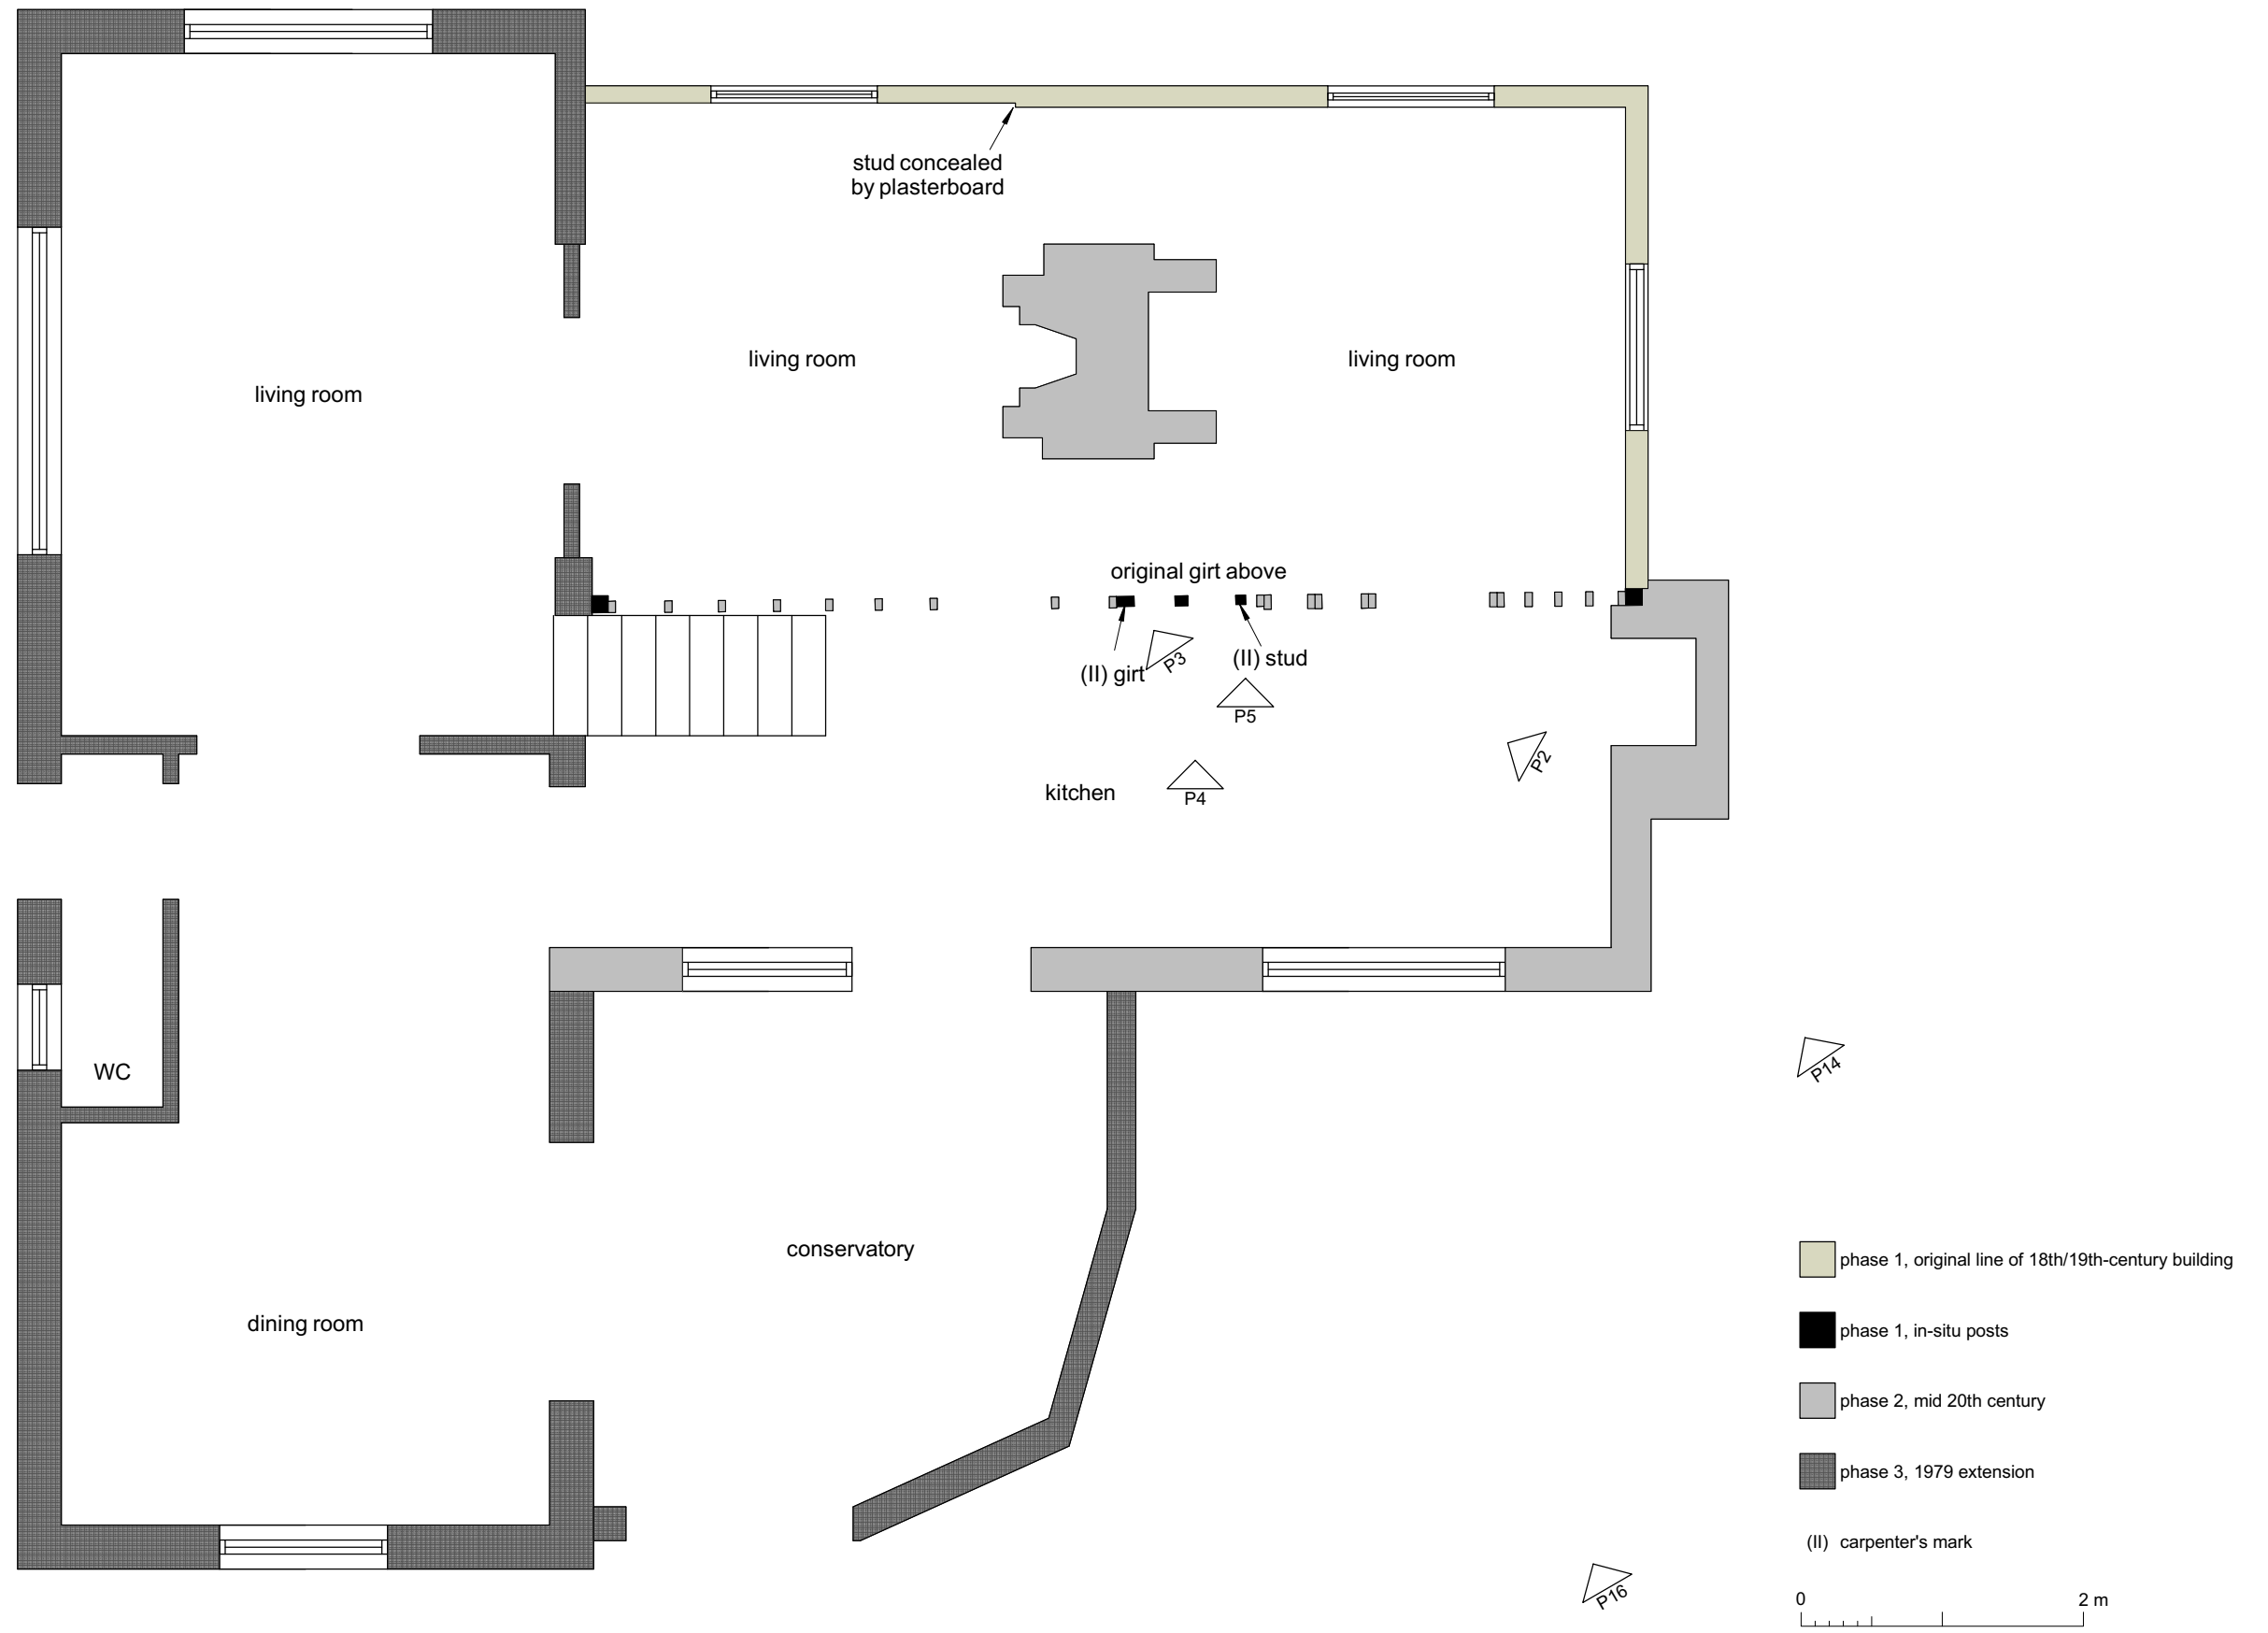
Fig 5 Ground floor plan of Rectory Cottage, showing the location and orientation of photographs included in this report.

In the following text the rooms of the cottage have been described according to perceived function with photographs cross-referenced to corresponding floor plans (Figs 5-6).

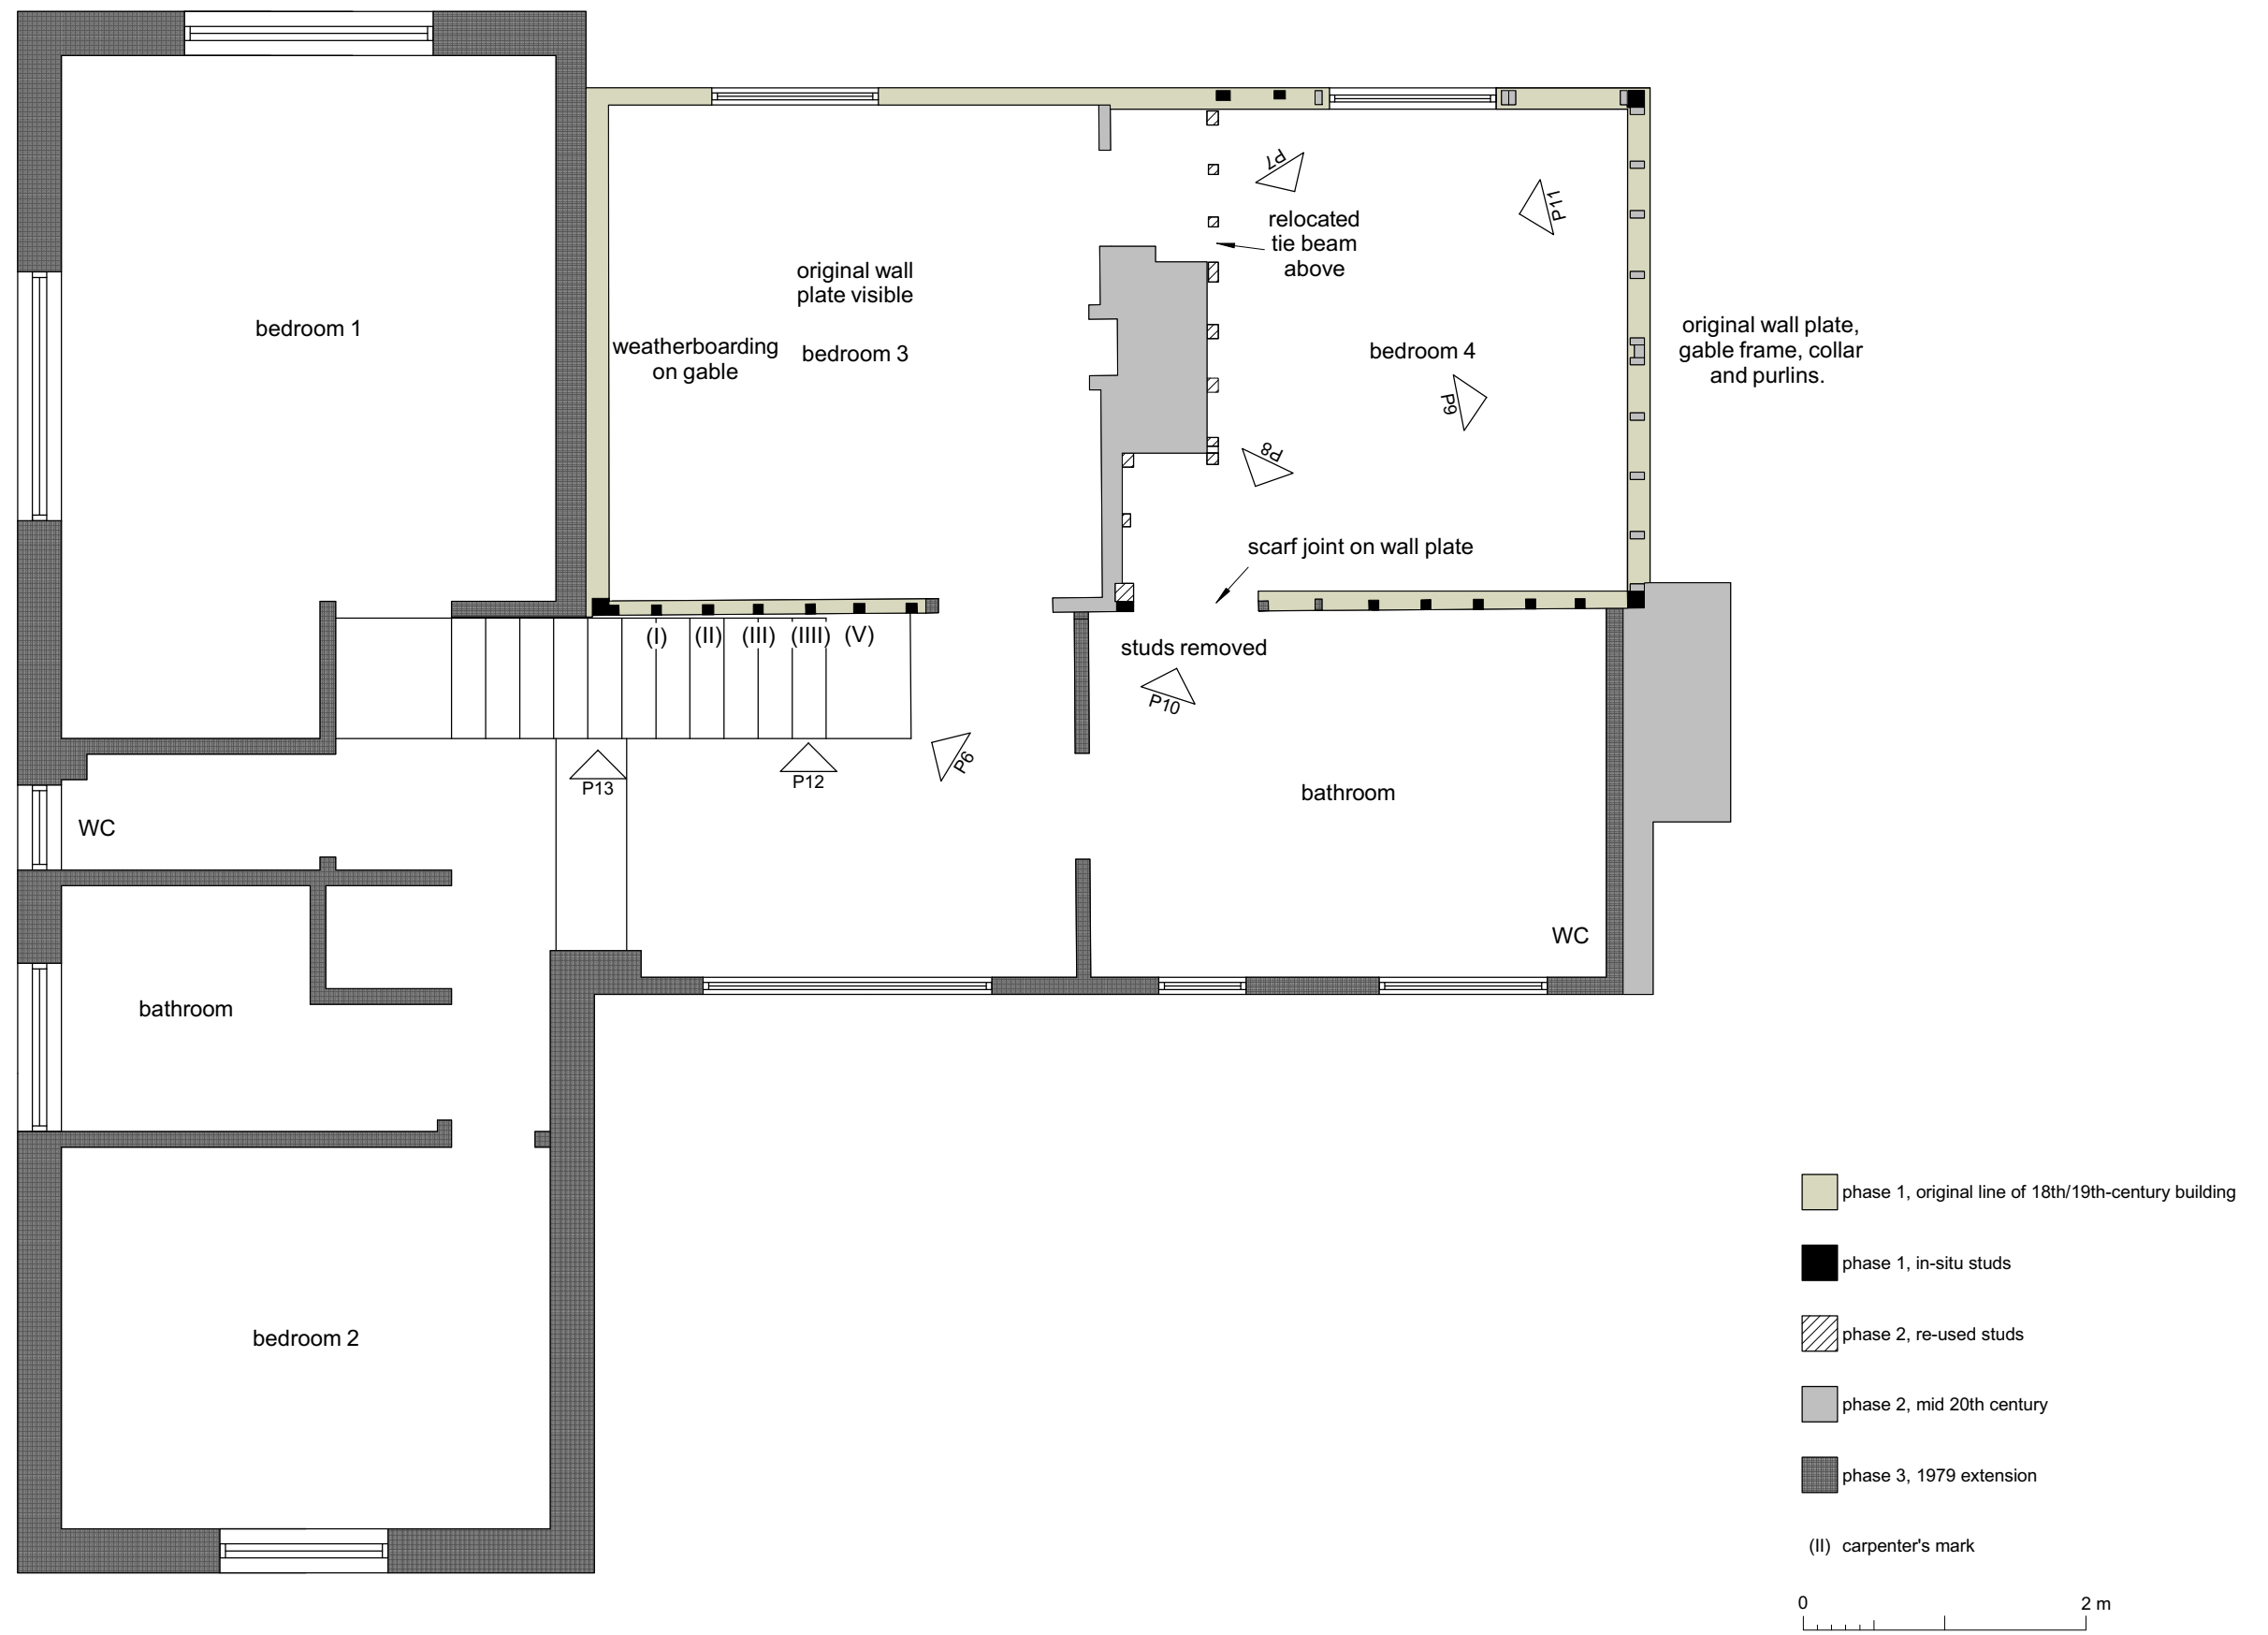
Fig 6 First floor plan of Rectory Cottage, showing the location and orientation of photographs included in this report.
