**Historic building recording at 11 Glen Avenue,
Colchester, Essex, CO3 3SD
September 2015**

**report prepared by
Chris Lister**

CAT Report 877
November 2015

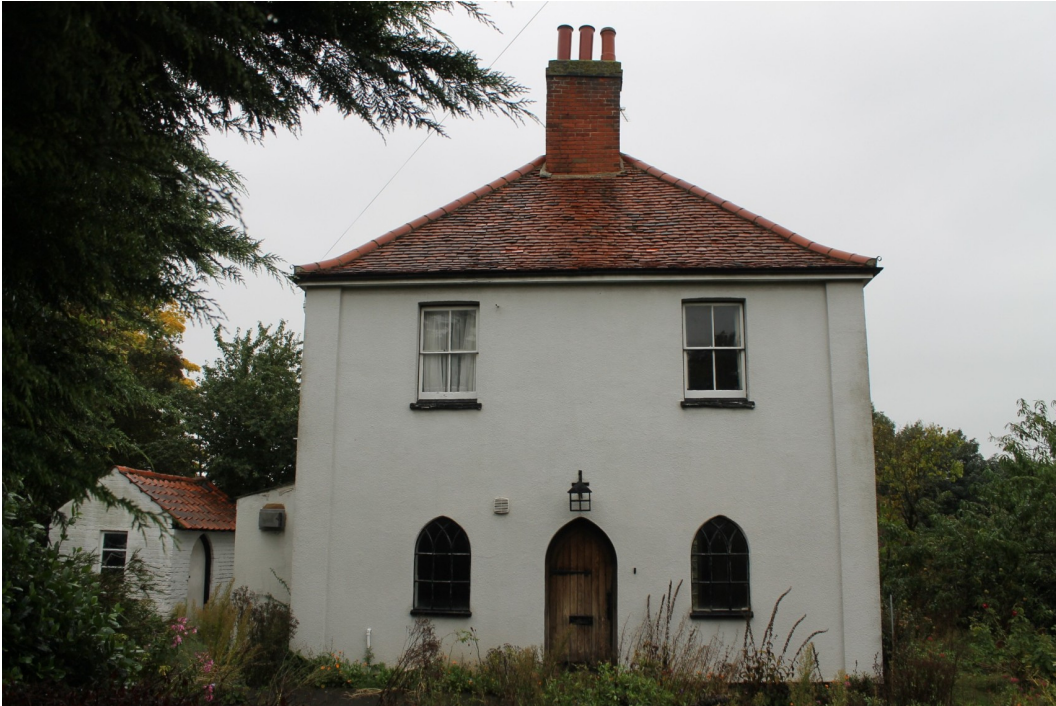
Plate 1 South-east elevation - view north-west.

The front of the house is the south-east elevation (Plate 1; Fig 4). This has a centrally-located entrance with a pointed arch and a Gothic Revival-inspired front door of heavy vertical wooden planks and wrought iron furniture. This doorway has been inserted into the elevation and probably dates to the mid 20th century. Either side of this inserted entrance is a Gothic Revival timber-framed window of twelve lights, the centremost of these being a side-hung casement (Plate 2). The first floor has plain unhorned sash windows of two-over-two lights, in line with their more ornate counterparts on the ground floor.

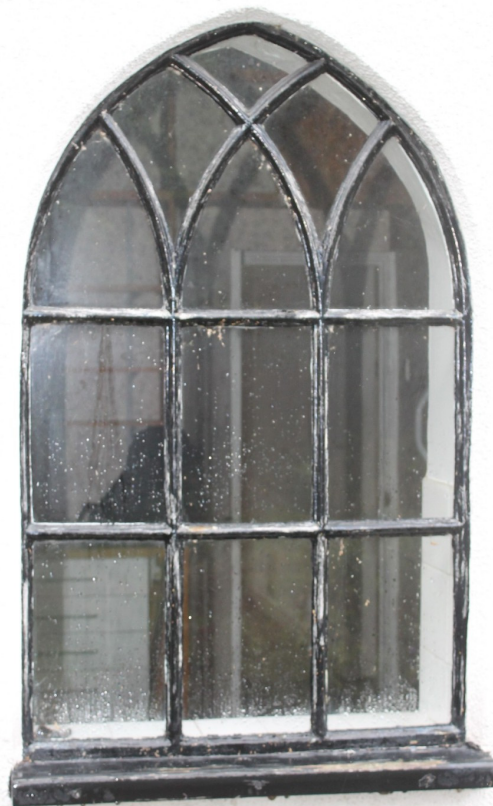
Plate 2 Detail of original timber-framed Gothic Revival window to south-east elevation - view north-west.

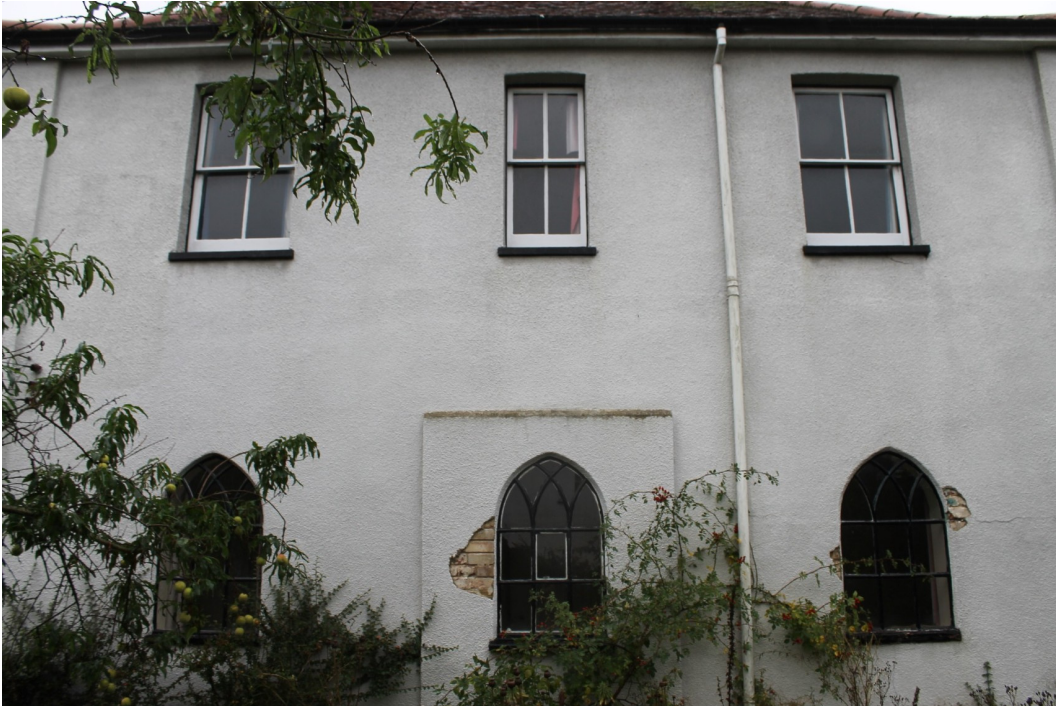
Plate 3 North-east elevation showing the replacement metal-framed Gothic window inserted into the original entrance way - view south-west.

The north-east elevation has a range of three Gothic Revival windows on the ground floor (Plate 3; Fig 5). However, on closer inspection, the middle one of these is revealed to be a

metal-framed replica, possibly commissioned from the Crittall Manufacturing Company in Witham, although this has not been substantiated. This replacement window is surrounded by lightly projecting brickwork and appears to be an insertion through the original entrance to the house. The first floor has a range of three unhorned sash windows of two-over-two lights, although the central window is narrower than the other two.

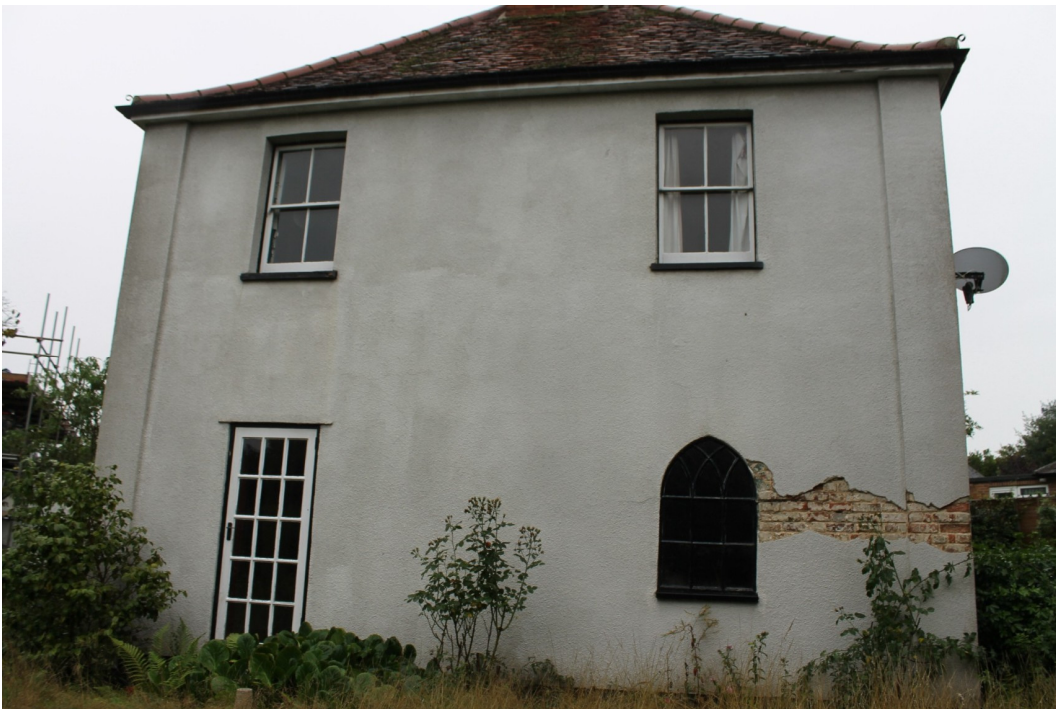
Plate 4 North-west elevation showing the 20th-century doorway inserted through an original Gothic Revival window opening - view south-east.

The north-west elevation has a pair of sash windows of two-over-two lights to the first floor, one with horns the other without. This elevation originally had a pair of the Gothic Revival timber-framed windows to the ground floor. However, one of these has been replaced by a doorway providing access from sitting room 1 into the garden (Plate 4; Fig 6).

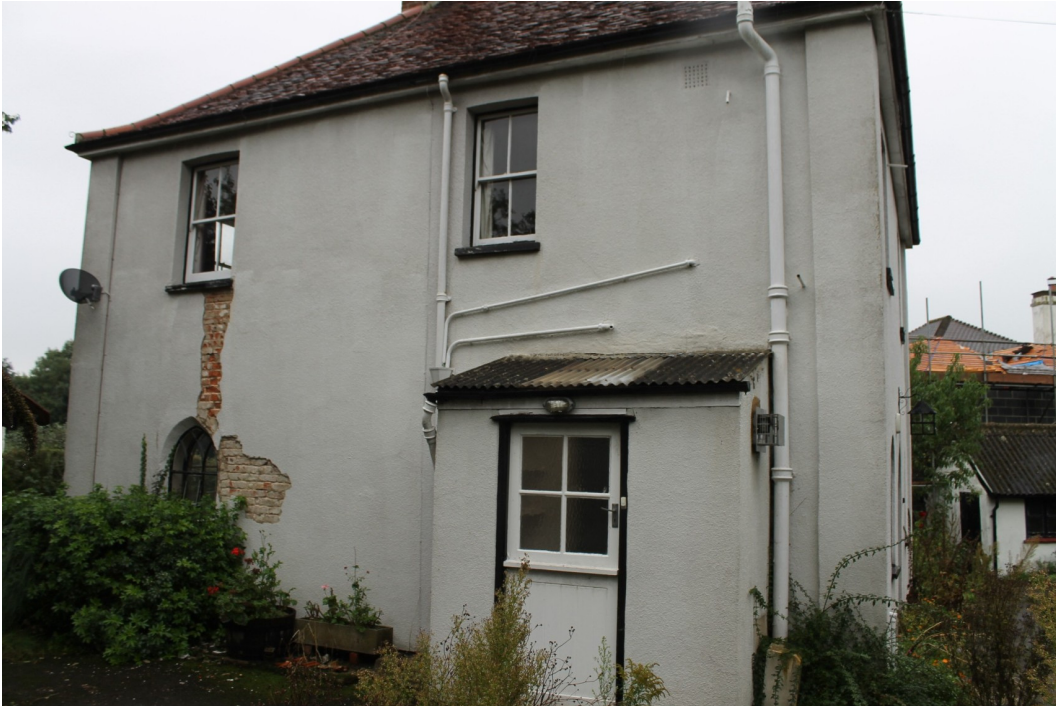
Plate 5 South-west elevation with 20th-century porch - view north-east.

The south-west elevation was originally the rear of the house (Plate 5; Fig 7). The first floor has two sash windows of two-over-two lights, although one is narrower than the other and is not in line with the window in the opposite elevation. Both have horns. The ground floor has a single metal-framed Gothic Revival window which has replaced an earlier timber-framed version. The location of a second ground floor window has been obscured by the construction of a 20th-century porch. This has a mono-pitch roof of corrugated asbestos panels and a stable door.

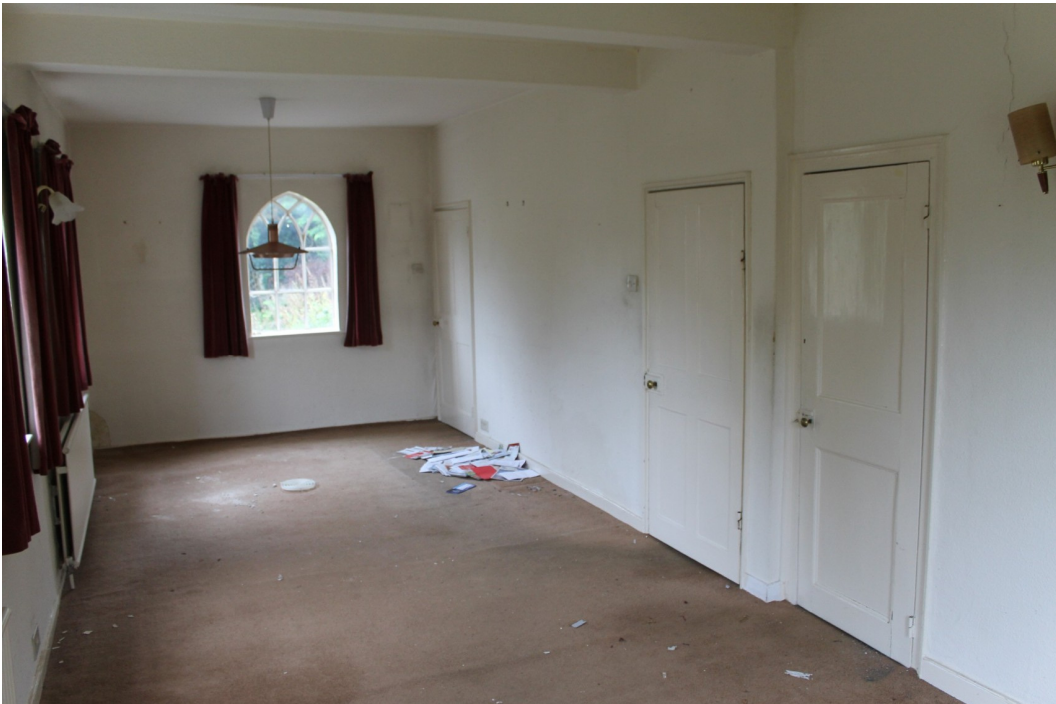
Plate 6 Interior of dining room viewed from sitting room 1, with the remnants of the original dividing walls visible as beams on the underside of the ceiling - view south-east.

The doorway inserted into the south-east elevation opens into a small porch, converted from a cupboard flanking one of the two chimney stacks. This opens into the dining room which has the original skirting board to the external walls (Plate 6). The original fireplace opening in the south-west wall has been blocked. Originally the dining room was separated from sitting room 1 by a hallway leading from the blocked entrance in the north-east elevation to the rear of the house, but the walls for this have been removed and survive only as beams attached to the underside of the ceiling.

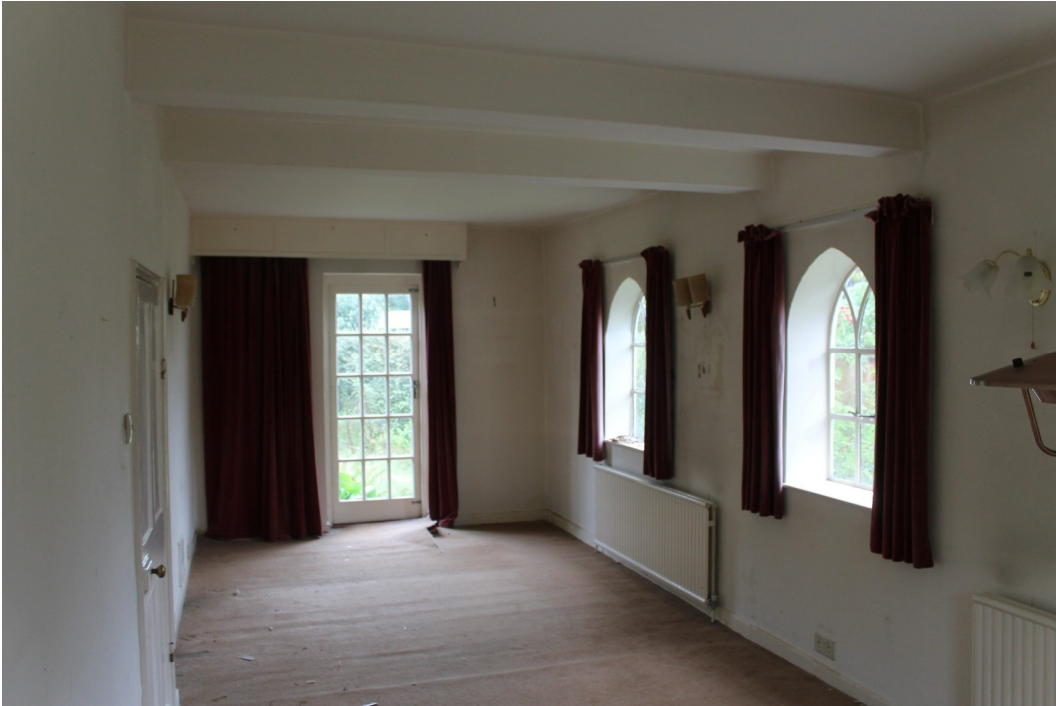
Plate 7 Sitting room 1 viewed from the dining room, showing the original entrance hallway indicated by the beams and the original entrance converted to a window on the right, and the doorway in the far wall inserted through an original window opening - view north

Sitting room 1 also has a blocked fireplace in the south-west wall and has a cupboard to the left of this, in a layout identical to the dining room (Plate 7). The doors to the converted cupboard in the dining room and to the rear of the house are original four-panel examples held on rising butt hinges, whilst the door to the cupboard in sitting room 1 is a replacement two-panel example.

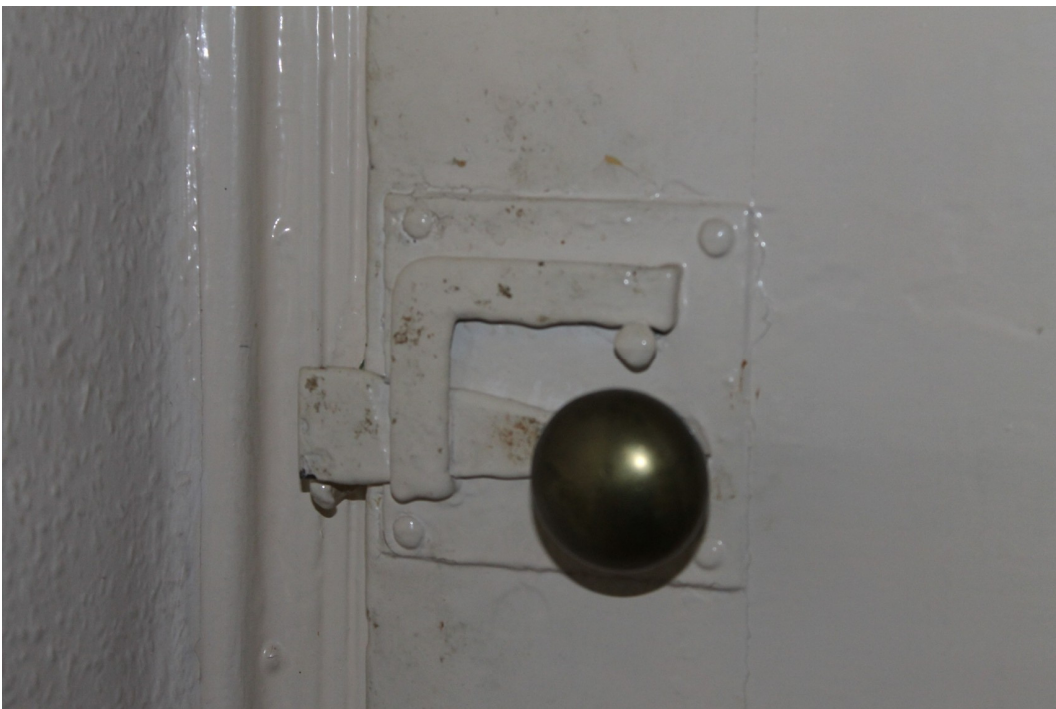
Plate 8 Detail of original? latch to cupboard in sitting room 2.

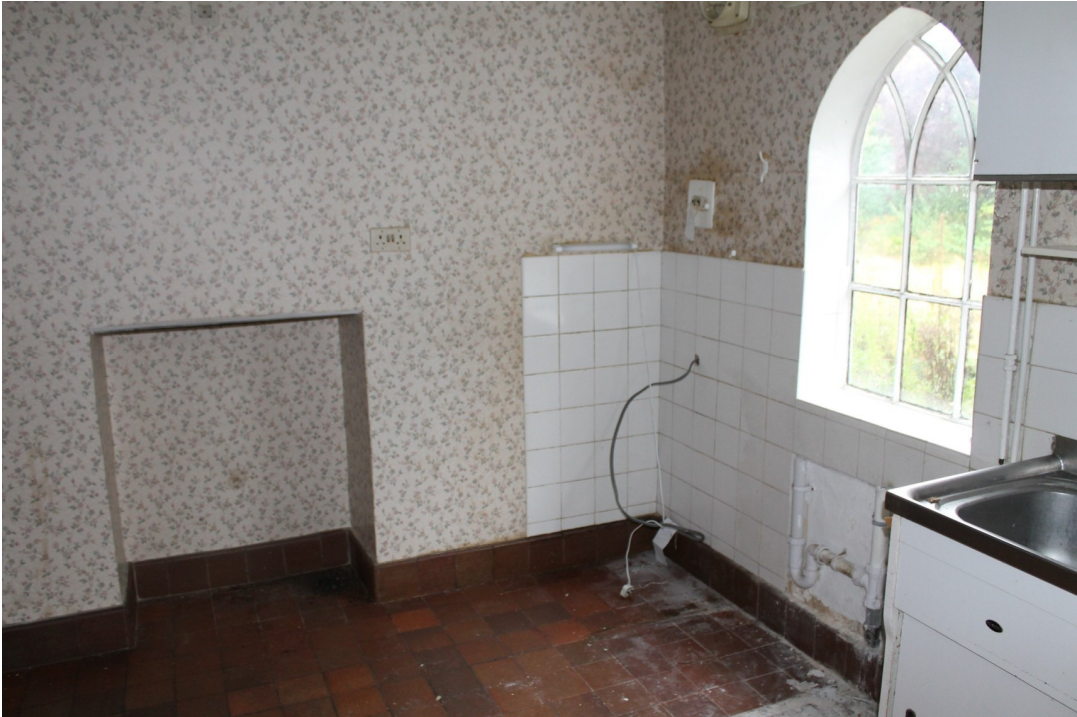
Plate 9 Interior of kitchen with 20th-century alterations and original fireplace opening - view north-east.

At the foot of the original stairs a four-panel door opens into the kitchen. Apart from the fireplace opening and the door all original features and fittings have been obscured/removed by the 20th-century kitchen fixtures (Plate 9). An opening in the rear wall, most likely converted from an original window, provides access to the 20th-century porch.

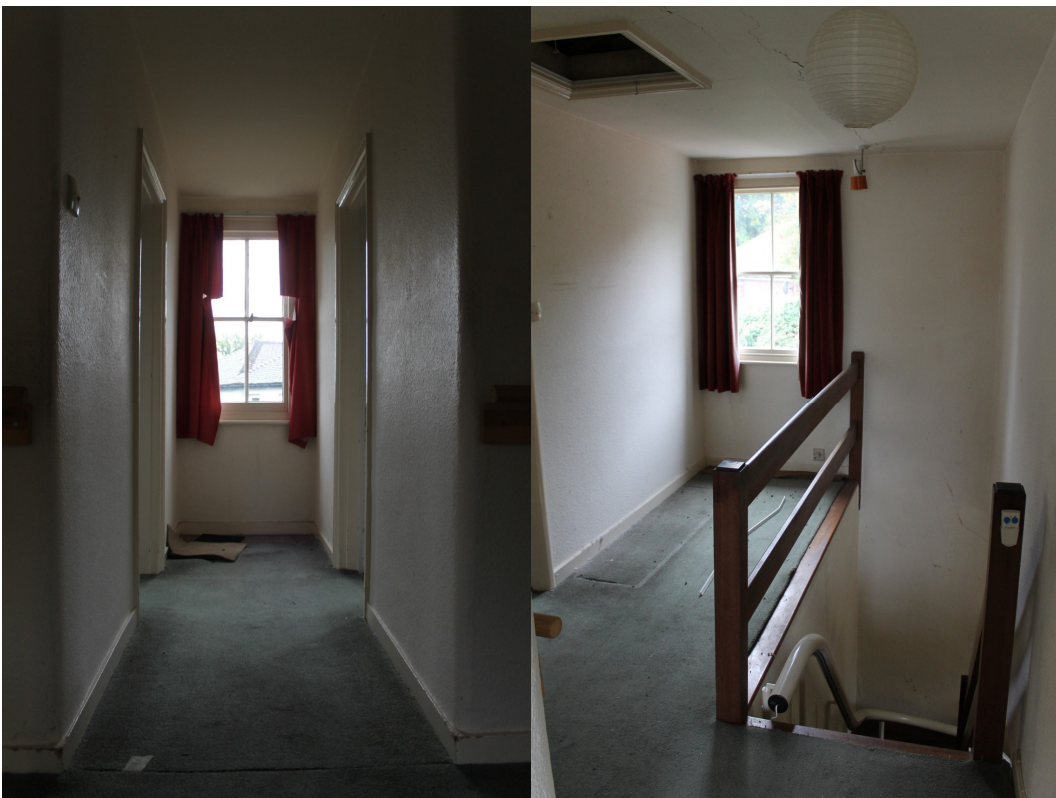
Plate 10 Staggered first floor landings showing 20th-century stairs in reversed position - view north-east and south-west.

The modern staircase opens onto a pair of staggered landings on the first floor, each illuminated by a sash window (Plate 10). Bedroom 1 at the rear of the house is the smallest of the three bedrooms. It has a narrow blocked fireplace, the original four-panel door and is well-lit by two sash windows (which have retained the original catches – Plate 11). Bedrooms 2 and 3 are at the original front of the house and are identical in size and layout. Both have narrow blocked fireplaces and what may be original coat hooks in the alcoves formed by the chimney stack and the internal walls (Plate 12). Each is illuminated by two sash windows. The fourth room on the first floor has been converted to a bathroom, although it retains the original four-panel door. This is the smallest room on the first floor and has only one window. This may have been a nursery or young child's room or possibly a servant's room.

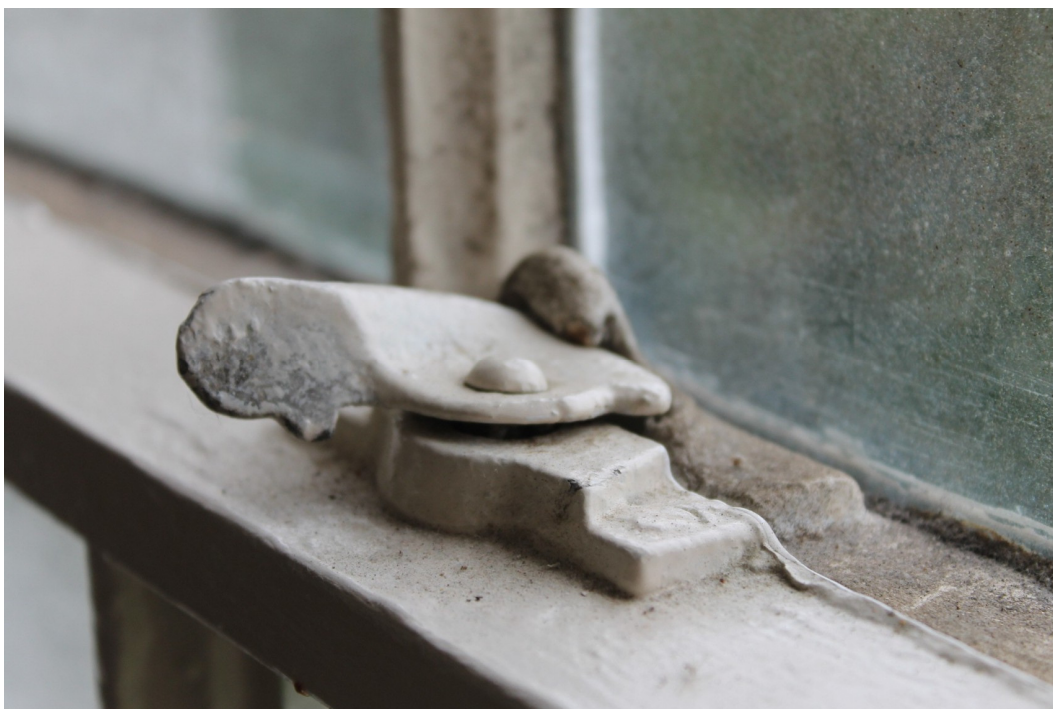
Plate 11 Detail of original catch to window in bedroom 1.

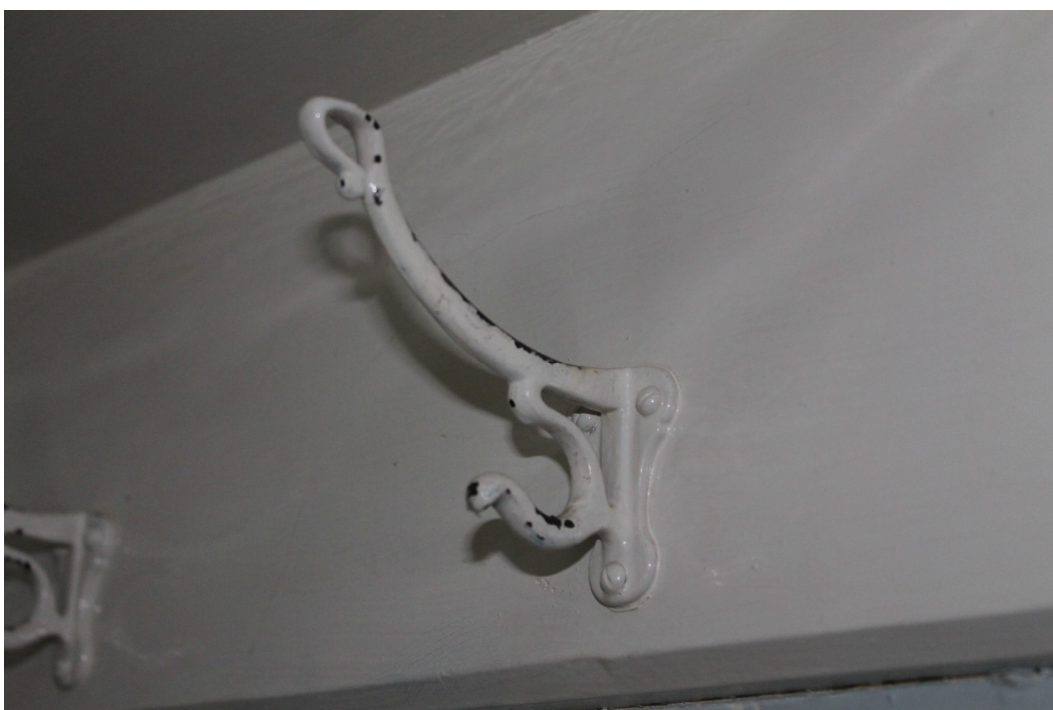
Plate 12 Detail of original? coat hook in bedroom 2.

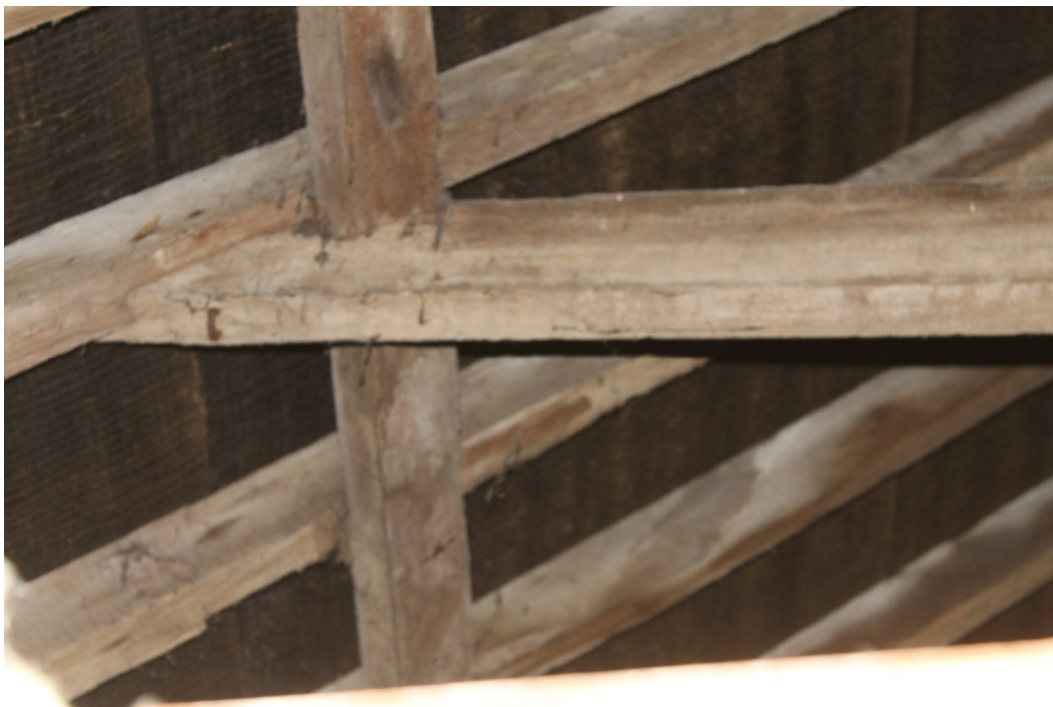
Plate 13 Detail of trrenched collar and through purlin in roof.

A visual inspection of the roof through the loft hatch showed that it is constructed from hand-sawn timbers with rafters of approximately 200mm x 100mm, rising to a ridge board, and collar braces trenched to the principal rafters (Plate 13). The through purlins are approximately 160mm² and are clasped by the collars. Above the rafters there is a layer of tar paper obscuring the battens to which the plain tile roof is nailed, indicating the roof has been re-laid in comparatively recent times.

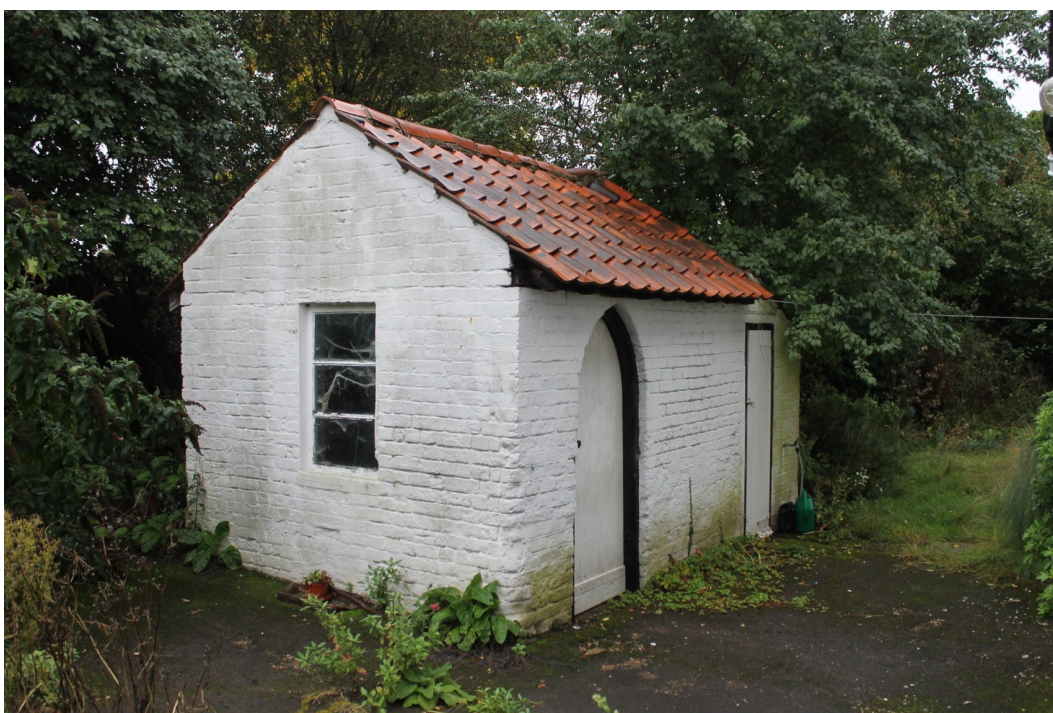
Plate 14 The contemporary wash house with later privy at the rear - view north-west.

The wash house is a small, single-storey structure measuring 2.75m x 3.3m with the later privy attached to its rear (Plate 14). It is constructed of white-painted red brick with dimensions of 226mm x 110mm x 65mm laid in irregular bond. It has a single entrance with a pointed arch in the north-east elevation, which mimics the Gothic Revival windows of the house. The door is a modern replacement. A timber-framed window of three lights in the south-east elevation is a replacement for a larger original window.

The gabled roof is of pan tiles, which is a replacement covering to the original roofing. The roof is carried on a wall plate 80mm high x 140mm wide and the machine-cut rafters are braced by nailed collars. This suggests the original roof failed and was completely replaced.

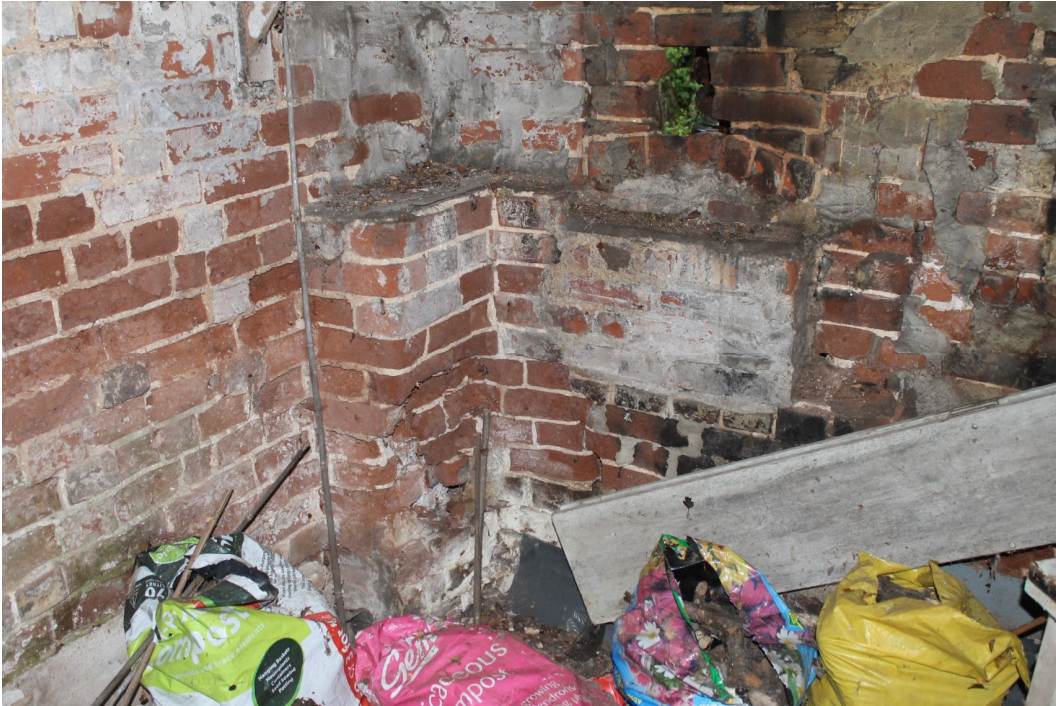
Plate 15 Interior of the wash house showing the former position of the copper and the blocked stoking arch - view north-west.

The interior shows that the building was most recently used as a potting shed but several features survive that indicate its original function was as a wash house. In one corner there are the remains of brickwork that would have supported a copper for boiling water, with a stoke hole for the fire box in the rear wall, although this has subsequently been blocked (Plate 15). Soot stains on the wall next to this indicate the location of the chimney which has been removed, probably at the time that the building was re-roofed.

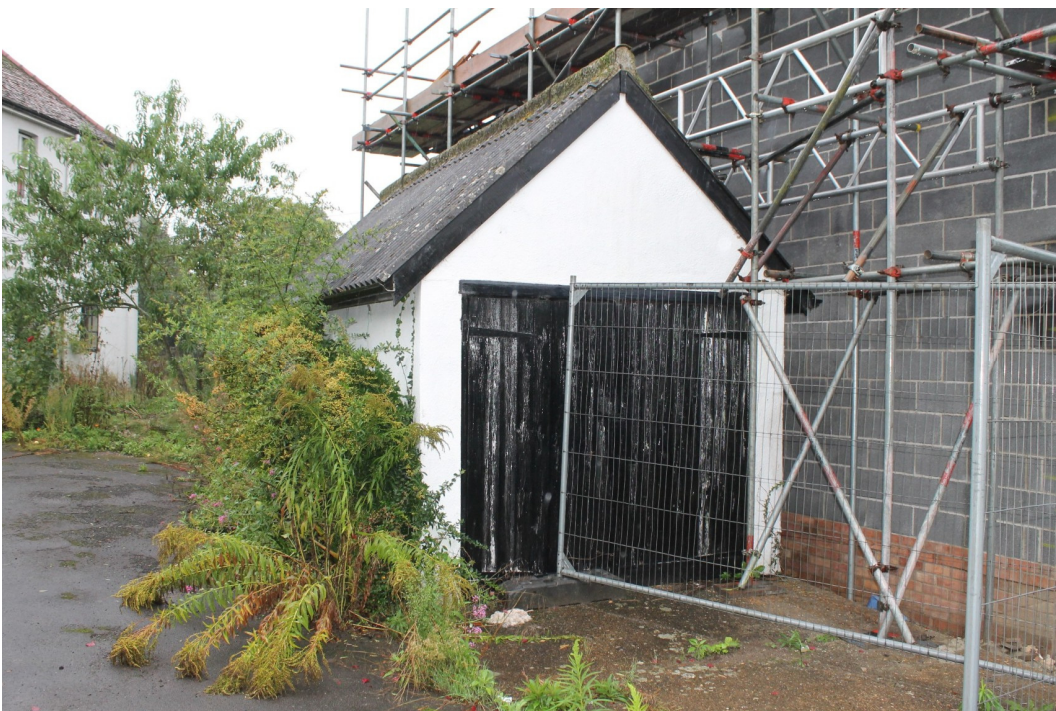
Plate 16 20th-century garage - view west.

The garage is a single-storey white-painted structure measuring 6.3m x 2.6m constructed from breeze blocks with an outer brick skin (Plate 16). It has a gabled roof of corrugated asbestos sheeting. The structure is divided between accommodation for a vehicle to the front and a small workshop/tool store to the rear. It has timber-framed double doors facing the road and a window of three lights with a sill of creasing tiles in the south-west elevation. The rear wall has a single timber entrance. This structure most likely dates to the mid 20th century.

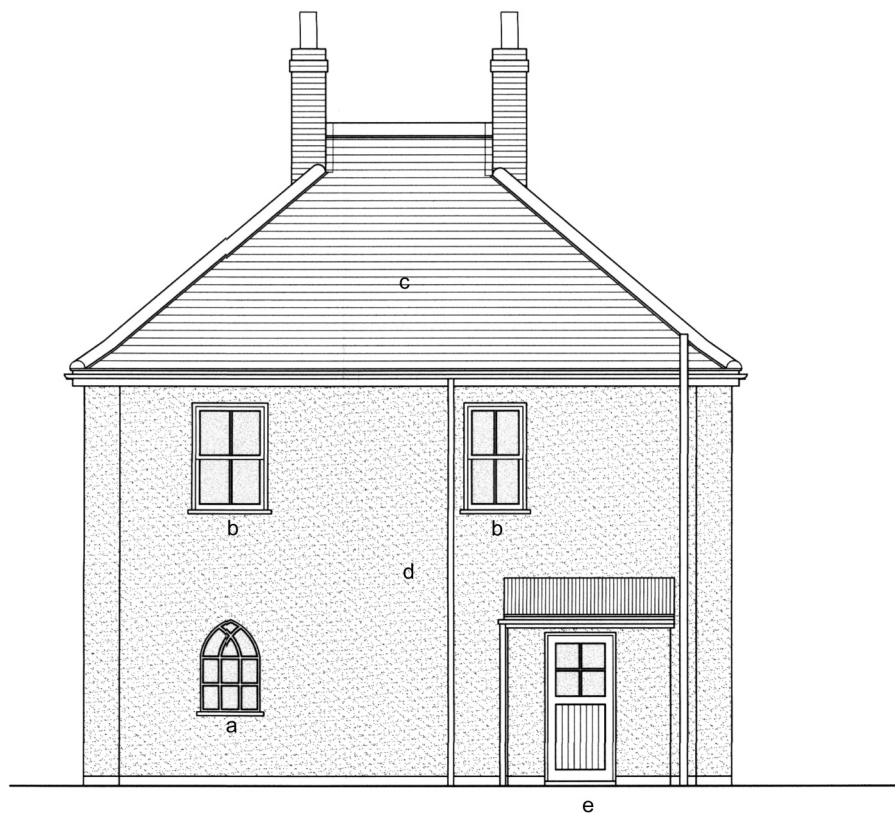
- a - metal-framed Gothic Revival window
replacing original timber-framed version
- b - horned sash window
- c - plain tiles
- d - modern cement render
- e - 20th-century porch
