**Historic building recording at
the Bricklayers Arms, 61 Hadham Road,
Bishops Stortford,
Hertfordshire CM23 2QY**

April 2018

**commissioned by
St James Contracts Ltd**

CAT Report 1263
May 2018

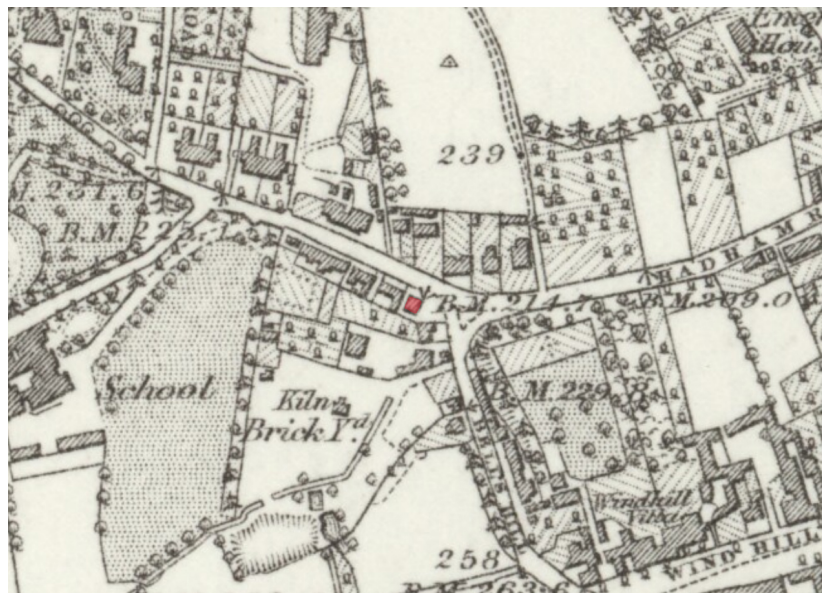
Map 1 1879 1st edition 6-inch OS map. Bricklayers Arms highlighted in red.

To the south-west of the site on the 1st edition OS map is a brickworks with a substantial rectangular kiln. This is the remains of a (since demolished) post-medieval brickworks (HER number 6855). These brickworks are the origin of the name of the pub. This map shows the pub as having an OS benchmark on its north-east corner, something that is not present on later maps or the structure as it stands today. The footprint of the pub appears to be smaller than in later mapping (see below), which perhaps suggests the projecting ground-floor is a later addition.

The pub first appears on the 1st edition OS map in 1879 (Map 1). It is not present on the 1839 tithe map. There are records of the building, described as a pub, being owned by a MR W Jeeves in 1867 (<http://www.stortfordhistory.co.uk>), providing a potential timespan of 28 years for the pub's construction.

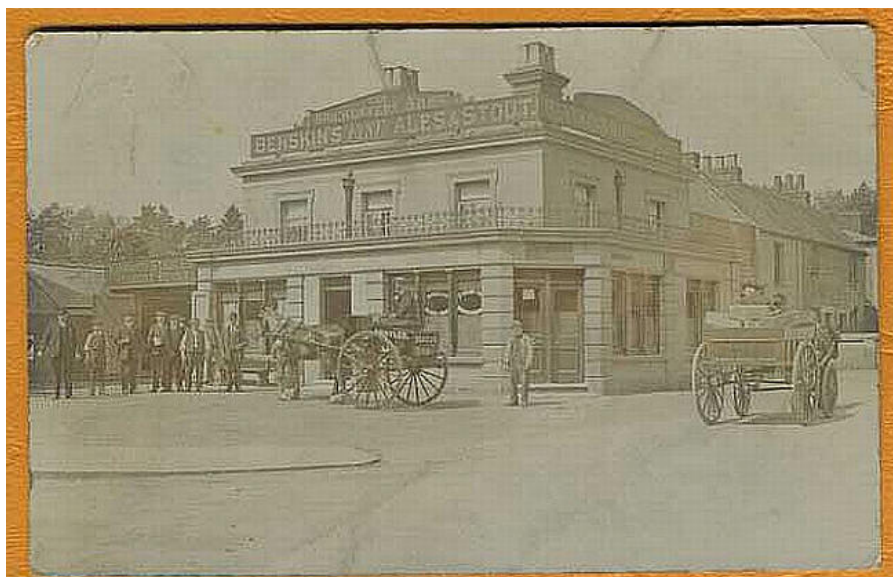
Photograph 1 The Bricklayers Arms in the early 20th century. 63 and 65 Hadham Road (since demolished) visible to rear of building. Extensions A and B also visible. Pub owned by Benskin's Brewery. Taken from <https://pubshistory.com/HertsPubs/BishopsStortford/BricklayersArms.shtml>.

Two early 20th-century photographs of the Bricklayers Arms show the pub as being owned by Benskins Brewery (Photographs 1 and 2). Benskins Brewery purchased Hawkes & Co in 1898 (<http://www.hertsmemories.org.uk>). They also show that extension B originally had large double doors on its south-east elevation.

The first-floor of the pub has wider horned sash-windows. All the pub's windows are replacements, as photographs of the pub from the early 20th century show (Photographs 1 and 2). Between adjacent windows on the ground-floor are ornate metal posts, decorated on their apex and base with floral motifs (Photograph 11). The windows on the north-east elevation of extension A are large four-light sash-windows, and are probably original (Fig 6).

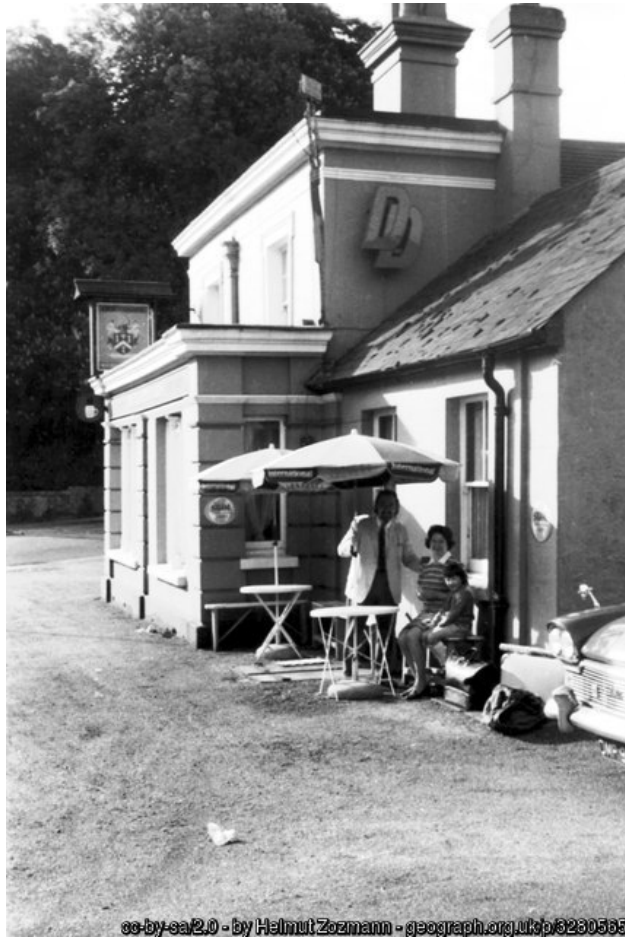
Photograph 3 Bricklayers Arms in 1971. Pub sign visible for first time (with different logo than today). Also visible are the horned sash-windows on the pub and extension A. Photograph taken facing south-east. From www.geograph.org.uk.

Photos of the pub taken in the 1970s (Photographs 3 and 4) show its owner as Ind Coops, who purchased Benskin's Brewery in 1957 (<http://www.hertsmemories.org.uk>). The photos show the current window-frames (although the glass has since been replaced) and an earlier pub sign.

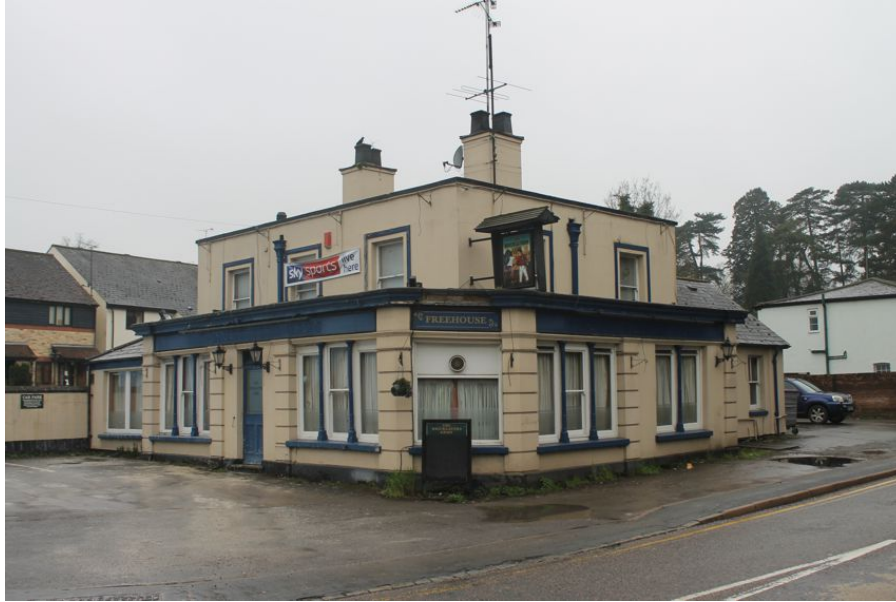
Photograph 5 Exterior of Bricklayers Arms showing north- and south-east elevations. Photograph taken facing west.

This record describes the pub and its three extensions. The pub is a two-storey structure. On the north- and south-east elevations the first-floor is set back, and the ground-floor projects outwards (Figs 6-7 and Photograph 5).

The pub has two chimneys projecting from either end of its ridge-line (Photograph 5), both of which are original. Both extension A and extension B also have chimneys (Photograph 6 and Figs 6-7).

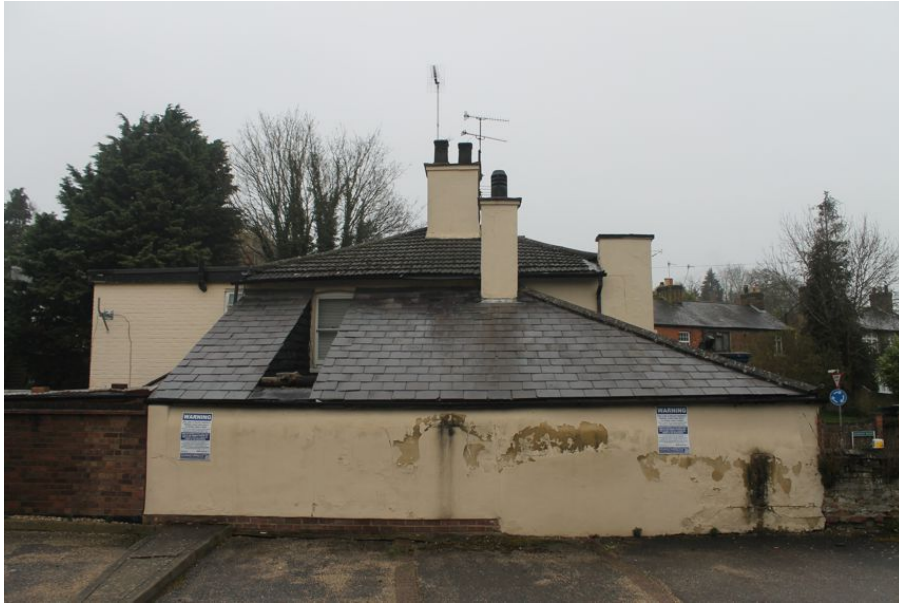
Photograph 6 Exterior of Bricklayers Arms showing extension B in foreground. Photograph taken facing north-east.

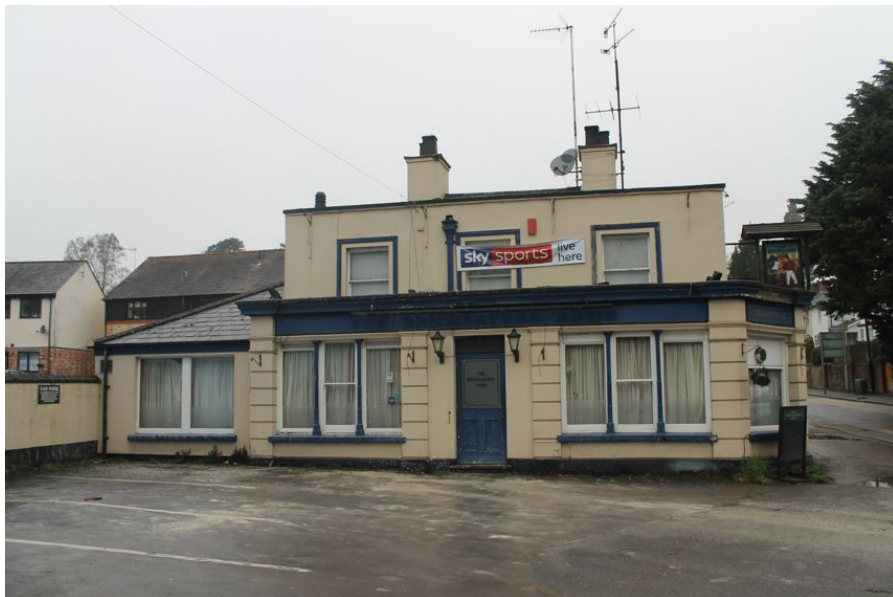
Photograph 7 South-east elevation of Bricklayers Arms. Photograph taken facing north-west.

The current main public entrance into the building is through a modern half-glazed door on the south-east elevation (Photograph 7), but originally there was a double door on the corner of the pub, between the north- and south-east elevations, that has since been blocked by a large fixed window (see historical background above). The rear of the pub is accessed through a modern hammered-glass partially-glazed door on the north-west elevation of extension A (Fig 7). There is also a set of modern french windows on the north-west elevation of extension B, leading out onto the decking at the rear of the pub.

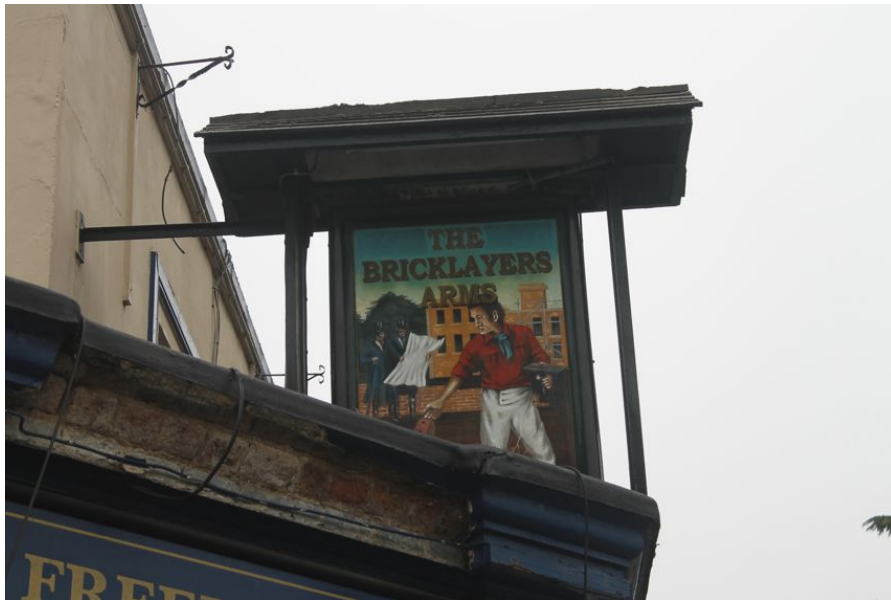
Photograph 8 Detail of pub sign. Photograph taken facing north-west.

The current pub sign (Photograph 8) post-dates 1973 (see historical background above).

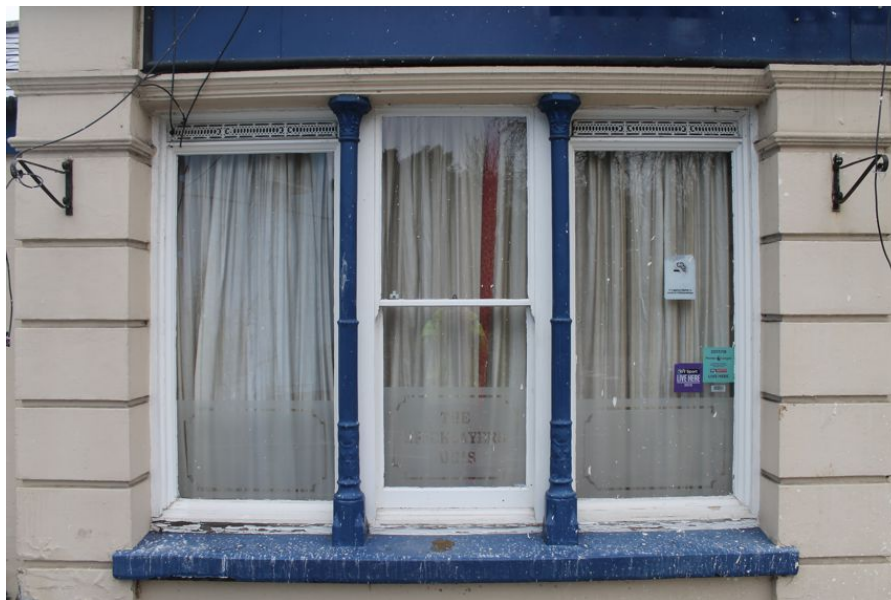
Photograph 9 Detail of fixed and sash-windows on south-east elevation. Photograph taken facing north-west.

The windows on the ground-floor of the pub are a mix of two-light horned sash and single-light fixed windows. They are mostly arranged with a sash-window in-between two fixed-windows (Photograph 9), although on the north-east elevation there are two, larger, adjacent fixed-windows (Fig 6). Above two of the fixed windows on the south-east elevation are ornate metal ventilation grills (Photograph 10).

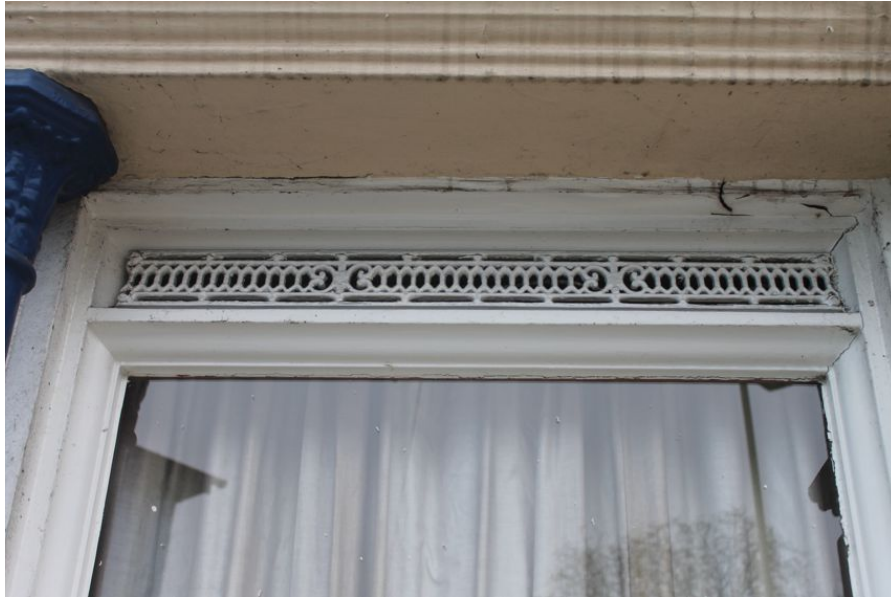
Photograph 10 Detail of vents above fixed windows on south-east elevation. Photograph taken facing north-west.

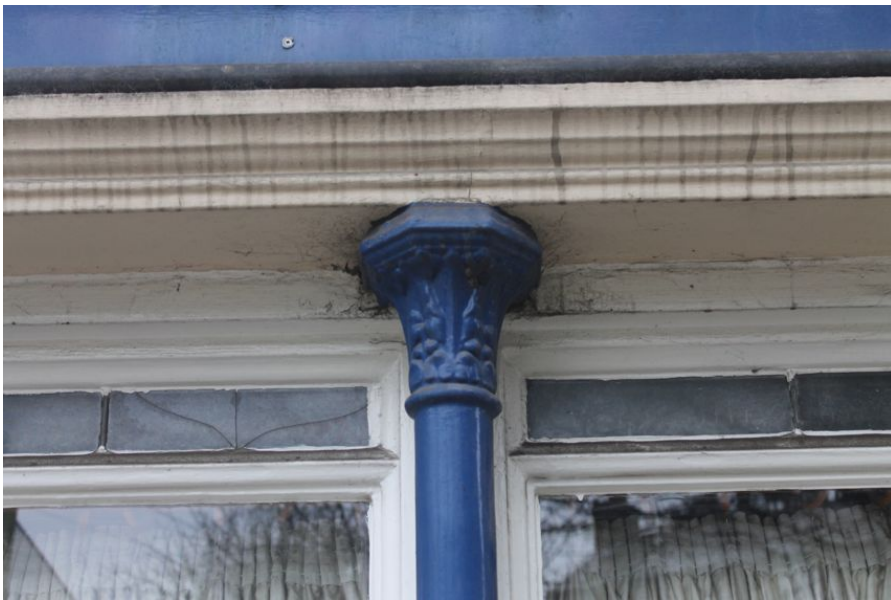
Photograph 11 Detail of decoration on apex of metal post between windows on the north-east elevation of pub. Photograph taken facing south-west.

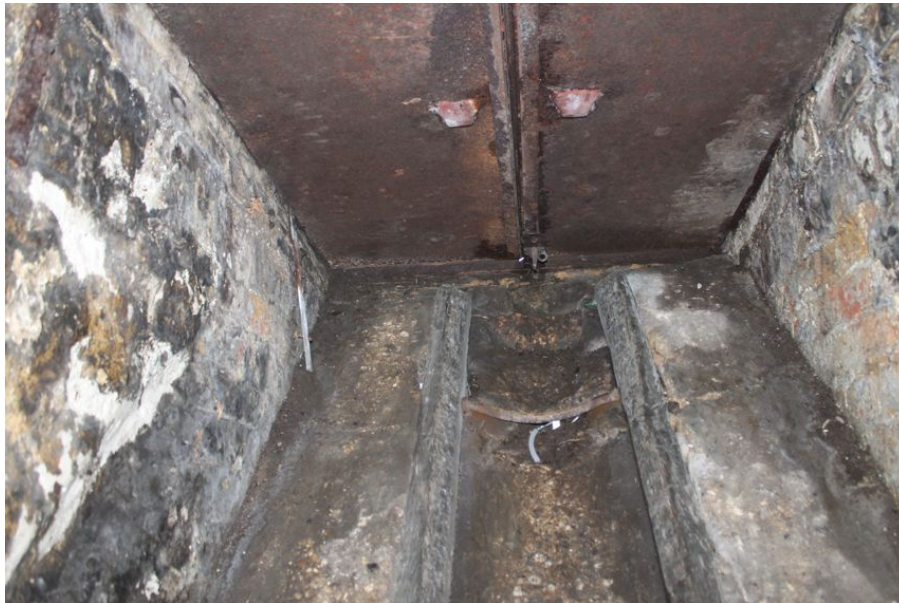
Photograph 12 Interior of cellar, showing hatch onto pavement and chute into cellar. Photograph taken facing north-west.

Extension A has a cellar beneath it, accessed both from a stairway within the pub and by a chute from the exterior of the building. The chute is brick- and concrete-lined, with two wooden and iron rails in the centre, designed to guide beer kegs and barrels into the cellar (Photograph 12). The door at the top of the stairway has four-panels, and is probably original (Photograph 13).

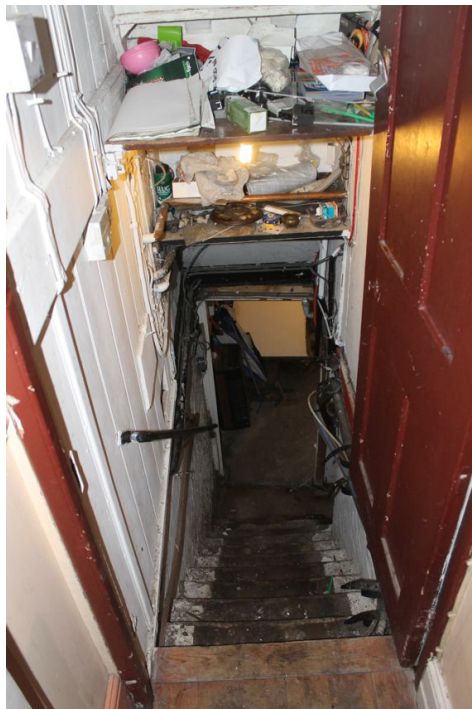
Photograph 13 Entrance into cellar from ground-floor of pub, with four-panel door visible to right. Photograph taken facing north-west.

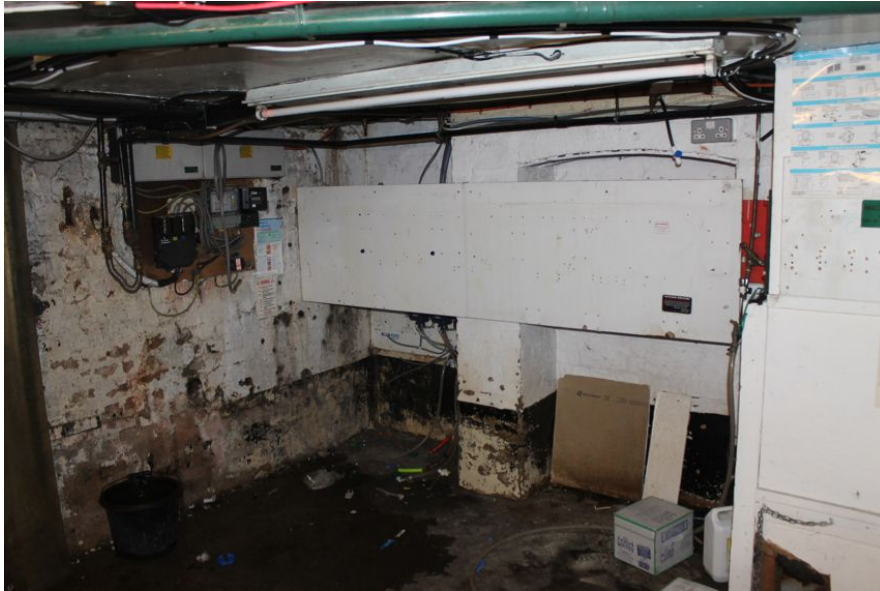
Photograph 14 Interior of cellar, showing brick arch supporting chimney-stack on upper floors. Photograph taken facing east.

The walls of the cellar are constructed of brickwork laid in English-bond with brick dimensions of 225mm x 110mm x 65mm. Within the cellar are several modern shelving units. On the south-east wall is a brick archway, supporting the chimney and fireplaces on the ground- and first-floors (Photograph 14).

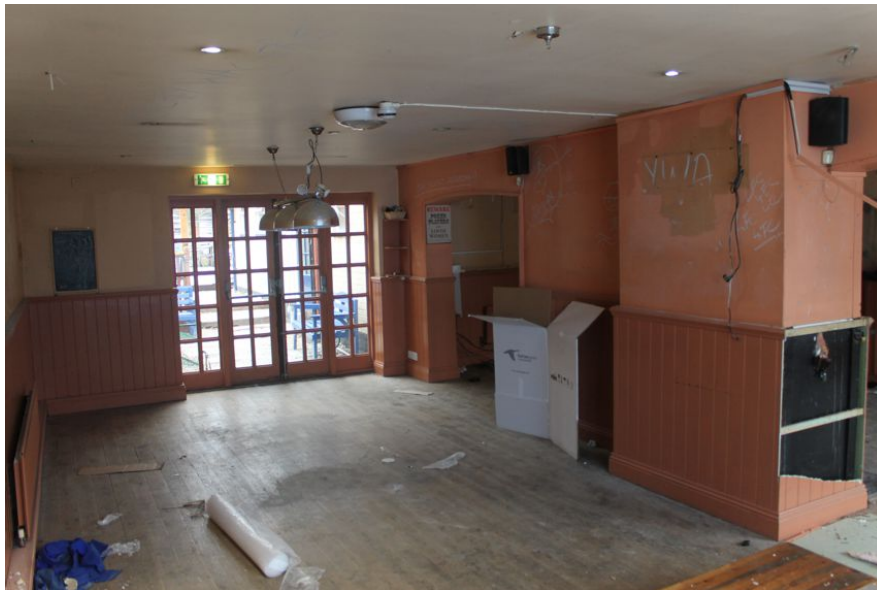
Photograph 15 Interior of extension B, showing dado-rail and blocked fireplace. Photograph taken facing north-west.

The interior walls of the ground-floor of the pub and extension B are rendered over and have a wooden-panelled dado, with an associated dado-rail (Photograph 15). The public entrance into the pub leads into a small foyer, and from there into two separate bars: a smaller one to the south, and a larger one to the north (Fig 4).

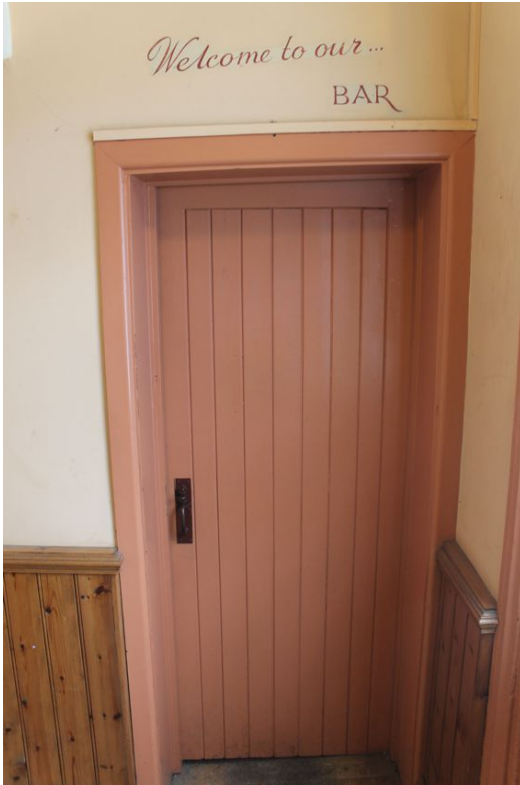
Photograph 16 Vertical-planked door leading into northern bar from foyer. Photograph taken facing north-east.

The interior doors on the ground-floor of the pub vary, although none are original. Some are vertically-planked doors (Photograph 16), some are modern doors, and some are four-panel doors, with the upper two panels glazed with frosted glass

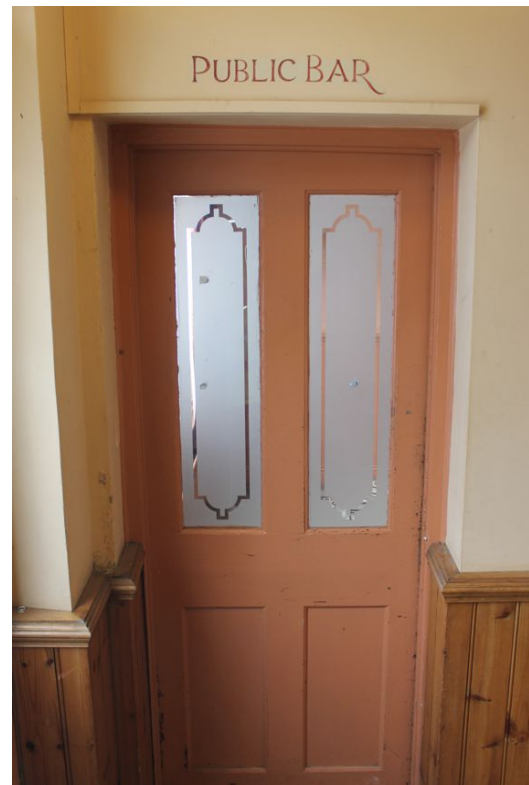
Photograph 17 Four-panel door leading to the southern bar from the foyer (the decal labelling this as the "Public Bar" is a modern addition, as this bar would almost certainly have been the lounge bar). Photograph taken facing south-west.

(matching the frosted glass on the windows) (Photograph 17). The floor in the northern bar is carpeted, but in the southern bar and the pool room the floor is bare floorboards.

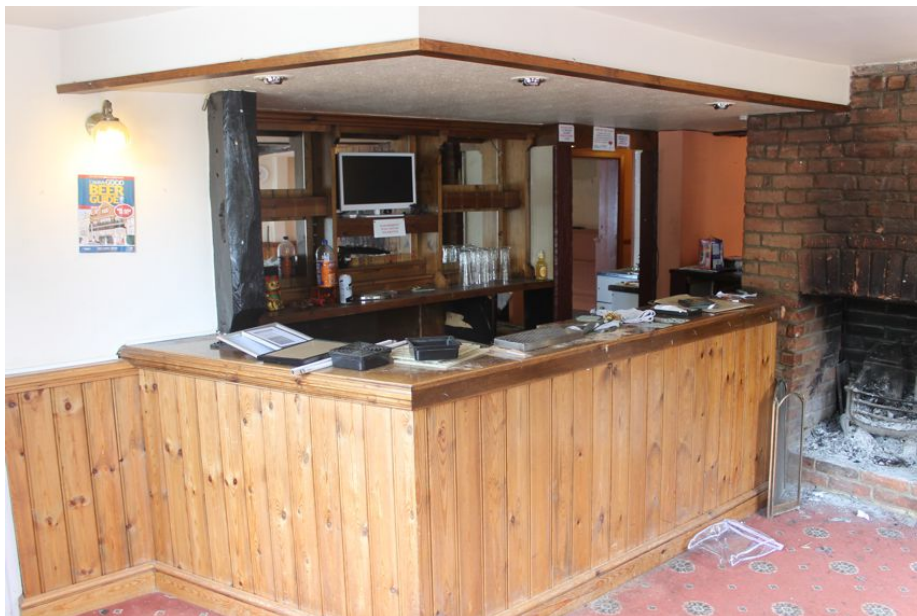
Photograph 18 Detail of bar in northern bar of pub. Photograph taken facing west.

The physical bar itself is panelled to match the dado (Photograph 18) and has a polished wood surface. While the current bar is a later replacement, it seems likely it is in the location of the original, given its central position in the pub (Fig 4).

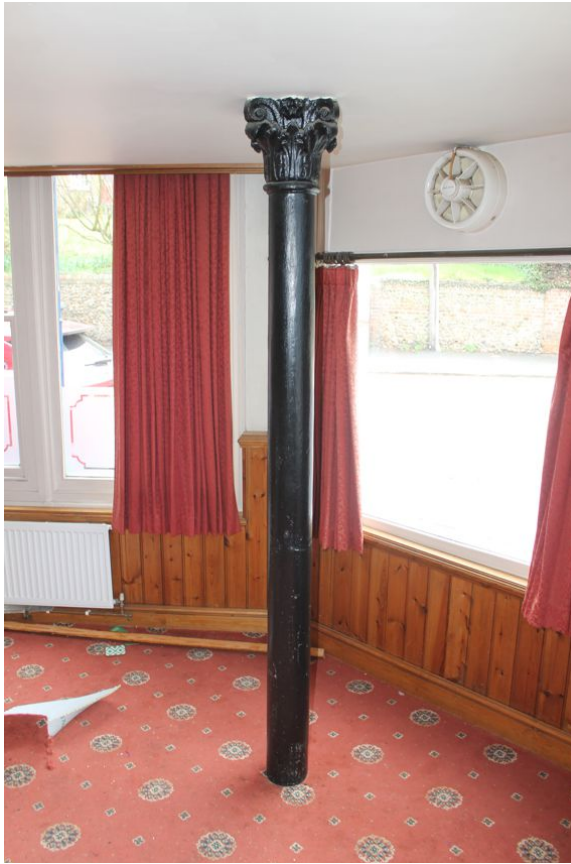
Photograph 19 Metal post in northern bar, supporting the first-floor. Note ornate decoration at apex. Photograph taken facing north-east.

In the eastern corner of the northern bar is a substantial metal post, in front of the large single-light fixed window on this elevation (see above). Like the smaller metal posts on the exterior, this one is decorated, in this case with a floral motif on the apex (Photograph 19). It serves to support the first-floor.

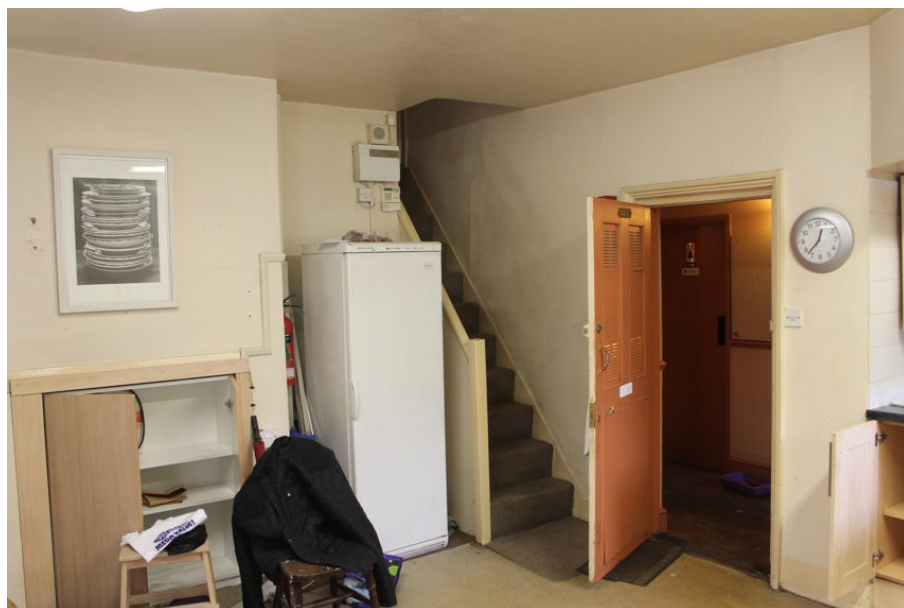
Photograph 20 Interior ground-floor of extension A, showing the blocked fireplace, door into corridor and stairway to first-floor. Photograph taken facing south.

The only private area of the ground-floor is extension A, which contains a blocked fireplace and the modern kitchen (Photograph 20).

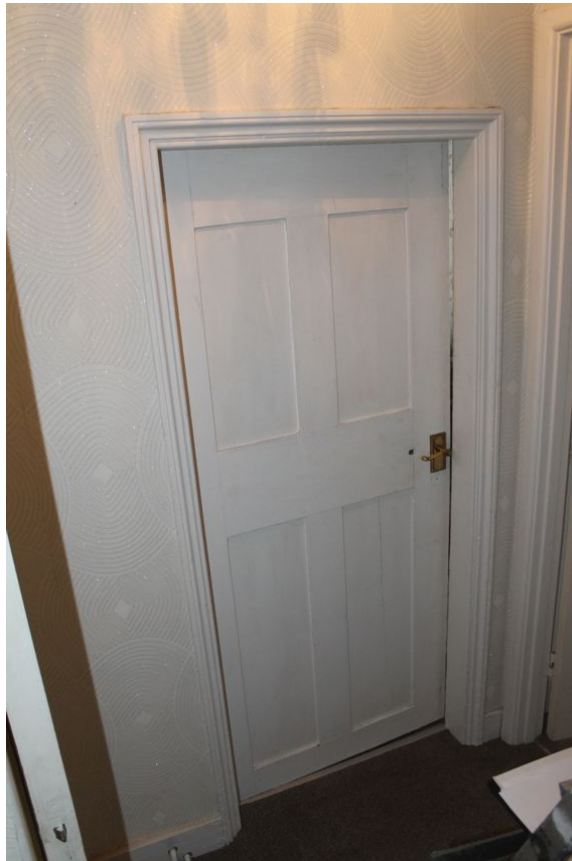
Photograph 21 Original four-panel door leading into northern bedroom on first-floor of pub. Photograph taken facing north-east.

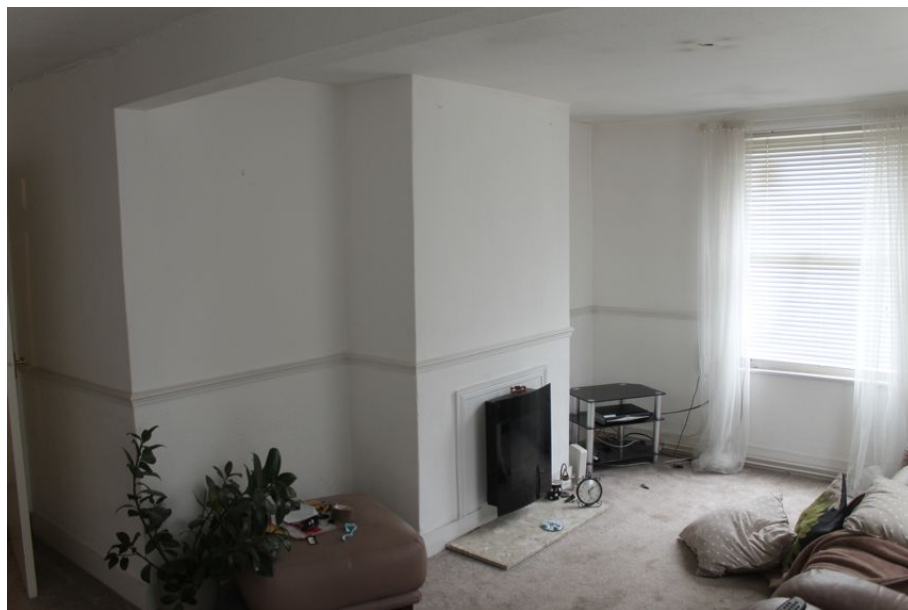
Photograph 22 Blocked fireplace in living room in first-floor of pub (replaced with electric heater). Photograph taken facing north.

Originally the first-floor would have had four fireplaces (two from each chimney stack), but these have all been blocked up (Fig 5 and Photograph 22). One of these pairs of blocked fireplaces corresponds with the ones below (in the northern bar), but the other has no corresponding fireplace below it in the southern bar.

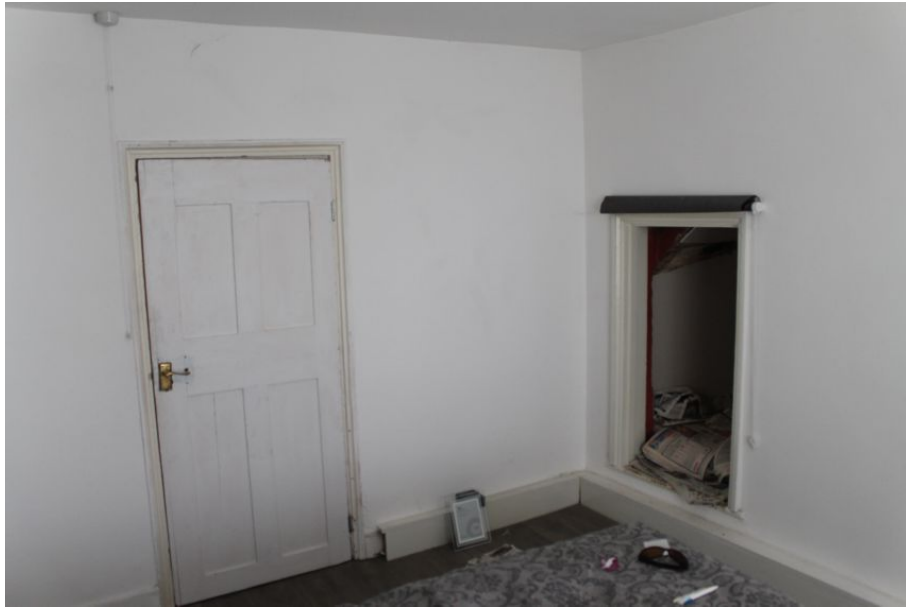
Photograph 23 Interior of northern bedroom in pub, showing original door (to left) and crawl-space into loft of extension A (to right).

The loft of extension A is accessible via a crawl space from the northern bedroom of the pub (Photograph 23). There is lath and plaster nailed to the rafters, which may be original (Photograph 24). Also visible in the loft is the chimney-stack for the fireplace below (Figs 3 - 4).

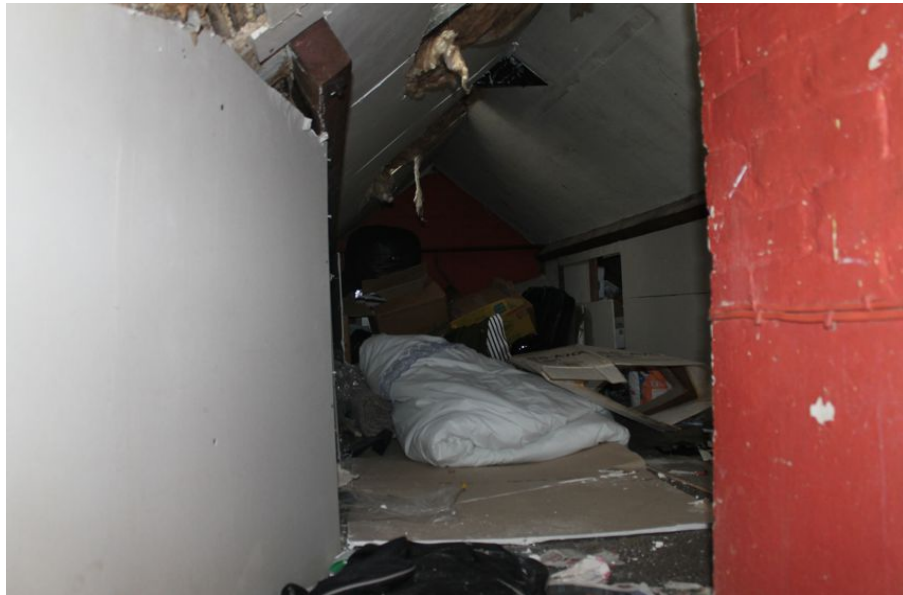
Photograph 24 Loft above extension A. Lath and plaster visible behind panelling. Chimney-stack visible to right. Photograph taken facing north-west.

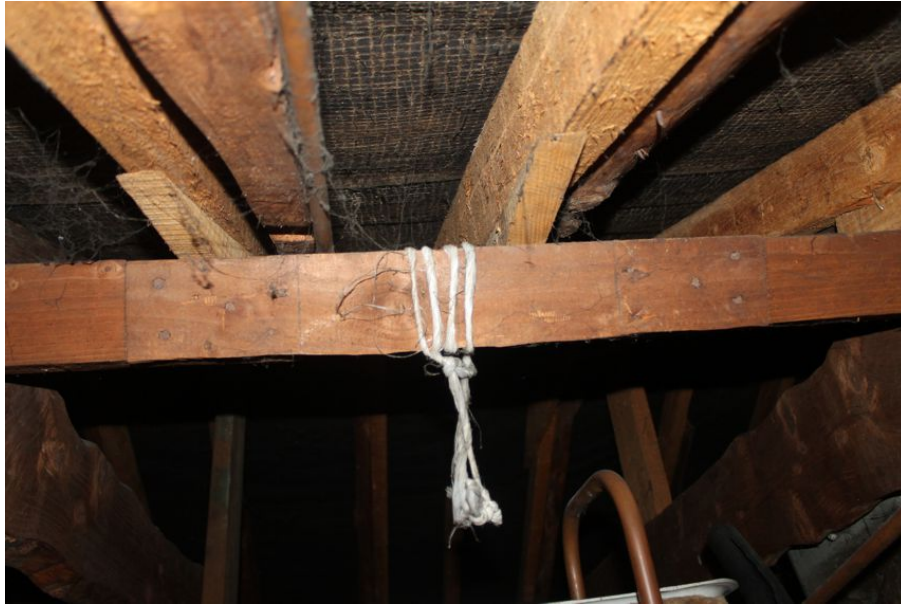
Photograph 25 Detail of purlin on north-west pitch of roof with two adjacent nailed scarf joints. Also at top of the frame visible are rafters with modern supporting timbers. Photograph taken facing south-east.

The roof of the pub was visible from the interior through a hatch in the landing. Inspection showed the roof was constructed of a mix of rudimentary hand-sawn and machine-cut timbers. The original rafters are hand-sawn (with dimensions 170mm x 100mm), but most of them are attached to a later machine-cut rafter (Photograph 25), which provides additional support. All the rafters rise to a ridge-board. As well as the additional rafters, there are several other timbers that are clearly later additions, supporting the roof in multiple locations.

There are a series of three rudimentary hand-sawn collars, between the chimney-stacks, that are nailed to the rafters (Photograph 26). There is one purlin on the north-west and south-east roof pitches, both of which are machine-cut. Both of the purlins also have two rudimentary scarf joints 500mm apart in the centre of the building: they are edge-halved scarfs with square abutments and secured with three nails (Photograph 25).

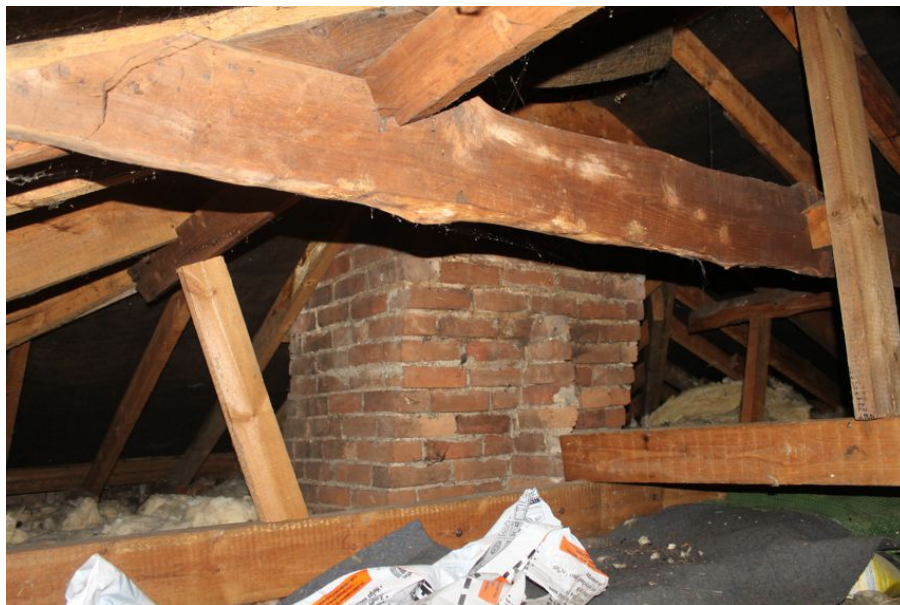
Photograph 26 Northern chimney-stack in roof. Also visible is rudimentary hand-sawn collar and clasped purlins. Photograph taken facing east.

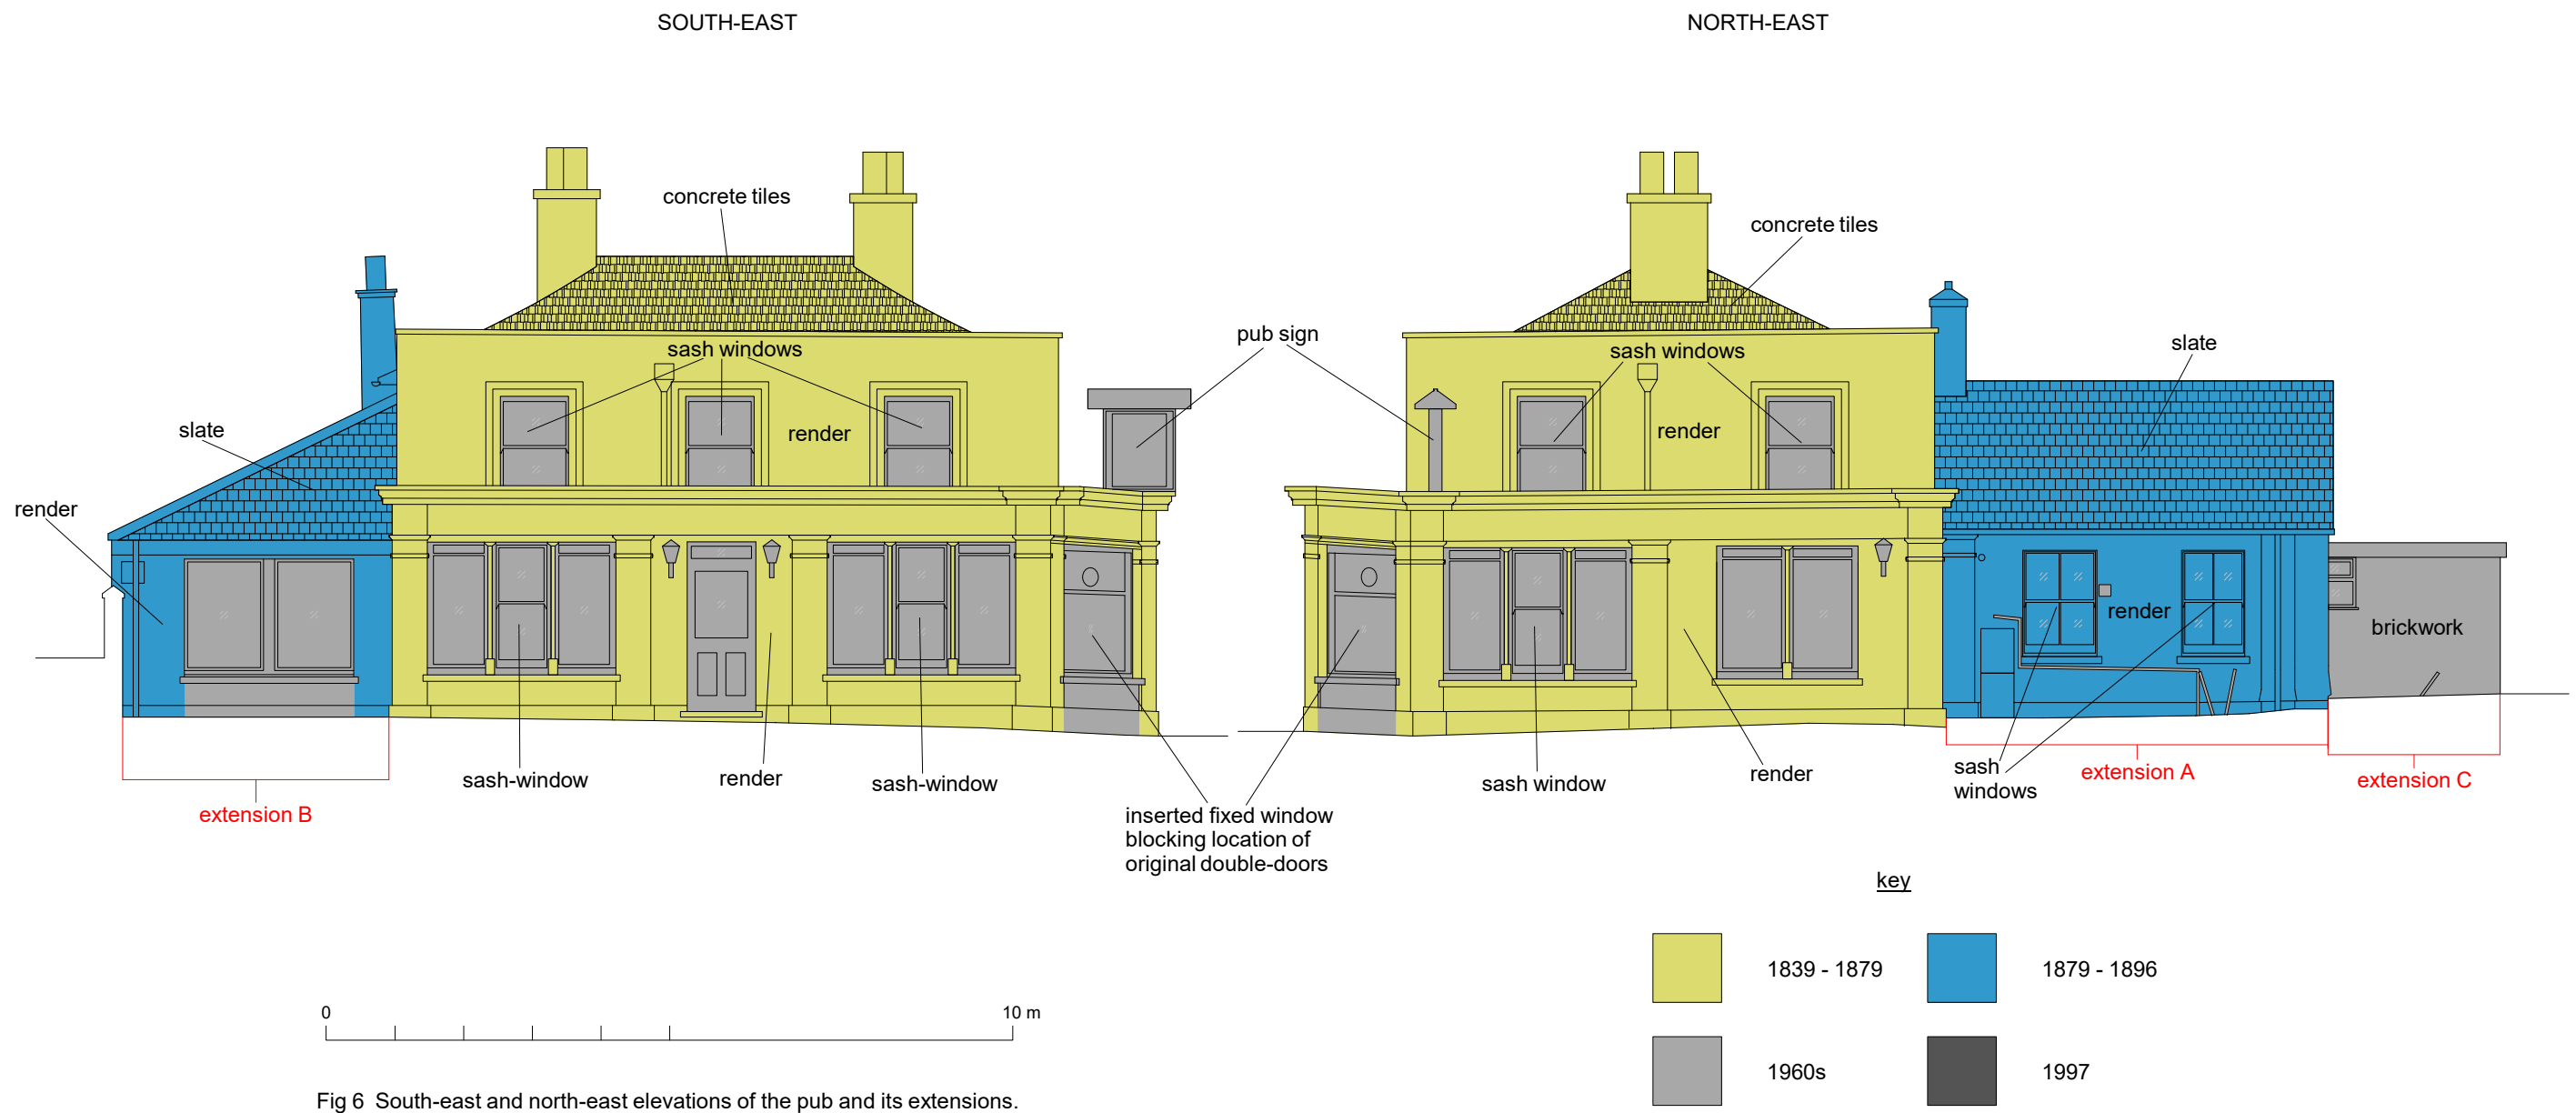
Fig 6 South-east and north-east elevations of the pub and its extensions.
