**Historic building recording at 1-7 Winnocks,  
Military Road, Colchester,  
Essex, CO1 2AF**

**April 2018**

**CAT Report 1277**  
June 2018

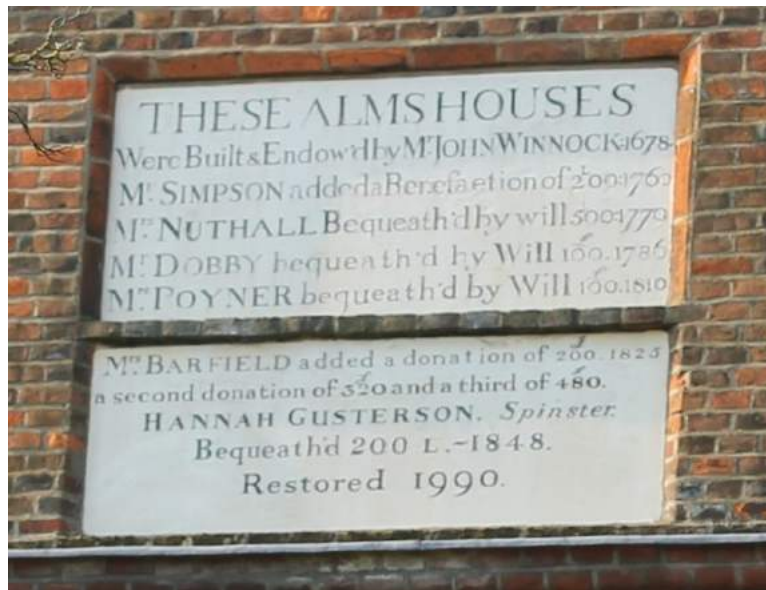
**Photograph 1**

Inscription in the pediment of the 1678 almshouse listing the benefactors of Winnocks.

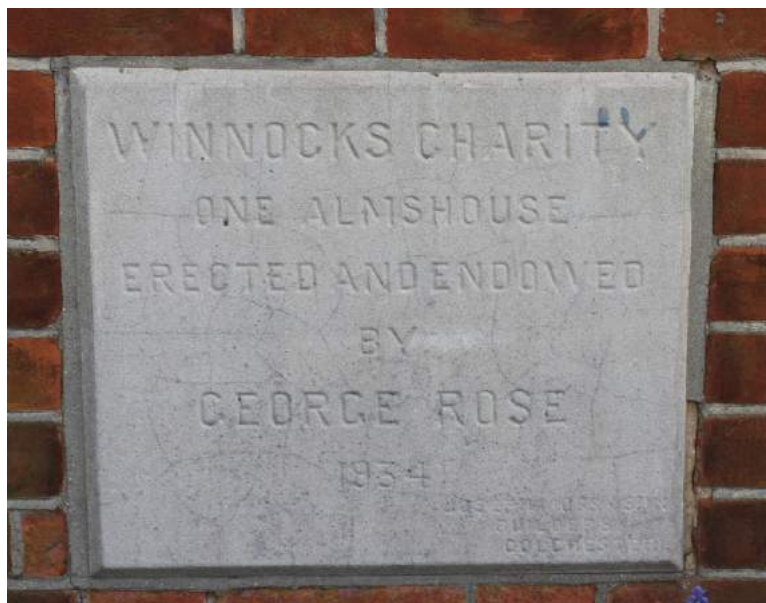
**Photograph 2**

Inscription stone found below the front window to each of the almshouses, recording the endowment by George Rose.

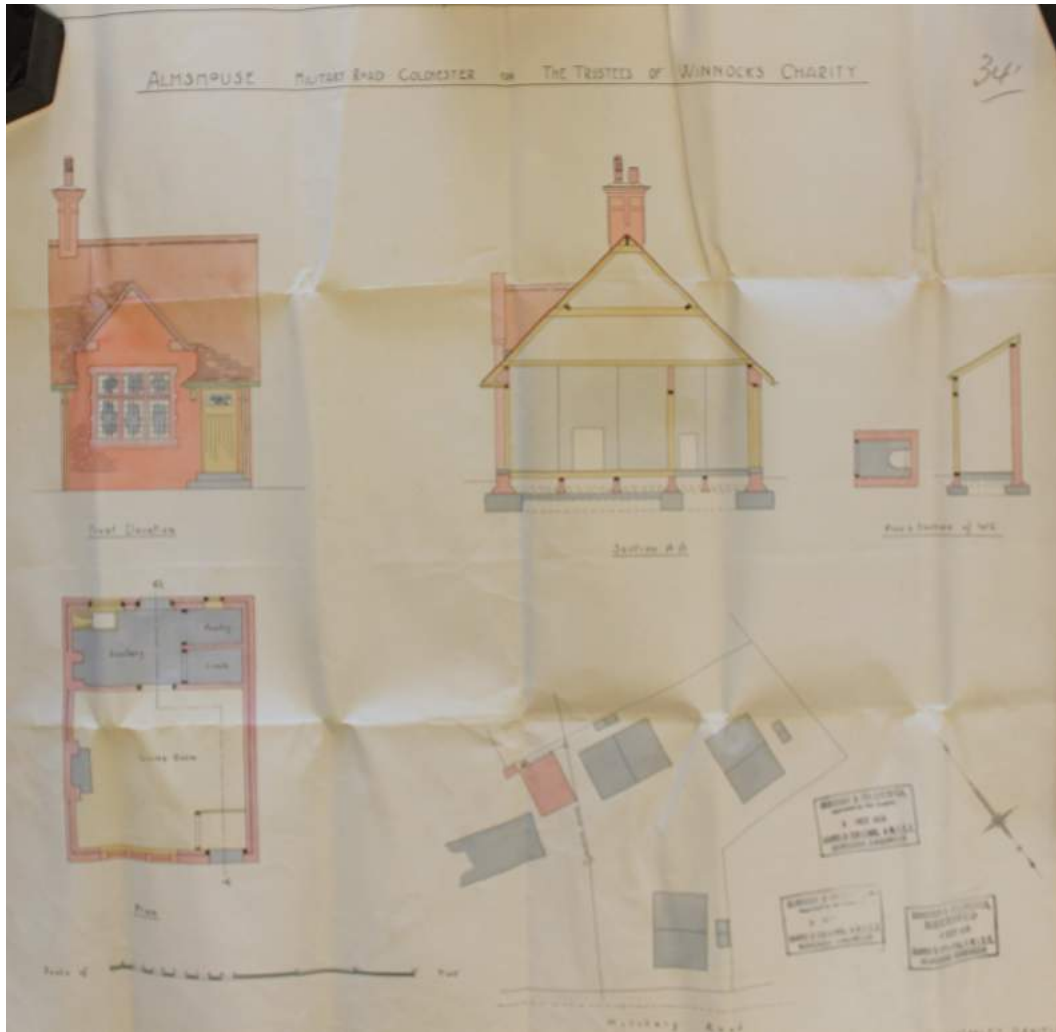
Plan 3 Plan by F Stanley Daniell of the single almshouse (No.7). ERO D/B 6 Pb3/6729.

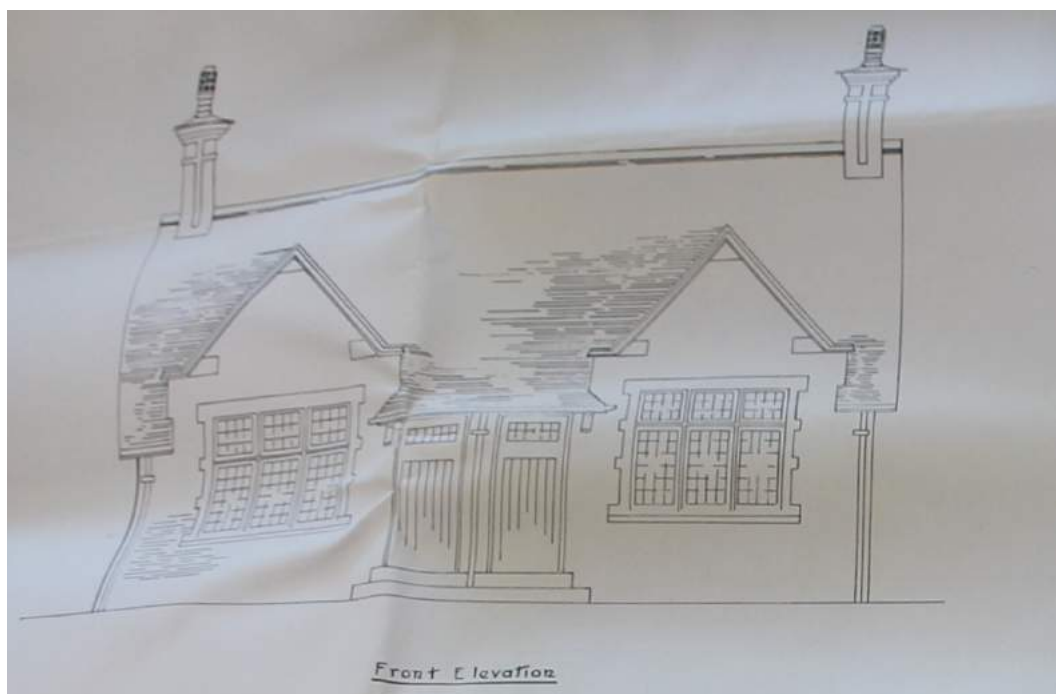
The almshouses were constructed in a neo-Tudor style with flat-headed stone mullion and transom windows, leaded comes, and a steeply pitched transverse roof with a smaller front-facing gable (Purcell 2018; Plan 5).

**Plan 5** Detail from Plan 1 (ERO D/B 6 Pb3/6526) illustrating the neo-Tudor style elevation to the almshouses.

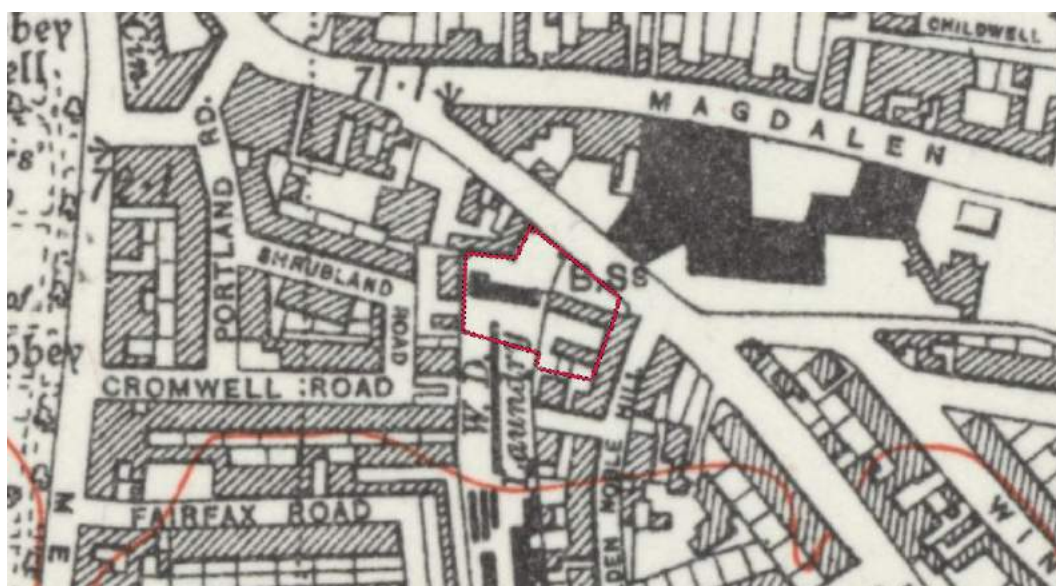
**Map 1** 1938 edition 6 inch Ordnance Survey. Despite the known construction date of 1934 none of the almshouses are shown.

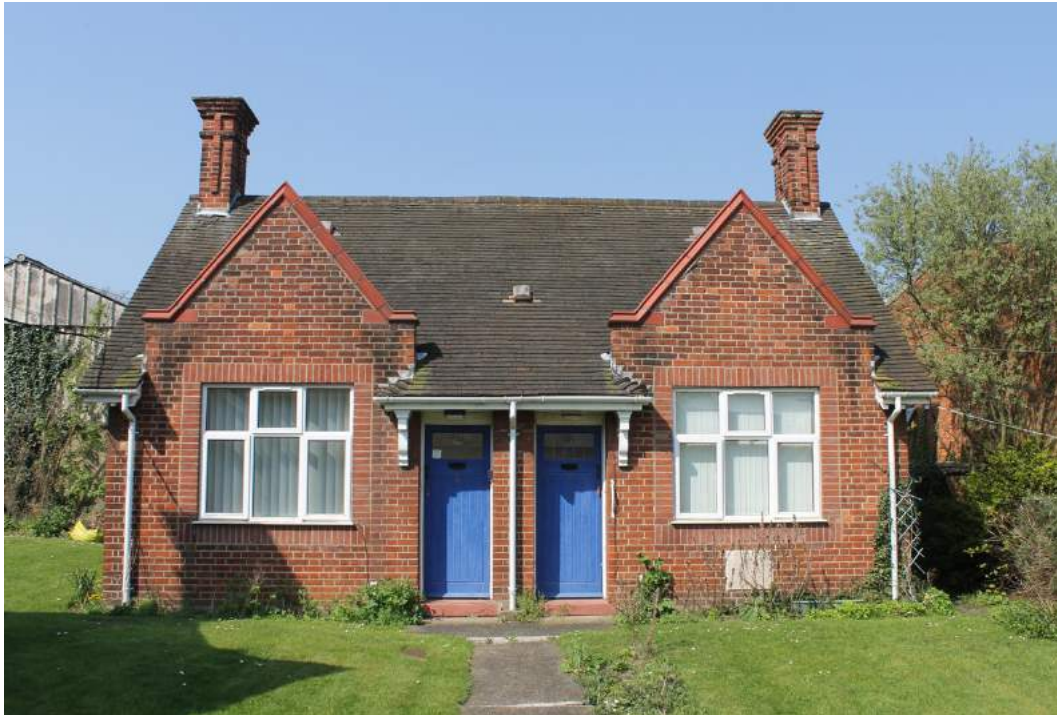
**Photograph 3**  
East elevation of Nos.3-4 Winnocks: the windows are replacement UPVC frames set into a brick surround. The doors appear to be original – view west.

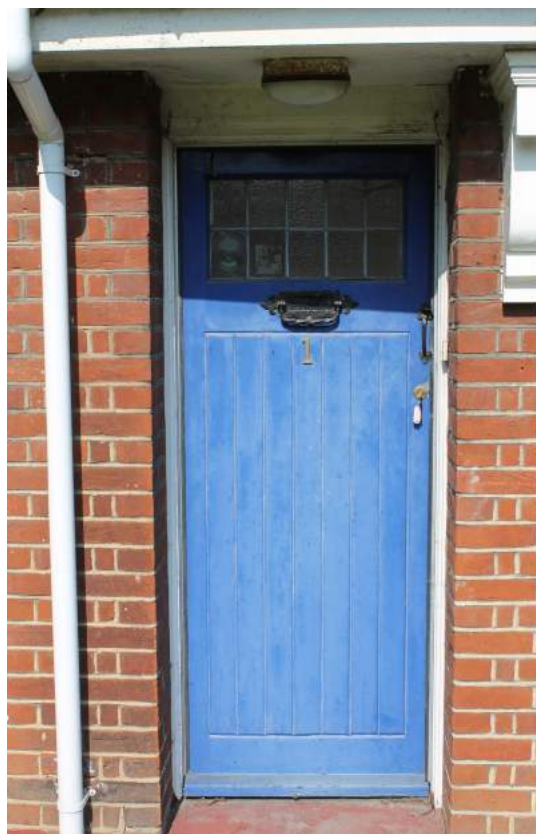
**Photograph 4**  
Original door to No.1 Winnocks – view north-west.

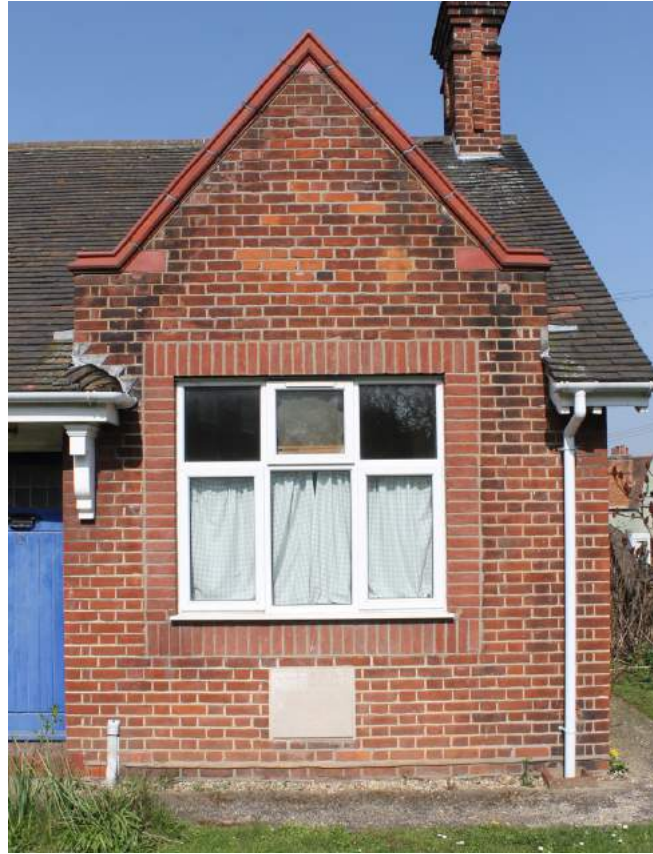
**Photograph 5**  
Replacement UPVC window and brick surround to No.1 Winnocks – view north-west.

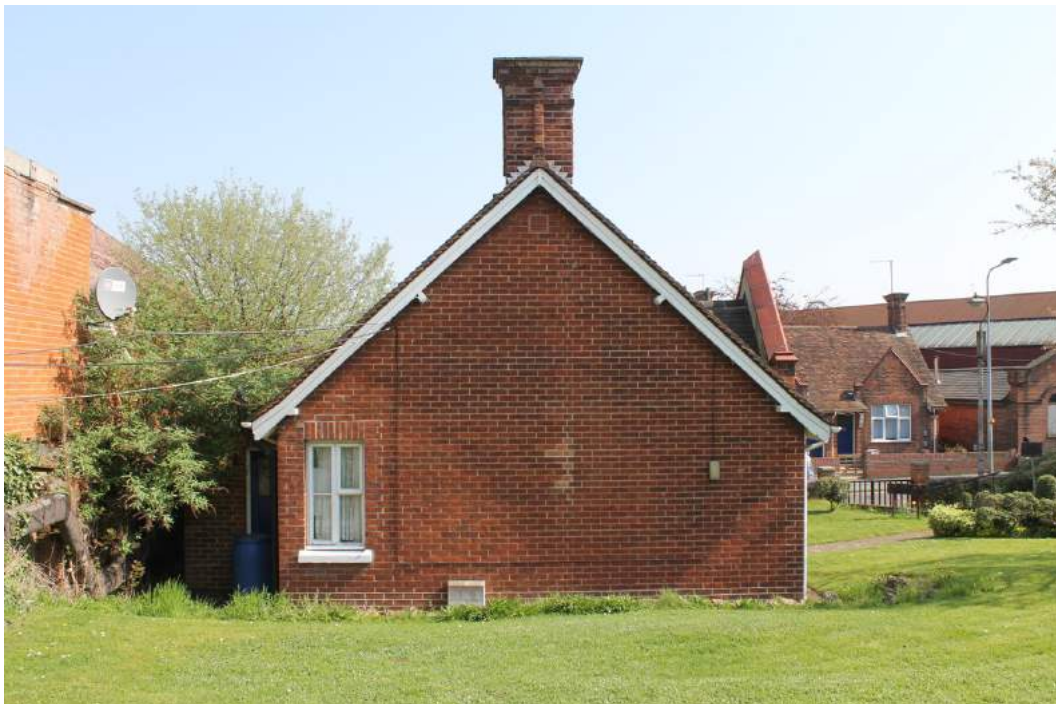
The side elevations are unremarkable brickwork with an air brick or pair of air bricks located directly below the apex of the gable. The exception to this is the south-west elevation of No.2 Winnocks (Photograph 6, Fig 5). Here a timbered-framed casement has been inserted.

**Photograph 6**  
South-west elevation of No.2 Winnocks, identical to the other gable elevations except for an inserted timber-framed casement – view north-east.

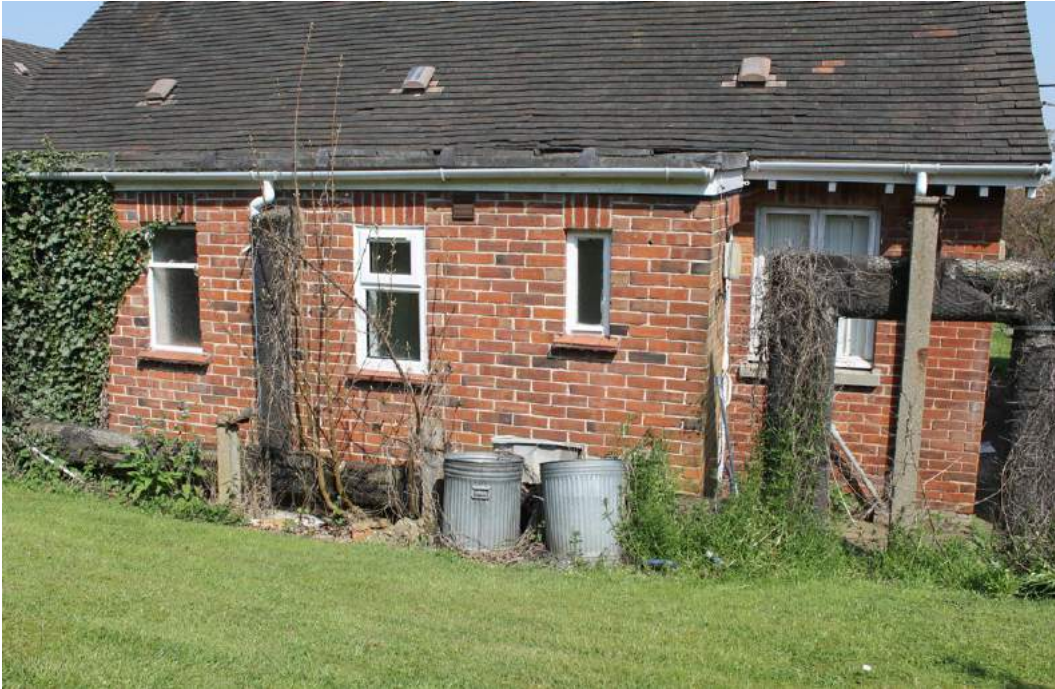
**Photograph 7**

1962 bathroom extension to Nos.5-6 Winnocks: the larger window is for the bathroom, the smaller one for the storage cupboard - view north-west.

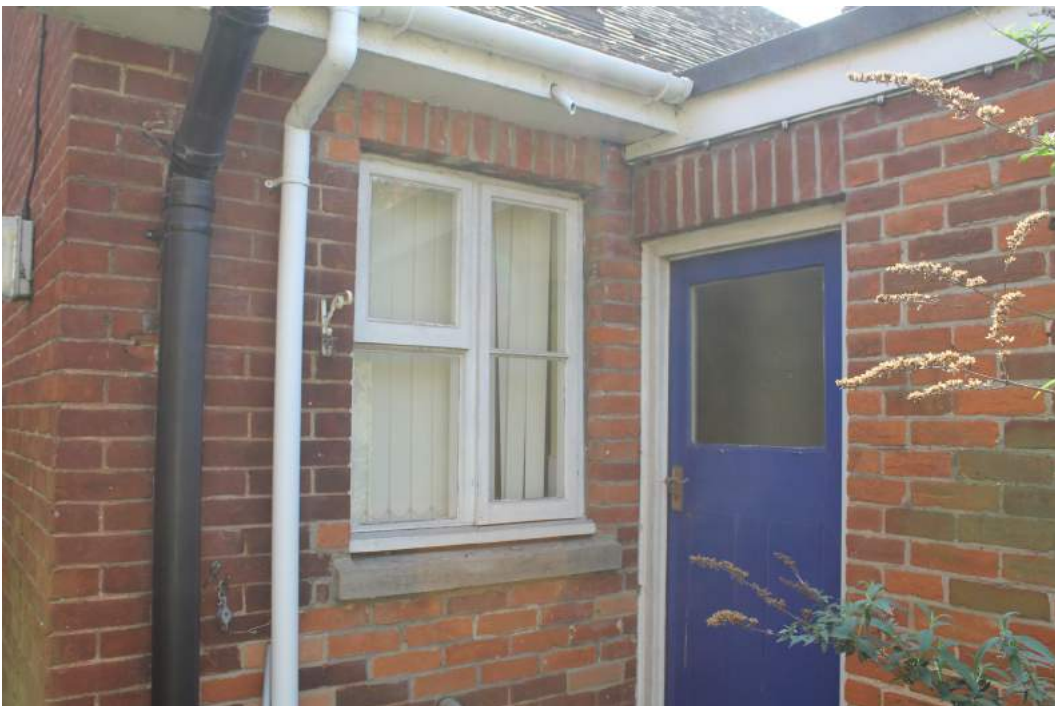
**Photograph 8**

1962 bathroom extension to No.1 Winnocks: the backdoor of the extension is possibly the original almshouse backdoor, relocated and reused in 1962. The timber-framed casement window is a replacement for the original metal-framed Critall window - view south.

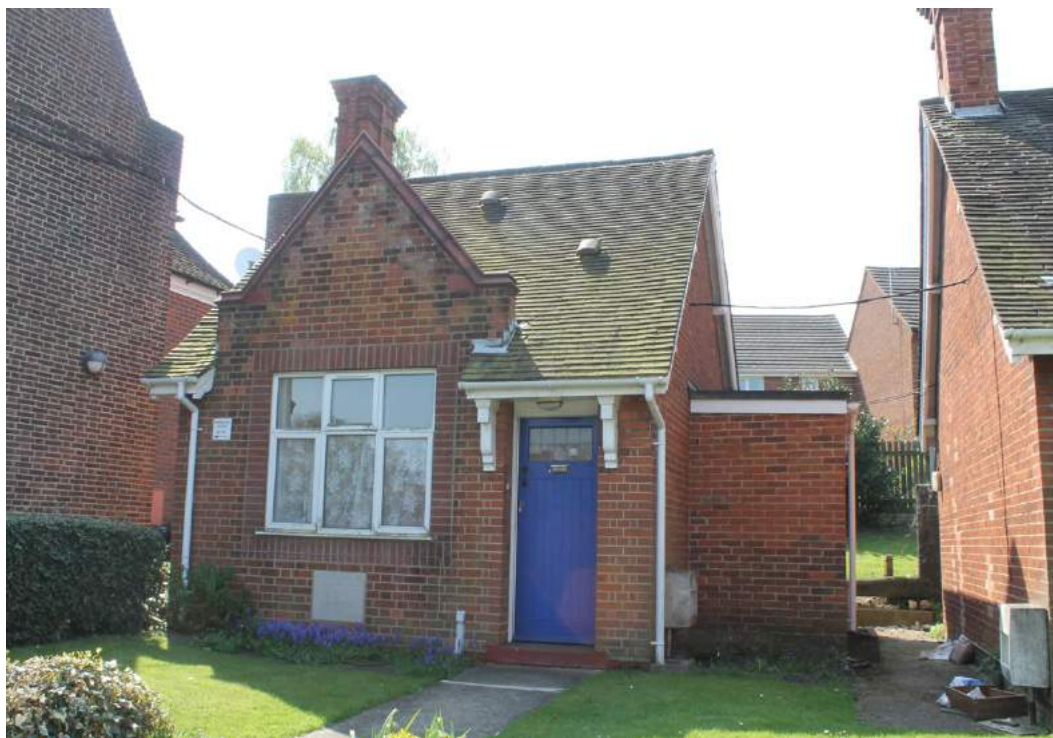
**Photograph 9**

1962 bathroom extension to No.7 Winnocks: insufficient space to the rear of the almshouse required the extension to be located along the side of the building - view south.

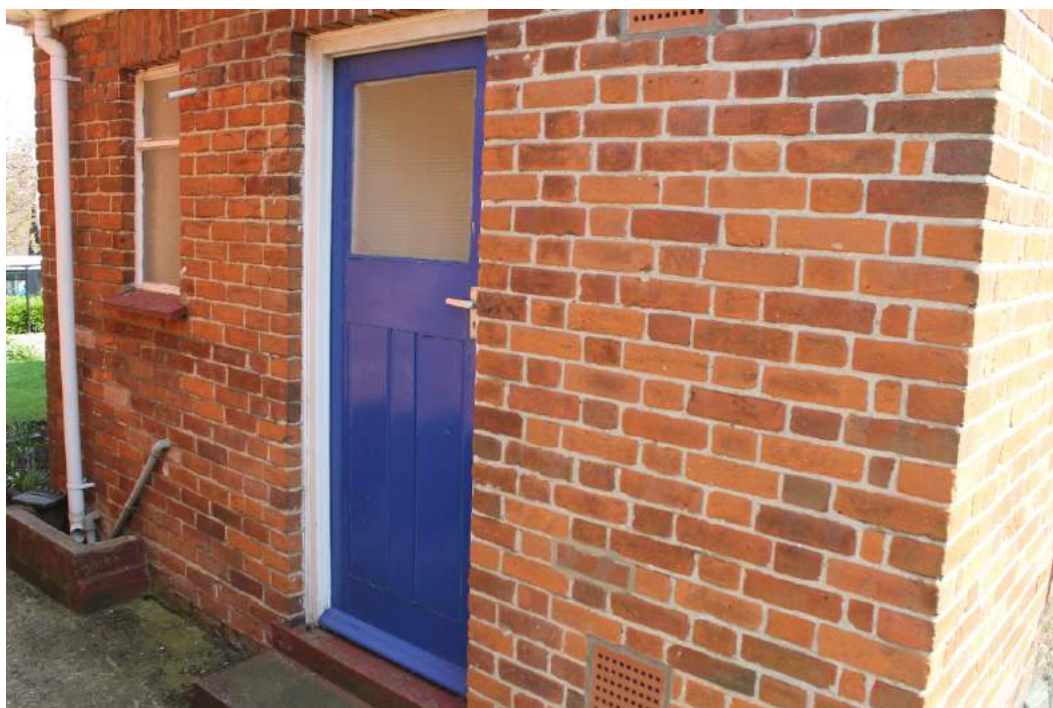
**Photograph 10**

1962 bathroom extension to No.7 Winnocks with only one metal-framed window and the backdoor located in the long elevation instead of the short - view north-east.

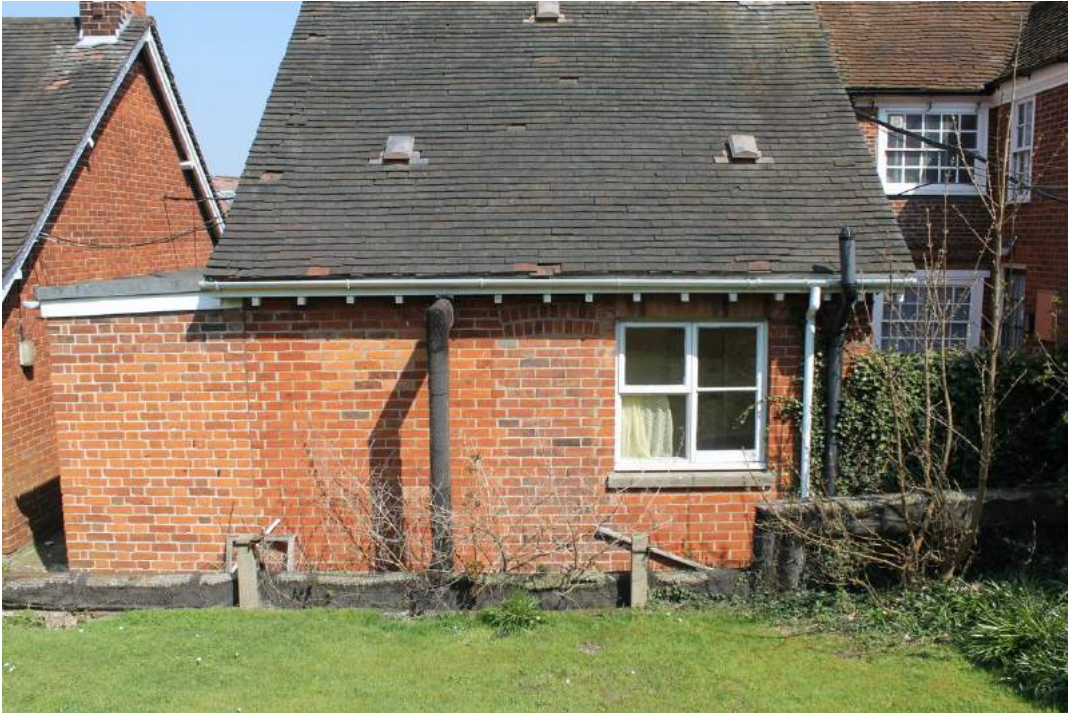
**Photograph 11**

South-west elevation to No.7 Winnocks with the 1962 bathroom extension to the left. The blocked in pantry window and backdoor are clearly distinguishable by the change in the brickwork and the original metal-framed window has been replaced by a timber-framed casement - view north-east.

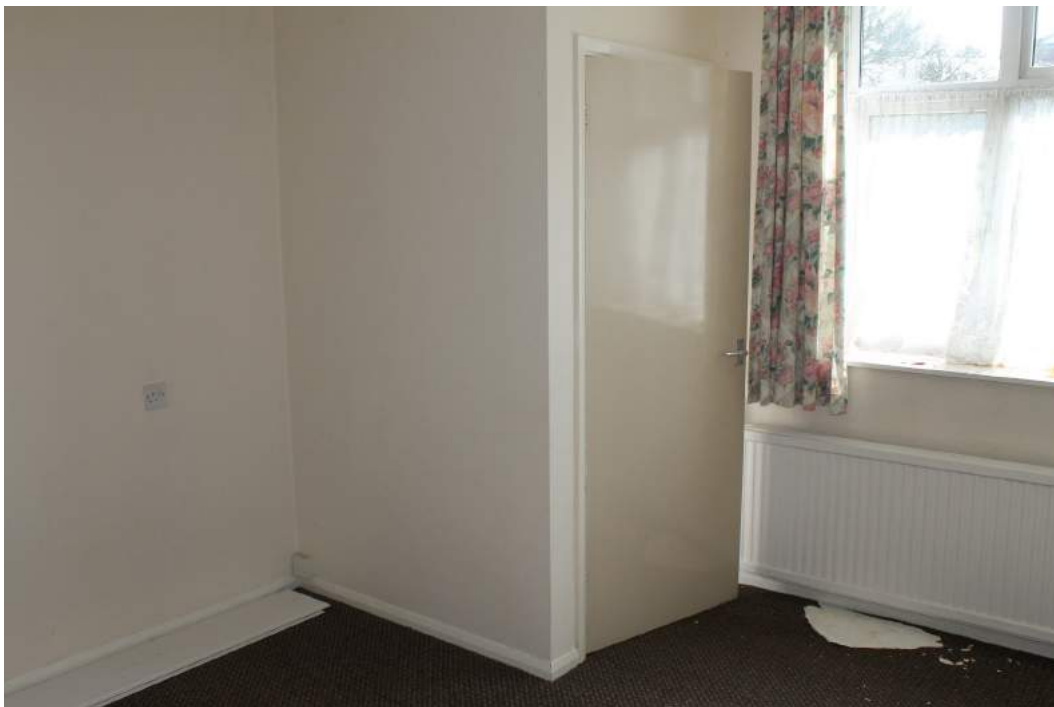
**Photograph 12**

The front door opens into a small entrance lobby, just large enough to accommodate the door, that opens into the bed-sitting room (Photograph 12). This was presumably designed to cut down on draughts for the elderly occupant. In each of the almshouses the original coal-fired hearth in the bed-sitting room has been blocked in and replaced by an electric fire (Photograph 13). The coal-fired hearth was originally the only source of warmth until central heating was installed in the 1970s. To accommodate the hot water tank for the central heating system, cupboards were constructed to one side of the chimney breast. Although not an original feature to the almshouses, Nos.2 & 5 (and presumably all the almshouses at one time) were equipped with intercom systems, linking the residents to the on-site warden (Photograph 14). This is not perhaps an earth-shattering observation until it is noted that the intercom system is by Tunstall Byers, a Doncaster-based company who, in 1966, developed the world's first Warden's Intercommunication Call System. Although the models located in the almshouses are probably later versions it indicates that Winnock's Charity sought to provide the residents with the most up to date care equipment.

Entrance lobby to No.2 Winnocks with replacement internal door - view east.

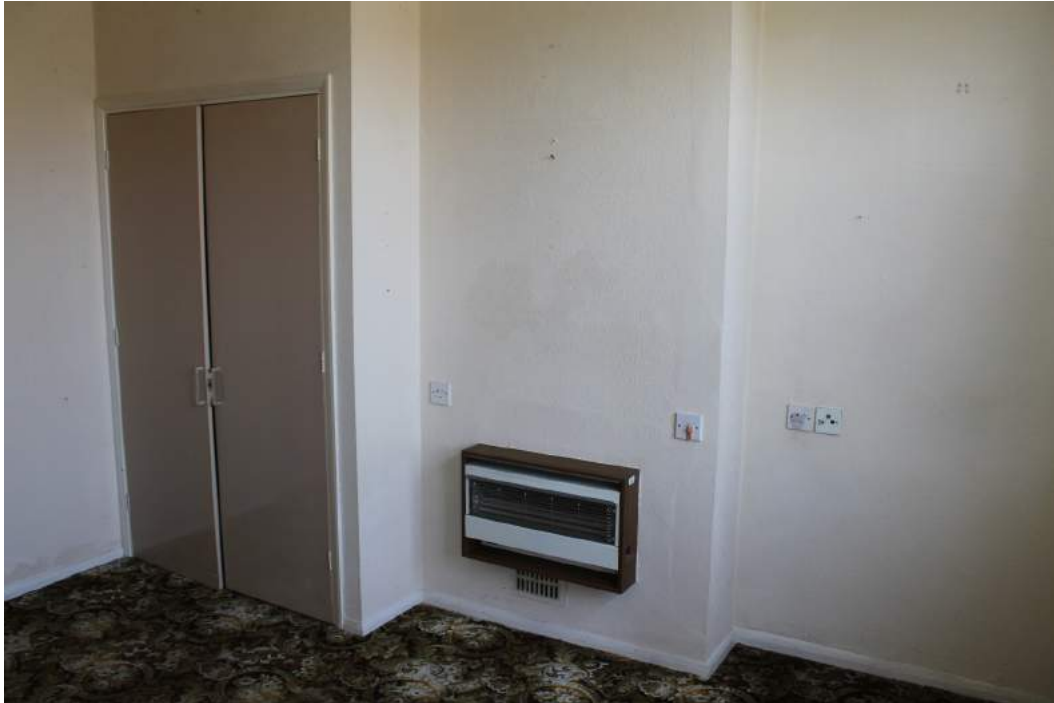
**Photograph 13**

Bed-sitting room of No.5 Winnocks showing blocked in hearth with replacement electric fire and cupboard for central heating system to the left of the chimney breast - view south-west.

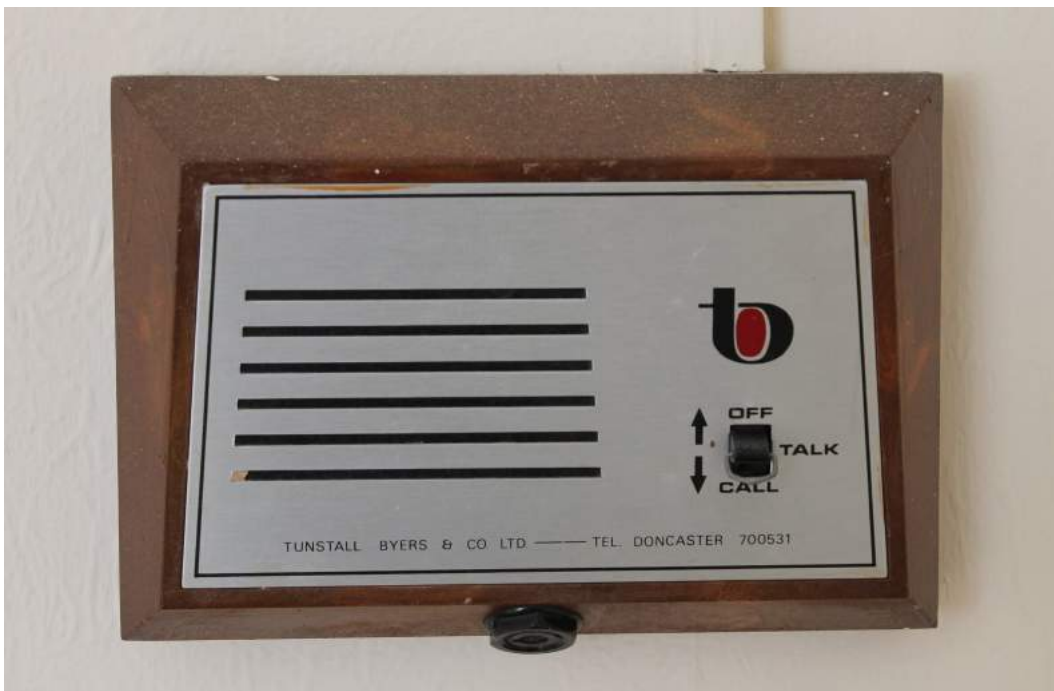
**Photograph 14**

Tunstall Byers & Co. intercom system located in the bed-sitting room of No.2 Winnocks.

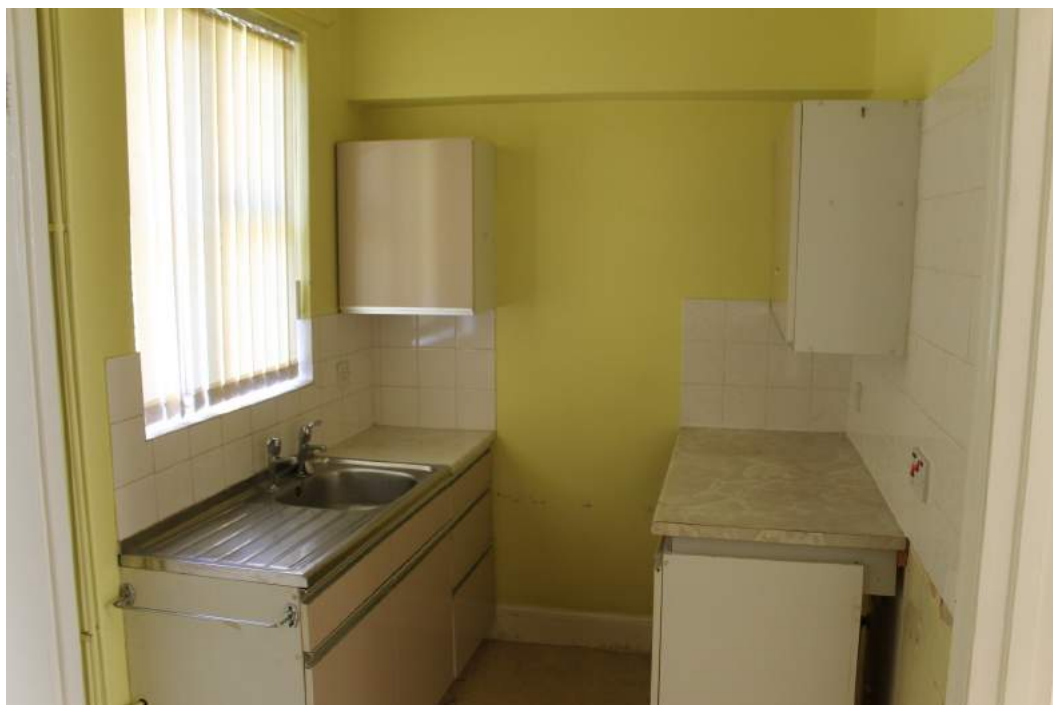
**Photograph 15**  
Kitchen of No.3 Winnocks: the original scullery hearth was in the right-hand corner - view north.

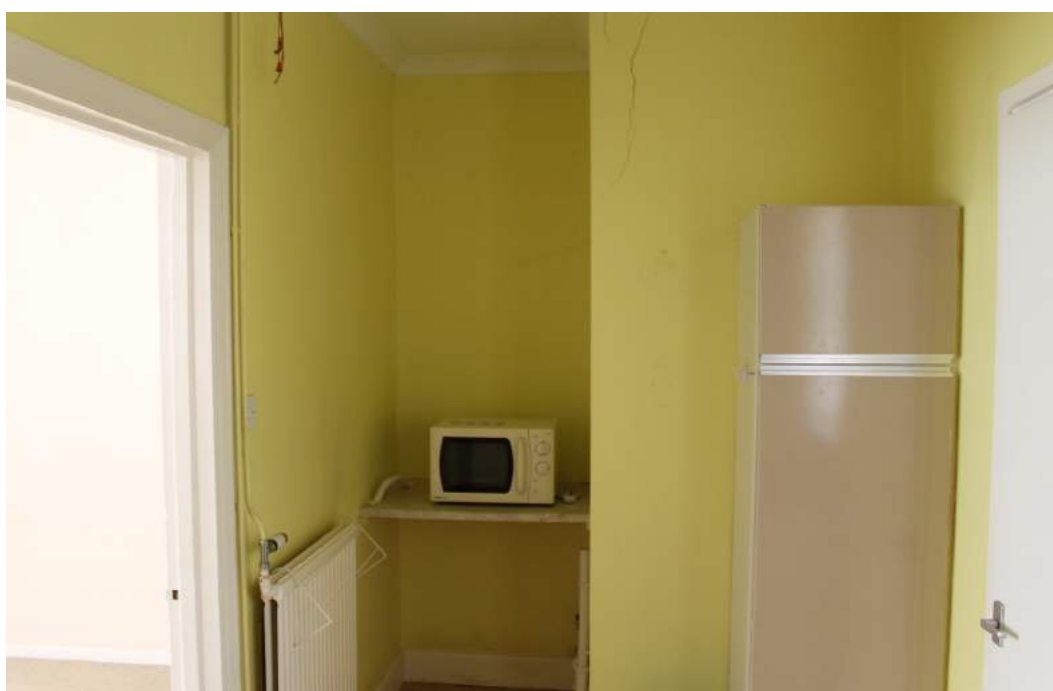
A centrally-located doorway in the rear wall of the bed-sitting room opens onto what was originally the scullery but became the kitchen after the addition of the 1962 bathroom extension (Photograph 15). The scullery hearths have all been removed and the coal stores and pantries converted, the coal stores into additional kitchen space and the pantries into the WC for the 1962 bathroom extension (Photograph 16).

**Photograph 16**  
Kitchen of No.3 Winnocks: the original coal store was located to the left, now a handy nook for a microwave. The pantry has been blocked off from the kitchen and turned into the WC for the 1962 bathroom extension - view south.

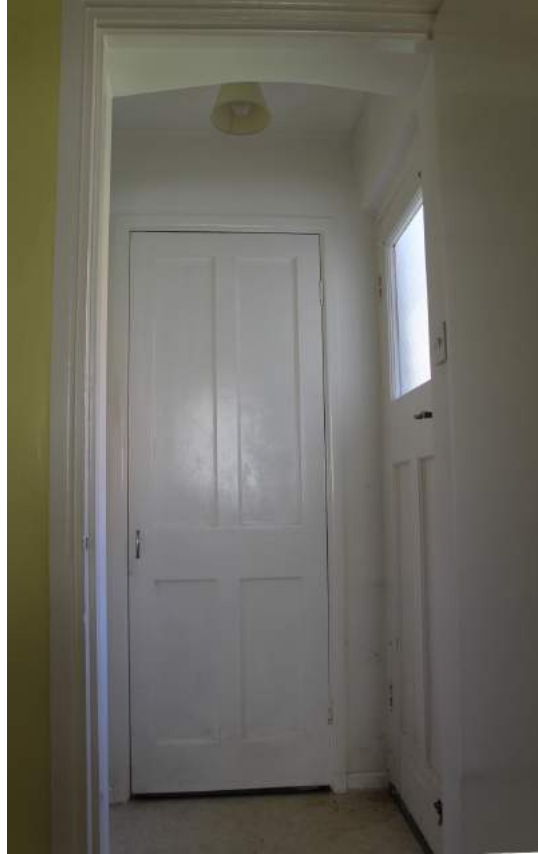
**Photograph 17**

Original rear entrance to No.3 Winnocks, converted to an access to the 1962 bathroom extension with a storage cupboard directly opposite - view west.

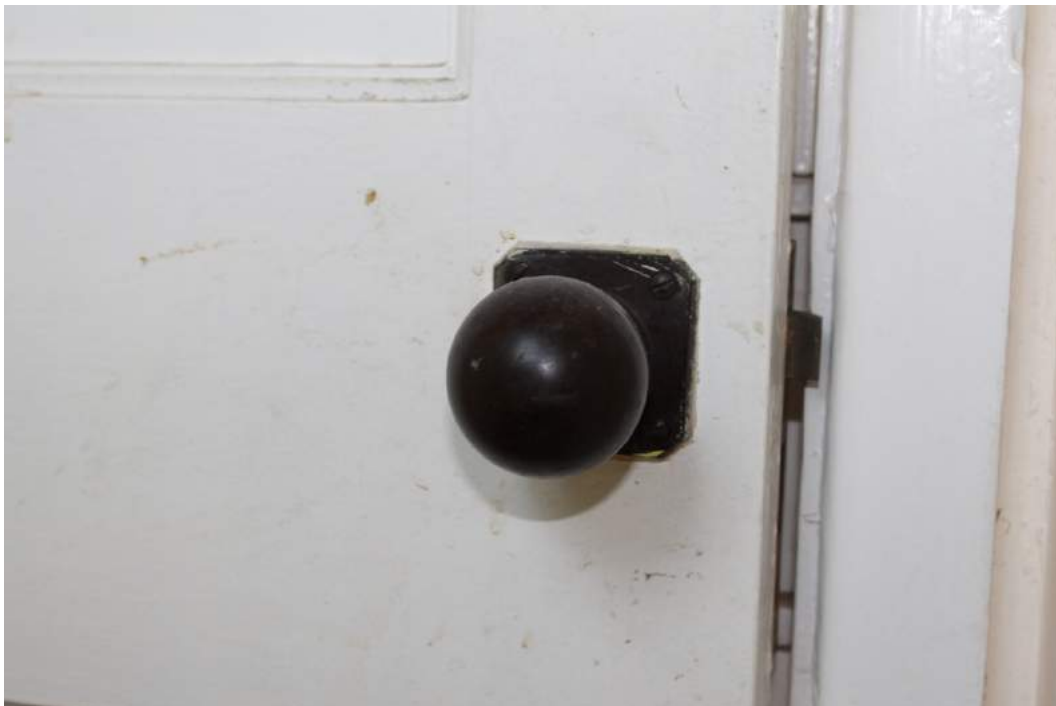
**Photograph 18**

Bakelite doorknob on the exterior of the bathroom door to No.4 Winnocks.

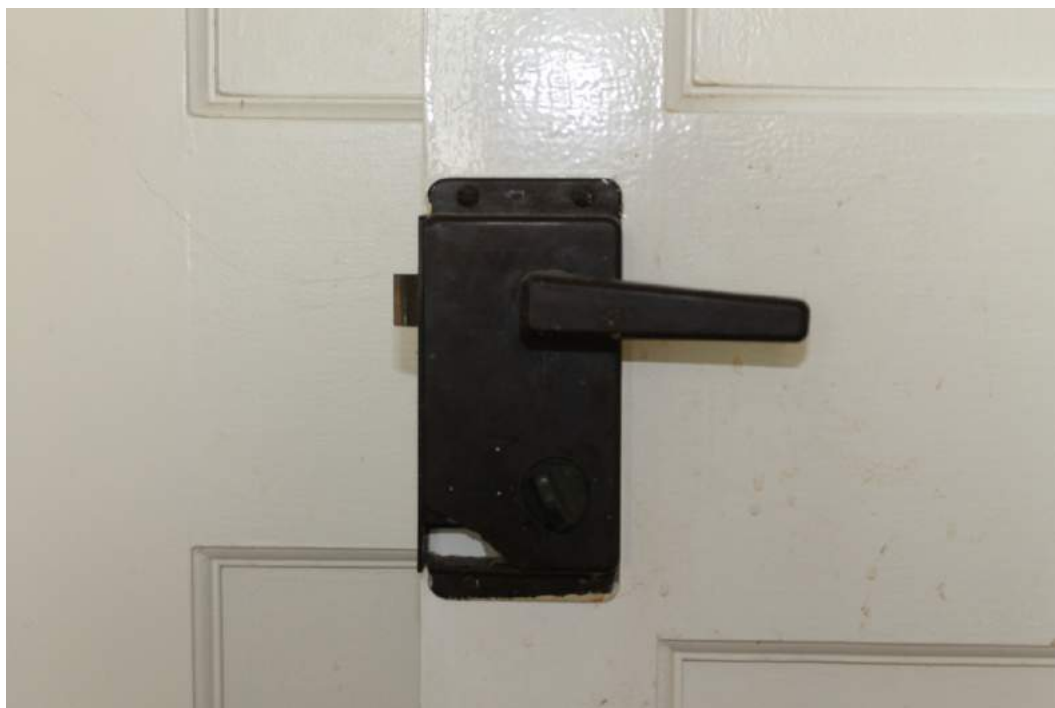
**Photograph 19**  
Bakelite door handle and locking mechanism on the interior of the bathroom door to No.4 Winnocks.

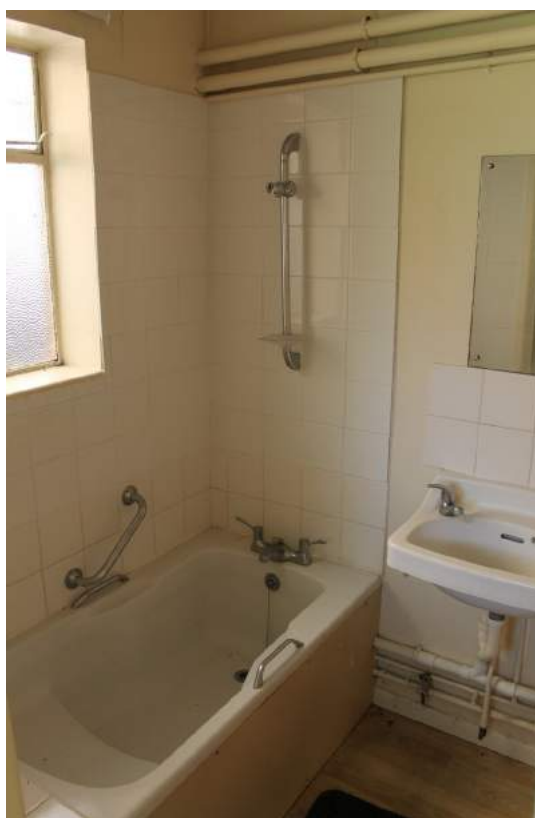
**Photograph 20**  
Bathroom of No.2 Winnocks, probably dating from the 1980s – view north.

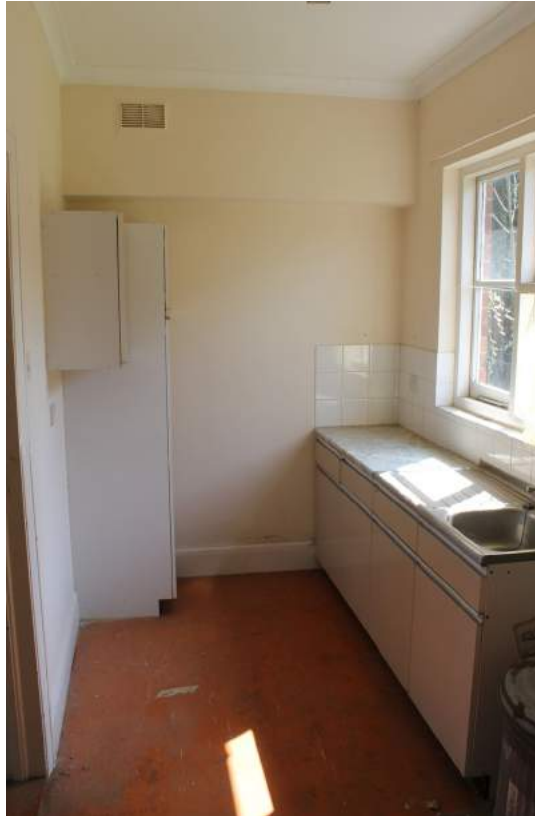
**Photograph 21**  
Kitchen of No.7 Winnocks – view south-east.

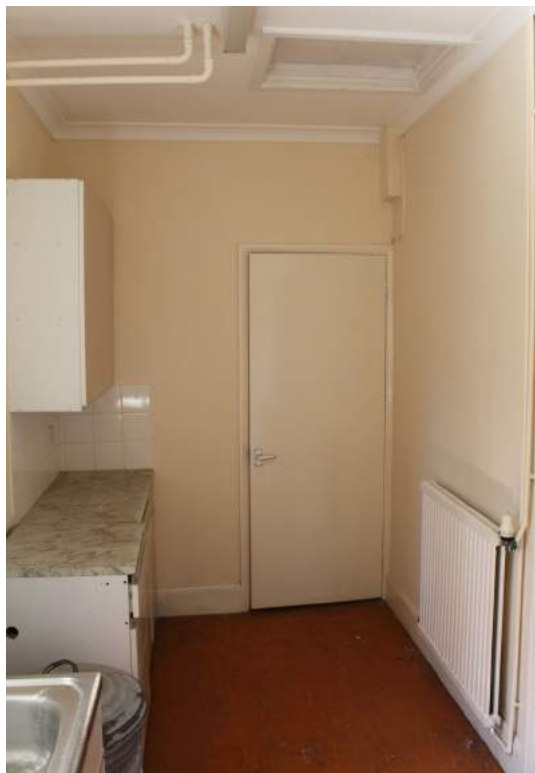
**Photograph 22**  
Former pantry and coal store of No.7 Winnocks, converted to provide an access to the 1962 bathroom extension – view north-west.

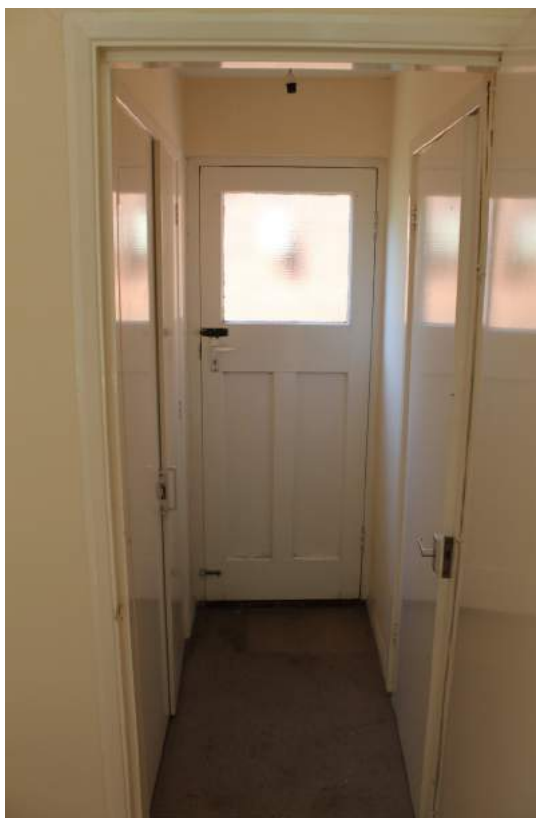
The original plan form of No.7 is identical to the other almshouses, but the inability to locate the 1962 bathroom extension to the rear of the building necessitated changes to the scullery/kitchen layout not present in Nos. 1-6. The conversion of the scullery to the kitchen resulted in a layout predominantly identical to the other almshouses (Photograph 21) but with one major difference. The end of the scullery formerly occupied by the coal store and the pantry has been combined and an opening cut through the rear of the coal store to provide access to the bathroom extension (Photograph 22). A short corridor behind this leads to the new backdoor with the bathroom to the right of the corridor and a double-width storage cupboard on the left (Photograph 23).

**Photograph 23**  
1962 bathroom extension to No.7 Winnocks,  
with storage cupboard to the left and  
bathroom on the right – view north-west.

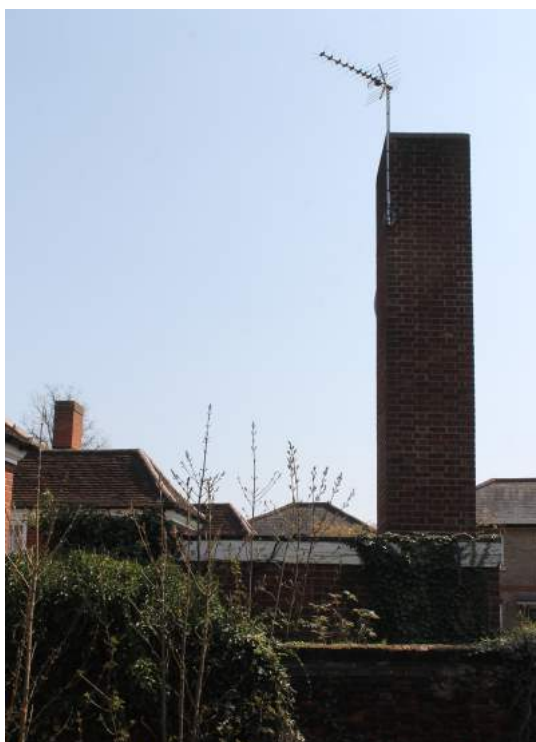
The boiler house is a single-storey, flat-roofed brick structure located to the rear of the main 17th-century range of almshouses. It has a tall, square brick chimney and dates to the early 1970s when the almshouses were provided with oil-fired central heating, generated within this structure (Photograph 24).

**Photograph 24**  
Boiler house to the rear of the 17th-century  
range, dating from the early 1970s – view  
south-east.

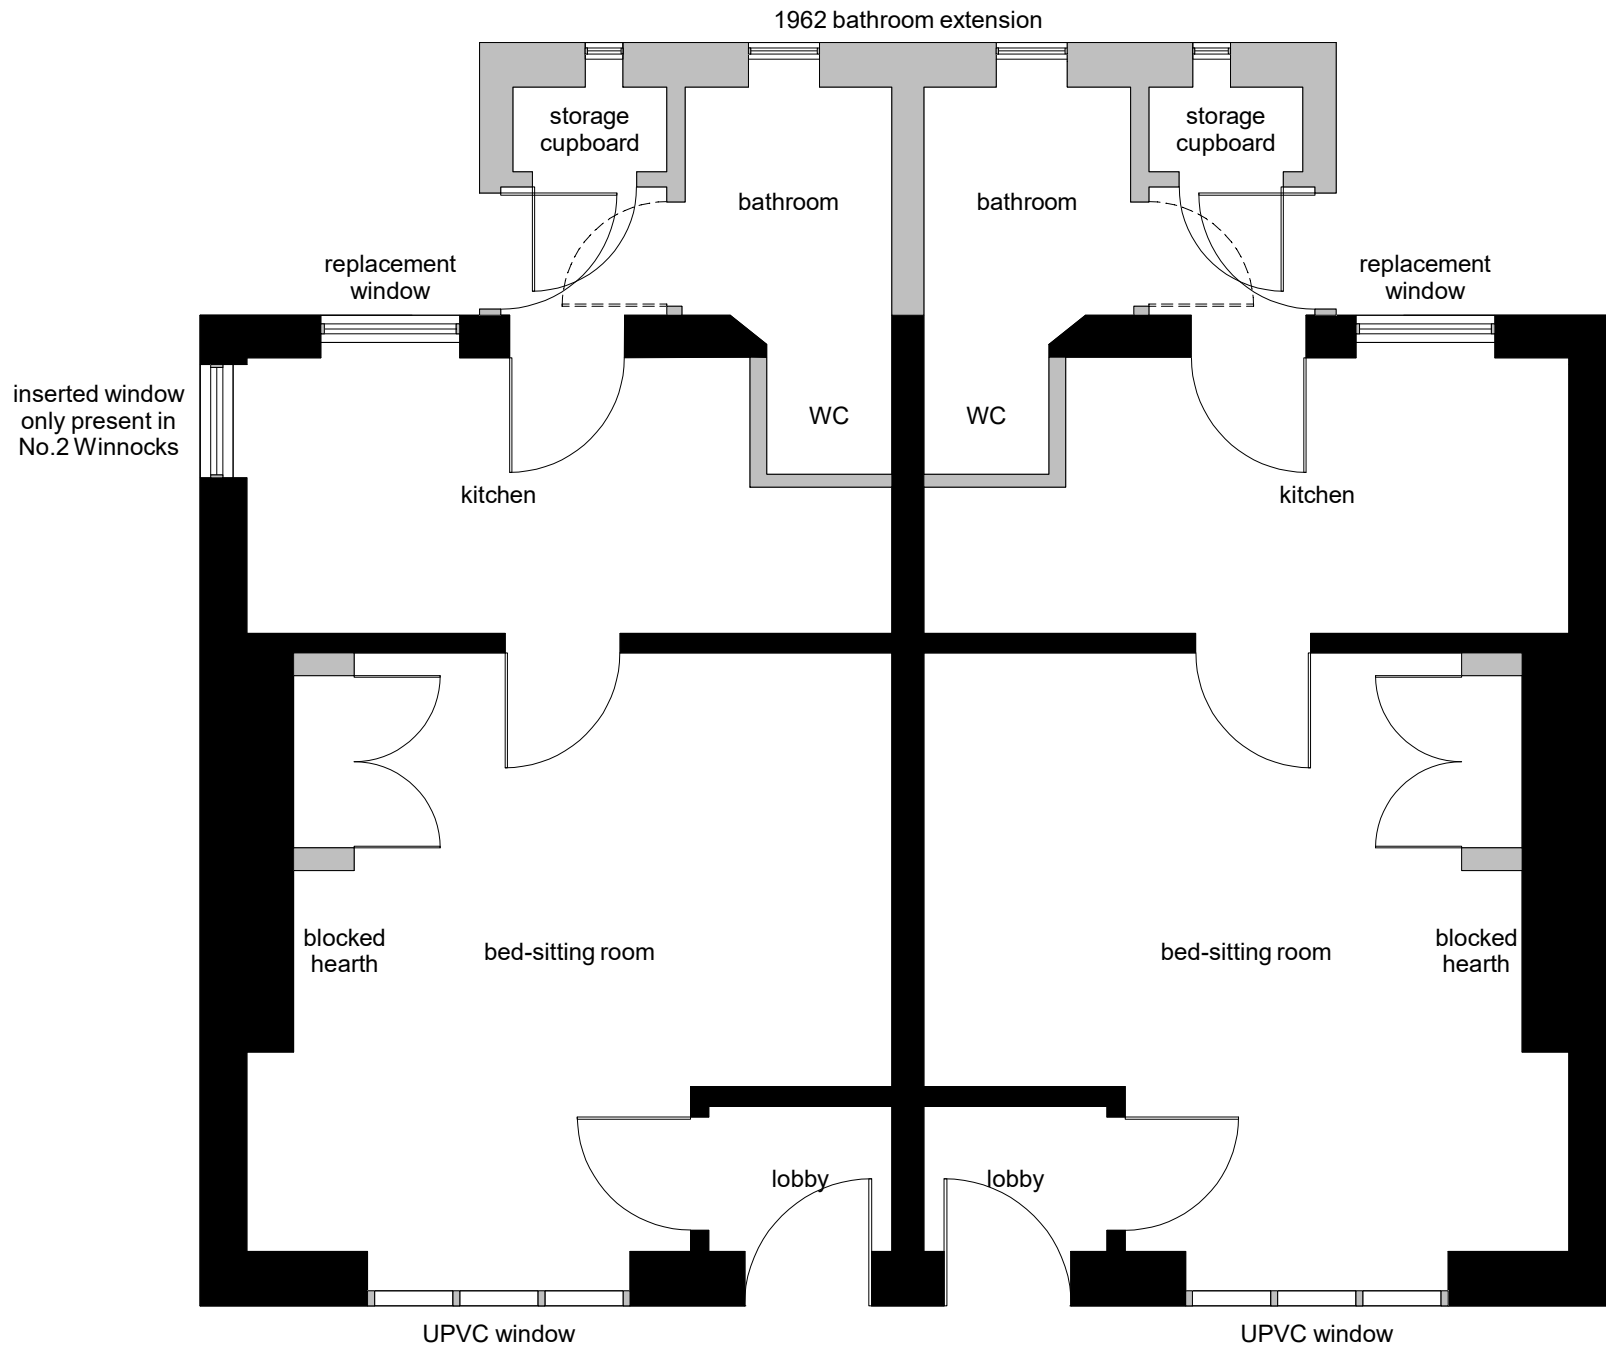
Fig 2 Floor plan of paired almshouses.

The interiors of Nos.1-7 Winnocks have been subject to alteration which has stripped almost all original features from the buildings. Although the plan form remains basically the same (bed-sitting room with kitchen area to the rear) modernisation has required the removal of period features including the windows, fireplaces, coal store and pantry (Figs 2 & 3).
