**Historic building recording at 1-7 Winnocks,  
Military Road, Colchester,  
Essex, CO1 2AF**

**April 2018**

**CAT Report 1277**  
June 2018

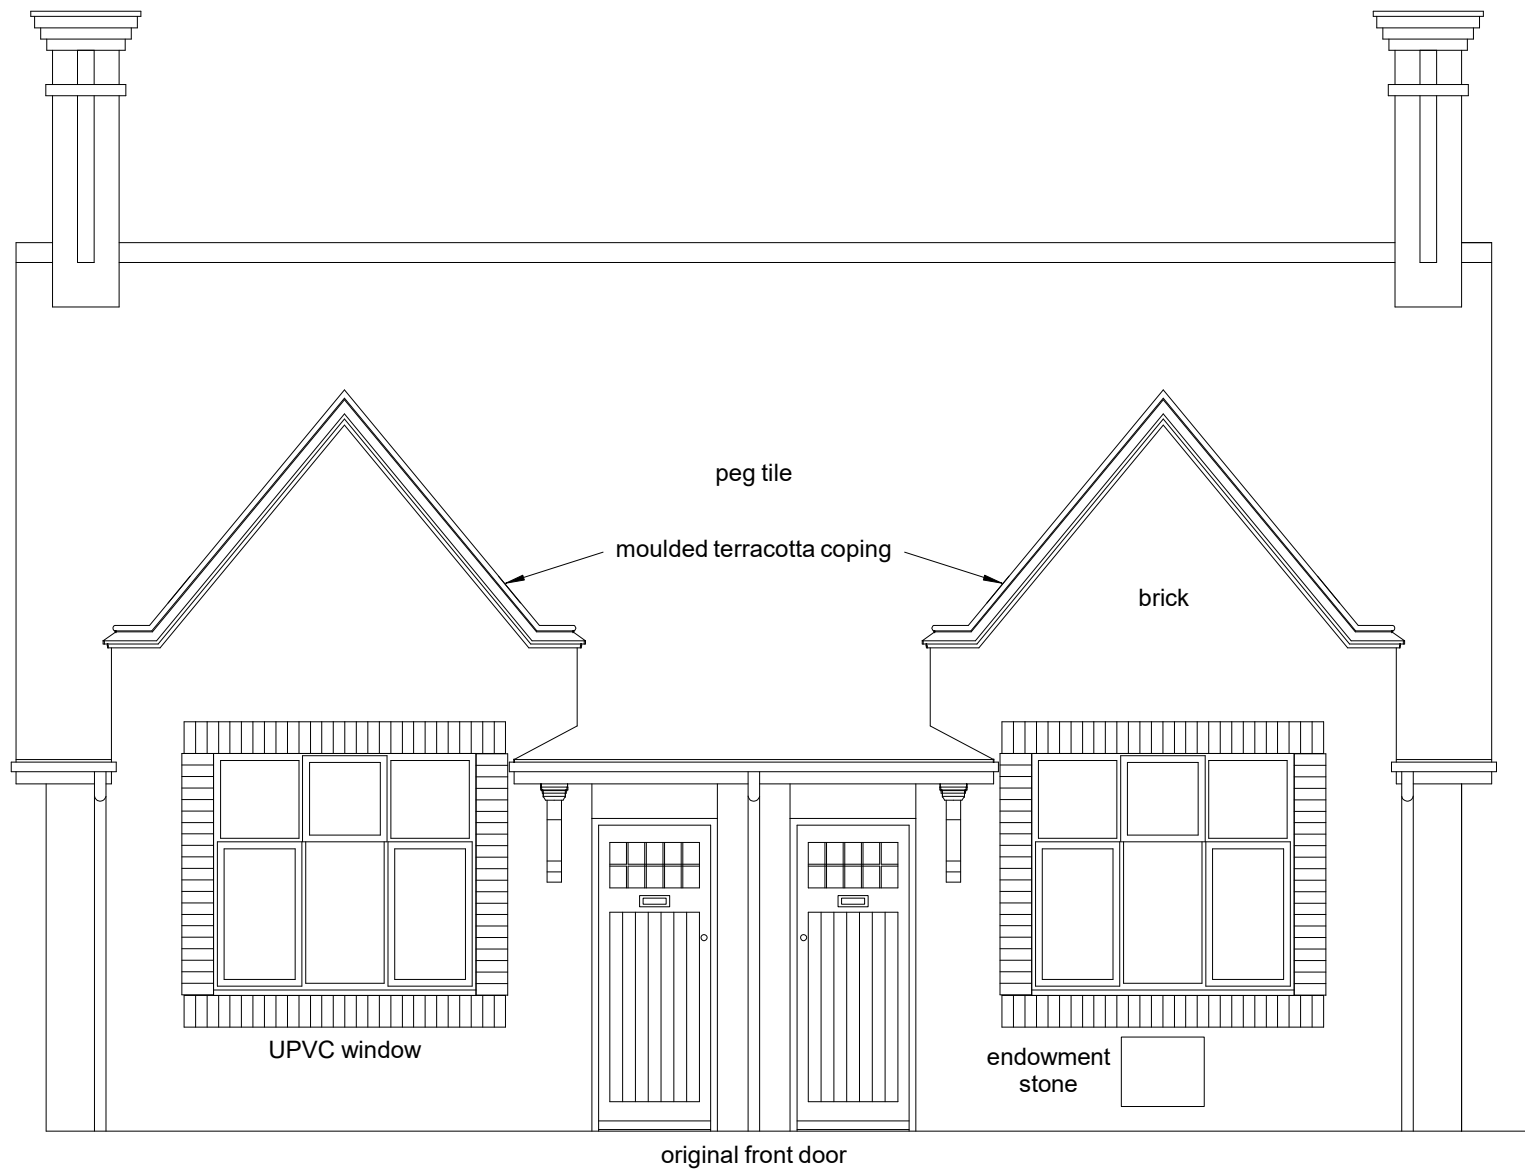
Fig 4 Front elevation of paired almshouses.

Nos.1-7 Winnocks are built of red brick laid in Flemish bond with tiled roofs and a front-facing pointed gable in a simple neo-Tudor style, with Nos.1-2, 3-4 and 5-6 having mirror symmetry (Photograph 3, Fig 4). The flared chimney stacks have a cruciform pattern of raised brickwork on each face in keeping with the neo-Tudor style. The buildings have blue-painted timber doors with leaded lights and black-painted ironmongery which appear to be the original doors illustrated on F Stanley Daniell's plans and elevations (Photograph 4). Below each gable is a large window with a red brick surround (Photograph 5). These windows are UPVC-framed, double-glazed replacements for the original stone transom and mullion windows and the red brick surrounds are part of the modification. The timber brackets that support the roof over each door are painted white as is the remainder of the joinery. Nos.1,3, 5 & 7 have an inscription stone below the window, recording that the almshouses were endowed by George Rose in 1934 (Photograph 2). Apart from the modern windows the front façades remain predominantly unaltered.

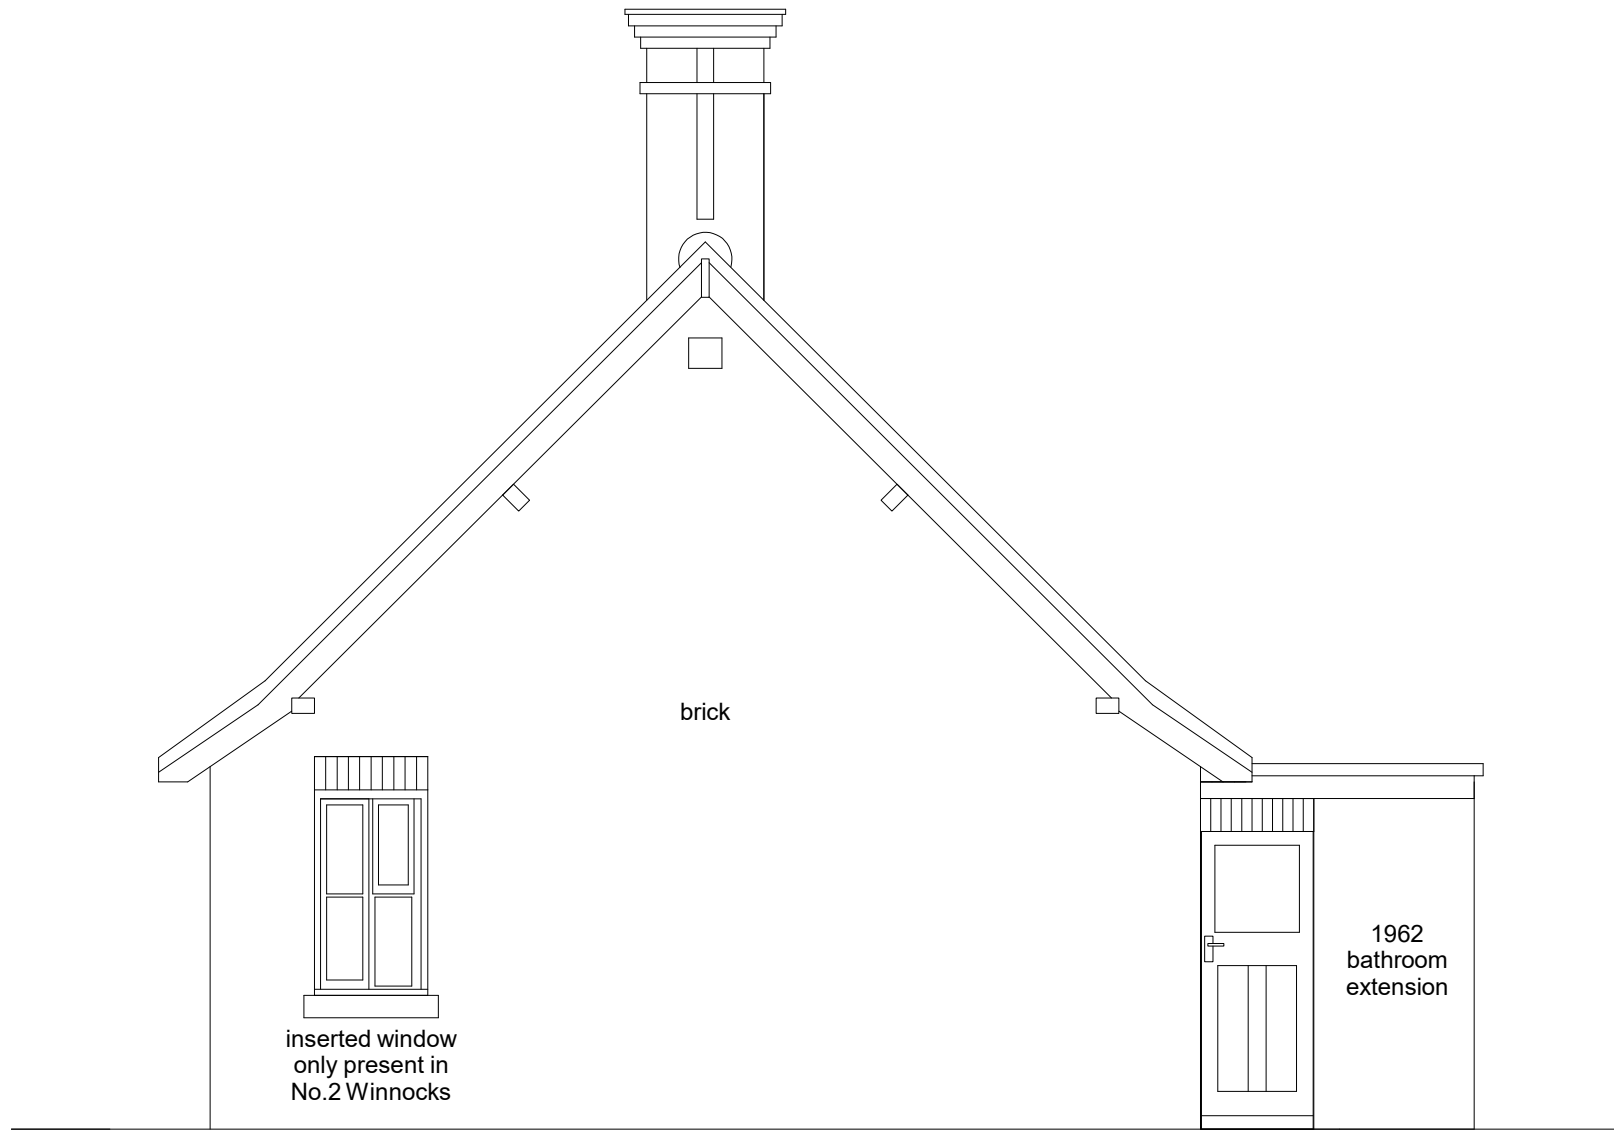
Fig 5 Side elevation of paired almshouses.

The side elevations are unremarkable brickwork with an air brick or pair of air bricks located directly below the apex of the gable. The exception to this is the south-west elevation of No.2 Winnocks (Photograph 6, Fig 5). Here a timbered-framed casement has been inserted.
