# Archaeological excavation on land at the former car park off Ravensdale, Clacton-on-Sea, Essex, CO15 4QH

October 2019

**CAT Report 1488**  
November 2021

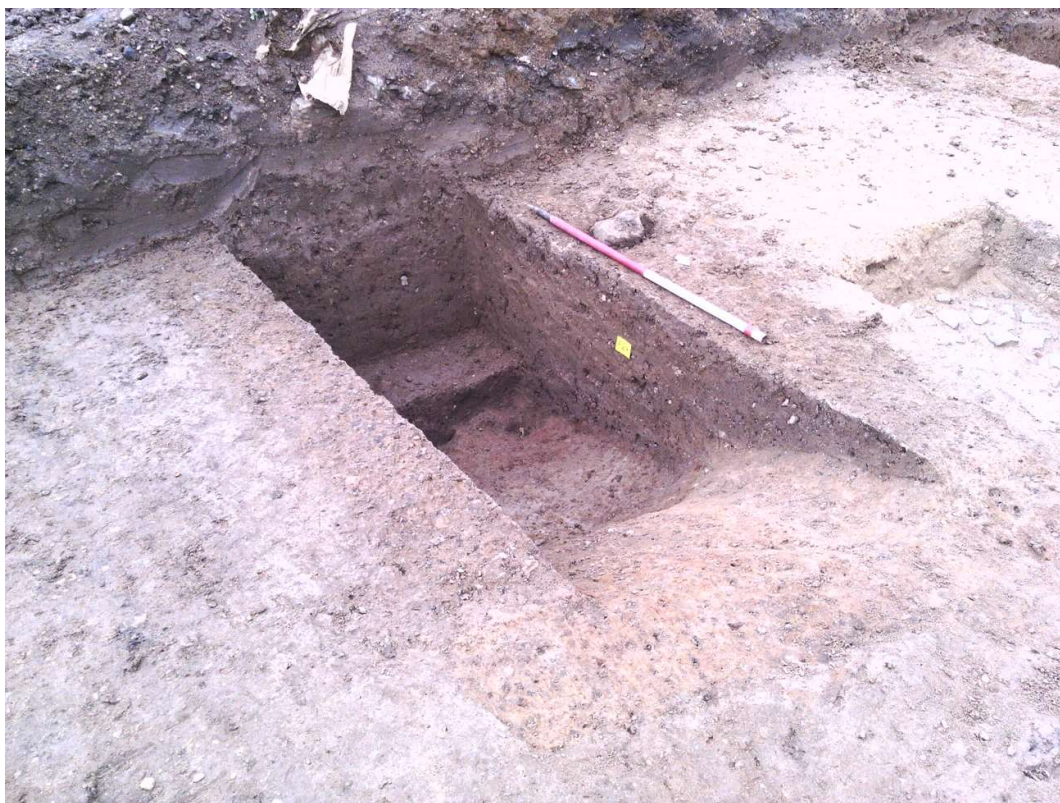
Pit F25 was cut pit F24. Pit F24 also extended beyond the LOE, but its exposed extent was 2.09m wide. The feature was excavated to a depth of 0.71m and then augured for a further 0.2m to its base.

**Photograph 1** Pit F24, looking south-west

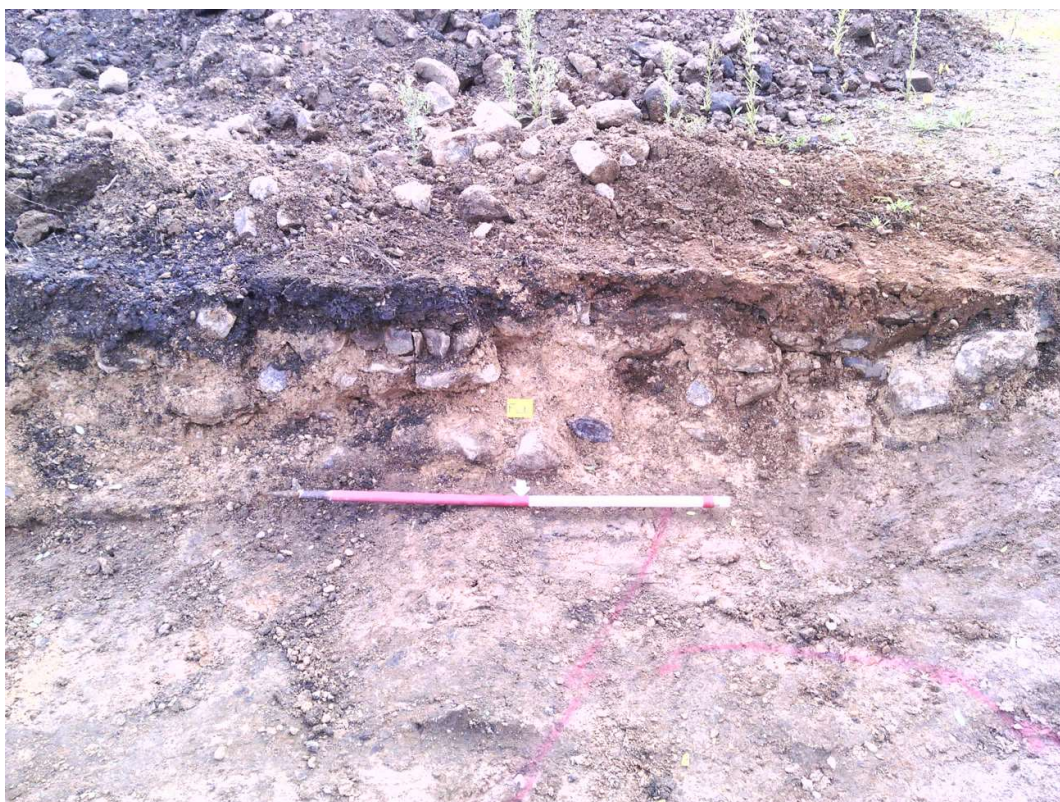
Wall foundation F26 was exposed in profile in the southern LOE, and cut pits F24 and F25. It was constructed from septaria and mortar and lay on an E-W alignment. The LOE was cut back in order to establish the width of the foundation, which was determined to be approximately 1m.

**Photograph 2** Wall foundation F26, looking south

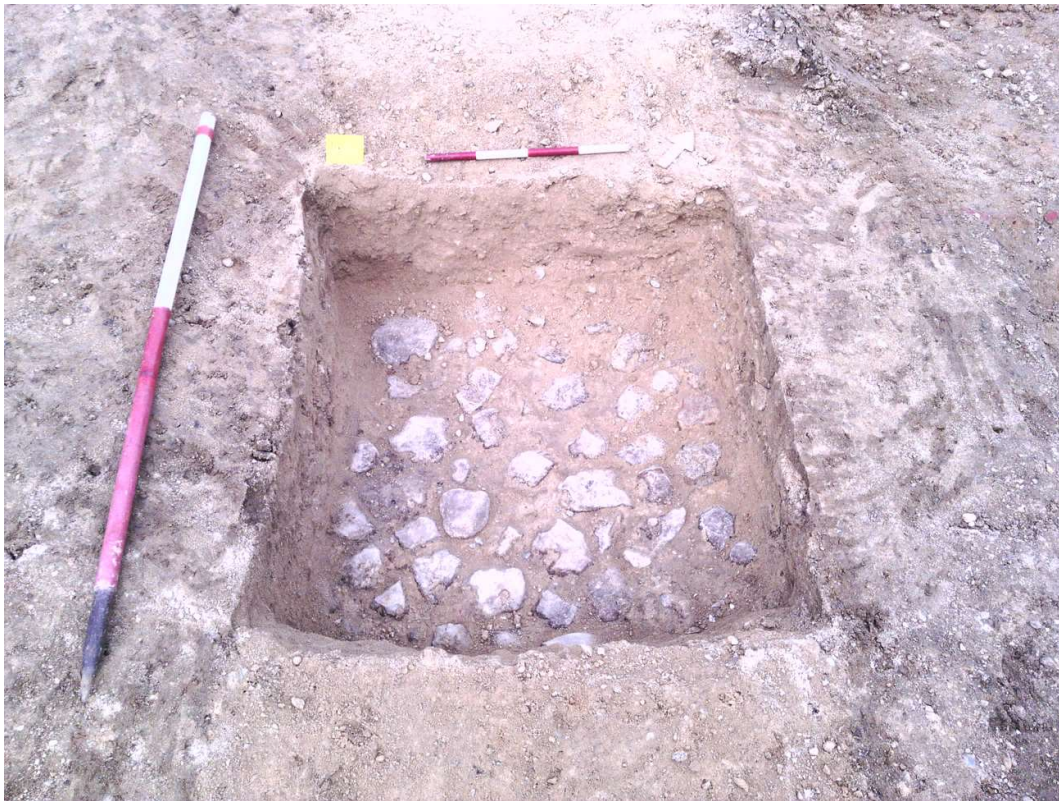
**Photograph 3** Wall foundation F20, looking north-west

Foundation F20 extended north from F26, cutting pit F24, and was cut by a modern service trench. The upper part of the foundation had been robbed-out, and only the base – composed of septaria and mortar – remained. The foundation trench was 0.78m wide and was excavated to a depth of 0.24-0.3m until the base of the foundation was exposed.

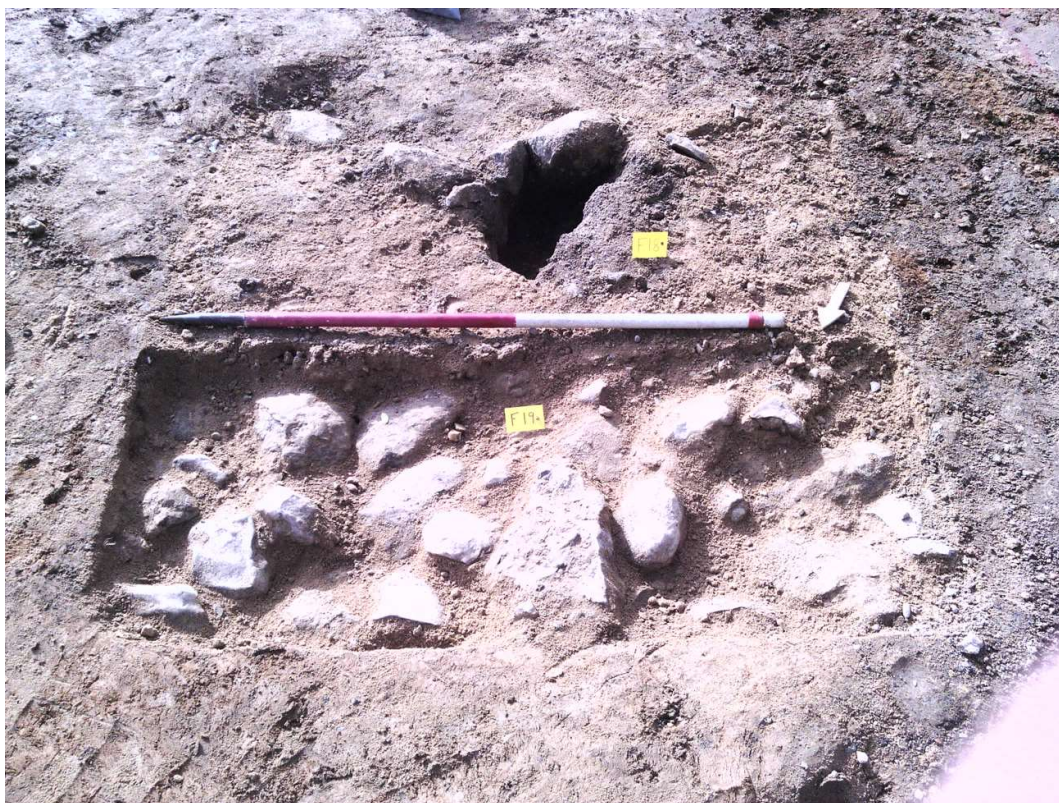
Two foundation pads were also uncovered: F19, on the western side of the excavation area, and F22, on the eastern side. F19 was 1.38m wide and was excavated to a depth of 0.02-0.11m, and F22 was 0.87m wide and was excavated to a depth of 0.11-0.16m to expose the base of the robbed-out foundation trench.

Two medieval or post-medieval post-holes – F15 and F18 – were uncovered in the western half of the excavation area. F15 was 0.39m in diameter and 0.11m deep, and F18 was 0.48m in diameter and 0.3m deep. The two features could only be dated broadly to the medieval or post-medieval periods, although F18 cut F19, indicating that it post-dated the demolition of this structure. It is possible that the two features formed part of a posted structure.

**Photograph 4** Post-hole F18 and foundation pad F19, looking south south-east

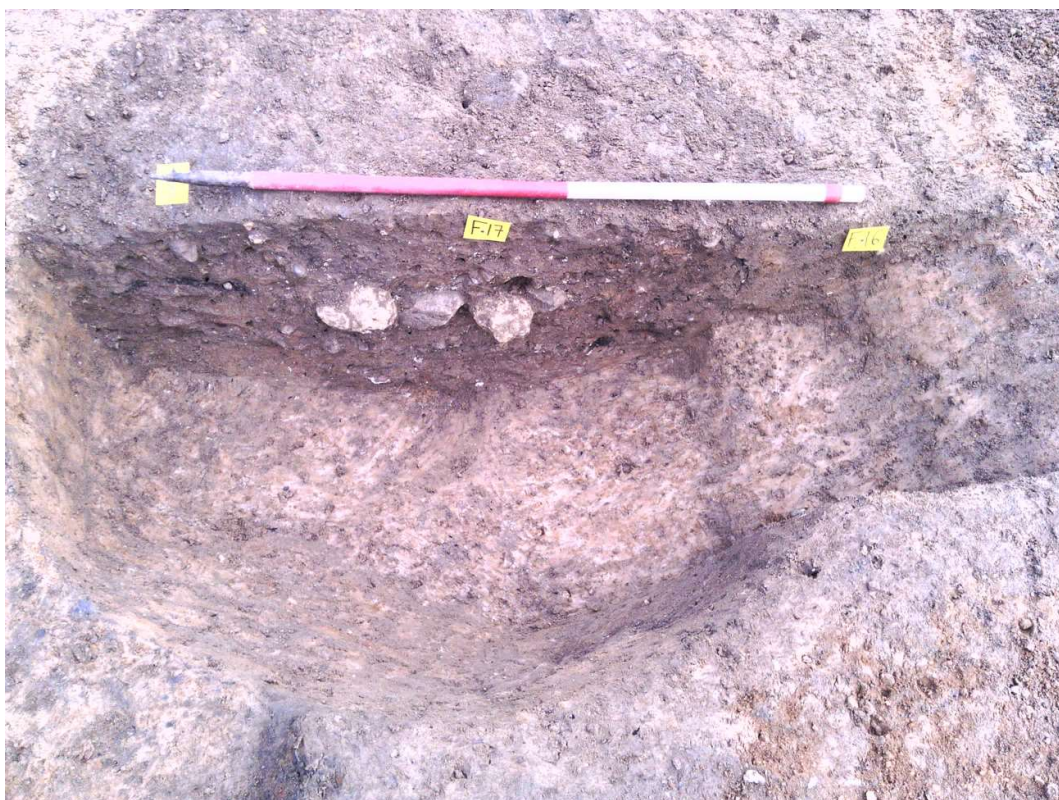
A further pit, F17, was uncovered within the western half of the excavation area. It was 1.23m wide and 0.52m deep, and cut undated ditch F16. It yielded a fragment of peg-tile as well as twelve sherds of 11th-13th century pottery, indicating that it was of mid 13th-century date at the earliest. It is possible, therefore, that it is the product of a separate, subsequent phase of activity at the site during this period.

**Photograph 5** Ditch F16 sx2 and pit F17, looking north

Two undated features were also excavated. Ditch F16 was 1.58m wide and 0.41m deep. It extended on a north/south alignment through the western half of the excavation area, turning east at the southern LOE and terminating. While no dating evidence was recovered, it was cut by 11th-13th century pit F17 and 12th-14th century pit F25, so is earlier than these features.

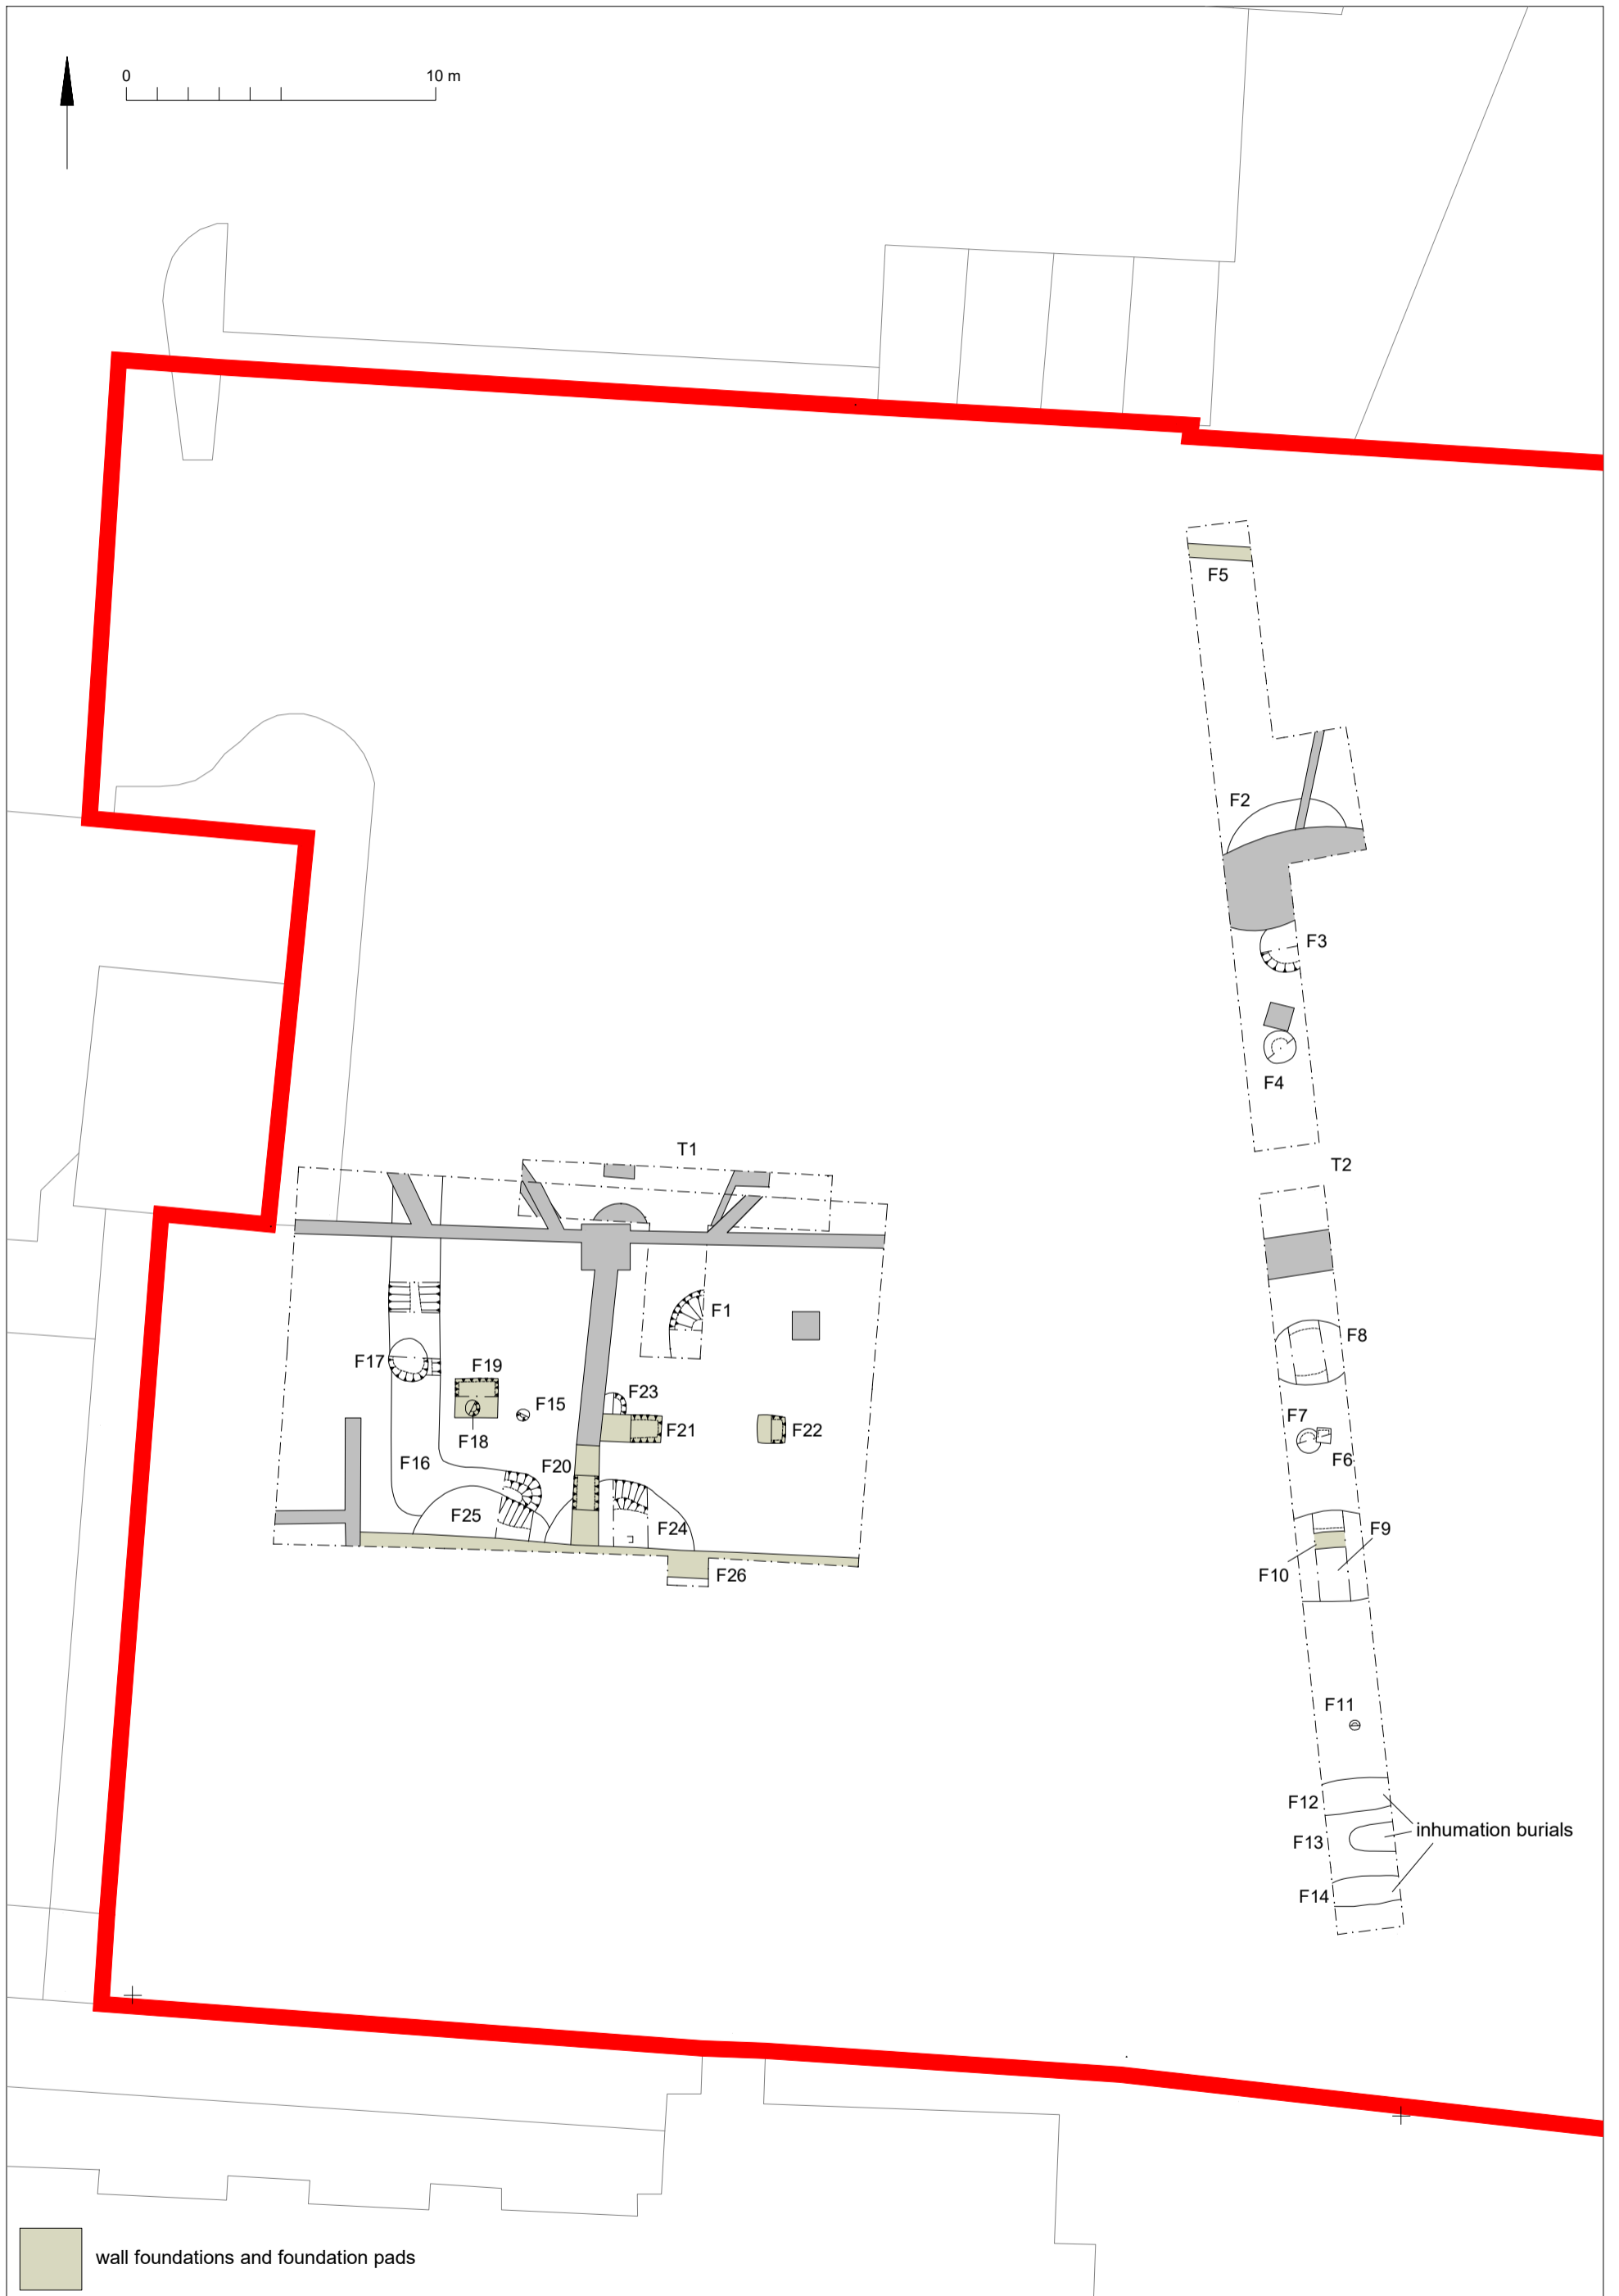
Fig 3 Results of the 2018 evaluation and 2019 excavation

This excavation follows on from an evaluation conducted within the footprint of the proposed new buildings in 2018. Two evaluation trenches were excavated. In Trench T1 to the west, there was considerable disturbance caused by modern service trenches but an undated pit was excavated. Trench T2 to the east produced some significant remains. Three burials, probably of medieval date, were clustered together at the southern end of the trench. As per the WSI, the burials were left in situ. To the north of the burials was an undated east-west aligned wall foundation, 0.47m wide, constructed out of septaria blocks set into mortar (similar to that identified in 2004). At the northern end of the trench was another east-west wall foundation, constructed of unfrosted bricks and of post-medieval date. It was associated with a ?post-medieval cobbled yard surface. Two post-medieval pits, a modern pit/posthole, two undated pits and a tree-throw/natural feature were also present. The burials indicate that the graveyard for the church of St John the Baptist previously extended further to the north and that burials are still present underneath the car park. The wall foundations and yard surface are all likely to be associated with Great Clacton Hall and the pits, predominantly post-medieval date, are likely the product of domestic activity linked to the Hall (CAT Report 1338). All feature, layer and finds numbers used during the current excavation follow on from numbers assigned to contexts recorded during this evaluation.
