**Archaeological investigation at
St Nicholas' Church,
Copt Hall Lane,
Little Wigborough, Essex**

January 2019

CAT Report 1375
February 2019

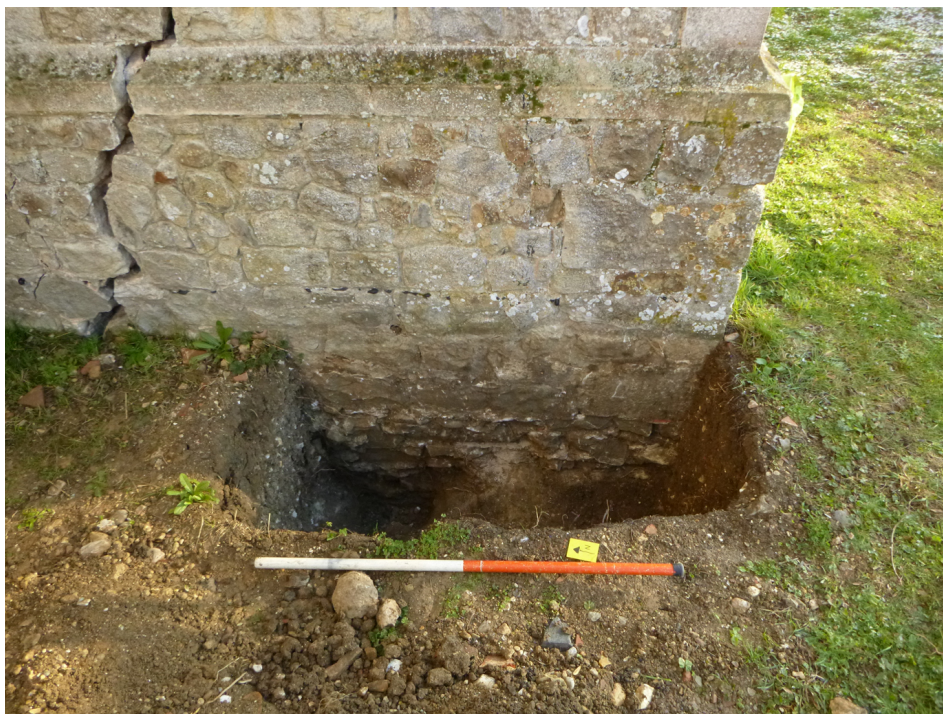
The exposed west nave and buttress wall foundation (F15) consisted of much the same material as observed in the 2005 (Fig 3). The foundations were a uniform vertical face of Kentish Ragstone bonded in lime mortar. Two small fragments of peg-tile were also observed within the foundations fabric. The full depth of the foundation was not reached in the test-pit, but it is known to be 1.35m deep based on previous investigation (CAT Report 350).

Photograph 1 Test-pit showing foundation of nave and south-west buttress. Substantial crack in wall visible to left. Photograph taken facing east.

As postulated in 2005, these appear to be the original 15th-century footings of the church.

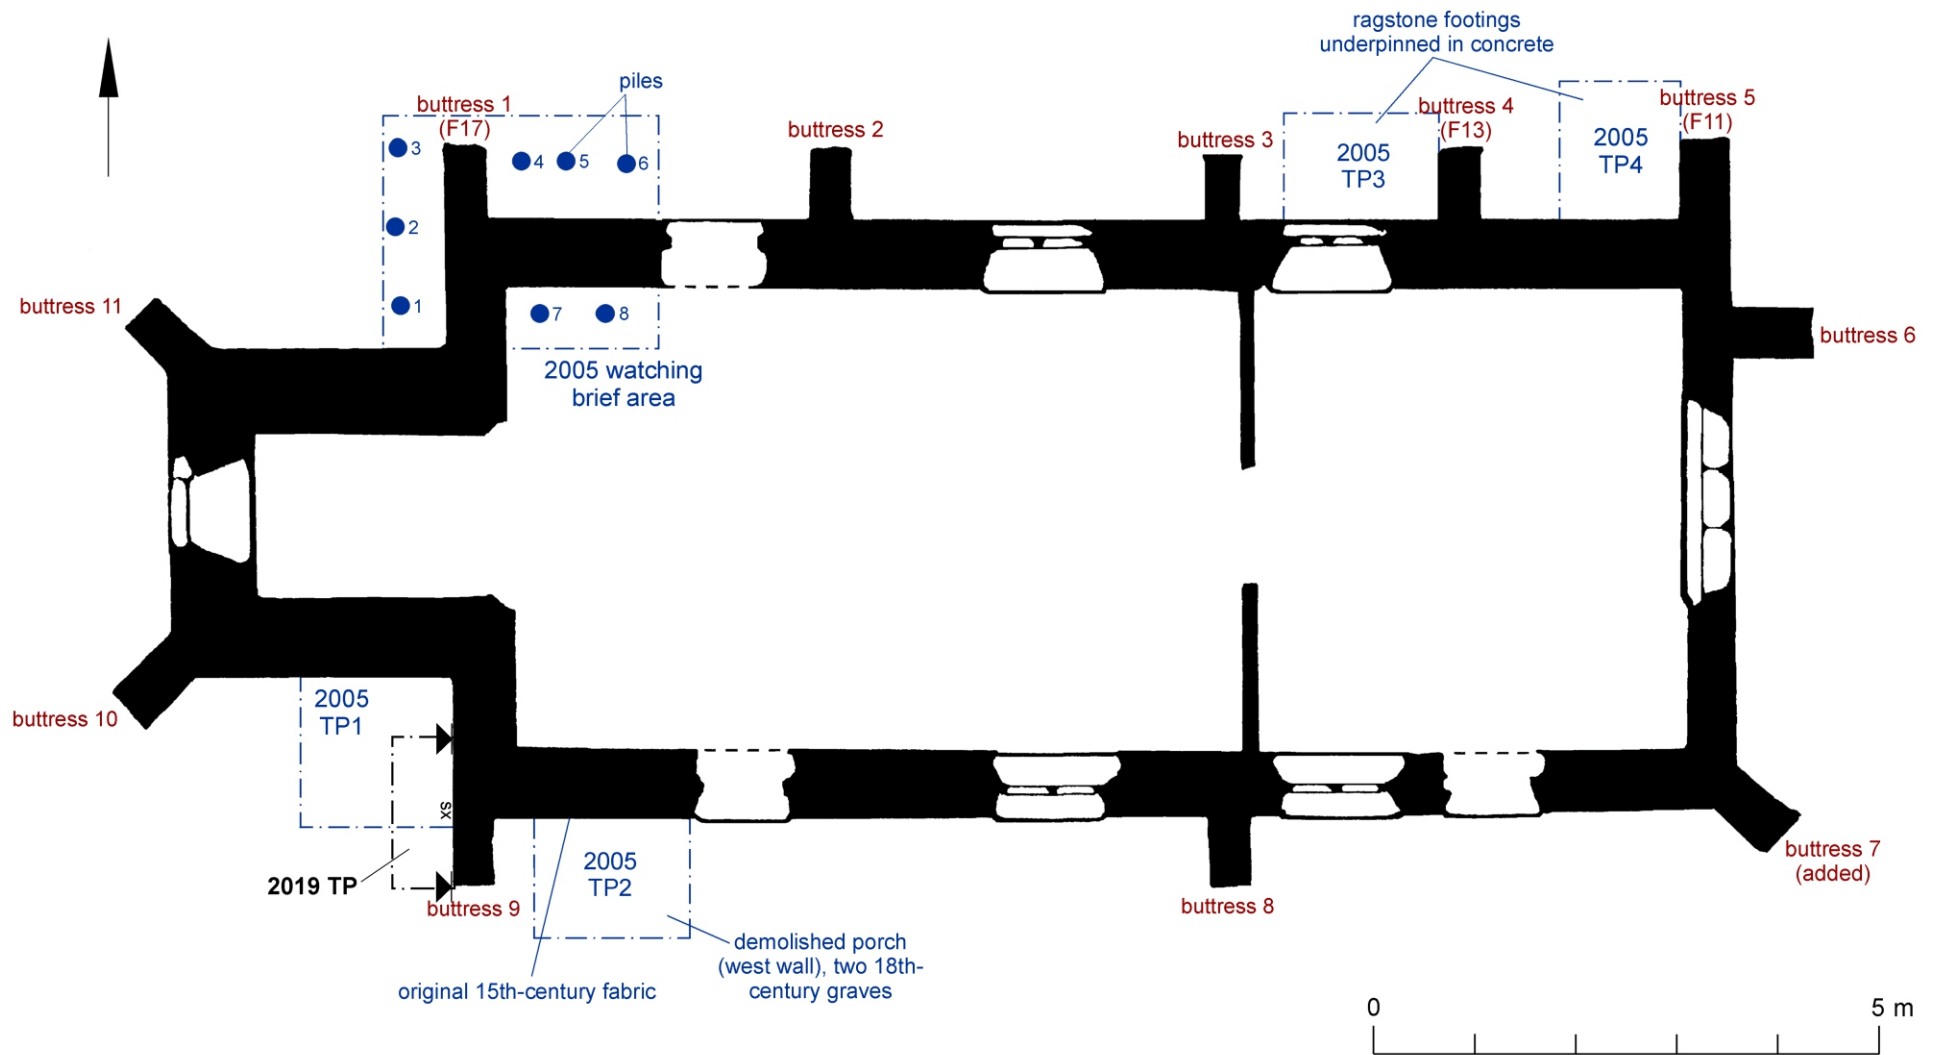
Fig 2 Plan of the church showing test-pit location and areas investigated in 2005 (in blue).

The single test-pit was located against the exterior western wall of the nave, adjacent to the west of south-west buttress (Fig 2). It measured 1.5 x 0.6m in size and was excavated to a maximum depth of 1.1 below the current ground level. It partially overlapped with the position of TP1 from CAT Report 350 (Fig 2).
