An archaeological watching brief at 57 Church Street, Harwich, Essex August 2006

CAT project ref.: 06/8g Colchester Museums accession code: COLEM 2006.110 NGR: TM 2606 3264

CAT Report 389 October 2006

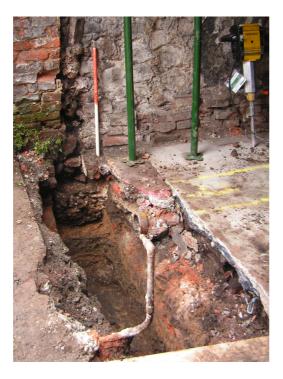
Plate 1 Footings trench at the rear of the building, view south-east.

At the rear of the building, part of the southern wall was exposed and seen to be of a septaria stone construction, partly patched with modern brick. The excavation of a 1m-deep trench for new footings gave an opportunity to expose and record the foundation of this stone wall. Where the wall and the foundation met, there was a facing of modern and post-medieval brick. The foundation was seen to be 750mm deep and its upper part consisted of a large septaria block faced by peg-tile and cobbles. This block had been set into a white lime mortar containing septaria chips. Underlying this was a dirty clay with septaria chips. At 750mm below ground-level, a clean yellow brown clay was observed. This appeared to be part of the foundation because, although it underlaid the septaria chips, it also faced them. The yellow clay sealed a dirty grey clay with stones and charcoal, starting at 850mm below ground-level. This deposit was clearly not natural clay and may have been a previous occupation level, pre-dating the existing building. Unfortunately there was no dating evidence from this layer.

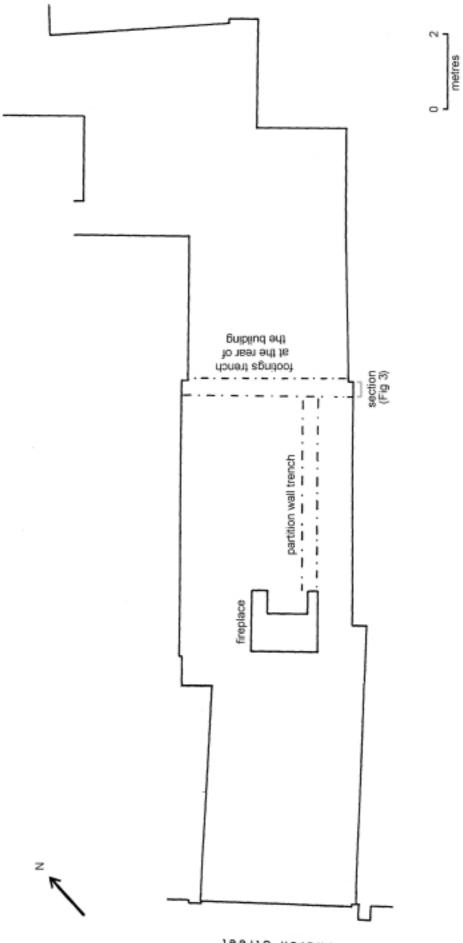
The watching brief was carried out in response to planning permission which was granted to erect an extension at the rear of the existing building. The extension was built on a raft foundation which involved a ground-level reduction. Two visits were made by Stephen Benfield of CAT to carry out the watching brief on two footings trenches. One was dug at the rear (east) of the existing building and a second footings trench for a partition wall was dug inside the building. However, the second trench was shallow (570mm deep) and did not reveal anything of archaeological significance.

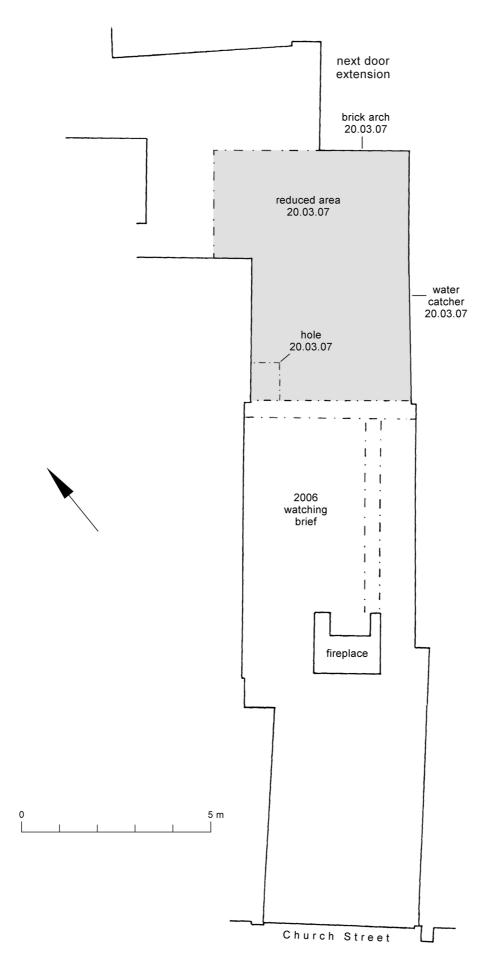
Fig 1 Ground plan showing trenches monitored in 2006 and area monitored March 2007.

On the 20th of March 2007 I was called out to monitor the second phase of work at the rear of 57 Church Street, Harwich. Following on from the internal footings that were dug and monitored last August (CAT report 389), they had reduced the ground level in the yard by 400mm -500mm. The ground was somewhat trampled by the time I got there but they seemed to have got down to a dirty clay layer. I observed a number of unfrogged post-medeval bricks and peg-tiles lying on the reduced ground surface as well as a small amount of pottery. The two sherds retrieved were 16th-17th century post-medieval red earthenware (fabric 40, Cotter 2000; Andrew, Milton and Walker 1990, 86). The finds have now been discarded. The ground reduction had exposed the brick foundations of the surrounding buildings and boundary walls.

In the south-west corner of the yard a small hole was dug to expose a drain. This was approximately 400mm deep i.e. the bottom of the hole was 800mm below the former ground level. Possible occupation layers and make up layers were seen in the section of the hole as follows; 40mm of yellow brown clay overlaid 100mm of greyish brown clay with flecks of charcoal and mortar. In turn this sealed 260mm of yellow brown clay containing red patches and daub (presumably from burning). Natural ground was not reached but this was to be expected as excavations elsewhere on Church Street have found natural to be 1.8m below ground level (Andrews et al, 1990, 64). Unfortunately there was no datable material such as pottery from any of the layers at no 57 Church Street. However a comparison with the other sites along Church Street where archaeological levels have been recorded may give pointers for dating. From 1.8m below ground a succession of occupation layers divided by thick layers of make up material dating from the 13th century to the present day have been recorded (Andrews

A modern-looking square brick rainback/cistern for catching rainwater was seen on the south-east side of the yard, next to the boundary wall. This had been partly machined away and what remained was filled in with brick rubble.

On the north-east side of the yard, the ground reduction had exposed the head of brick arch. The modern extension to the adjacent property (on Kings Head Street) had been built over it. With such a small area exposed it was not possible to see what the arch was for. It seems to be in the wrong place for a cellar to either to 57 Church Street or the property on Kings Head Street, being in the middle of the two properties. Another rainback seems probable and a brick vaulted parallel has been recorded at 50 Church Street (Andrews at al 1990, 69). Alternatively it could be a brick well that had been capped off with a domed vault. Something similar was recorded at the Methodist Church site on Church Street (Andrews et al, 1990, 69).

The attached plan shows the areas I am referring to. I hope this will do as a report but if you would like me to write a proper report I will be happy to do so.
