**An archaeological watching brief at  
St Michael's Church, Kirby-le-Soken, Essex  
July and October 2007**

**report prepared by  
Kate Orr**

**commissioned by  
the Morton Partnership  
on behalf of  
St Michael's Church PCC**

**CAT Report 441**

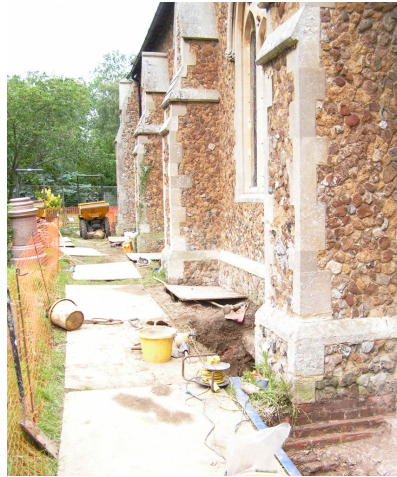
Plate 1 (front cover) the underpinning along the south aisle of St Michael's Church, view WNW.

- 5.1** The south aisle wall was underpinned by contractors hand-digging 21 rectangular pits (or 'pins') in a staggered fashion all the way along the exterior which were then filled with concrete. These pits were dug to a depth of 2.5m below ground-level and were wide enough to extend underneath the aisle foundations. By this method, a continuous strip foundation was achieved (see Fig 2).

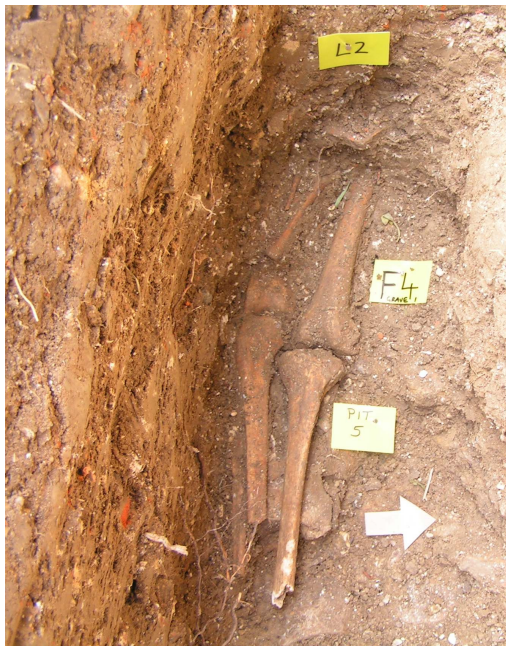
Plate 2: burial F4, view west.

One articulated skeleton was found here, consisting of leg bones (F4). The contractors had already picked up some of the foot bones. The head end would have been to the east and was outside the reach of the pit. The skull and another long bone were found while digging the adjacent pit to the west. Another piece of skull and an arm bone, probably of another individual, were found above the leg bones. The skeleton was encountered at 780mm below ground-level. It appeared to be lying on top of lumps of septaria which seemed to belong to the 19th-century rubble foundation F3. If so, then the burial post-dates the rubble foundation and therefore is post-1833. Peg-tile was the only datable find from the burial but this was in use from c AD 1200 to the present day.

Two articulated skeletons were exposed. The first burial (F4) was 780mm below ground-level and appeared to be cutting the rubble foundation (F3) which is 19th century. It is possible that F4 could be a post-1833 burial. The second skeleton (F8) was much lower down at 2m below ground-level and was overlaid by the rubble

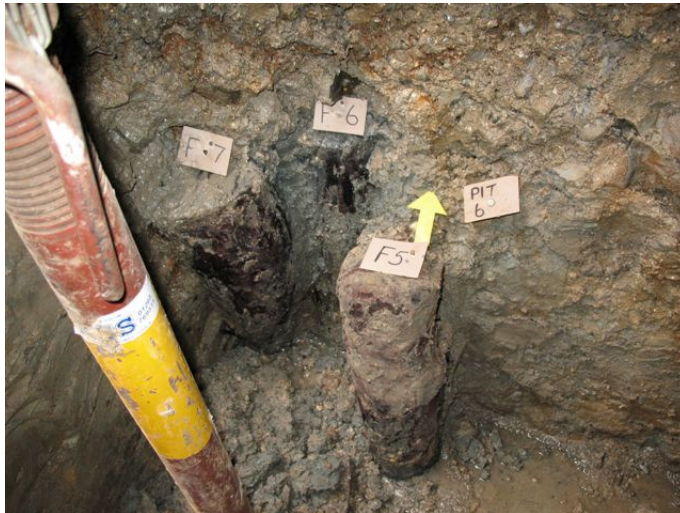
Plate 3: wooden piles F5, F6 and F7, view north-west.

The pit dug at the extreme western end of the south aisle, where it joins the tower, proved to be of interest. The pit was dug to a depth of 2.3m below ground-level and the rubble foundation (F3) was removed. Natural greyish clay had been reached and water was starting to seep up into the base of the pit. Two water-logged wooden piles (F5 and F6) were exposed and later inspection exposed a third (F7). All three were in the north-western corner of the pit and were upright. They were circular and had been cut flat on top. The only fully exposed pile (F5) had a diameter of 130mm, although F7 looked wider than F5 and F6. All three piles projected 470mm up from the base of the pit and were driven into the clay. They were underneath the rubble foundation (F3). No attempt was made to remove the piles; they were left *in situ*. A sample of F5 was taken for radiocarbon dating. A box was then made around the piles to protect them, and the pit was filled with concrete.

The pile was identified as elm (*Ulmus* sp.). The pile consisted of wide roundwood measuring 125mm in diameter. The wood was intact to the wood/bark interface but the bark was absent. About 14 annual growth rings were present. These were wide and indicated fast-growth, suggesting that the tree had grown in optimal conditions with little competition from other vegetation.

Three water-logged wooden piles (F5, F6, F7) made of elm were exposed where the tower joins the south aisle. The piles were under the south wall of the tower. The radiocarbon date of one of the three wooden piles suggests that the tower was built in the 14th or first half of the 15th century. This accords with the date of the tower on stylistic grounds. Presumably all three piles are contemporary and were inserted by the medieval builders when constructing the foundations to the tower, the wet ground conditions as well as the massive proportions of the tower probably necessitating such piling. The stone foundation that the piles supported had presumably been removed by the substantial 19th-century foundations.

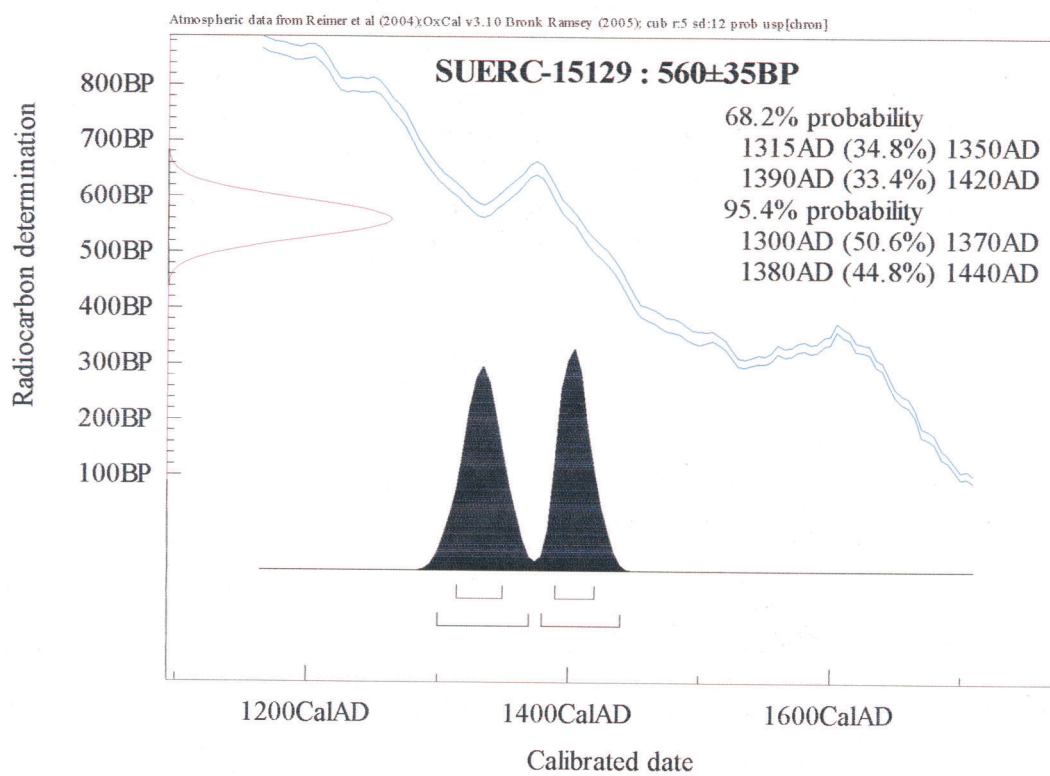
## Calibration Plot

The radiocarbon date, when calibrated, indicates two probable date ranges. At 1 sigma (68.2%), the probable date lies at 1315-1350 or 1390-1420, and at 2 sigma (95.4%), the probable date ranges are 1300-1370 and 1380-1440. In other words, the felling of the tree used to make the pile can almost certainly be dated to the 14th to mid 15th century and probably c 1330 or c 1400.

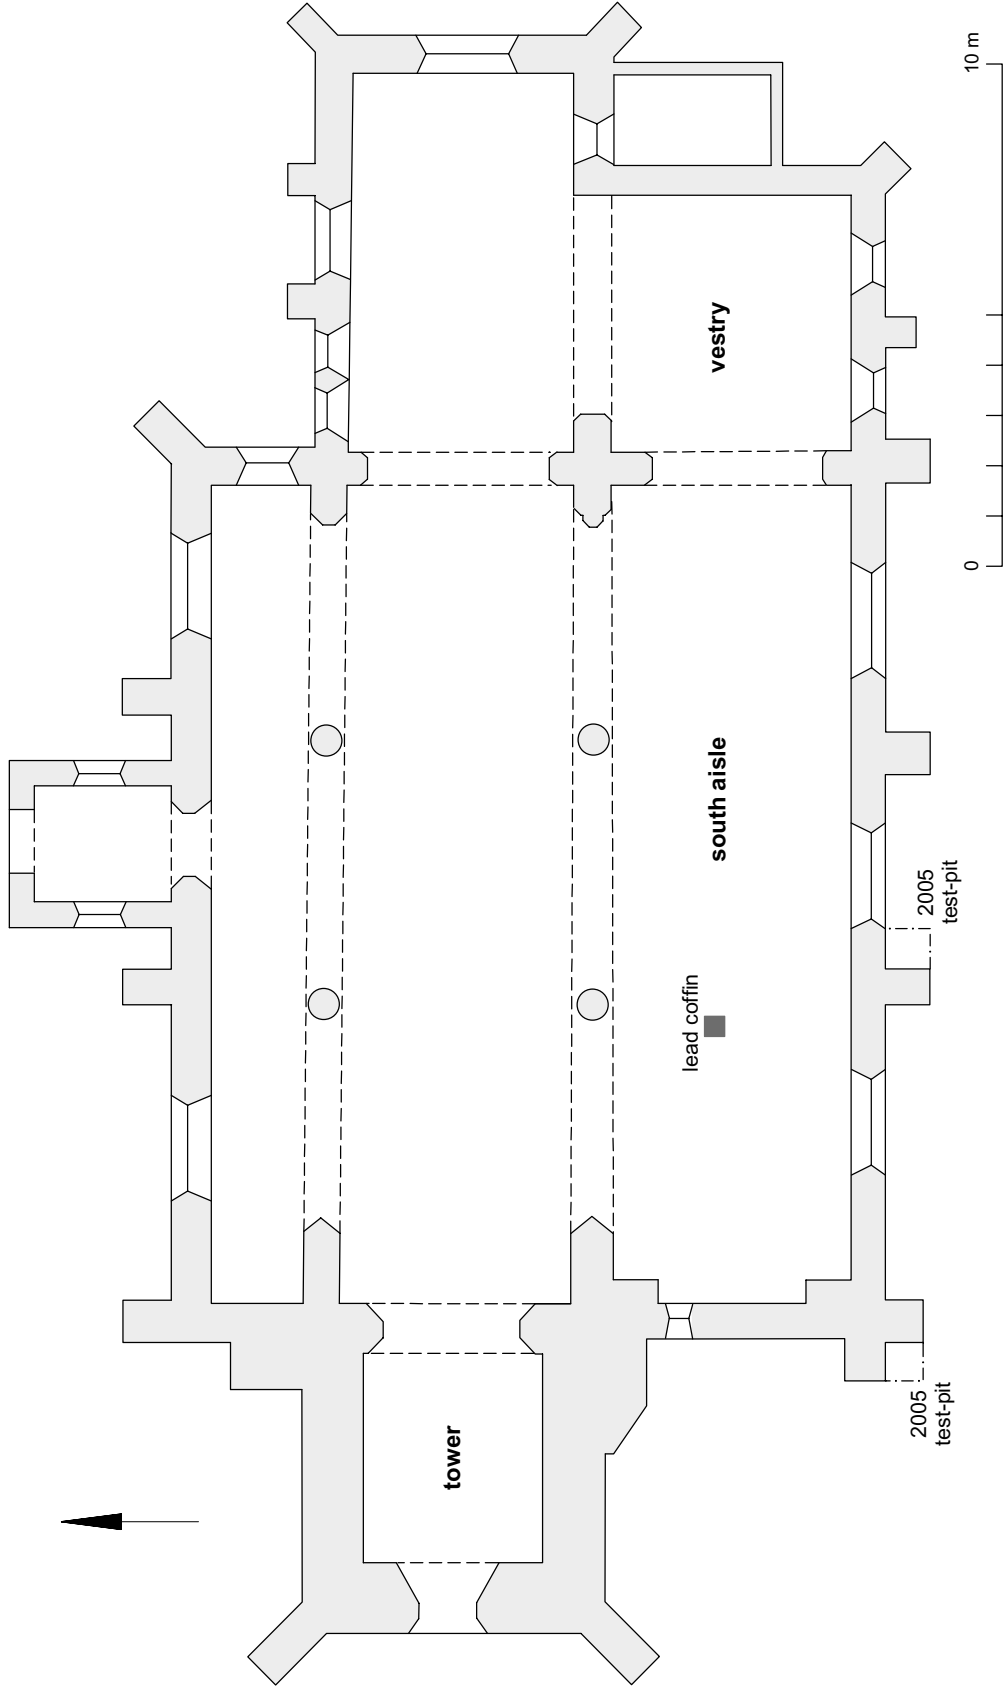
Fig 1 Church ground-plan (after RCHME 1922).

- 4.1 Only the 14th-century chancel and north aisle and the apparently 15th-century west tower survive from the medieval church (Essex Historic Environment Record or EHER no 3572). The tower is 'surprisingly big and important looking' (Bettley & Pevsner 2007, 514). The church is now, essentially, a 19th-century building following the complete rebuilding of the nave, south aisle and chapel. Rodwell and Rodwell (1977, 111) state that the south aisle, nave and chapel were completely rebuilt in 1833 and restored in 1870-73. However, Pevsner and Bettley (2007, 515) state that the chancel was rebuilt in 1870 and the nave restored in 1872, including new arcades, new south aisle and organ chamber on south side the chancel.

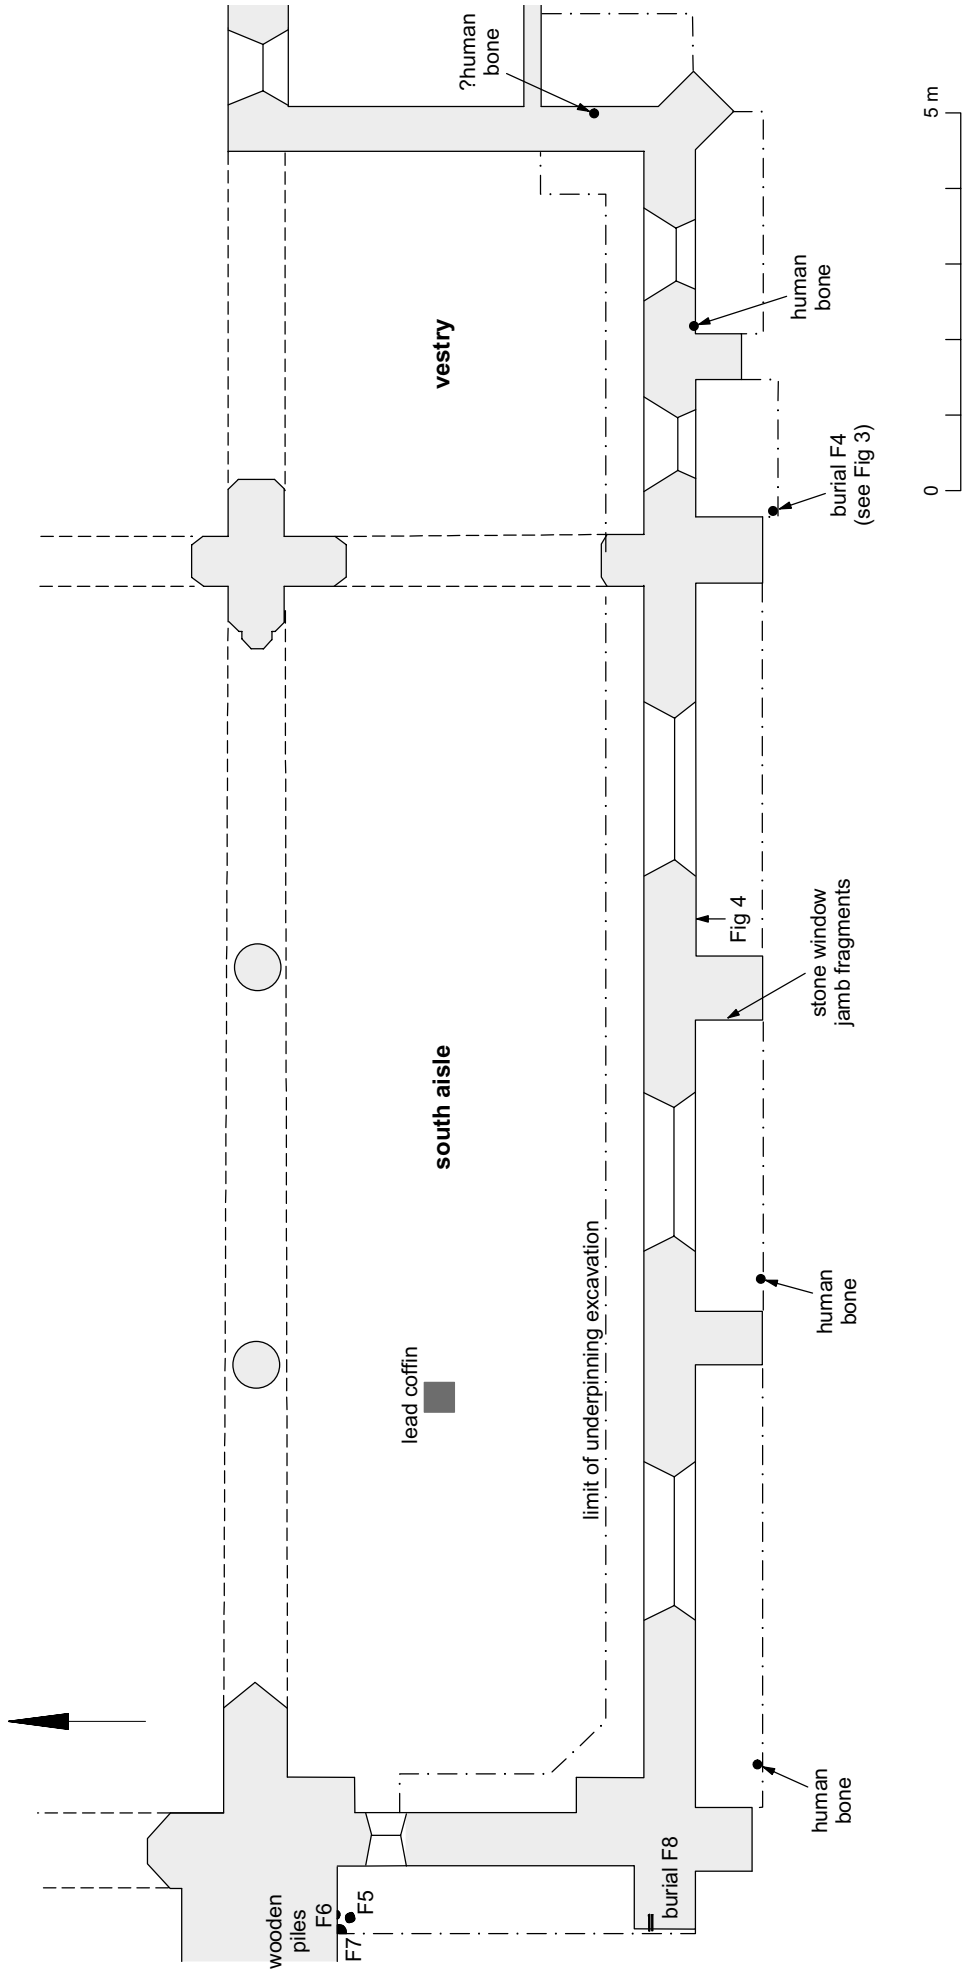
Fig 2 Plan of south aisle, showing finds and features.

Disarticulated human bone was found in two other places (see Fig 2), at least 1m below ground-level. The bone came from within the clay layer (L3) and no grave cuts could be discerned. As the clay at this level contained fragments of bone, this indicates that it is not natural after all.

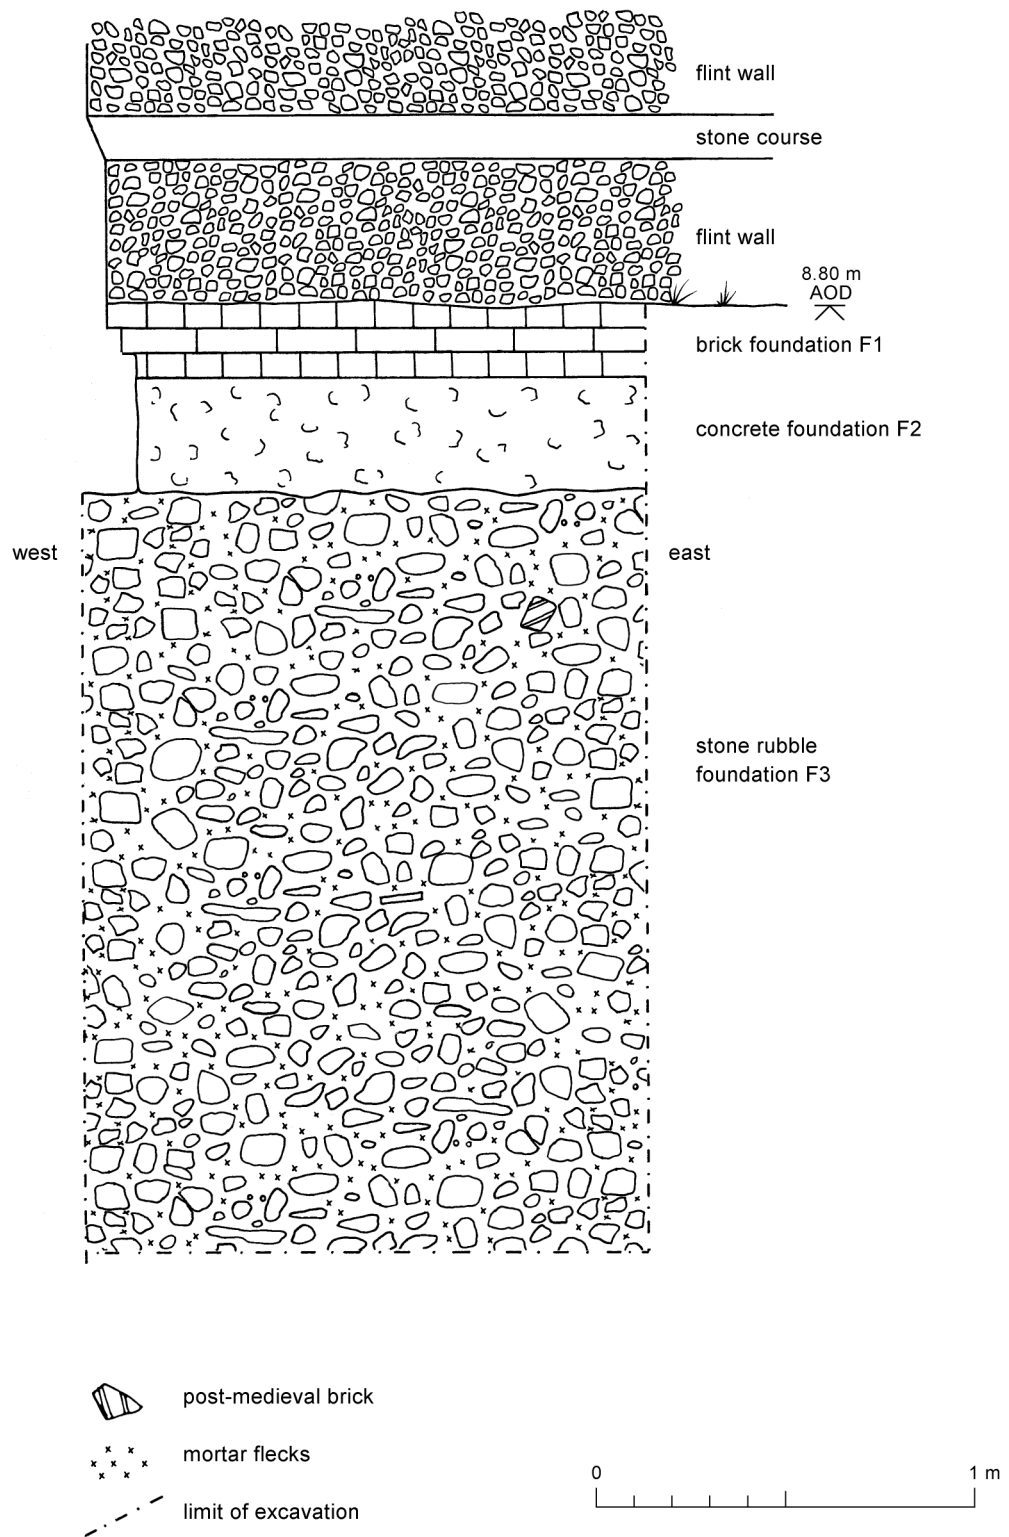
Fig 4 South-facing elevation of south aisle and section within pit dug for underpinning.

The pits dug along the central and western end of the south aisle encountered approximately 150mm of topsoil (L1) overlying between 550mm and 750mm of mortar-rich brown clayey loam containing brick and tile fragments (L2). At between 700mm and 900mm below ground-level, L2 gave way to a mottled greyish brown clay, assumed to be natural (L3). This clay continued to the base of the pits. On the church side of the pits, the foundations to the south aisle were exposed. These were fairly uniform, consisting of two or three brick courses (F1) overlying a concrete foundation 200-300mm thick (F2). The concrete foundation extended out 220-300mm from the exterior wall face. Judging from the previous test-pits that had been dug (see section 4.4), it was not expected that the foundations would be any deeper. However, the concrete foundations had been laid on top of a wide deep rubble foundation

which extended at least to the base of the pits (F3). This consisted mainly of rough nodules of flint but included some blocks of chalk, and some chunks of greensand and septaria, plus occasional brick. The rubble was loosely packed with earth which contained flecks of mortar. Kango hammers had to be used to remove it.

The rubble foundation (F3) was not a uniform width, but was 1.1m wide at its narrowest. It generally only extended out as far as the concrete foundation above it. This is probably why the rubble foundation was not encountered in the first test-pit that was dug in 2005. However, in some places it extended out further than the concrete, almost as far as the end of the buttresses. Under the eastern end of the south aisle it did not exist at all (see section 6.2). In the central section of the south aisle, four large pieces of dressed stone were picked out from this rubble foundation by the contractors. These are pieces of window jambs from the medieval church. The presence of brick argues against this foundation being medieval. It is thought to consist of rubble from the demolition of the medieval south wall in 1833 which was then re-used as a foundation by the 19th-century builders.

The underpinning trench exposed a very substantial 19th-century foundation to the south aisle (F3). This was made up of flint and septaria rubble from the demolished south wall of the medieval church. Four pieces of dressed stone from medieval window jambs were retrieved from this foundation. The rubble foundation was not so much in evidence at the eastern end of the south aisle. Concerns about the load-bearing capacity of the ground at that time may have made it necessary to create a substantial foundation. Alternatively it may have been more expedient for the 19th-century builders to dump the demolition debris on site rather than having it taken off-site.
