Archaeological monitoring at Southway Roman Church, Southway, Colchester, Essex, CO3 BU

July 2020-June 2021

CAT Report 1685

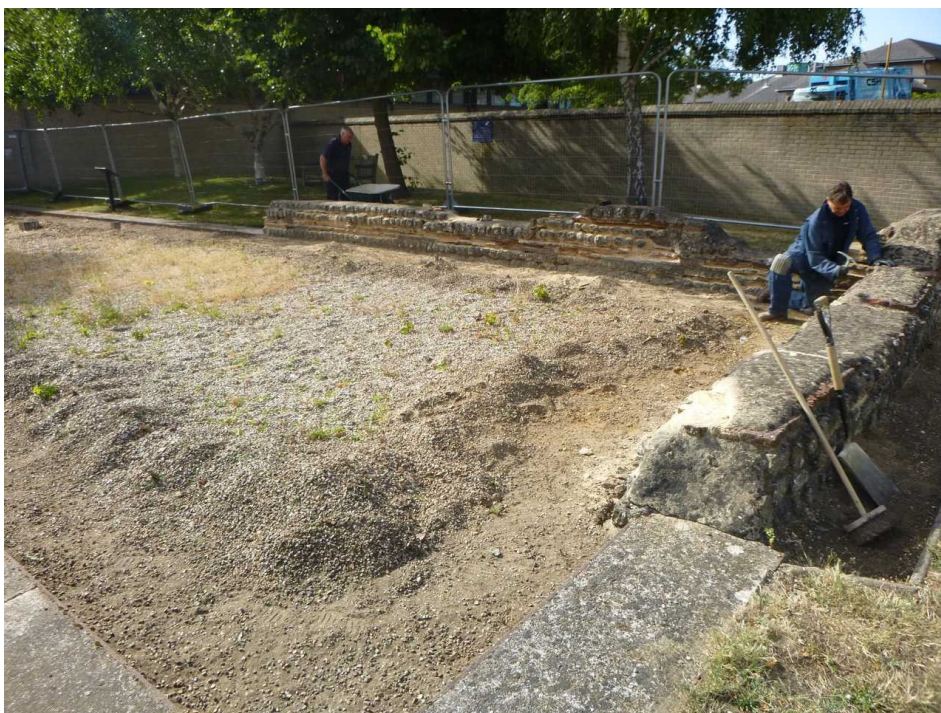
Eleven wooden posts were removed and replaced from the eastern end of the church. The posts were replaced in exactly the same locations as the removed posts so no other ground was disturbed. The replacement of the terram and gravel did not penetrate the ground.

Photograph 1 Working shot during renovation works – looking south-east

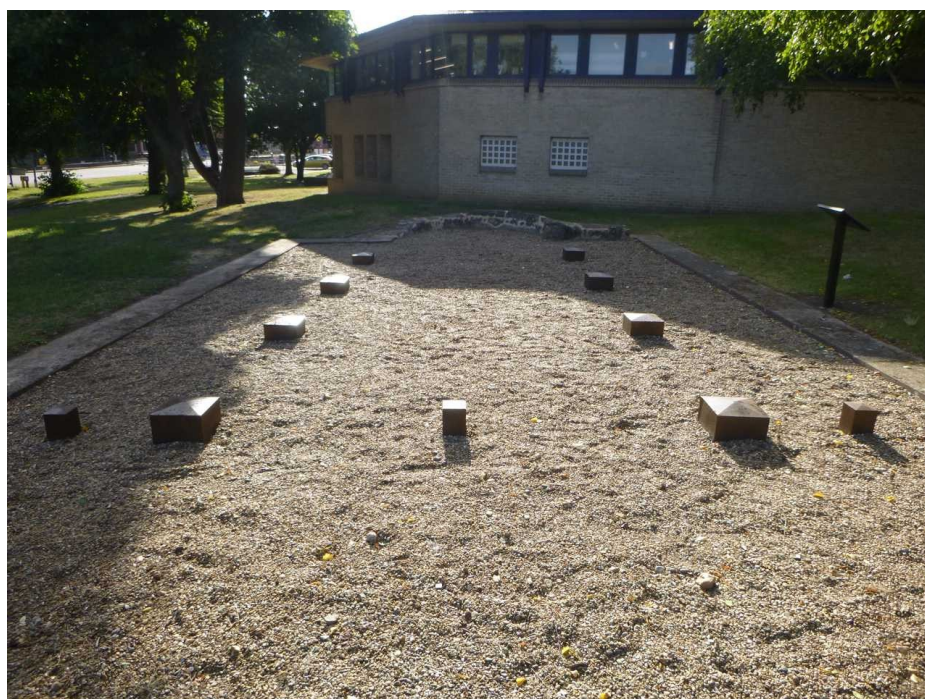
Photograph 2 Site shot showing new posts in place – looking east

The replacement of the wooden posts within the Southway Roman Church did not disturb any further ground than that of the removed posts. The removal and re-laying of the terram and gravel did not penetrate the ground.

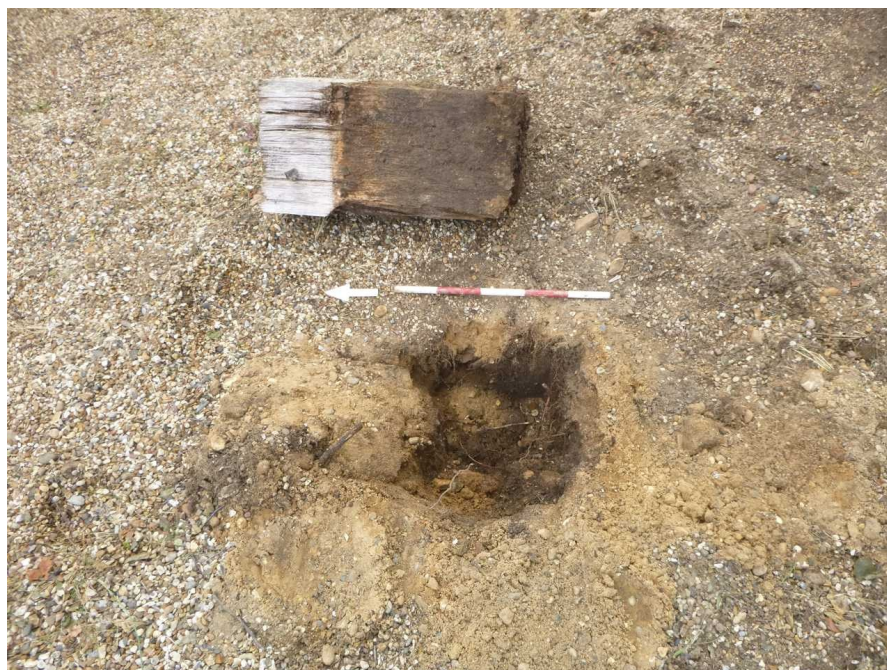
Photograph 3 Removed post – looking east

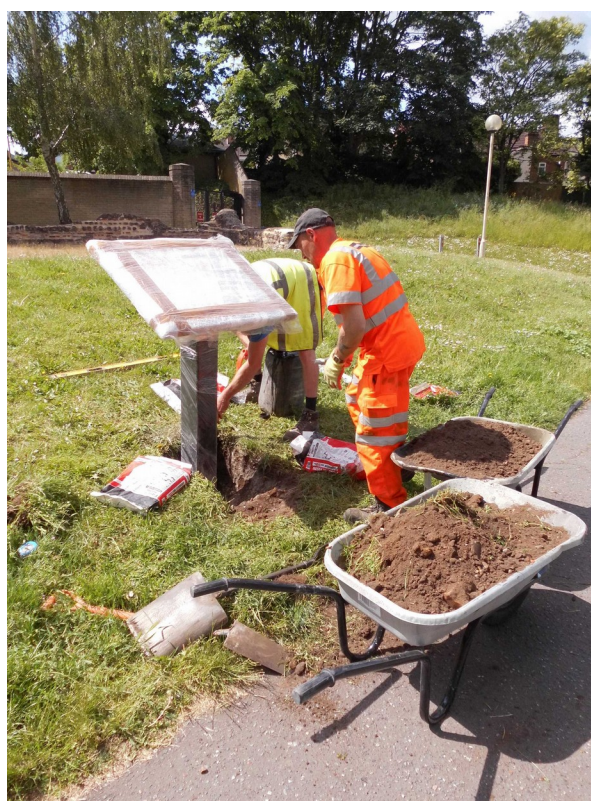
A post-hole (0.80m by 0.5m and 0.55m deep) was excavated through L1 (topsoil, c 0.20-0.25m thick, dark brown grey sandy silt) into L2 (accumulation layer, dug to 0.32m thick, very dark brown grey sandy silt).

Photograph 4 Working shot (interpretation panel) – looking south-west
