**A watching brief at firstsite,
Lewis Gardens, High Street, Colchester, Essex
December 2010-March 2011**

**report prepared by
Adam Wightman**

**on behalf of
Colchester Borough Council**

CAT Report 599
March 2012

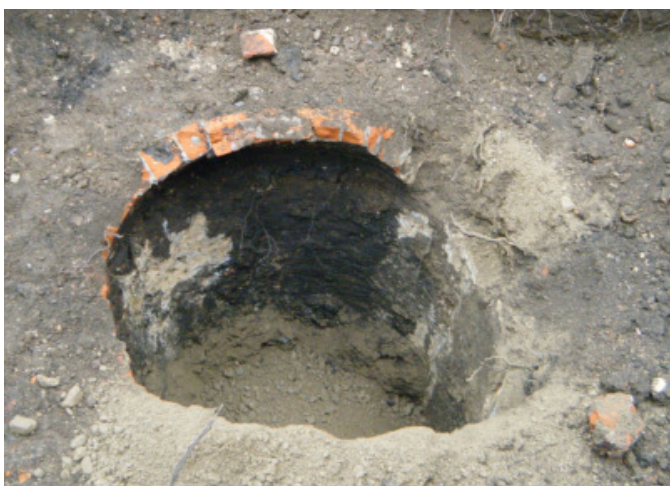
Plate 1: well F3, view south-west.

The well was roughly 1.5m in diameter and was lined with a circular rubble wall, the face of which appeared to have been plastered with mortar. The date of the well's construction is not known, but the absence of bricks in the well lining suggests that it was built in the medieval or early post-medieval period. The bricks in the dome capping the well were relatively large but did not appear to be frogged. The capping would have been constructed when the well was no longer needed. Complete pottery vessels and glass bottles were recovered from the fill of the well along with fragments of white glazed pottery, peg-tiles and other post-medieval building materials.

The well (F3) uncovered in the back garden of 15 Queen Street would have supplied water to the medieval/post-medieval property which once occupied this plot. Similarly, the well uncovered in the northern access road to firstsite (F4) would also have been located in the back garden/yard of a medieval/post-medieval property which once fronted onto the High Street. The finds recovered from well F3 suggest that it was backfilled sometime in the late 19th/early 20th century. This would have been after the well became redundant following the installation of the mains water supply. Both wells were probably each capped with a brick dome around this time as a means of sealing them. This was normal in the town centre because of the depth of the water-table (approximately 15m; CAR 3, 26). Other examples of similar wells in the town include those at 7-15 Long Wyre Street (CAR 6, 365) and at Middleborough (CAR 3, 209).
