**An archaeological watching brief
at St Mary's Church, Church Hill,
Lawford, Tendring, Essex
February 2009**

**report prepared by
Donald Shimmin**

CAT Report 510
August 2009

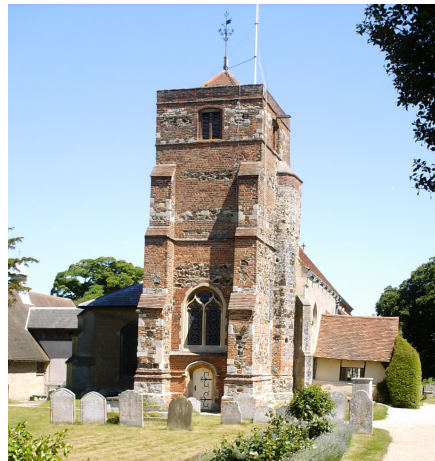
Plate 1	St Mary's Church tower, viewed from the west.	(front cover)
Plate 2	Foundation F2, viewed from the north-west.	3
Fig 1	St Mary's Church: site plan.	
Fig 2	Detail plan of F1 and disarticulated human bone in north aisle (above) and Sx 1 (below).	
Fig 3	Ground-plan and elevation of St Mary's Church in 1826.

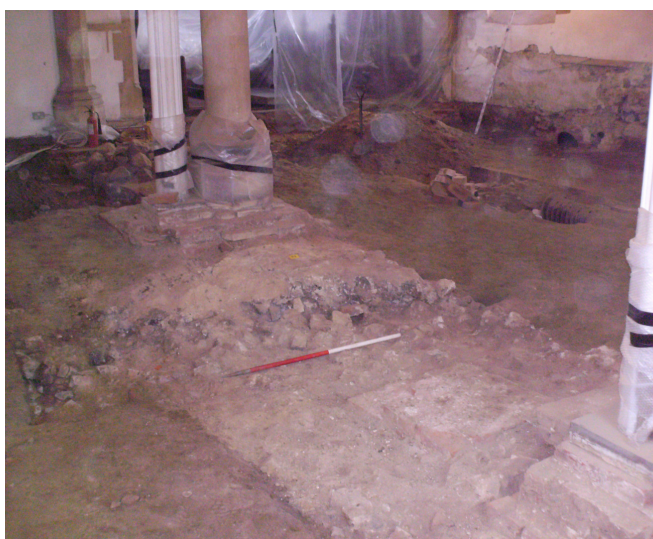
Plate 2: foundation F2, viewed from the north-west.

- 6.2.2** Between the two stone columns in the north arcade, the foundation was of more substantial stone-and-mortar construction (F2). This consisted of a friable pale brown mortar with septaria fragments. It was initially uncovered immediately west of

the eastern stone column only 220 mm below the modern floor-level. Further west and north it was more extensively robbed and lay approximately 320-400 mm below the modern floor-level. Sparse fragments of peg-tile, unfroged brick and white wall-plaster were observed on the robbed surface of F2.

The foundation was 2.2 m wide and was uncovered for approximately 5m east-west. It was probably the remains of the upper part of the foundation for the former north wall of the nave. Why F2 was so much wider than F5 is unclear (see section 8.3). The foundation was only traced a short distance to the west of the western stone column. It did extend beyond this point but lay well below the depth limit of 350 mm and was left unexcavated.

Slight traces of the brownish-yellow sandy lower part of the foundation, similar to F5, were observed protruding out from under the stone-and-mortar upper part along the southern edge of F2. There was, however, no evidence of this along the northern edge or elsewhere.

- 8.2** The east-west medieval foundation (F2, F5) for the former north wall of the nave, demolished in 1826, was revealed under the north arcade. This was constructed of an upper stone-and-mortar part sealing a lower deposit of large, unmortared septaria blocks set in sand and gravel. Septaria occurs naturally along the Essex and Suffolk coasts nearby. The foundation probably dates to the 14th century.

- 8.4** The unexpected width of F2 and the discovery of a foundation F4 extending off to the north (see sections 6.2.2-6.2.3) are not easy to explain. Possible interpretations include a side chapel, a north porch, an earlier phase of tower, or a monument in the graveyard outside the nave. However, none of these is particularly convincing. A side chapel might seem a plausible suggestion, but side chapels are usually located off the chancel rather than the nave.

The width of foundation F2 need not necessarily be medieval. The mortar was slightly loose, especially the northern part, and it had peg-tile and post-medieval brick on its surface. Perhaps F2 had been widened as part of the 19th-century or later alterations. However, this still does not explain the north-south foundation F4.

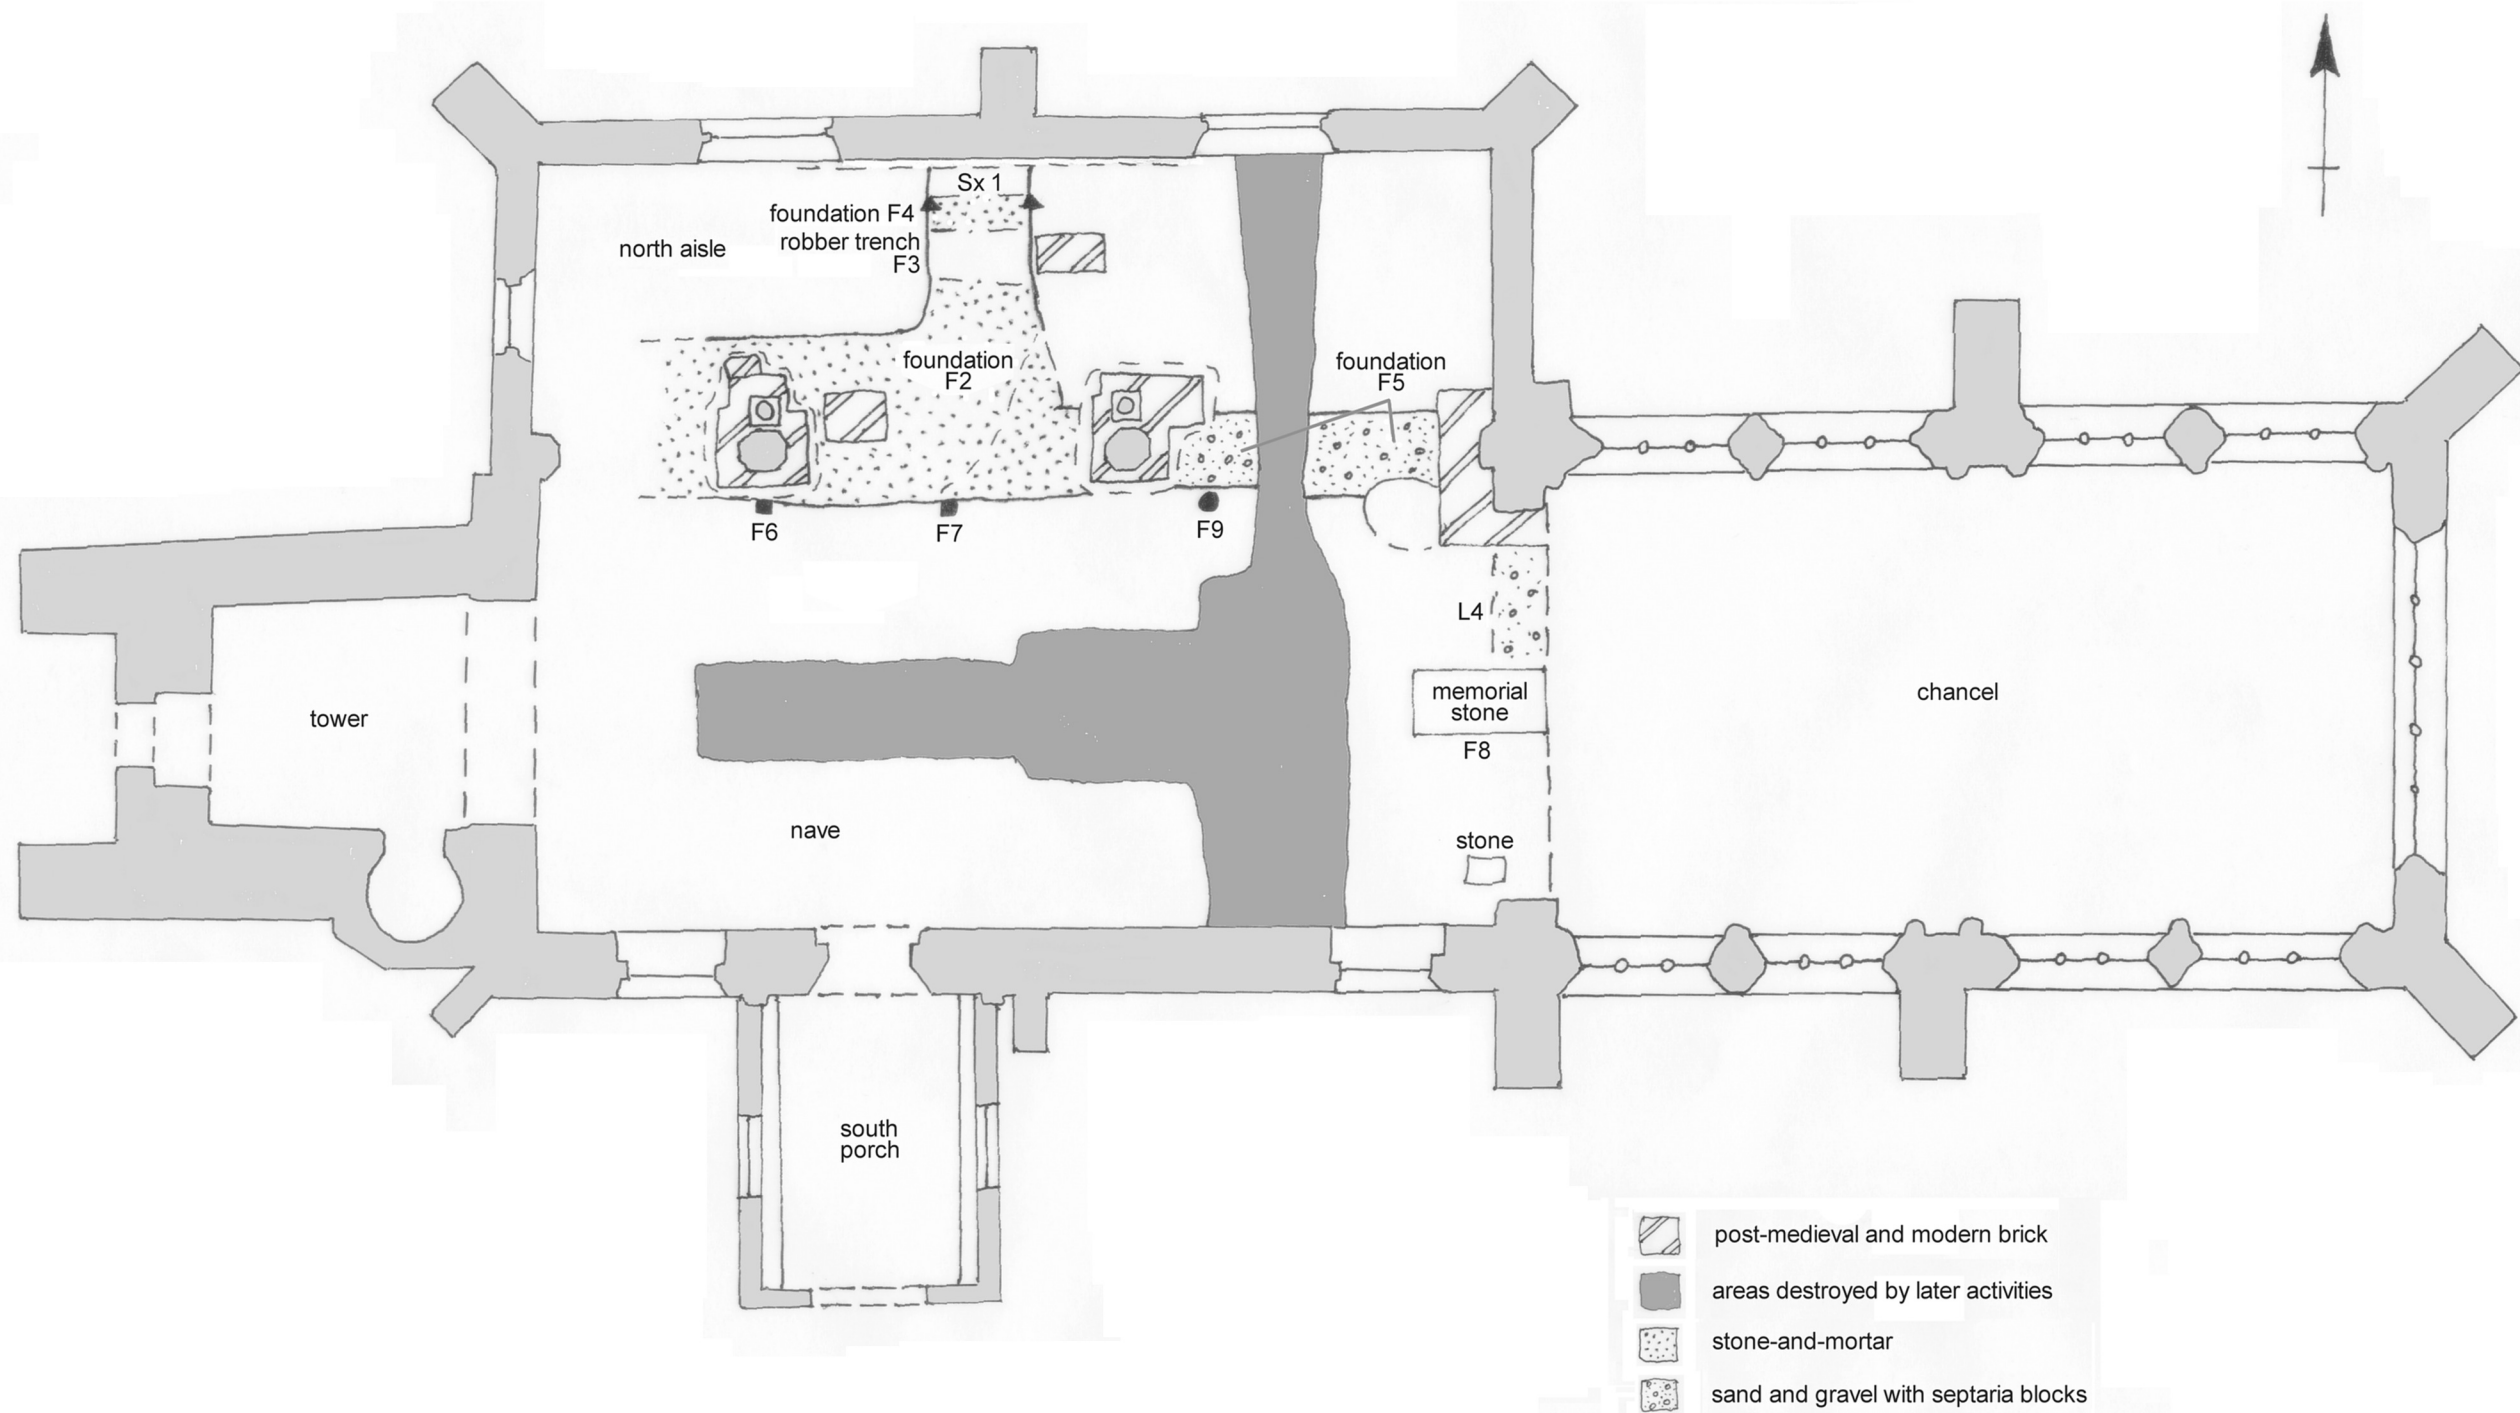
Fig 1 St Mary's Church: site plan.

- 6.2.1** The remains of an east-west foundation were uncovered in the north arcade between the nave and the north aisle. The eastern part of the foundation (F5), to the east of the stone column nearest the chancel, was 1-1.05 m wide. It was constructed of large unmortared septaria blocks set in brownish-yellow sand and gravel. It had been cut by a modern service trench, and the eastern end of F5 was further damaged during machining. Its upper surface lay 300-350 mm below the modern floor-level, but its depth was not established.

This was probably the lower part of the medieval foundation for the north wall of the nave, which was demolished when the north aisle was added in 1826. There were only slight traces of the mortared upper part of the foundation in this stretch of foundation.

6.3.4 A memorial stone (F8; Fig 1) at the east end of the nave was lifted and set aside (see section 5.1). The memorial was to Edward Turner and was dated 1750. The stone sealed a loose rubbly layer, from which a piece of Wedgwood pottery of probable 19th-century date was recovered (see section 7.1). This indicates that the stone had been reset in the floor on at least one previous occasion. Presumably the memorial stone and rubble layer sealed a burial vault but this lay below the 350 mm depth limit.

6.3.5 A rectangular piece of dressed stone was uncovered in the south-east corner of the nave (Fig 1). It measured 480 x 360 x 80 mm and lay 180 mm below the modern floor-level. The stone was positioned directly beneath where the pulpit normally stands, although its purpose was unclear. It was retained at the church.

6.3.6 In the north aisle, immediately to the east of F3, a rectangular brick feature was uncovered (Fig 1). It was aligned east-west and lay 350 mm below the modern floor-level. The bricks formed a flat surface measuring approximately 0.9 m x 0.5 m. They appeared to be yellow or buff in colour and unfrosted, and were set in a white mortar.

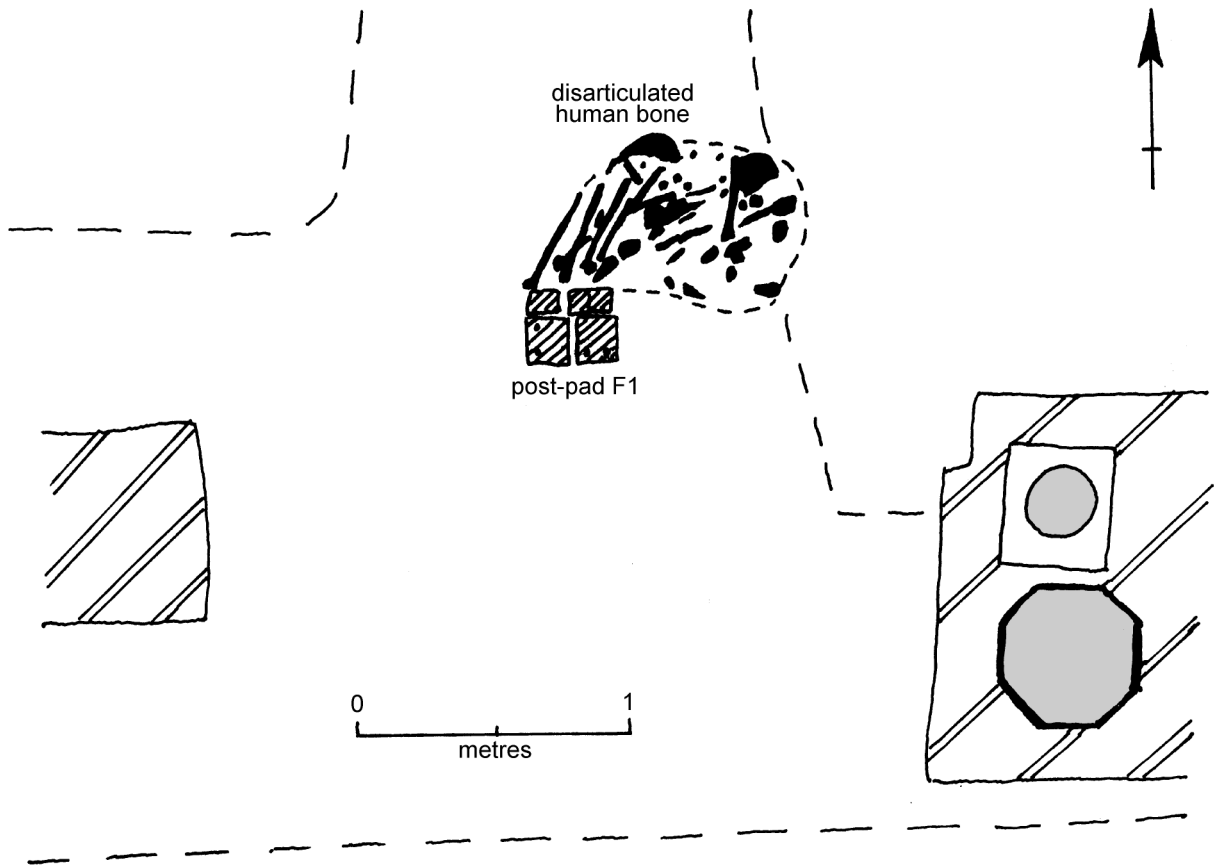
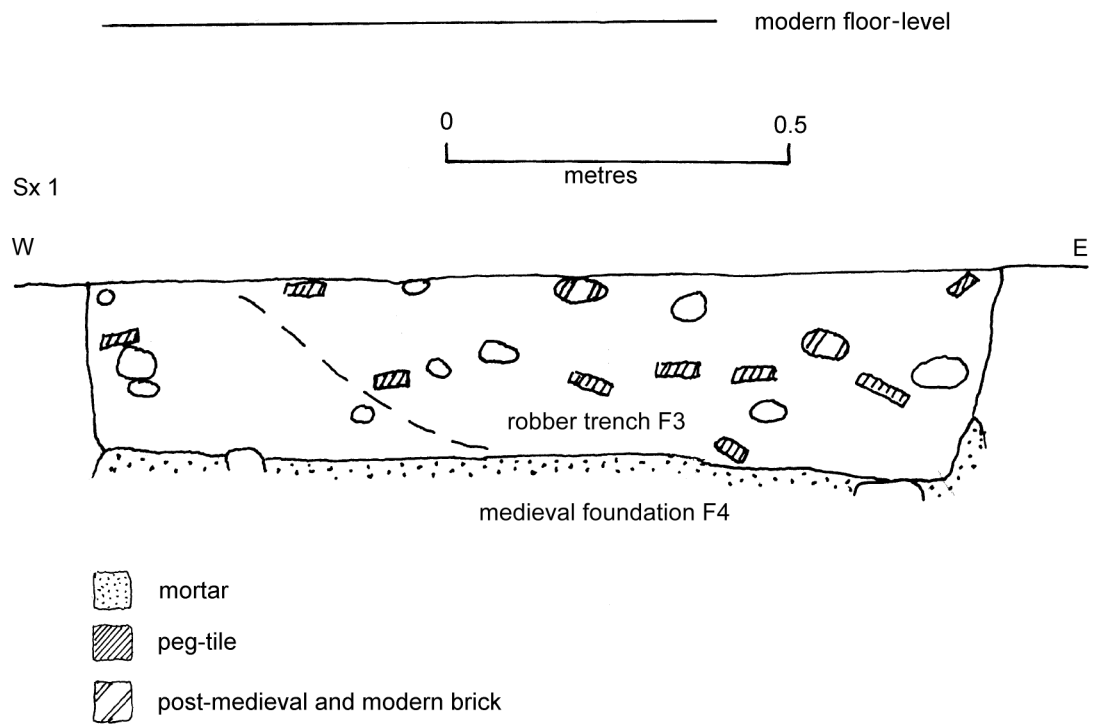
Fig 2 Detail plan of F1 and disarticulated human bone in north aisle (above) and Sx 1 (below).

- 6.2.3** A foundation (F4) extended south-north from F2. It was approximately 1.3 m wide and also consisted of pale brown mortar with septaria fragments and sparse pieces of peg-tile. The upper part of F4 had been robbed (F3; Fig 2). It was traced for 2.1 m north of F2 and appeared to extend under the north wall of the north aisle. The top of the foundation lay approximately 0.64 m below the modern floor-level.

- 6.3.1** The robber trench (F3) for the north-south medieval foundation F4 was 1.3 m wide and 300 mm deep (Sx 1; Fig 2). It contained fragments of window glass, peg-tile and unfroged brick, as well as a residual sherd of Roman pottery (see section 7.1). The robber trench was probably post-medieval in date.

6.3.3 A rectangular setting of peg-tile (F1; Fig 2) was excavated in the north aisle. It measured 340 mm by 270 mm and consisted of a single, horizontal course of large, unmortared peg-tile fragments. These lay 300 mm below the modern floor-level and sealed a thin layer of greyish-brown fill (L1) which overlay F2.

Early on in the stripping of L1, a jumble of disarticulated human bones was uncovered in the north aisle (finds no 1; Fig 2). The bones lay 250-400 mm below the modern floor-level, and were confined to a fairly small area, approximately 1 m east-west by 0.6 m north-south. It seems likely that the bones derive from several individual burials which were disturbed during an earlier phase of building work, such as the construction of the north aisle in 1826.

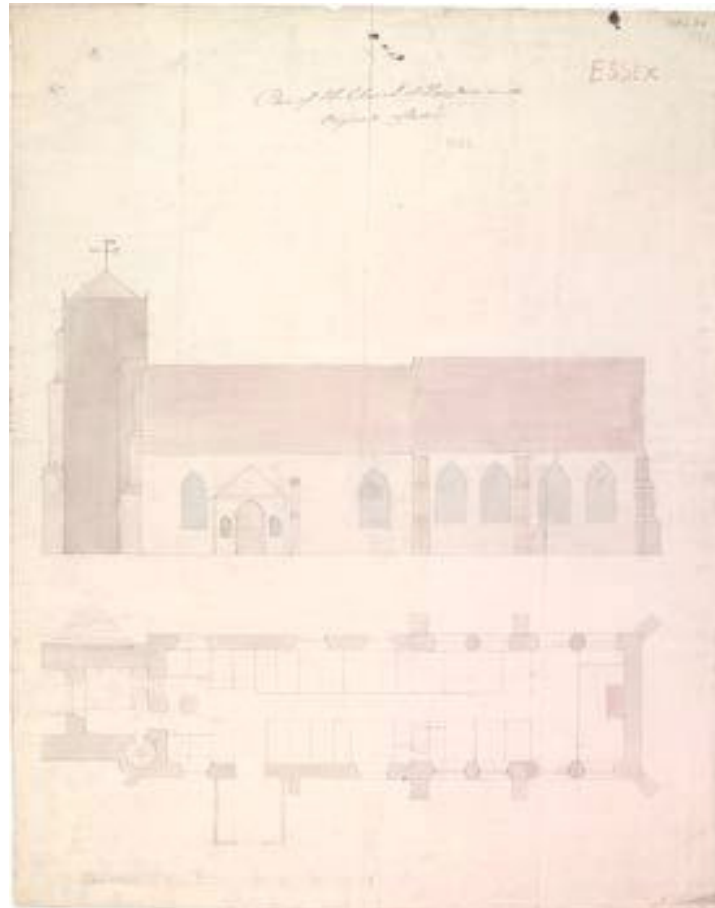
Fig 3 Ground-plan and elevation of St Mary's Church in 1826.

- 8.3** An architect's survey shows the layout of the church immediately prior to the construction of the north aisle in 1826 (Fig 3; web reference below). The north wall of the nave is of a uniform, moderate size all the way along and there is no north doorway or porch.
