Littleferry

Cable Undergrounding

Archaeological Watching Brief

Report No.	HAS110402
Site Code	HAS-LFC11
Client	SSE
Planning Ref	N/A
OASIS	highland4-100661
Date/ revision	09/05/2011
Authors	John Wombell and John Wood

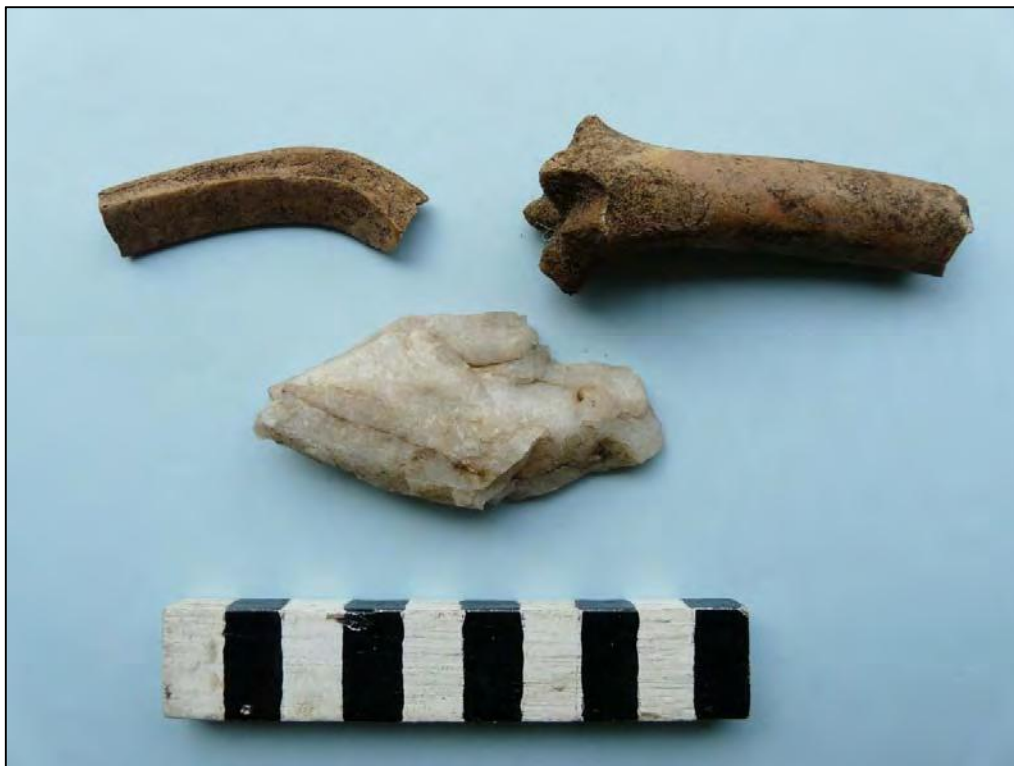
Photo 2 Finds from recorded area: butchered farm animals; angular quartz
Scale in 1cm divisions

the cable trench. No charcoal particles were noted in the black deposit. The only finds from the topsoil over the structure were two pieces of apparently butchered bone, which could have come from anywhere, and a piece of vein quartz measuring 70mm x 35mm x a max of 13mm thick (see Photo 2 below) recovered from the base of the trench.

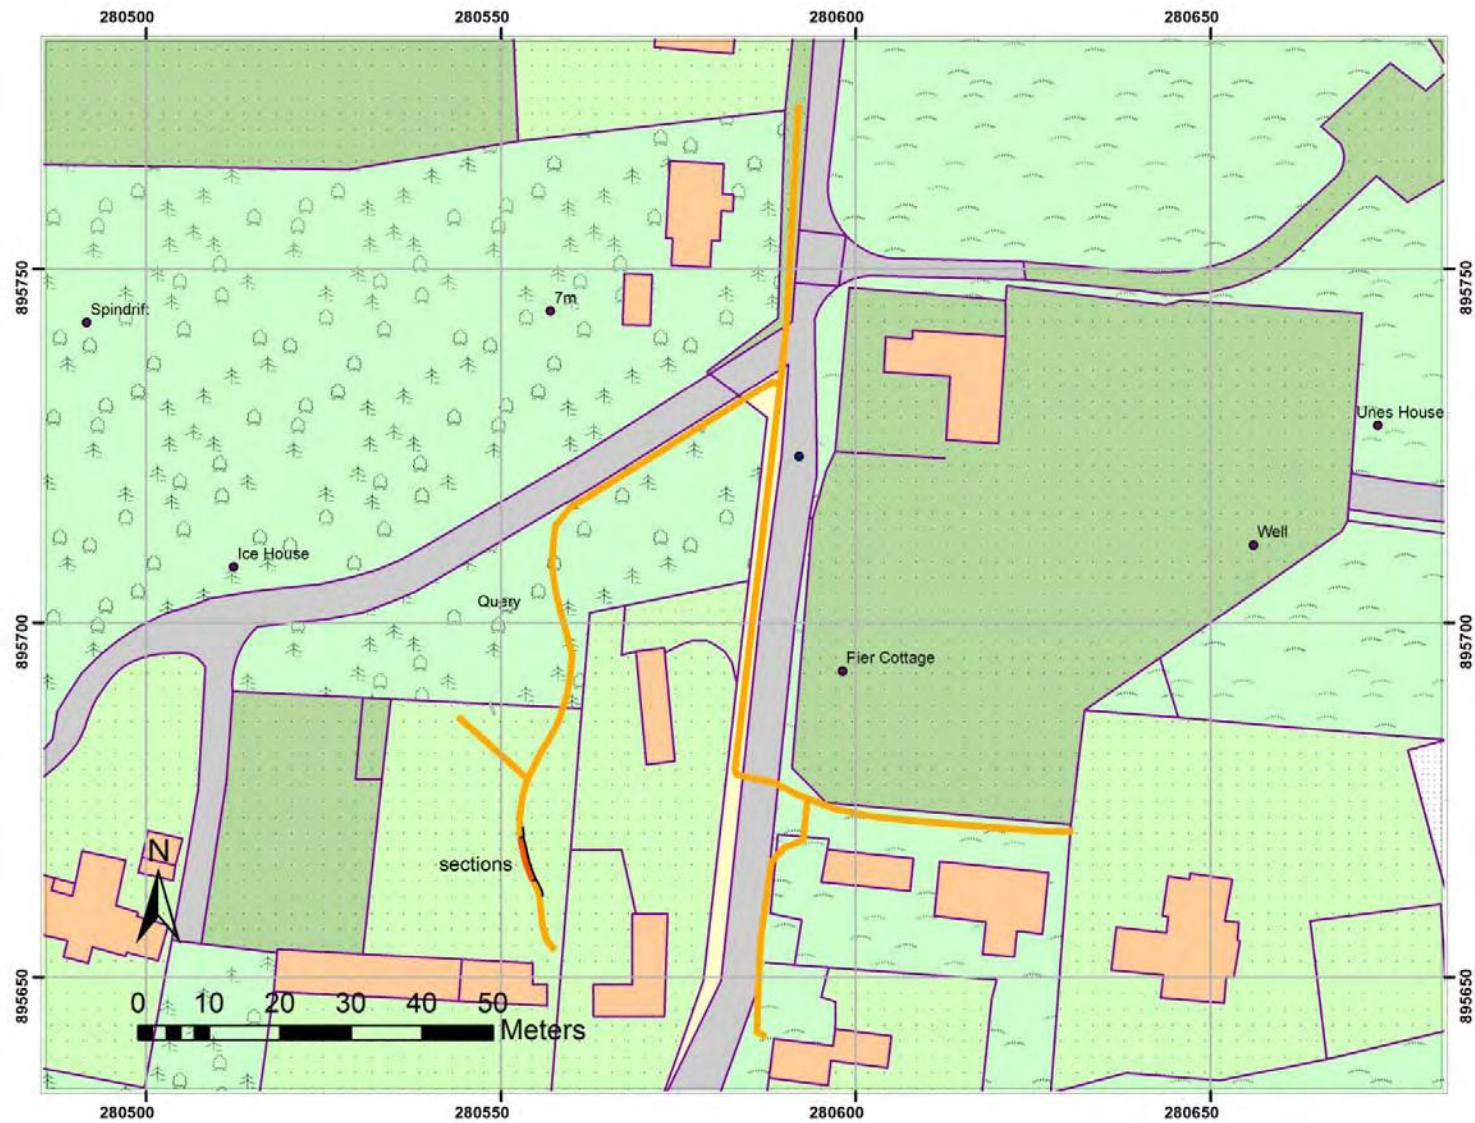
Figure 5 Area covered by watching brief: observed cable trenches

Following a check of all relevant archaeological and historical records accessible locally or online, a watching brief was maintained on excavations for undergrounding cables. This took place from 21 March to 1 April 2011, in accordance with Institute for Archaeologists standards and the Highland Council Archaeology Unit's (HCAU) Development Guidance. The area covered is shown in Figure 5 below. The weather was fine and dry with sunny intervals.

The cable trenches were cut using two back-acting mini-diggers fitted with 300mm (1 foot) wide digging buckets (toothed). The trench depth was approximately 750mm throughout and apart from the sections noted below, revealed about 300mm of topsoil above clean sand.
