# Pluscarden Abbey

## Archaeological Watching Brief

<b>Report No.</b>	HAS120601
<b>Site Code</b>	HAS/PCN12
<b>Client</b>	Pluscarden Abbey
<b>OS Grid Ref</b>	NJ 1418 5761
<b>Planning Ref</b>	11/01508/APP
<b>OASIS</b>	highland4-128767
<b>Date/ revision</b>	15/06/2012
<b>Author</b>	J Wood

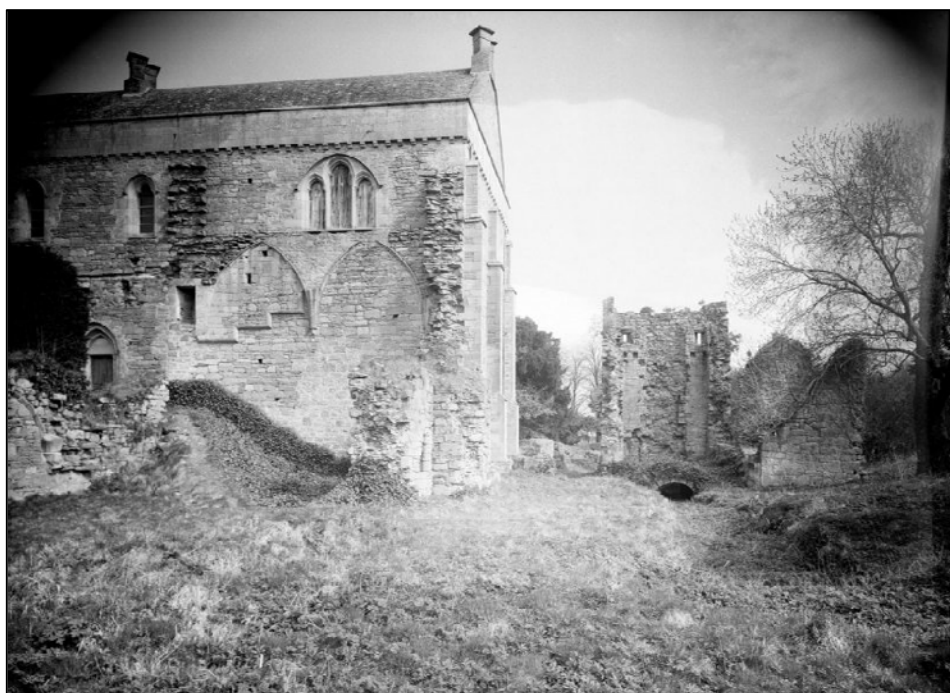
**Figure 8 Southern side of site ('Fraternity from SW'), undated but probably c.1930**  
*RCAHMS: SC1201678*

The renovations and developments of the last 60 years have clearly raised the ground levels along the south side of the site. An undated photograph, probably from the 1930s shows the area subject to the present watching brief (Figure 8).

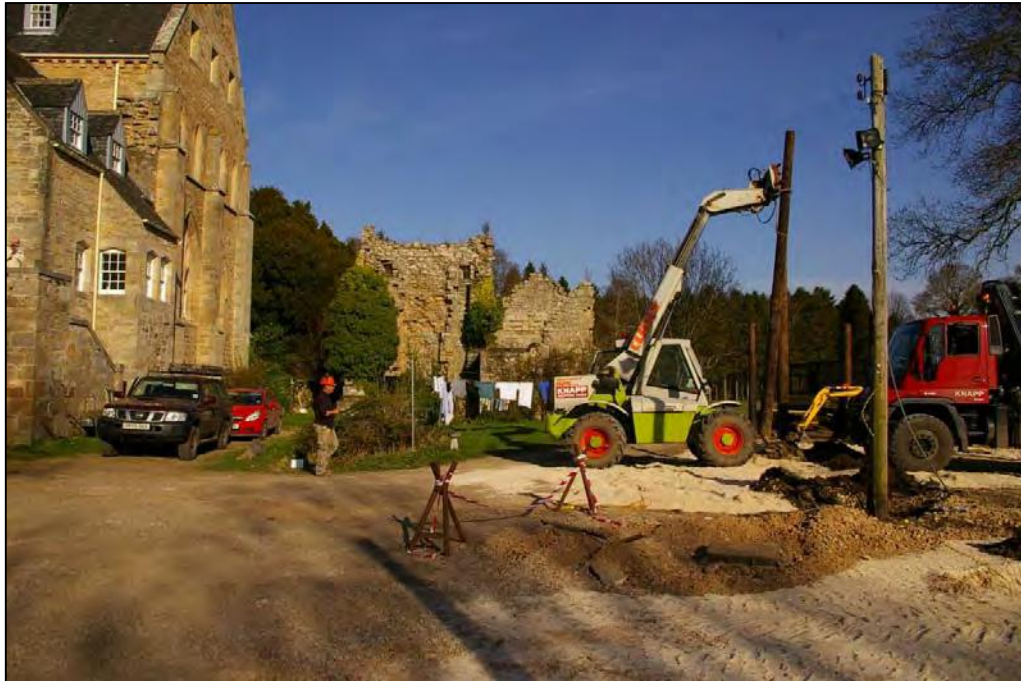
**Plate 1 View east, 2012: erection of fuel store poles**  
*Compare with Figure 8 above*

Some initial excavation had already taken place at the site for the boiler house some time before to the writer's first visit. However on inspection it was clear that this lay within an area of disturbed ground and no archaeology was likely to have been affected (Plates 1,2). Excavations for the erection of poles for the log store (Plates 1,4) and a trench to connect the boiler house with the abbey itself were observed (Plate 3). The trench was excavated using a back-acting digger fitted with a 1m wide straight edged bucket.

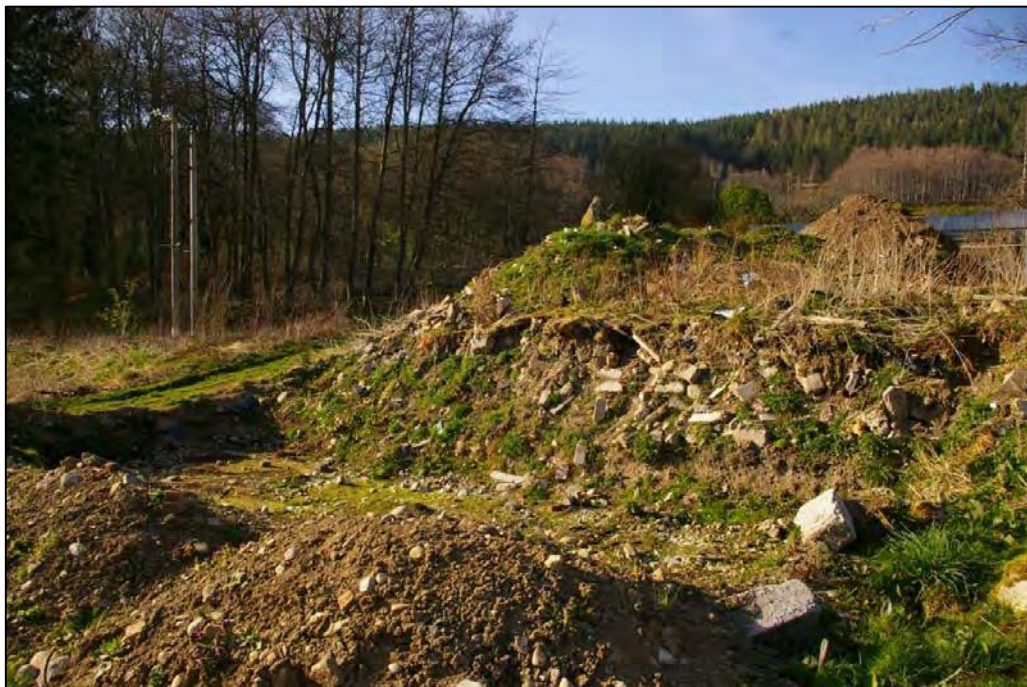
**Plate 2 Boiler house site as found, showing modern deposition of rubble and debris.**

Apart from part of the boiler house site, which was in any case clear of archaeology, the entire footprint of the present development lay within made-up ground containing modern stone and other rubble to build up the levels.

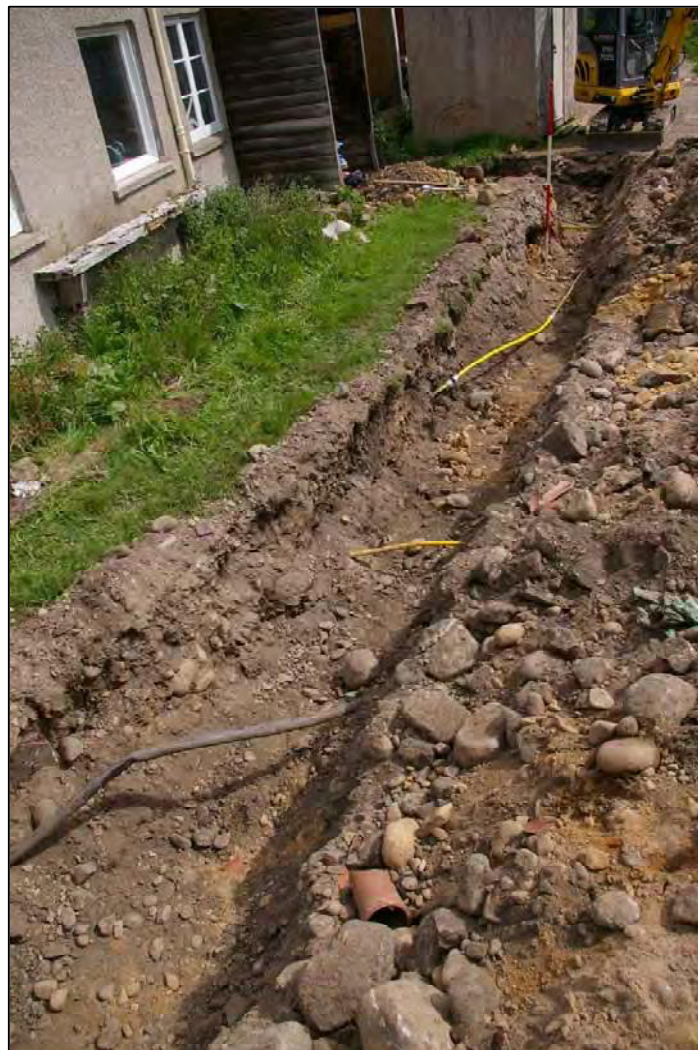
Plate 3 Connection trench, view ENE, showing services and disturbed ground

and drains. The excavations cut through very mixed material including builders' rubble, as well as orange periglacial sands, gravels and occasional boulders up to c.20cm dia. (Plate 3). No archaeological features or artefacts were recorded.

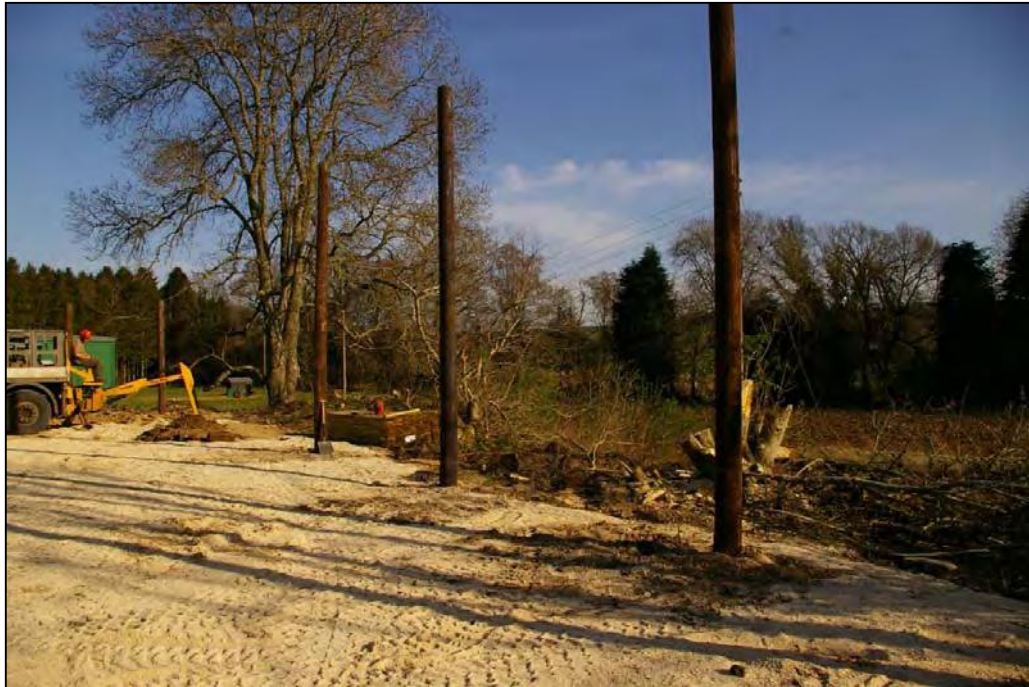
Plate 4 Construction of fuel store
