## Watching Brief

## Littleferry House Sutherland

### Littleferry House Sutherland

Report No.	HAS070608
Site Code	HAS/ LFL07
Client	Mr S Lyon
Planning Ref	04/00362/REMSU
Report Date	22 June 2007
Authors	Mary Peteranna

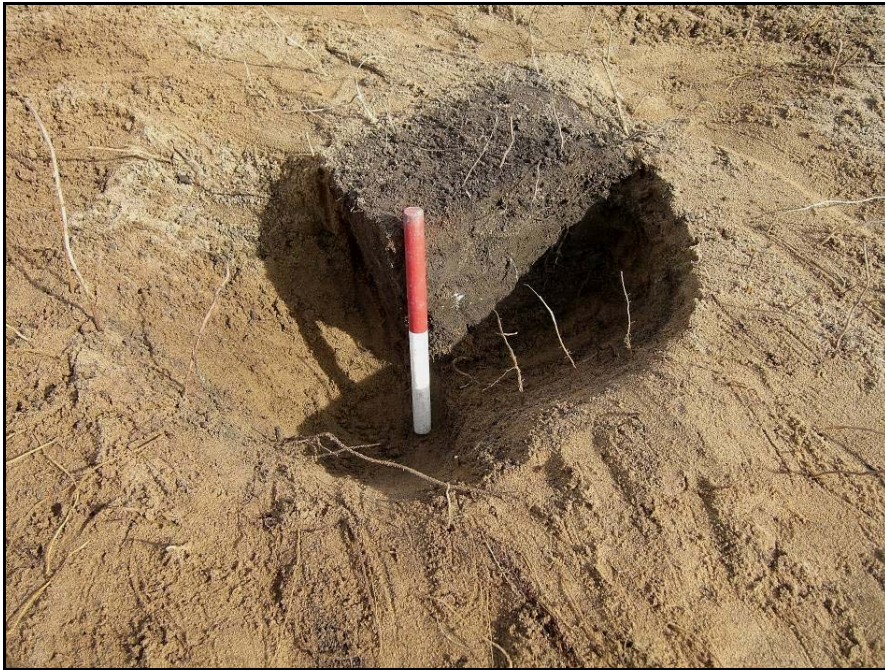
Figure 4: Feature 1

One feature (F1) was identified and excavated (see Illustration 4 above) and later determined to be the result of root action. Similar sub-circular features were seen throughout the site in association with many other former shrubs and trees.

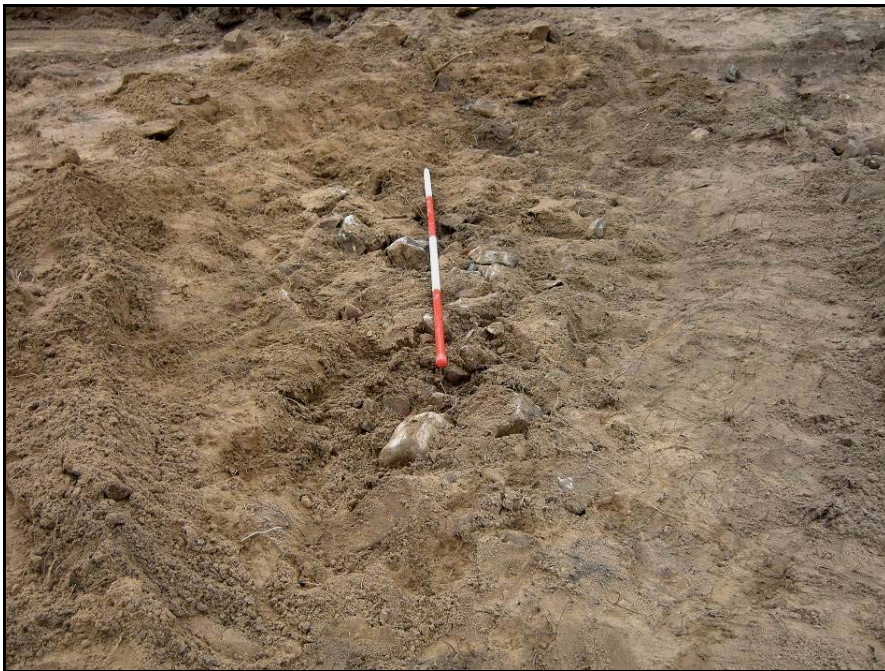
Figure 5: Feature 2

Next, a loose dump of rubble (F2) was revealed within the northeast portion of the site cleared for the garage. This appeared directly below the turf and had two broken 20<sup>th</sup> c. plate fragments and drainage pipe fragments within it. It is believed that the stones could be rubble from the ruined dry-stone wall that stands next to it by the eastern driveway (See Illustration 5).

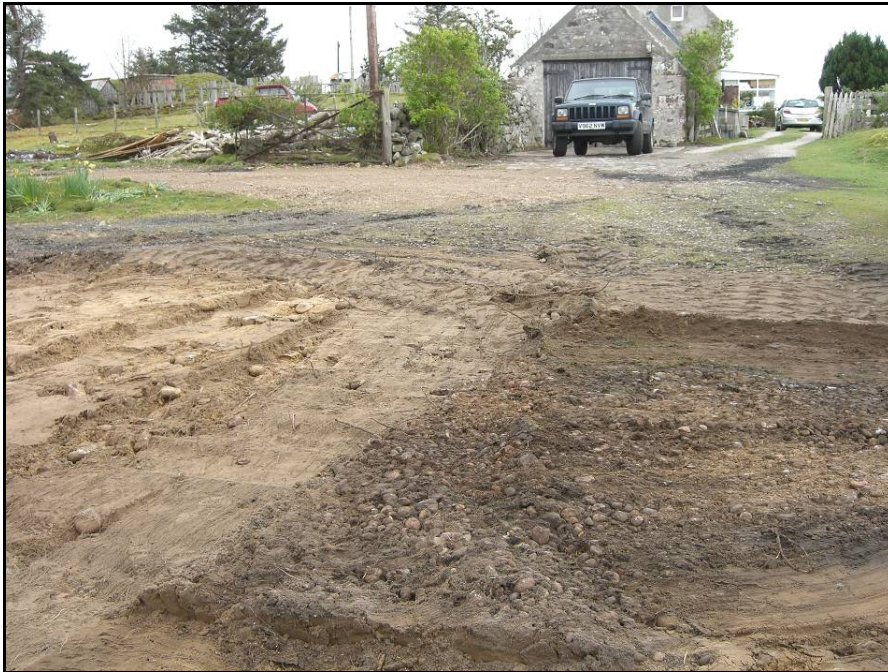
Figure 6: Feature 3

Lastly, the remains of a loose gravel surface (F3) covered approximately one half of the south half of the site (see Illustration 6). It was about 3-4cm thick, and lay directly below the turf. Although no finds were recovered, the gravel was full of the beach flint (see Illustration 7 below) that is so prevalent in Littleferry. It is possible that the surface was associated with the use of the old pier in front of the site, or that it was an earlier drive for the residents of Littleferry Cottage, next to it. However it did not appear to have any apparent archaeological significance.

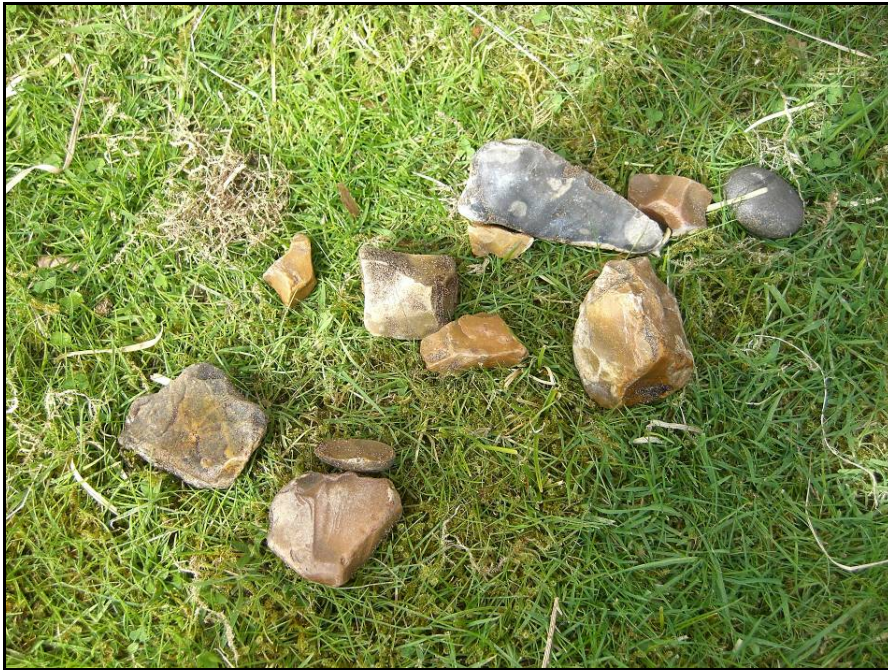
Figure 7: Beach flint from Feature 3

No features of archaeological interest were identified. It is worth noting the amount of beach flint amongst the gravel on site. This is an indication of a good natural source of flint for early residents of the area involved in stone tool manufacture.
