## **Controlled Topsoil Strip**

**Murphy's Croft  
Bonar Bridge, Sutherland**

**September 2007 and July 2008**

Report No.	HAS070902
Site Code	HAS/ MCB07
Client	Mr G Smart
Planning Ref	SU-07-063
Date/revision	14/04/2010
Authors	John Wood and Cait McCullagh

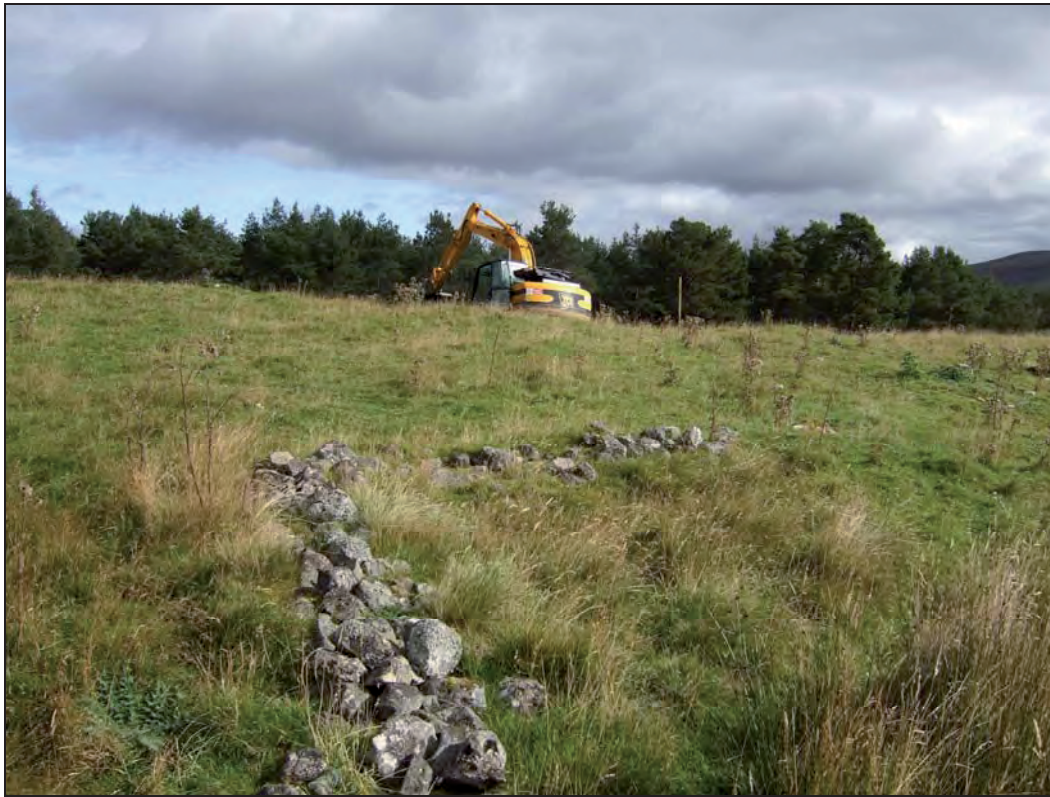
Plate 1 Stone dyke

is shown extending into the SE corner of the present site. This seems to be unenclosed on the map but it coincides very approximately with a field dyke noted during the fieldwork. This dyke appears to post-date the map and may have been constructed to delimit this area more clearly (see Fig 5 below).

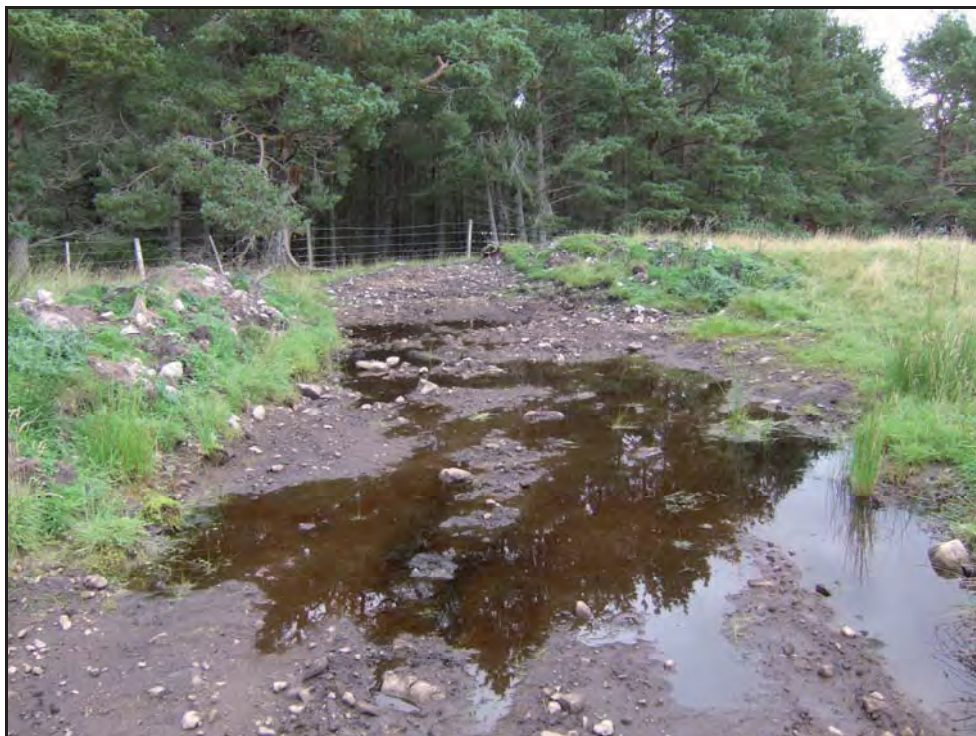
Plate 2 Previously cleared access road line

A tracked back-acting mechanical excavator fitted with a 1.8m straight-edged ditching bucket cleared topsoil and turf from the house site itself and part of the access road under archaeological supervision. On arrival it was found that an access road line and site for a caravan had been stripped some time previously. These had been left open and were inspected and photographed, but no archaeological features could be seen.

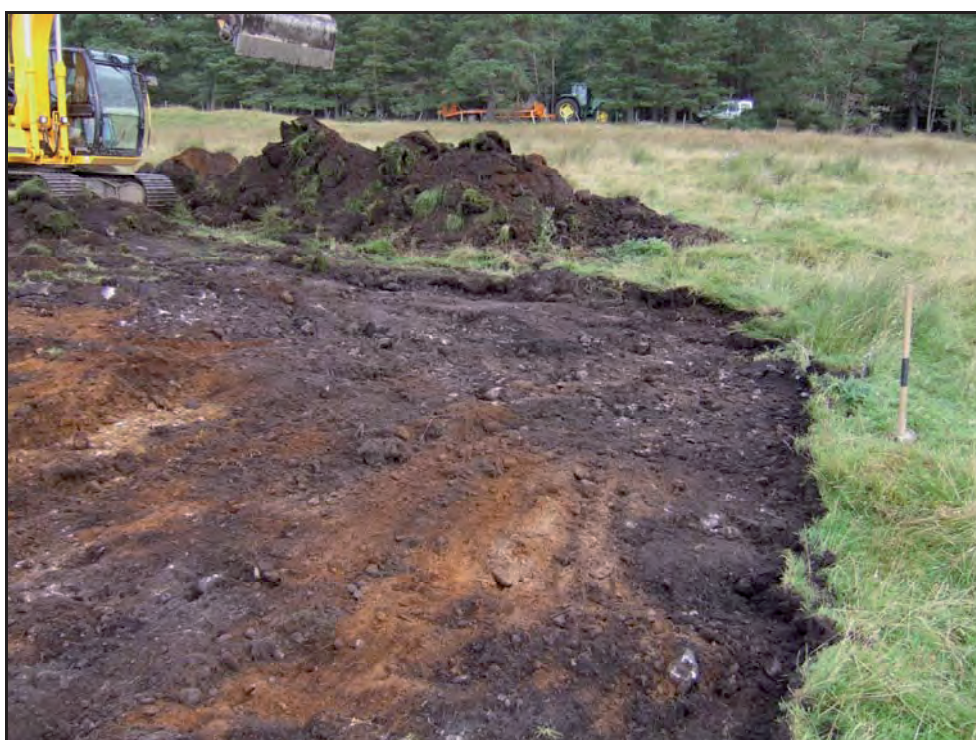
Plate 3 Clearing the house site - showing ground conditions.

The house site itself occupies the top of a natural glacial mound composed of red sands and angular pebbles. No archaeological features or structures were found in the areas cleared, although in one area a group of larger stones appeared to be a filled-in hollow. The ground conditions were varied in the line of the driveway but all of natural peri-glacial origin. Throughout, the trenches came down onto natural sands, gravels and rocks at 10-20cm depth.

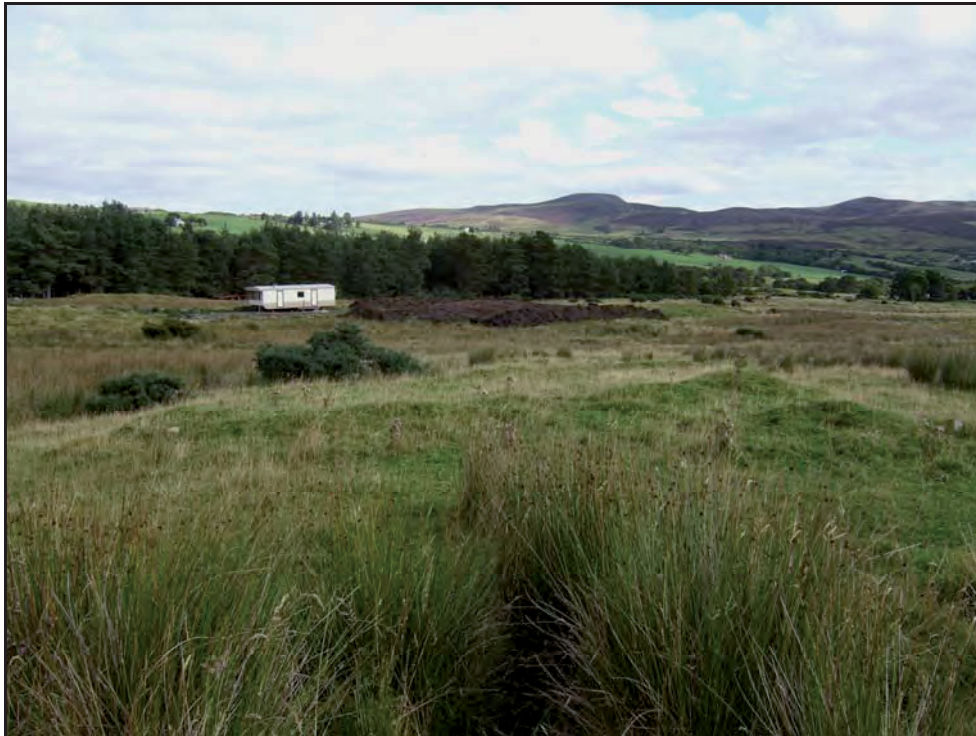
Plate 4 View to site with hut circle in foreground (September 2007).

The opportunity was taken in September 2007 to make a rapid DGPS survey of the nearby hut circle and field clearance cairns (see below). For all site mapping, a Magellan Promark 3 unit was used in mobile mapping mode, with satellite-based differential correction provided by EGNOS. This

typically provides sub-metre horizontal accuracy. The results were then corrected against the Ordnance Survey Mastermap data.

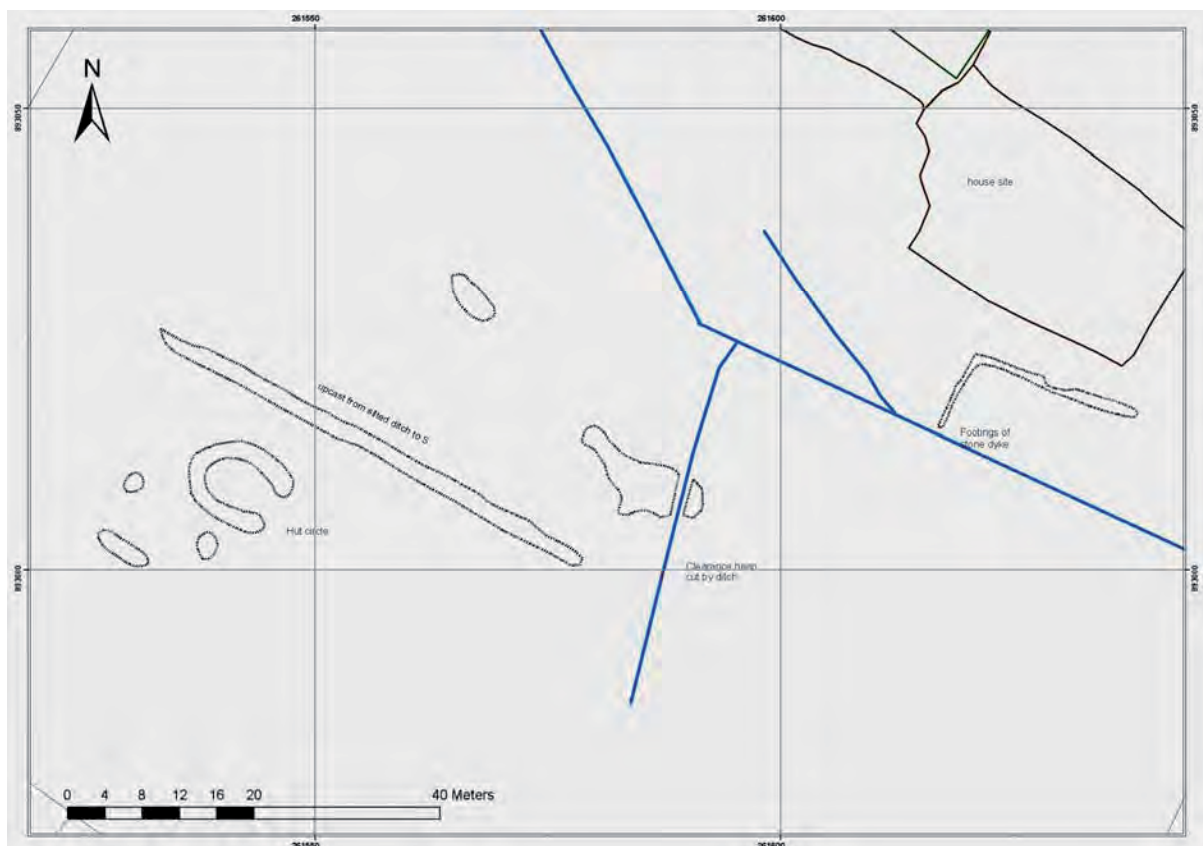
Figure 3 Hut circle and other archaeological features

*Note that the full extent of the branching ditches was not obtained.*

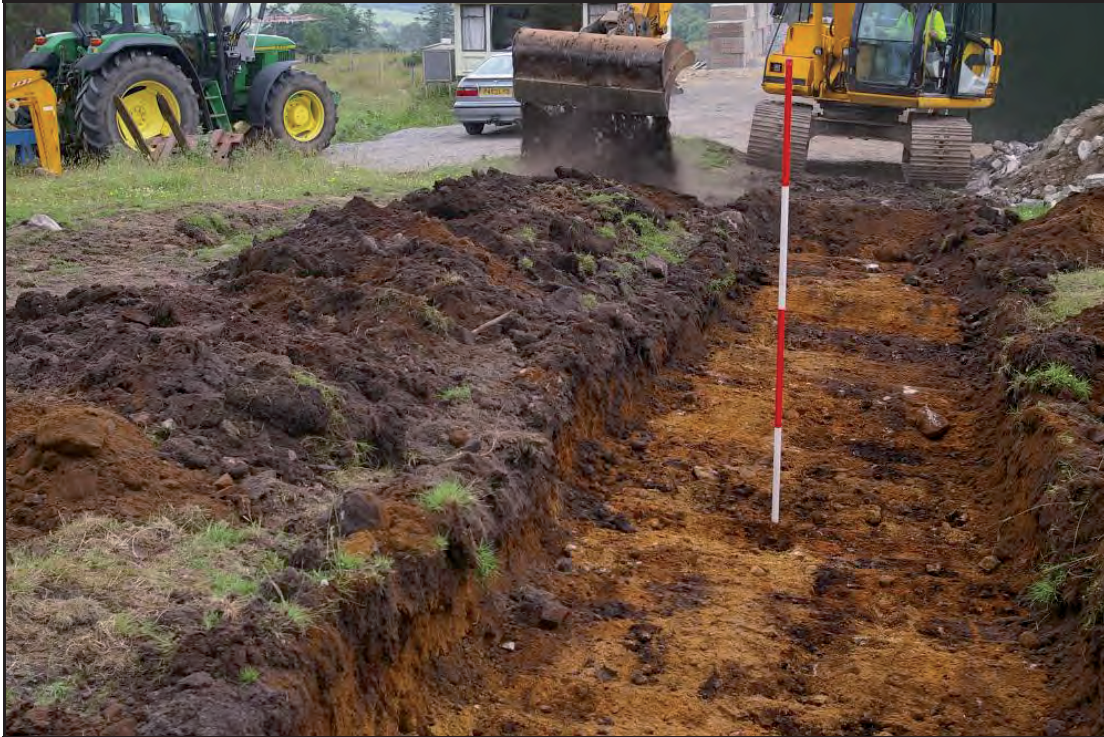
**Plate 5 Trench 1 under excavation, July 2008**

Trench 1, the proposed site for a bore hole, is aligned NNW – SSE and occupies part of a natural glacial mound composed of red / yellow sands and angular pebbles, upon which the house site, investigated in September 2007, stands.

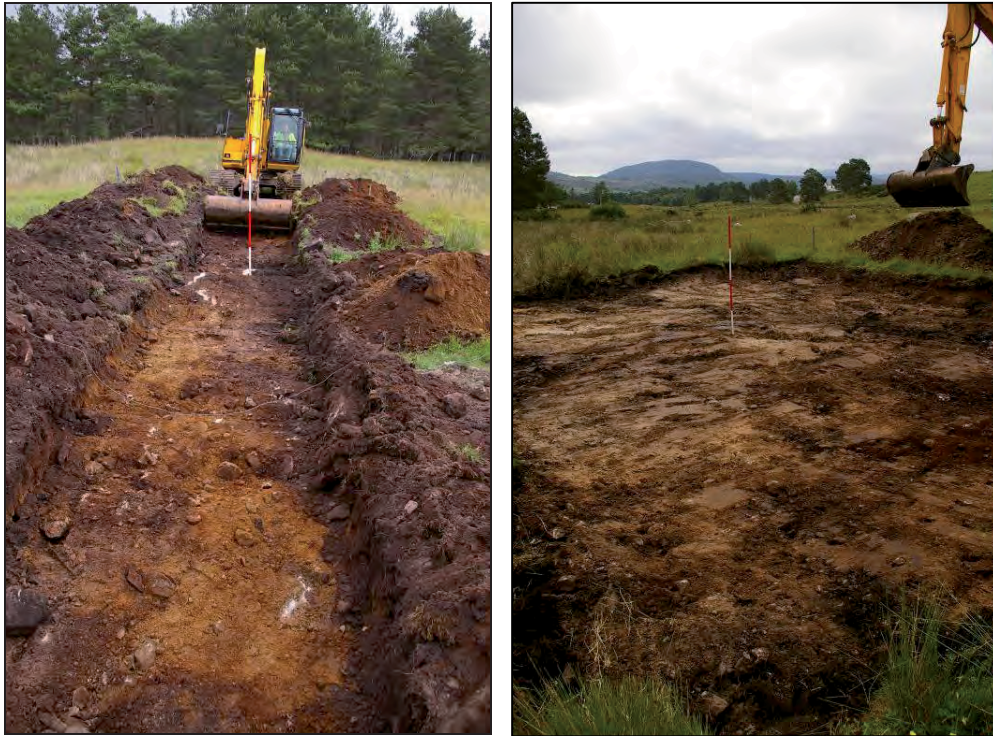
Plate 6 Trenches 2 (left) and 3

The ground conditions in Trench 2, running NNE - S, part of the cutting for a geo-thermal heating complex, were somewhat similar to those for Trench 1, being of natural peri-glacial origin. A notable rock outcrop was visible mid-way along the trench line here.

Although there were some variations the ground conditions for Trenches 3 and 4 – cut for the geo-thermal heating complex and a drainage channel and soakaway area, respectively - both came down rapidly onto peri-glacial till. No archaeological features or structures were found in the areas cleared. Throughout, the trenches came down onto natural sands, gravels and rocks at 10-25cm depth.

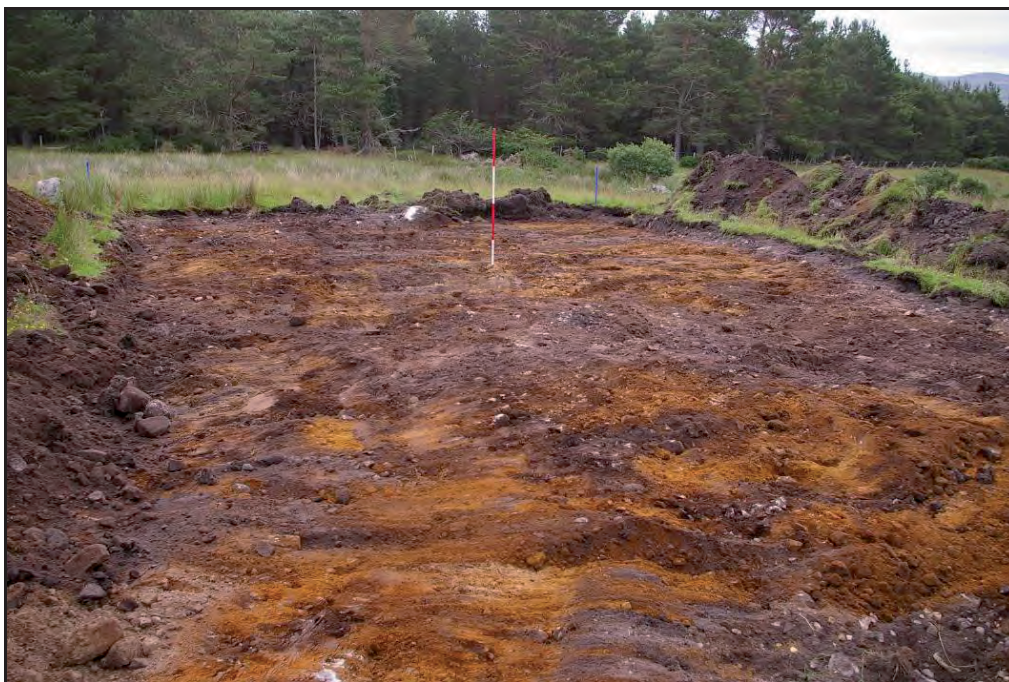
Plate 7 Trench 4

4	NH6165393025	Length = 15.3m Width = 10m Depth = 0.45m (approx)	In section, as Trench 1, though here the subsoil is more clearly silty sand in an undifferentiated, loose mix with angular pebbles and occasional cobbles. Boulder inclusions occur frequently. There is a notable sedimentary rock boulder at the northern extent of the trench.
