Highland Archaeology Services Ltd

Archaeological Watching Brief Gordonstoun School, Moray

Report and Recommendations

Report No. HAS050101

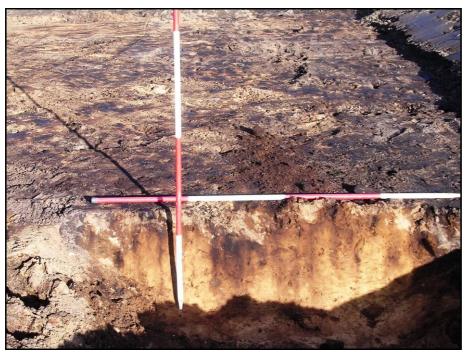
Figure 7 Trial excavation: N - S section on east side of excavation, after topsoil removal over the site. Note leaching of mineral deposits into underlying sand

Approx. 500mm of homogenous brown topsoil overlay sand, with an extensive mineral pan layer at the interface. This mineralised layer was very varied in nature and depth.

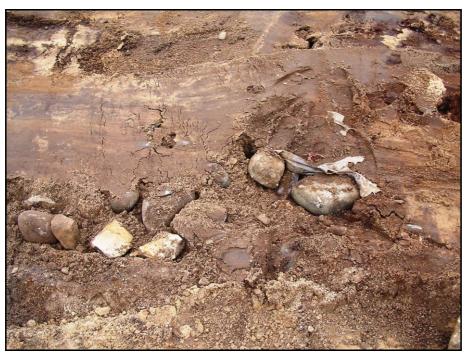
Figure 8 Modern disturbance along W side of trench

Along the western edge of the trench for the new building ran a modern disturbance containing $20^{th} - 21^{st}$ c. debris. This was apparently the result of recent fibre-optic cabling work.

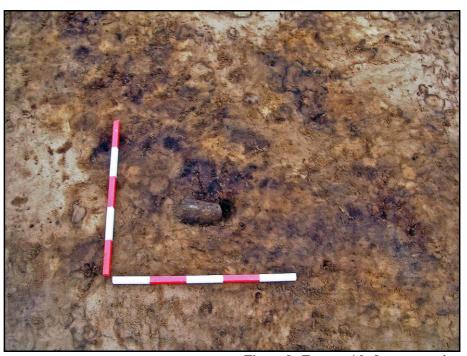
Figure 9 Feature 1 before excavation

In the southern side of the trench, four potential archaeological features were noted. These were all ill-defined blackened areas. They were investigated to establish whether they could be the extremely truncated remnants of post or stake holes and so be archaeological in origin. This sort of evidence is common along the southern Moray Firth coastal lands, especially in areas (as at Gordonstoun) where crop-marks have been seen.

They were cleaned by hand and Features 1 and 4 were half sectioned, but it quickly became apparent that all of them represented natural variations in the mineral pan deposit.

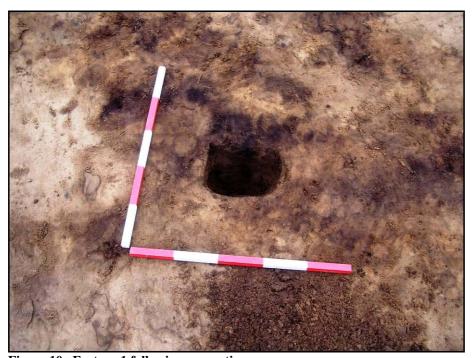
Figure 10 Feature 1 following excavation

This proved to be a natural stone-hole which had attracted a concentration of mineralised deposits.

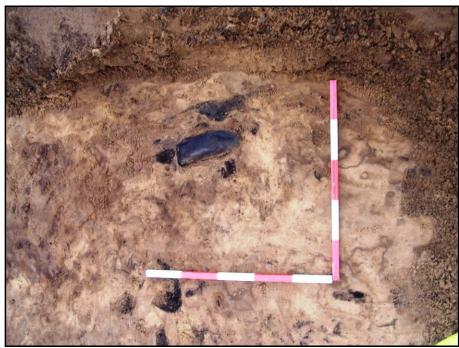
Figure 11 Feature 2

In this case the features observed are all the result of natural variations in the extensive mineral pan that lay at the interface between the sand and the topsoil. No finds were made, nor was any material found suitable for sampling for dating or other diagnostic purposes.
