Land at Leanach Farm, Leanach, Culloden Moor

Archaeological Metal Detecting Survey & Watching Brief

for Scottish & Southern Energy Networks

Report No.	LEC18-3	
Site Code	LEC18	
Client	Scottish & Southern Energy Networks	
Planning Ref	N/A	
OS Grid Ref	NGR 7550 4478	
Date/ revision	17 th May 2018	
Author	Andrew Young MCIfA

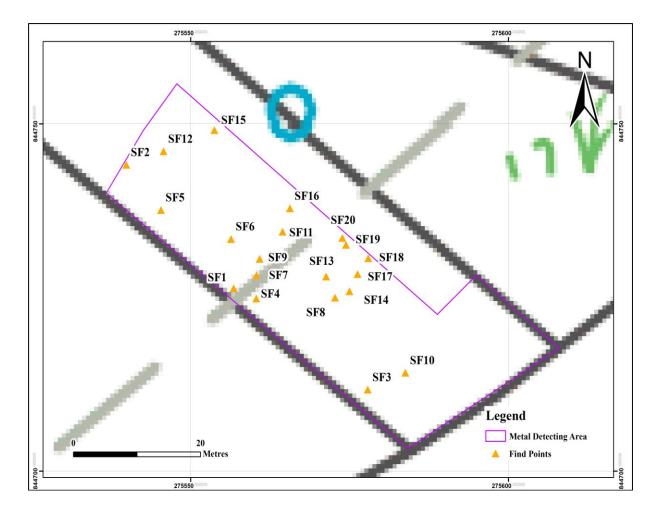
Figure 10: Distribution of metal detecting finds

A total of 20 metal objects (Appendix 3, SF1 to SF20) were identified and lifted within the survey area, the distribution of which is shown on Figure 10.

Finds recovered during the metal detecting survey (Figure10) are listed in Appendix 3. The collection mainly consisted of modern agricultural items that included fragments of rusty fencing and miscellaneous bolts, nails and small fittings, which have all been discarded. The assemblage also includes two modern one pound coins and three irregular lumps of lead. These, along with two larger iron items, have been retained for possible submission for Treasure Trove assessment.

None of the objects recovered by metal detecting are thought likely to reflect items associated with the battle of Culloden Moor.

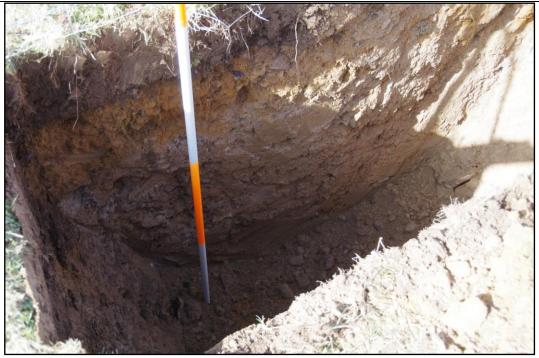
Figure 12: RTP2 as excavated. Scale in 500mm graduations

The pit (Figure 9) was excavated for the relocation of existing power pole TP12. It was opened alongside the modern fence line at c NH75506 44763 and excavated to a maximum depth of 1.7m. It revealed 200mm of stone free sandy silt topsoil that lay directly over a natural substrate of light yellowish-brown gravelly sand and narrow bands of coarser till gravels, which extended beyond the depth of the pit.

The pit failed to reveal any significant archaeological deposits or finds.

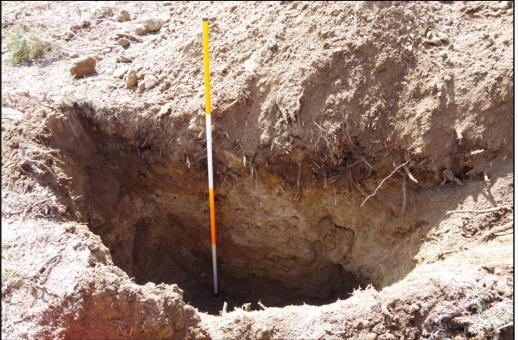
Figure 13: RTP5 as excavated. Scale 2m

The pit (Figure 9) was excavated for the relocation of existing power pole in rough sloping ground at the south eastern end of the cable trench, approximately 2.5m to the west of the existing pole. The cutting measured 2.2m x 900mm in plan and was opened at c NH75618 44707. The pit was excavated to a maximum depth of 1.7m and revealed 300mm of very rooty sandy silt topsoil that overlay a natural substrate of light yellowish-brown sandy silt that contained sparse stone sized to large cobble inclusions.

The pit failed to reveal any significant archaeological deposits or finds.

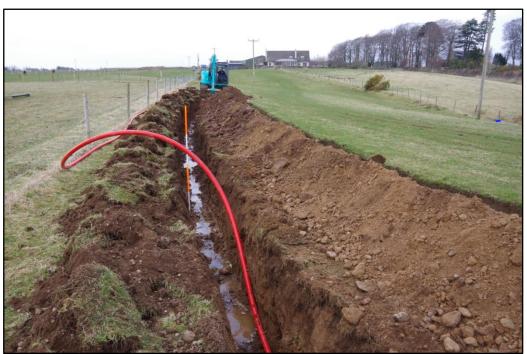
Figure 14: The cable trench as excavated. Facing NW. Scale 2m

The cable trench was excavated for a total distance of c 75m in grassland and rough ground between RTP1 and RTP5 (Figure 9). Beyond the fence line to the southeast it was opened in rough sloping ground that declines increasingly steeply to the river Nairn.

The trench was up to 1.1 m deep and 700mm wide throughout. The topsoil (101) varied between 250mm and 350mm deep and consisted of friable sandy silt that was generally stone free. The topsoil in the part of the trench opened in rough and sloping ground to the southeast of the fence was broadly similar but contained many more tree and plant roots.

The topsoil overlay undisturbed natural substrate (102) throughout the trench although the nature of that natural material varied. The southern part of the cable trench and pole-pit RTP5 revealed a sandy silt substrate containing variable but subordinate inclusions of stone to small boulder sized inclusions. The northern third or so of the trench and RTP1 revealed a very different substrate consisting of an unsorted and poorly consolidated glacial till deposit.

No archaeologically significant features of any kind were revealed in the trench and no finds of any kind were recovered.

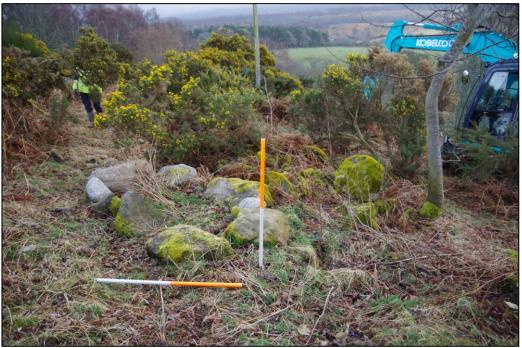
Figure 15: Clearance cairn 103. Facing SE. Scales 1m

A probable modern clearance cairn (103) was noted immediately to the southeast of the field boundary (Figure 10). Some of the stones had been arranged in an oval shape. Despite its probable modern origin the cable trench was adjusted to avoid the feature.
