Mid Craggie Farm, Daviot, Highland

Archaeological Strip & Record Project

Report and Recommendations

HAS Report No.	MCF18 - 3
Site Code	MCF18
Client	Theresa Kemp
Planning Reference	16/04514/FUL
OS Grid Reference	NH 3500 9108
Date	July 2018
Author(s)	Andrew Young MCifA

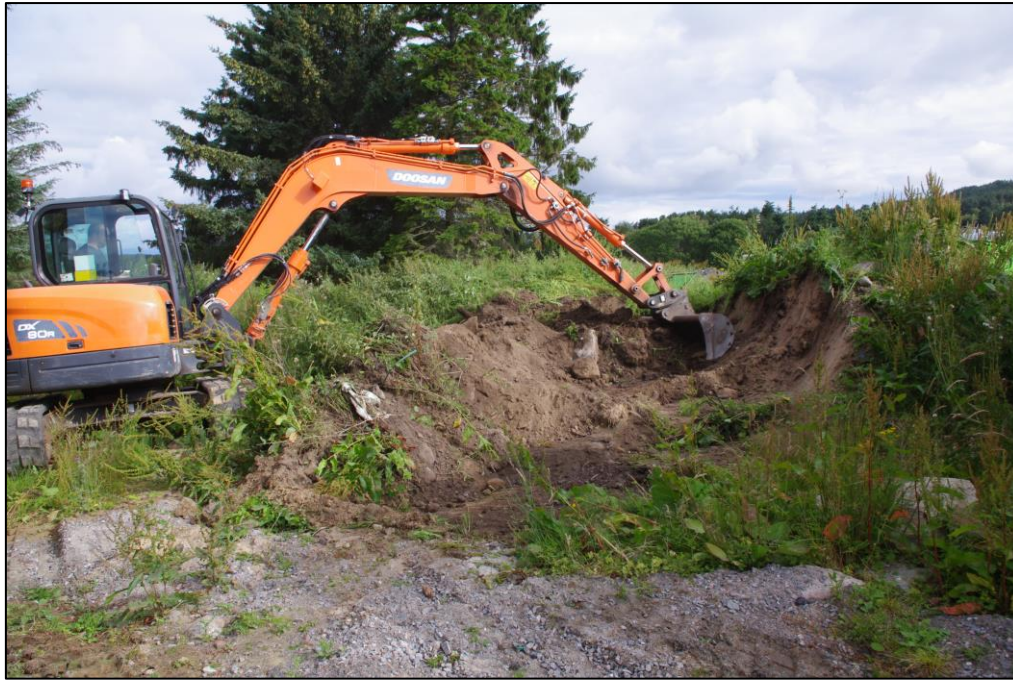
Figure 8 – Removal of modern spoil heaps in progress. Facing N

A series of large modern spoil heaps were removed by machine (Figure 8) in order to allow controlled soil stripping. These deposits were clearly of recent origin and were not examined or recorded archaeologically.

The Strip & Record area (Figures 4, 5 and 9) was opened using an 8 ton slew tracked excavator equipped with a toothless grading bucket under archaeological direction. In practice the work was undertaken in two stages: initial clearance of the several large mixed modern spoil heaps on the site followed by the excavation of in-situ deposits to the upper surface of the natural substrate (Figure 8).

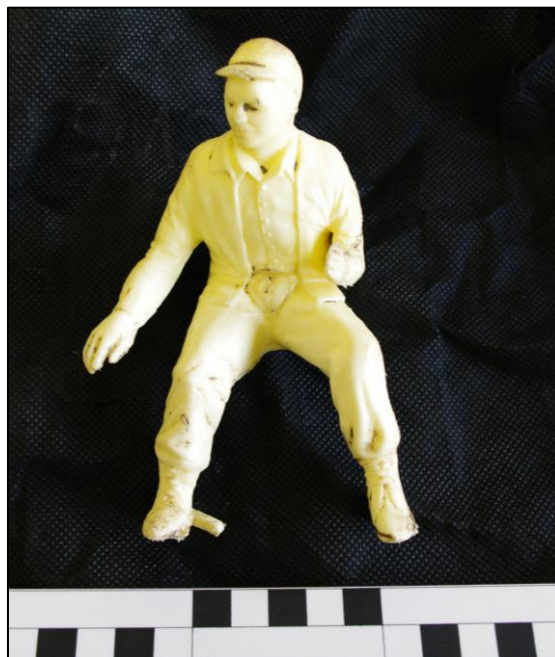
Figure 12 – The c 1970s plastic toy digger driver from Deposit (106). Scale in cms

Finds were restricted to a collection of modern items including fragments of bottle and vessel glass, and sherds of Transfer Printed pottery, the latter recovered from both the fill of the boulder and rubble soakaway (106) and the fill (104) of the modern service trench (103). The lower part of Deposit (106) also produced a splendid white plastic ‘digger driver’ toy, of c 1970s vintage (Figure 12).
