Balcroy Cycle Track, Kilravock, Highland

Archaeological Watching Brief Project

Summary Report

HAS Report No.	BAC17-1
Site Code	BAC17
Client	Kilravock Estate
Planning Reference	13/03771/FUL
OS Grid Reference	NH 82473 51192
Date	24 th November 2017
Author(s)	Andrew Young MCIfA

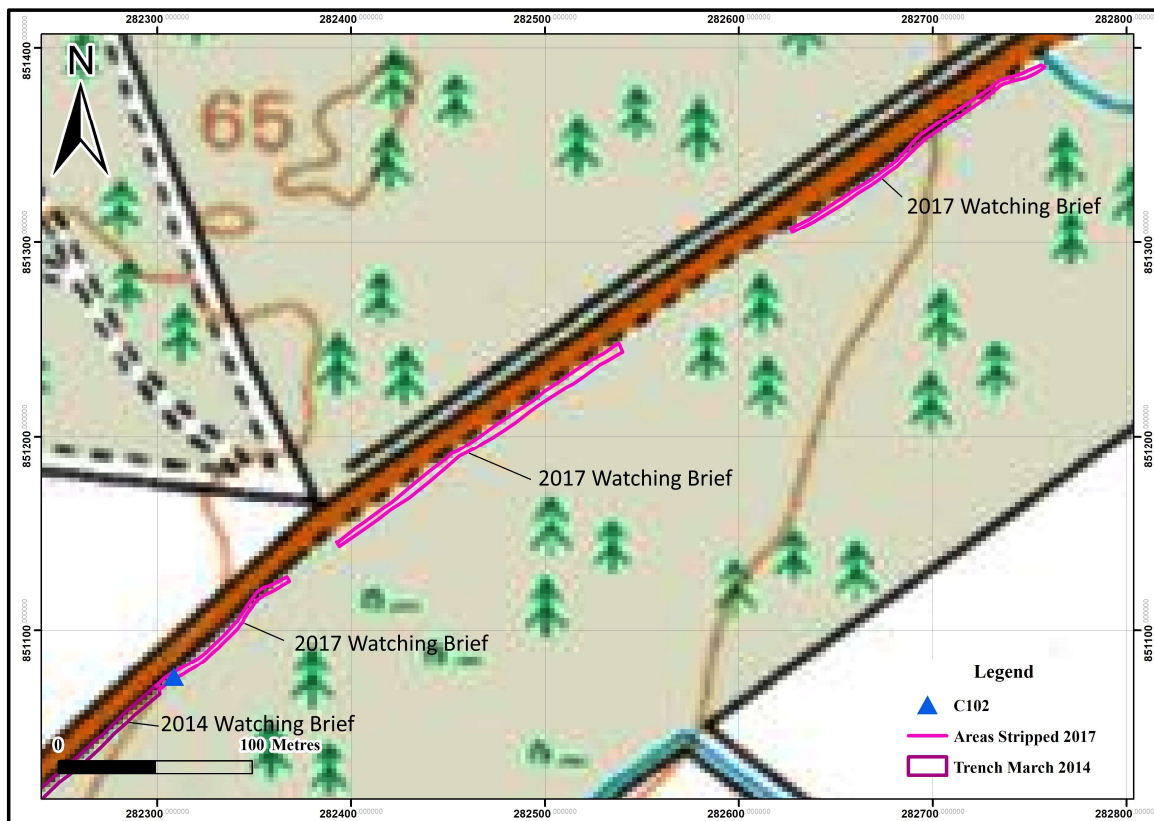
Figure 3a and b – Location of the 2017 Phase 2 Cycle Track Archaeological Monitoring

Work on phase 2 of the trackway (Figure 3a and b) was undertaken on the 20th and 21st of November 2017 and involved monitoring of machine excavation in areas to the SW and NE of the portion of the cycle track route monitored in 2014. Both these sections of the cycle route followed the line of the B9091 and ran through rough grassland to the SW and mixed Birch woodland to the NE.

The remains of a possible field clearance cairn (Figure 3, C102) of unknown date were identified at NH82308 51075.

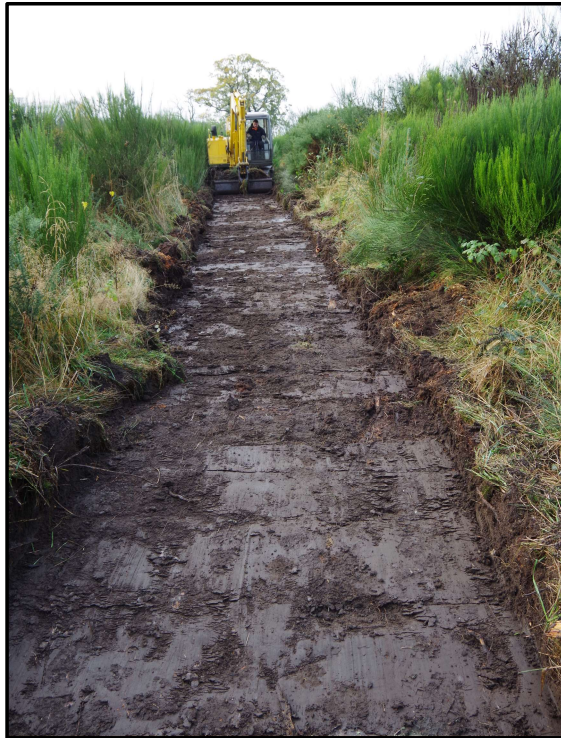
Figure 4 - The cycle track corridor (SW) as stripped at CP2. Facing SW

Fieldwork was undertaken over two days on the 20th and 21st of November 2017. The route was opened using an 8-ton slew tracked machine equipped with a flat grading bucket to a width of between 2m and 3m and to a general depth of approximately 500mm (Figure 4). The machine stripping was opened in two sections. The first section was opened between NH 82129 50898 and NH 82007 50808 to the southwest of the area monitored in 2014. The second strip was opened between NH 82300 51070 and NH 82756 51390 immediately to the northwest of the 2014 work (see Figures 3 and 4).

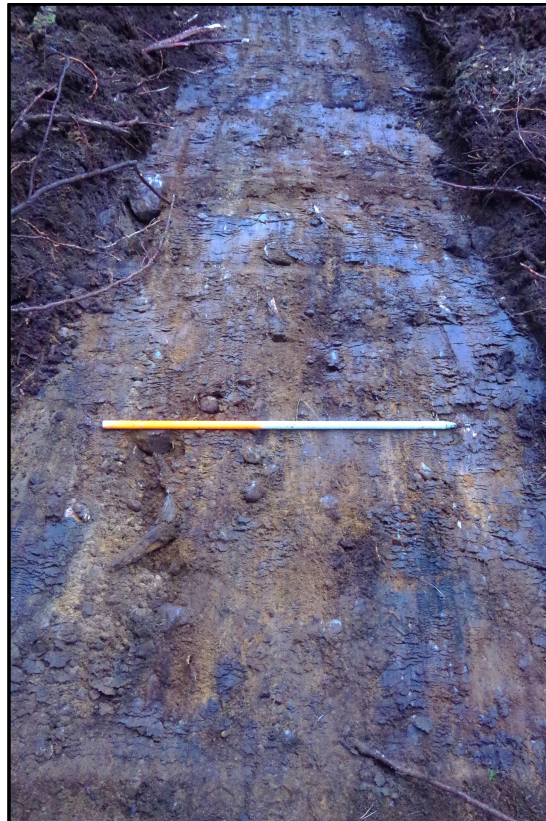
Figure 6 – Detail of the natural substrate in the NE stretch. Scale 1m

The natural substrate (Figure 6; contexts 103 and 104) was only revealed directly below the topsoil in the NE sections of the cycle track. Here it consisted of mixed dark grey to brown to yellowish-cream sandy clay with common to abundant stones and occasional larger cobbles and boulders (Figure 6).
