## Glen Feshie

Archaeological Walk-over Survey and Mitigation for  
Cable Undergrounding Project

### Final Report

<b>Report No.</b>	HAS100509
<b>Site Code</b>	HAS-GFS10
<b>Client</b>	SSE
<b>Planning Ref</b>	N/A
<b>Date/ revision</b>	19/05/2010
<b>Authors</b>	Mary Peteranna Lynn Fraser

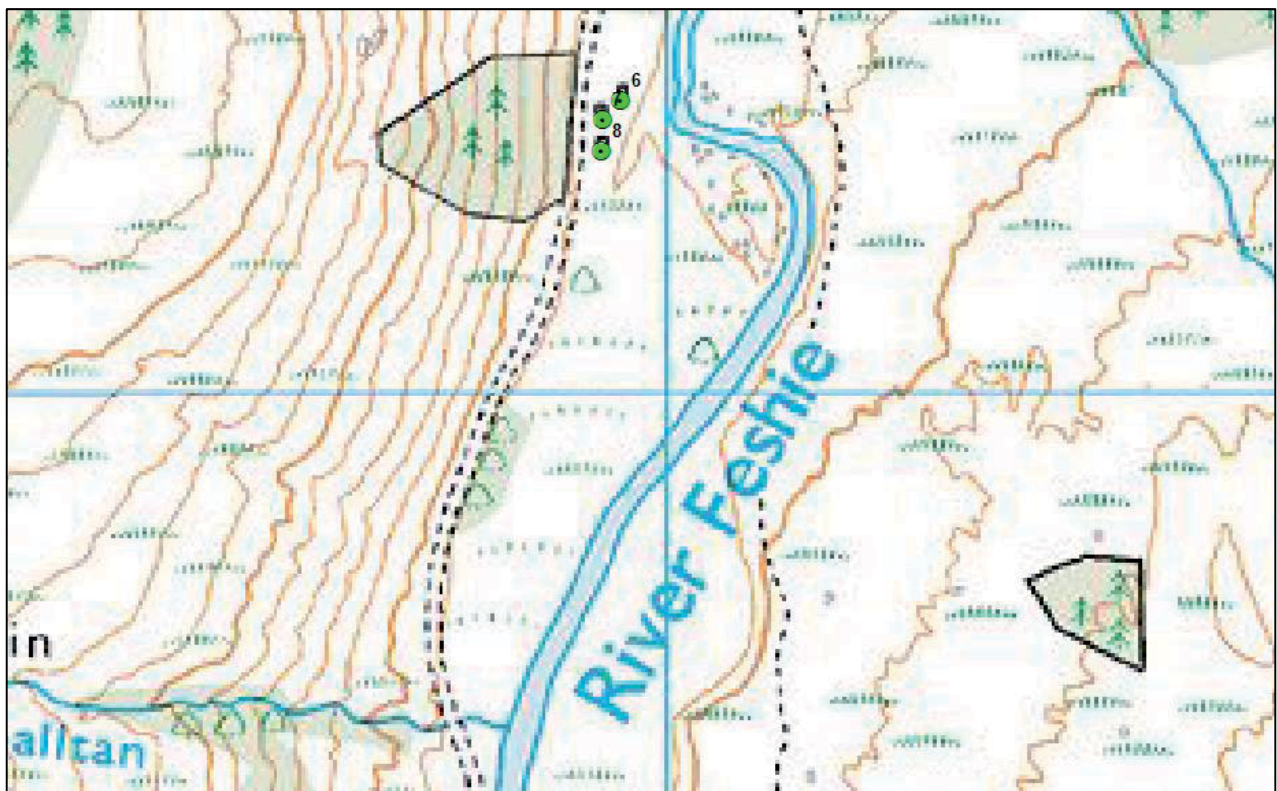
Figure 4 Sites 6-8

Three sites of archaeological interest were identified in close proximity to the trench route near Pole 23 and Pole 24 (see Figure 4). Situated on a turf- and heather-covered terrace on the west side of the River Feshie at approximately 330-340m OD, they correspond with three previously recorded structures (Str. F, G and H in Figure 6) forming part of Stronetoper Township South (HHER #MHG4553).

Sites 6-8 were located in very close proximity to the proposed trench, which was routed across the enclosure wall north of Site 6 and along the west side of Sites 7 and 8. It was recommended that the sites be flagged with high visibility tape and that the trench be routed around the sites under archaeological supervision.

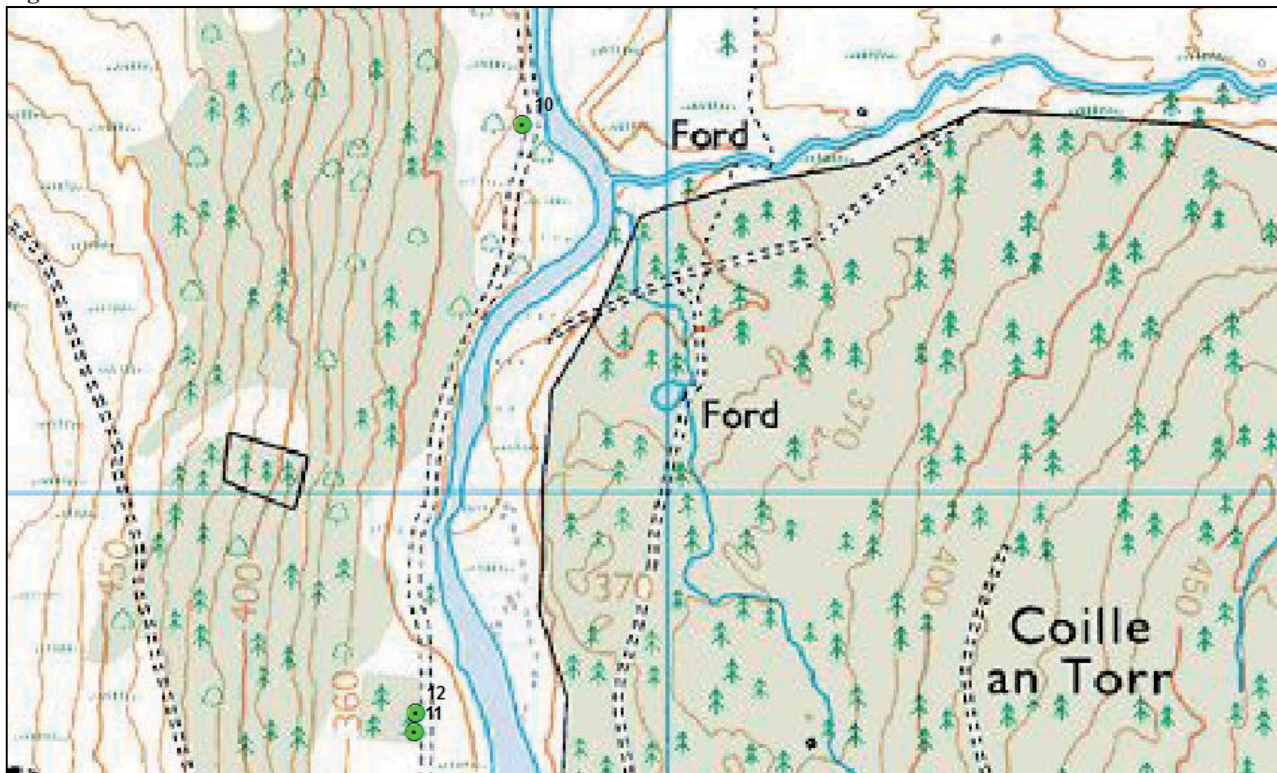
Figure 5 Sites 10-12

The turf structure was recorded in line with the proposed trench route north of Pole 36 (see Figure 5) and corresponds with previously recorded site HHER #MHG 24927. It was situated on the west side of the River Feshie at approximately 350m OD, to the east of a tract of forested land and 3m west of the present-day road. The turf- and heather-covered structure, aligned N-S was significantly degraded, particularly to the west side and showed no visible entrance. There were no other structures found with it.

Site 10, a turf structure, was in-line with the proposed trench route. It was recommended that the site be flagged with high visibility tape and that the trench be re-routed around the sites under archaeological supervision.

Site 11 and Site 12 were also in-line with the proposed trench route. It was recommended that the sites be flagged with high visibility tape and that the trench be re-routed around the sites under archaeological supervision.

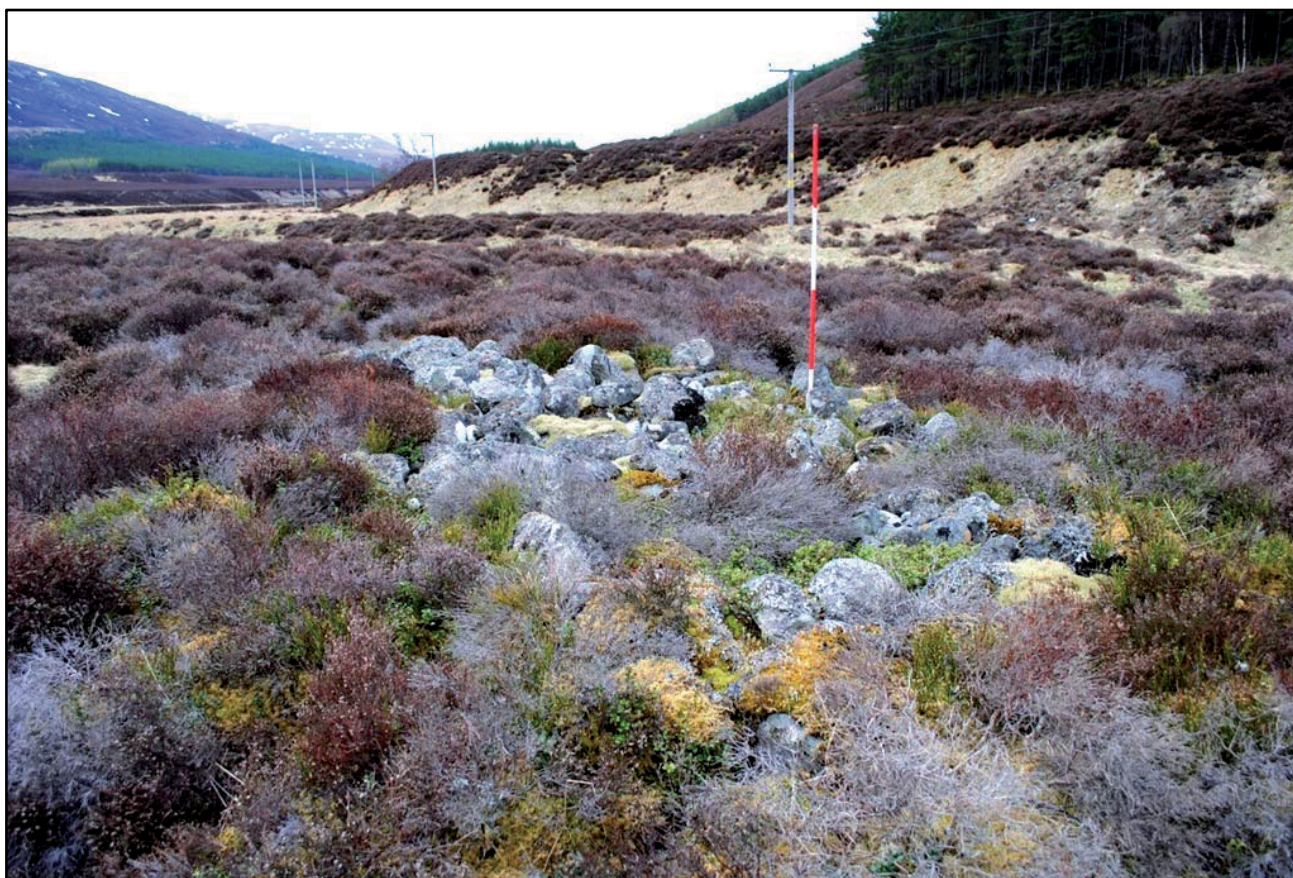
A subrectangular cairn (HHER #MHG45825), orientated north-south measuring 7m by 5m with a height of 0.5m above ground

The cairn consists of moss- and lichen-covered rounded large- and medium-sized stones situated on a platform on a wide, heather-covered river terrace. A drystone curvilinear wall extends southward from the south end of the cairn (see Plan 1 in Appendix 3).

**Plate 1 Subrectangular cairn facing south, Site 1**

Sites 1-3 were located on a wide river terrace in close proximity to the proposed cable trench. It was recommended that the sites be flagged with high visibility tape and that the trench be routed around the sites under archaeological supervision.

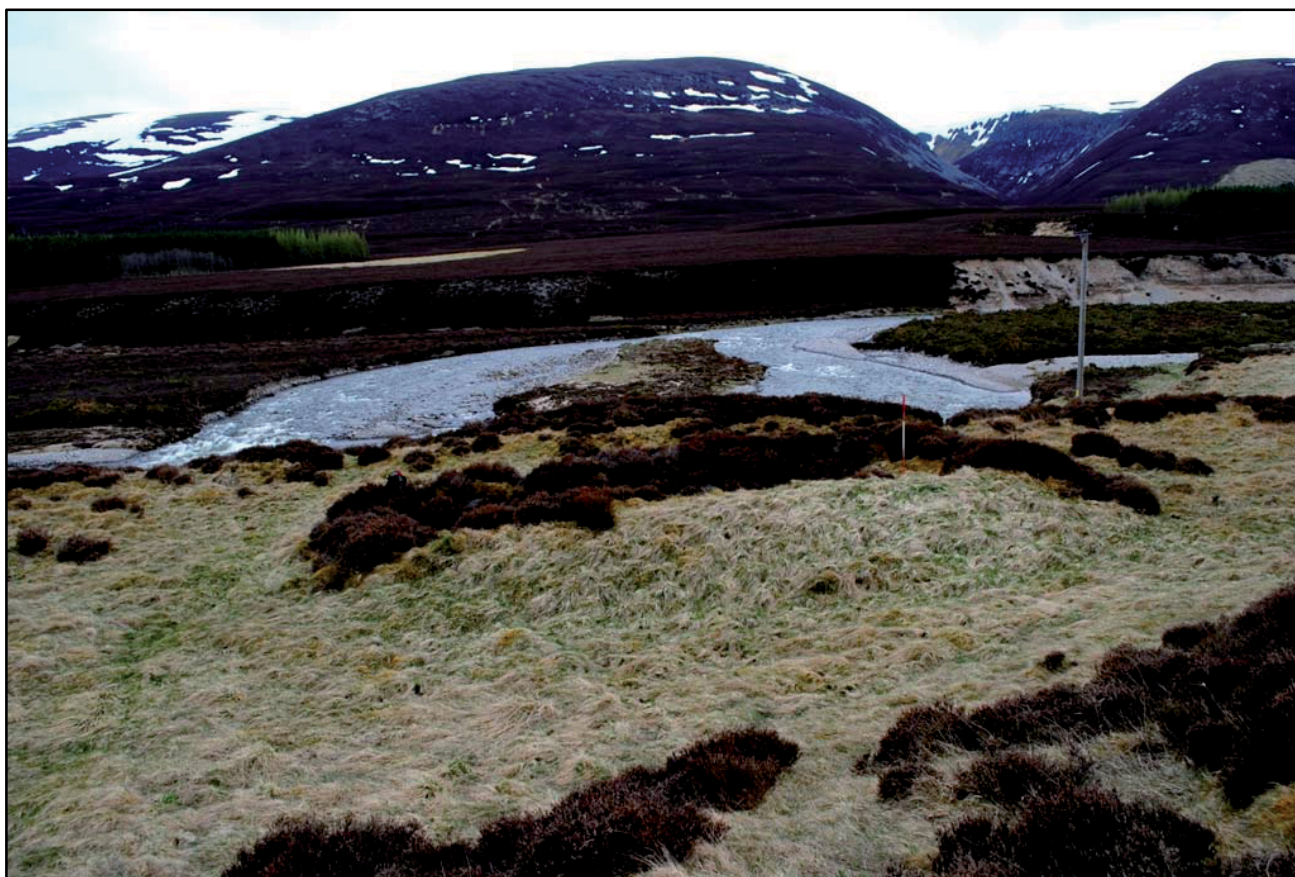
Remains of rectangular turf and drystone building, interior 8m long by 3m wide, 1.0-1.5m high

The structure, aligned N-S with an east-opening entrance, is comprised of turf-covered stone footings approximately 1m wide with a heather-covered interior showing no signs of internal partitioning (see Plan 2). It is situated on grassy river terrace and the wasted remains of a curvilinear turf enclosure disappears north-westward from north side of building at the base of the terrace.

**Plate 2 Turf and stone building facing east, Site 6**

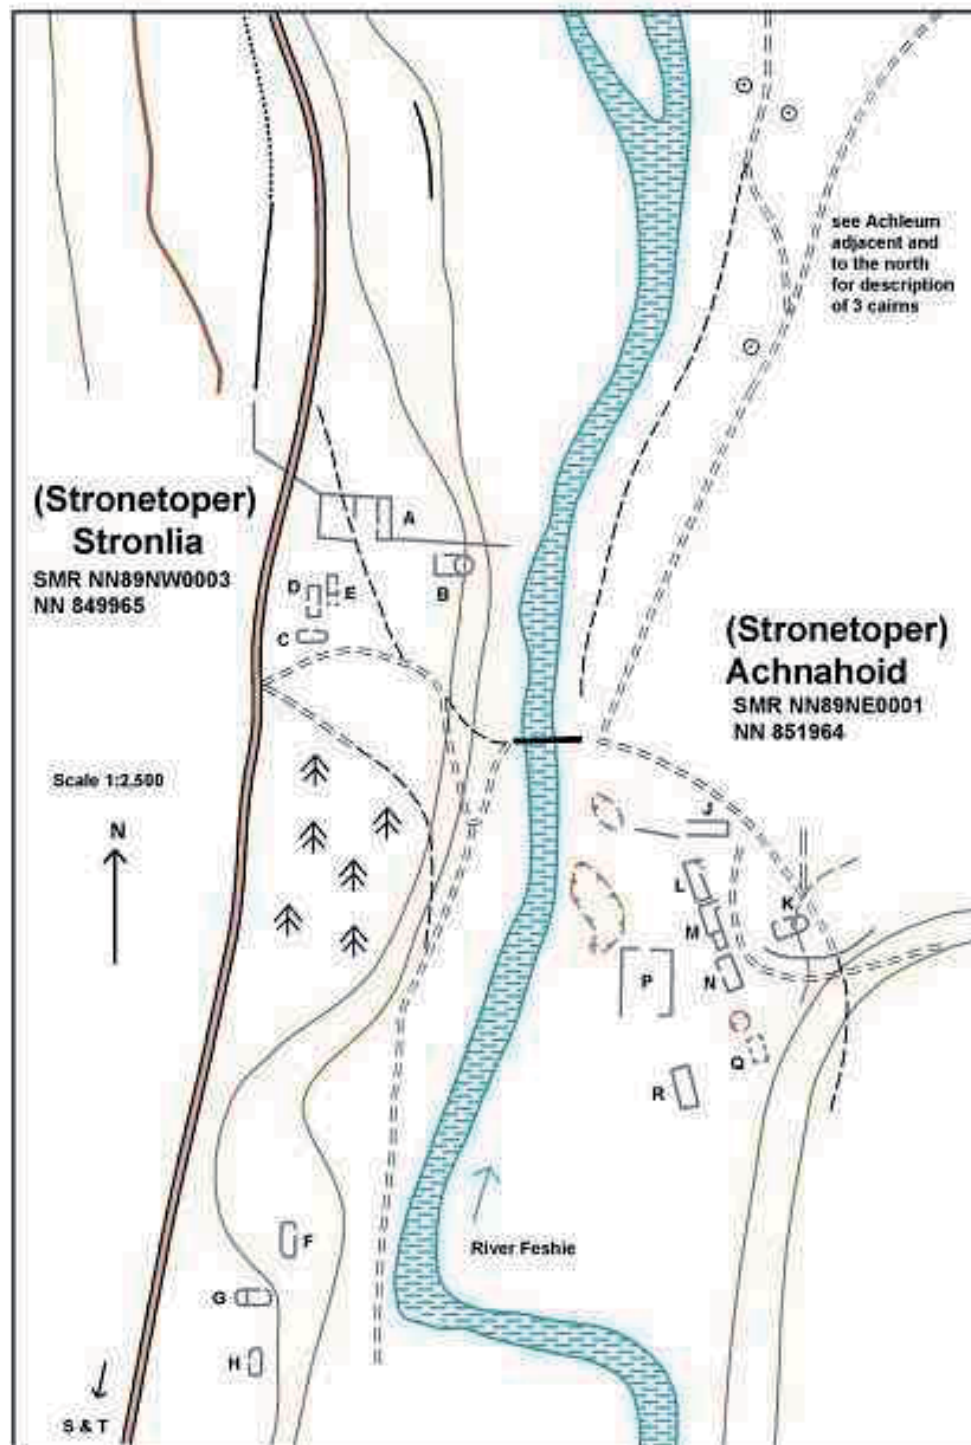
Figure 6 Stronlia and Achnahoid Plan (M Marshall 2001)

The settlement, comprising two groups of buildings on the west bank of the River Feshie is depicted on Roy's military survey. It is not shown on the First Edition Ordnance Survey map but is depicted on the current 1:25000 Ordnance Survey map. The site was surveyed by NOSAS (see Figure 6, below).

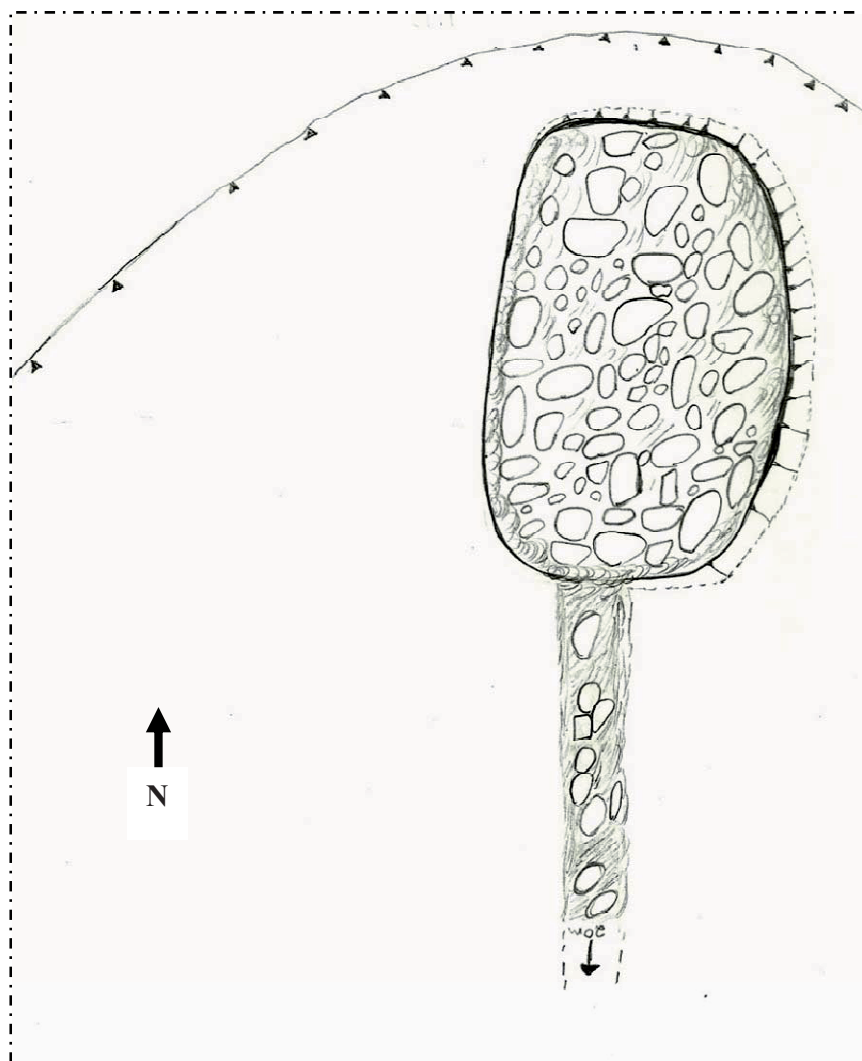
### Plan 1 Cairn (Site 1)

*Drawn at 1:100. Not reproduced to scale.*

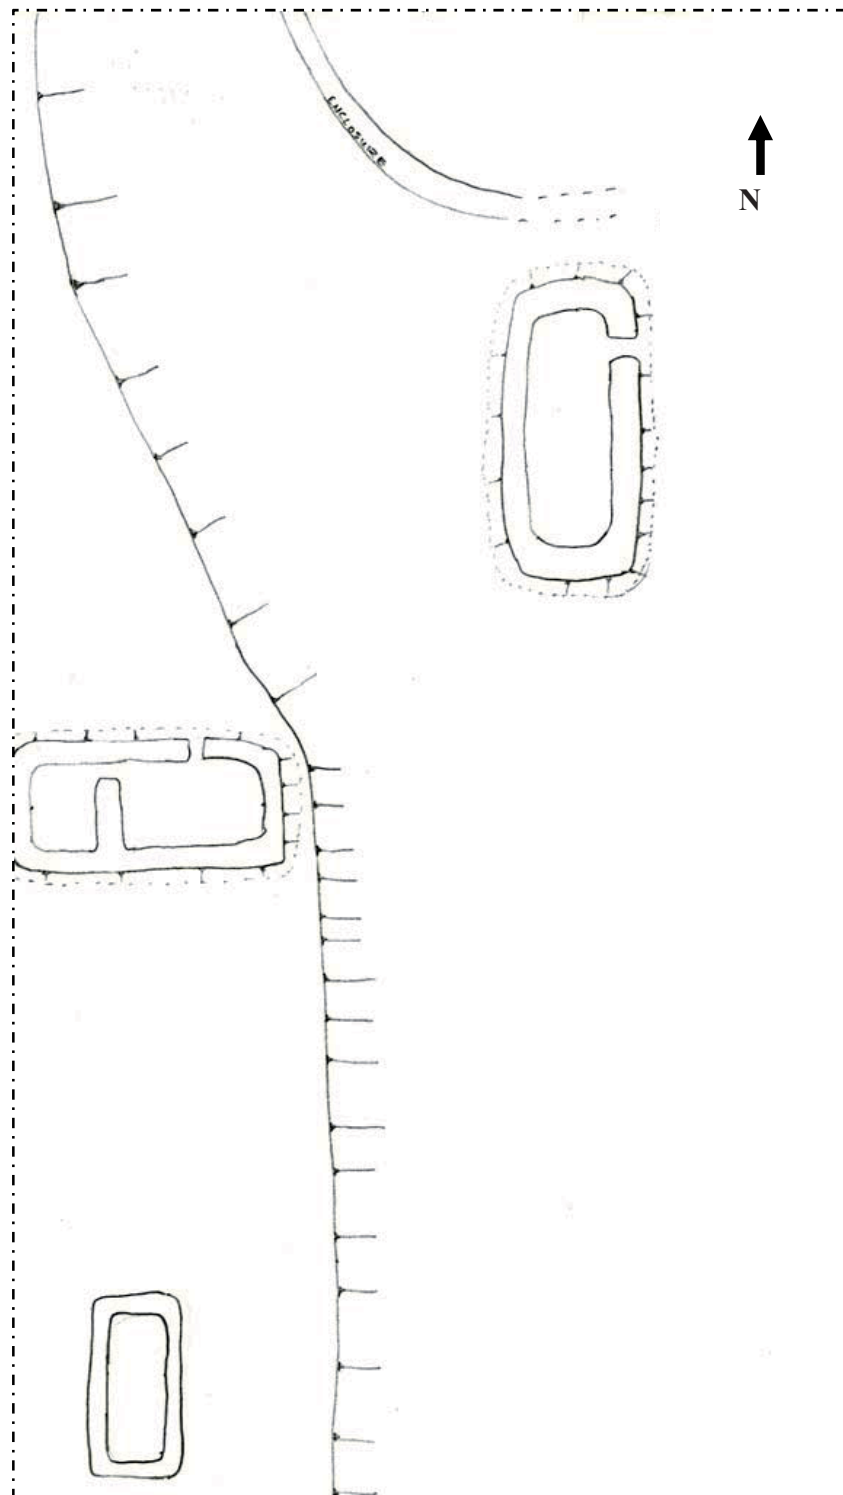
**Plan 2**

The heather-covered structure, aligned E-W with opposing north-south entrances, is comprised of 1m-wide turf-covered stone footings with one internal partition. It is situated on a grass- and heather-covered river terrace above the location of Site 6 and north of Site 8 (see Plan 2).

**Stronetoper South (Sites 6, 7, 8)**

*Drawn at 1:200. Not reproduced to scale.*

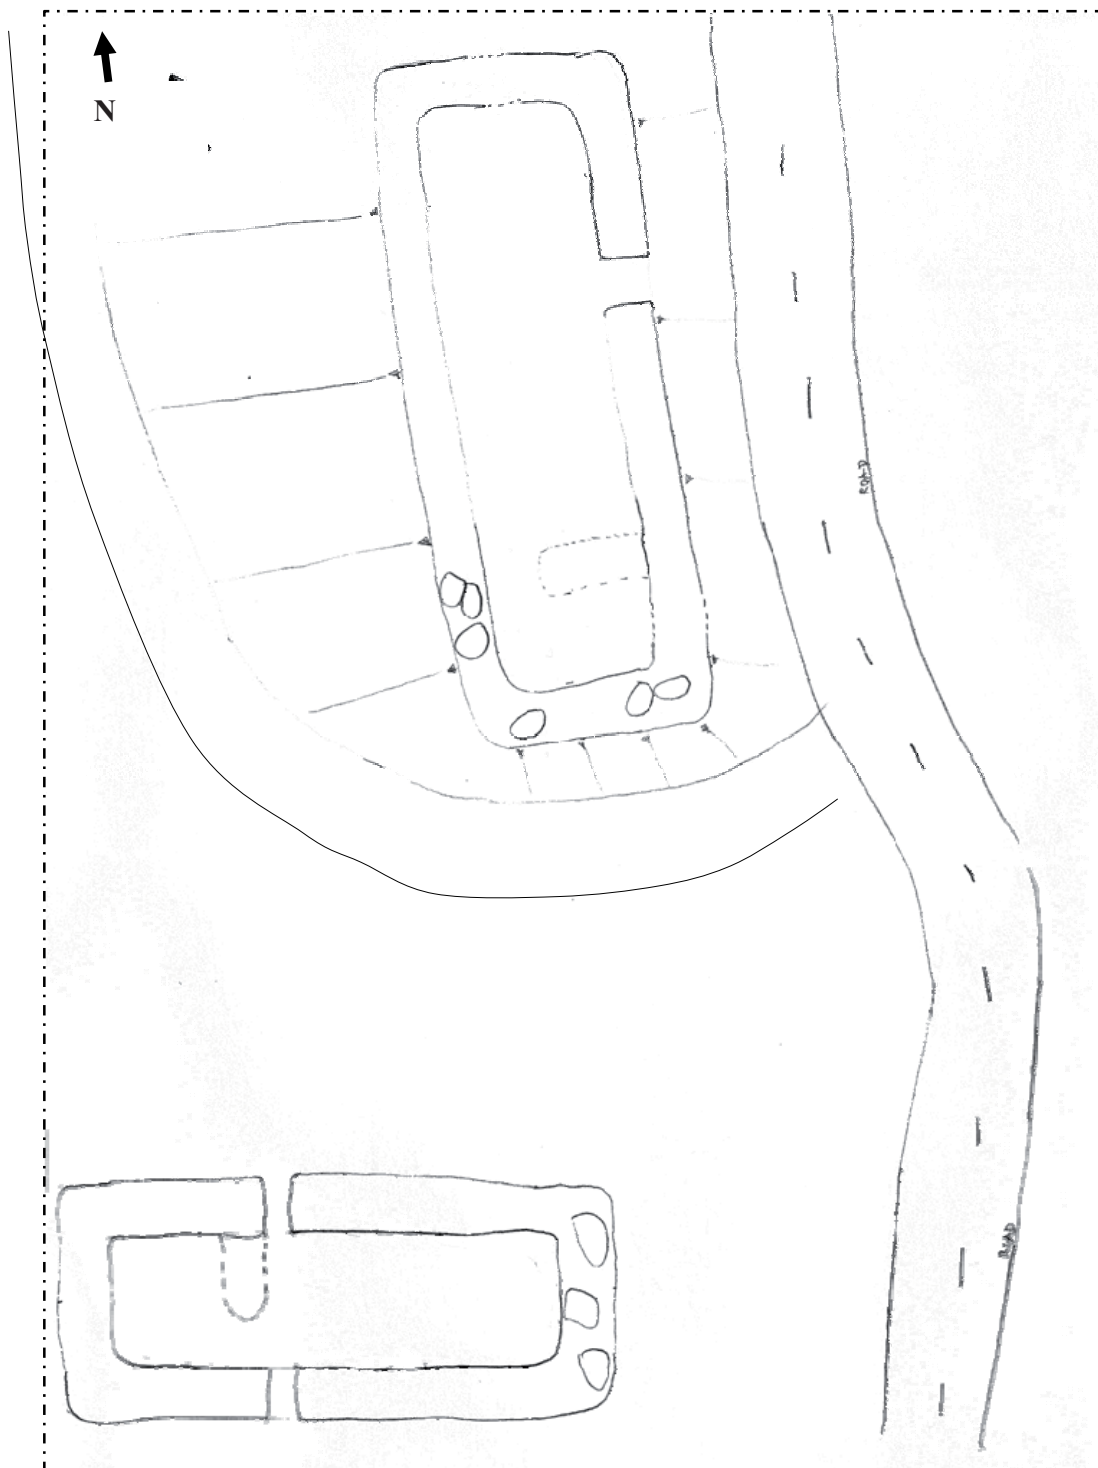
**Plan 3**                      **Carnachuin North (Sites 11 & 12)**

*Drawn at 1:100. Not reproduced to scale.*

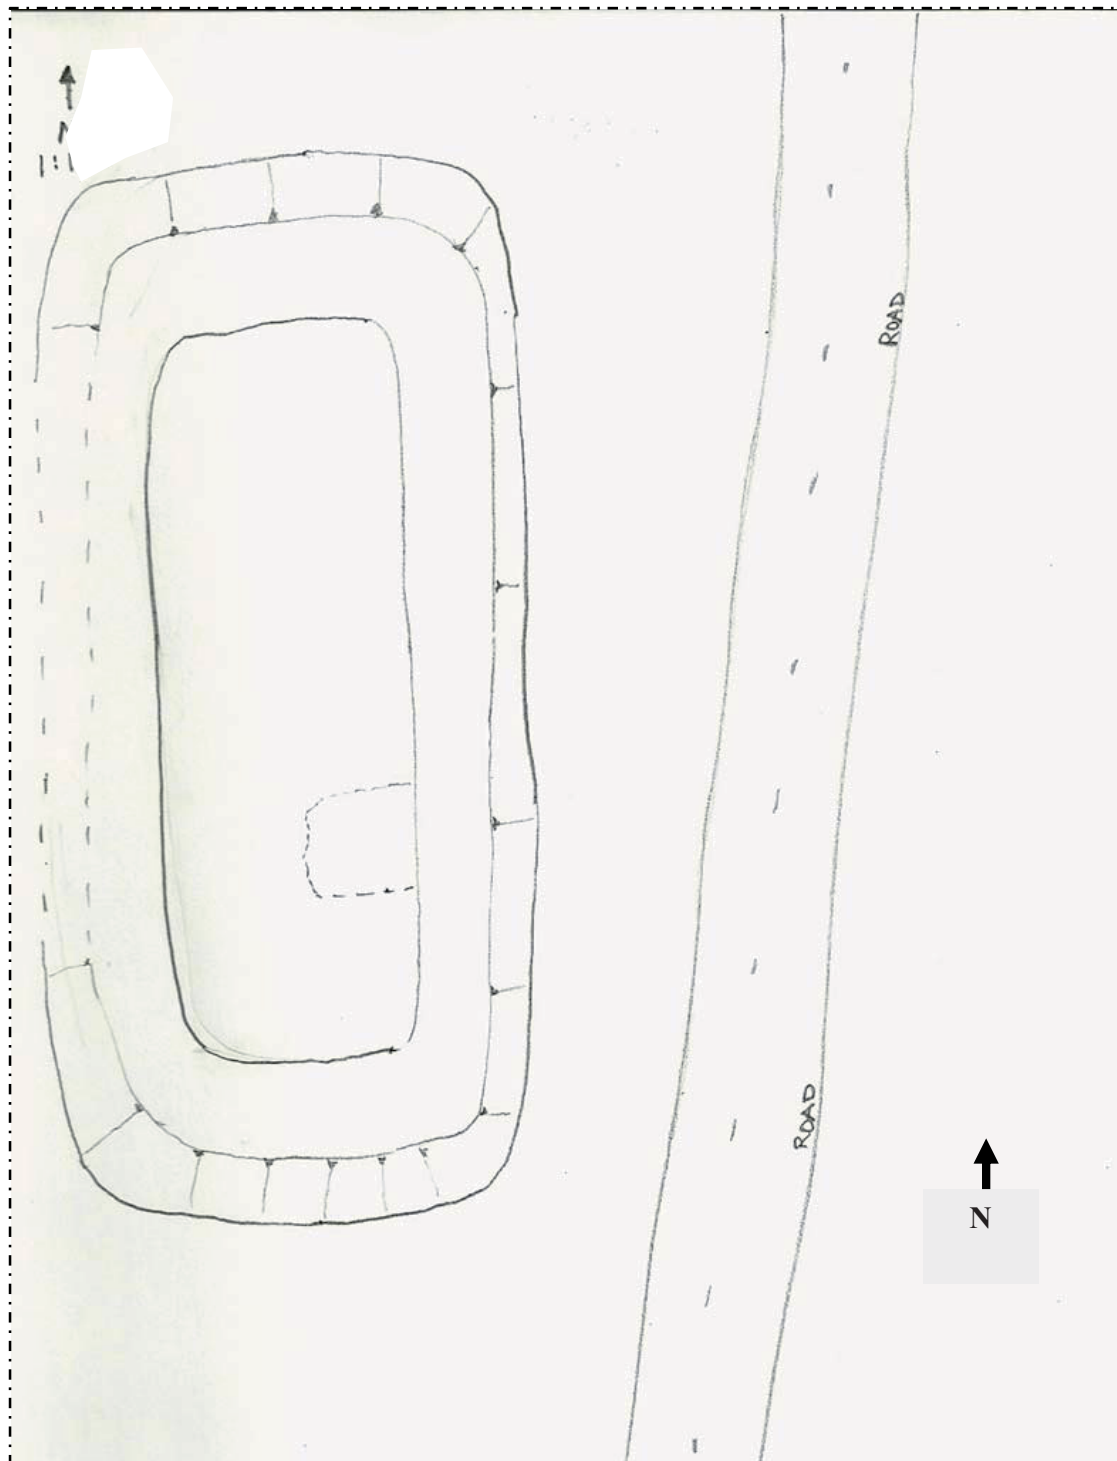
**Plan 4**

**Site 10**

*Drawn at 1:100. Not reproduced to scale.*

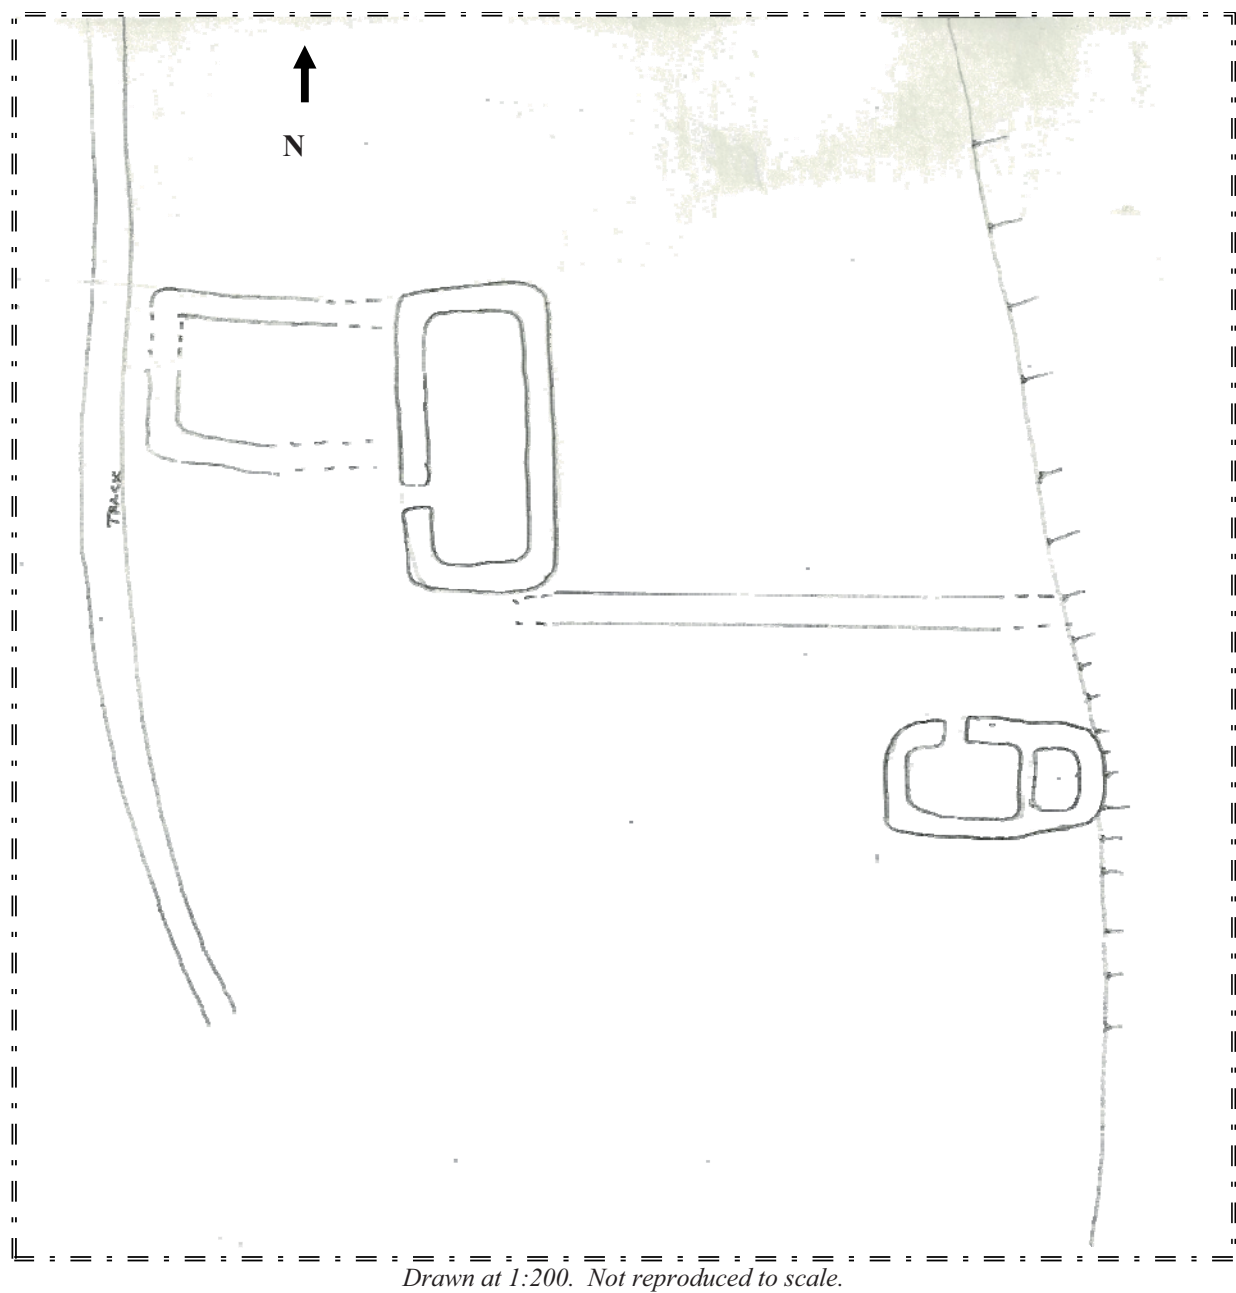
**Plan 4                      Stronetoper North (Sites 4& 5)**

The heather-covered walls (1-1.5m wide) of the building were located one metre to the west of the proposed trench route. A boundary wall, twenty metres in length, extended eastward from the southeast corner of the building to the base of the river terrace and was located in the line of the proposed trench. The building, aligned N-S had a possible entrance on its west side and there was no evidence of internal partitioning in the turf-covered interior. Wasted remains of stone and turf footings of a possible enclosure were located on the west side of the building and were difficult to identify in the extremely high heather.

A kiln (2m wide) and kiln-barn (3m long by 2.5m wide) were located fifteen metres to the east of the building, at the very edge of the river terrace (see Plan 5 in Appendix 3).

Sites 4 and 5 were the only two structures in the Stronetoper Township that would be directly affected by the original cable trench location. The proposed route crossed over the boundary wall (Site 5), running very close to the structure at Site 4 and about 10 metres from the kiln-barn to its east. It was recommended that the trench be rerouted to the base of the terrace in order to avoid all of the structures in the township. If this was not possible, and the trench had to cross the township, truncating the boundary wall (Site 5), the walling could be dismantled by hand and the sections recorded. Due to the machinery and vehicle movement on the site, it was also recommended that each of the structures in the settlement be demarcated with high visibility tape and for all work in the vicinity to be conducted under archaeological supervision.
