## Aberdeen Harbour

### Archaeological Evaluation and Recording Area 1: Interim Report

<b>Report No.</b>	HAS100503
<b>Site Code</b>	ABH10
<b>Client</b>	Aberdeen Harbour Board
<b>OS Grid Ref</b>	NJ 949 054
<b>Date revised</b>	17/5/2010
<b>Authors</b>	Alison Cameron and John Wood

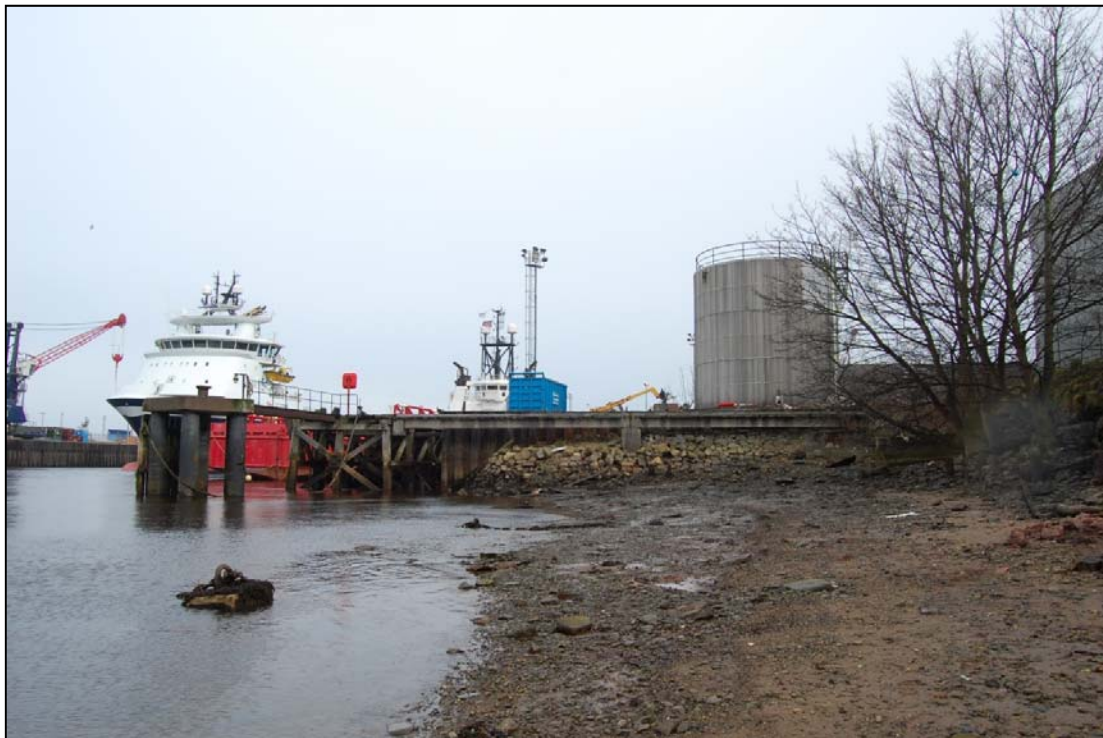
Plate 1 Foreshore area, facing East

This site is now on the foreshore of the river Dee between the low and high tide lines (NJ 949 054). To the south of the excavation area, a stone embankment for Maitland's Quay survives as do several slipways and wooden post alignments which are to be buried during this redevelopment (Patrick Jordan, Aberdeen Harbour Board, pers com).

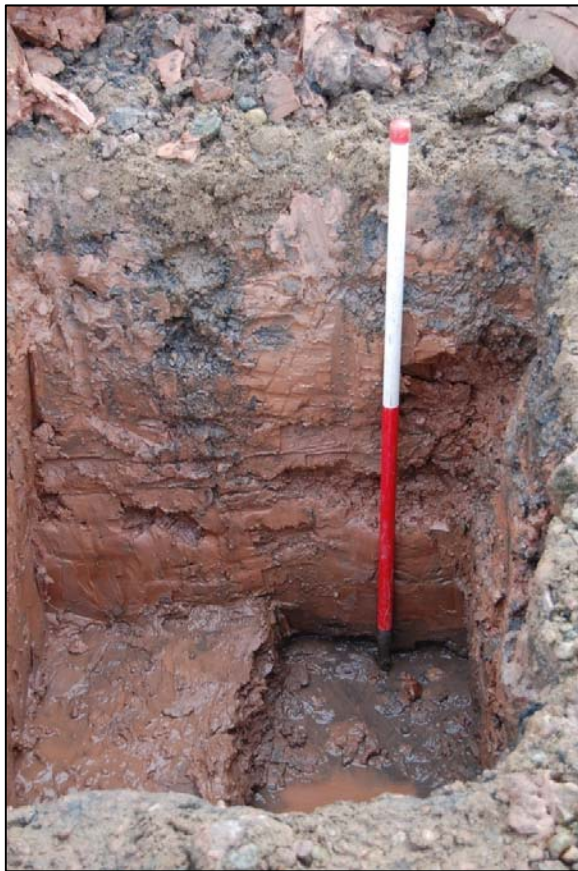
Plate 2 Trench 1: natural clay deposits

Under the sand and shingle layer Trenches 1, 2, 4, 6 and 7 contained only natural clay beds laminated with lenses of sand and silt.

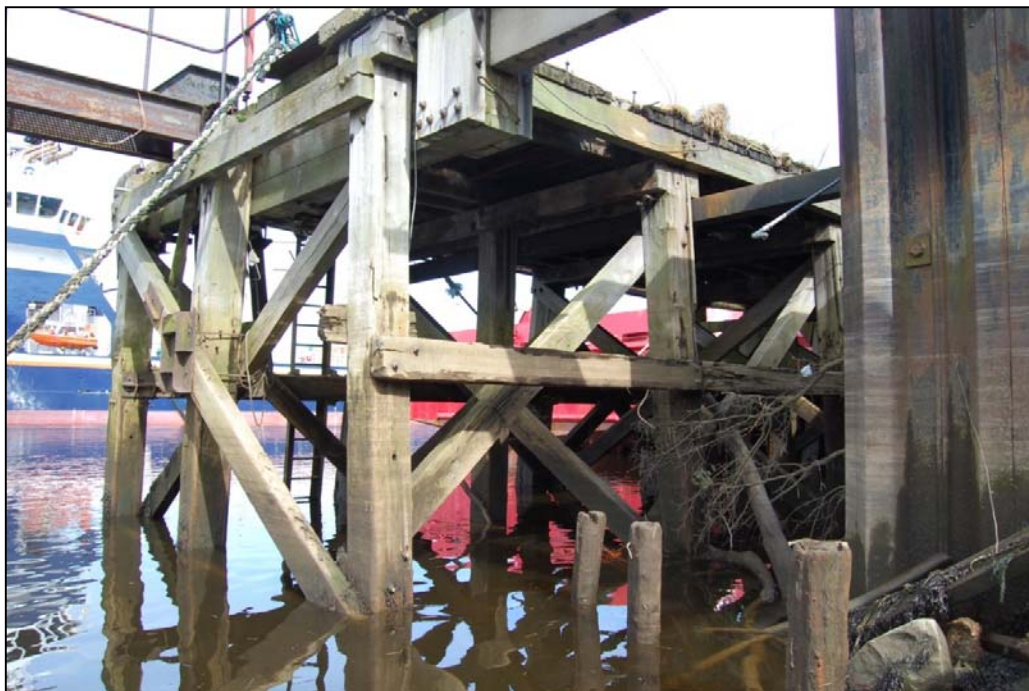
Plate 3 Current jetty structure 88 with posts 83 (right foreground); facing NNE

The slipways and jetties recorded on the foreshore date to the recent period; the shuttered concrete structures are probably mid 20th century in date, and associated with the salmon fishing which took place on this shore of the river Dee until the late 1980s.

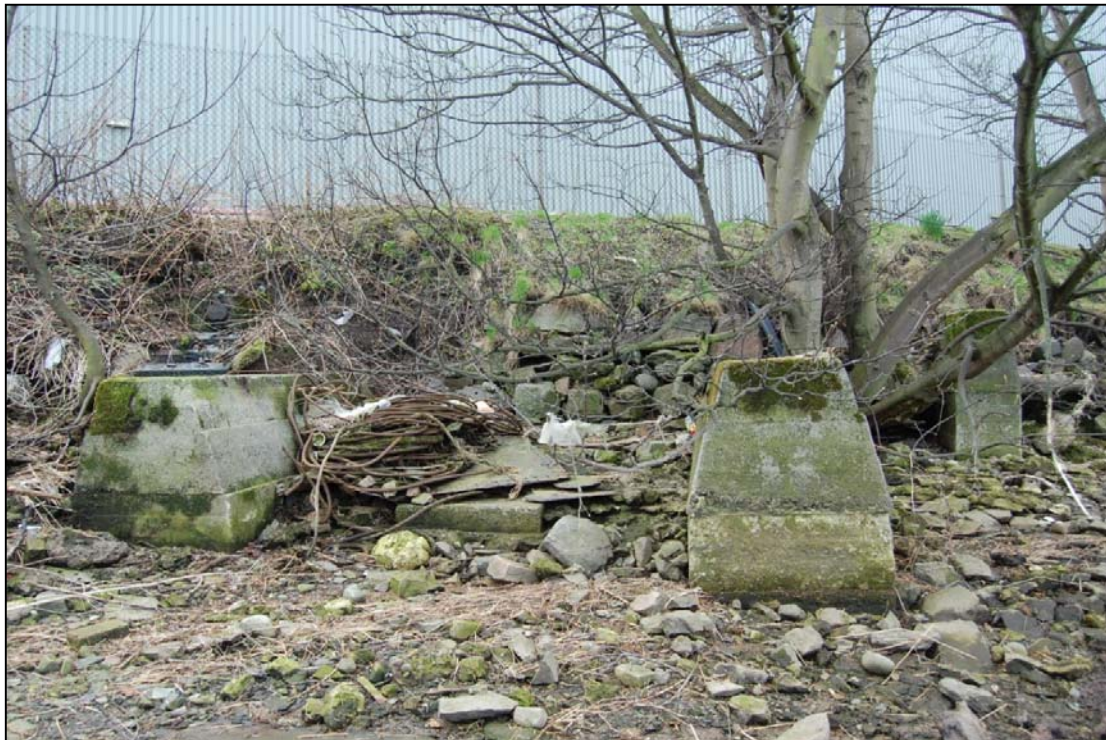
Plate 4 : Jetty 82, facing south

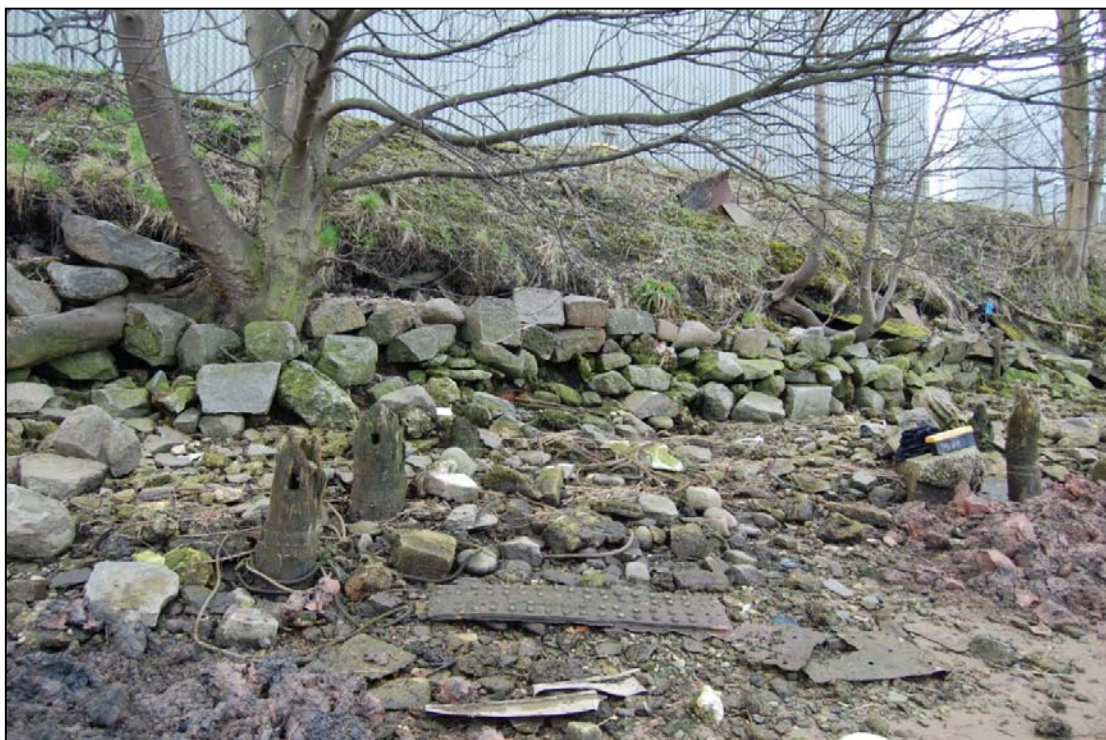
Plate 5 Post alignments 84 (left) and 85 (right); facing SSE

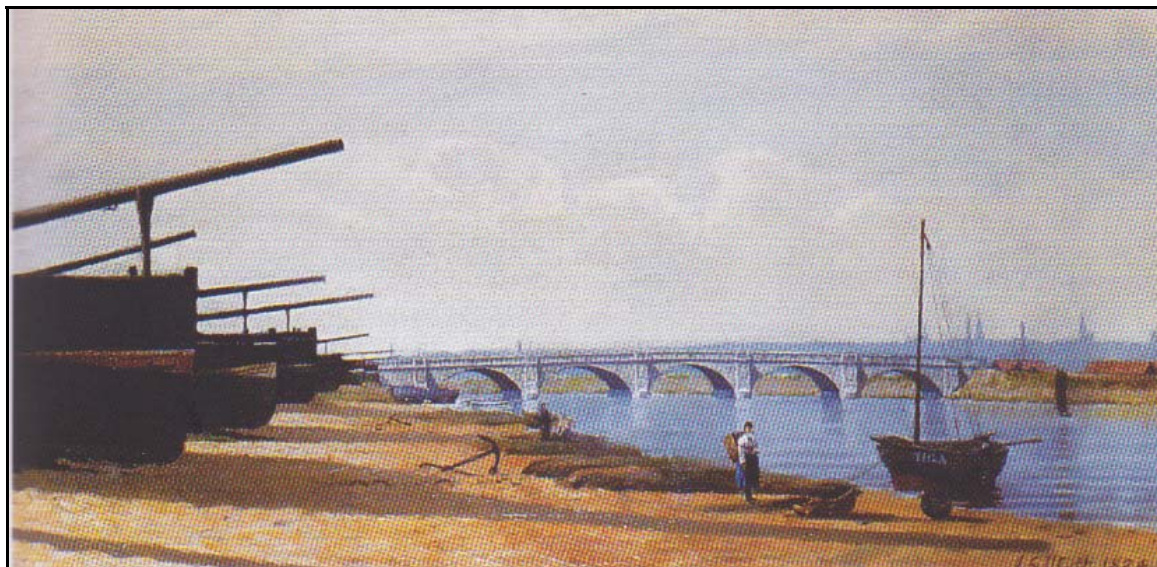
Plate 6 New Victoria Bridge, James Watt, 1884 (from Edwards 2004, 45) showing the excavated foreshore.

This area shows in several images including the painting New Victoria Bridge by James Watt (Plate 6 below).
