Preston's Croft

Roster, Caithness

Watching Brief Report

Report No.	HAS101005
Site Code	HAS- OPC10
Grid Ref	ND 2667 3966
Client	Gmack Construction
Planning Ref	08/00187/REMCA
OASIS	highland4-85135
Date/ revision	26/10/2010
Author	Paul Humphreys

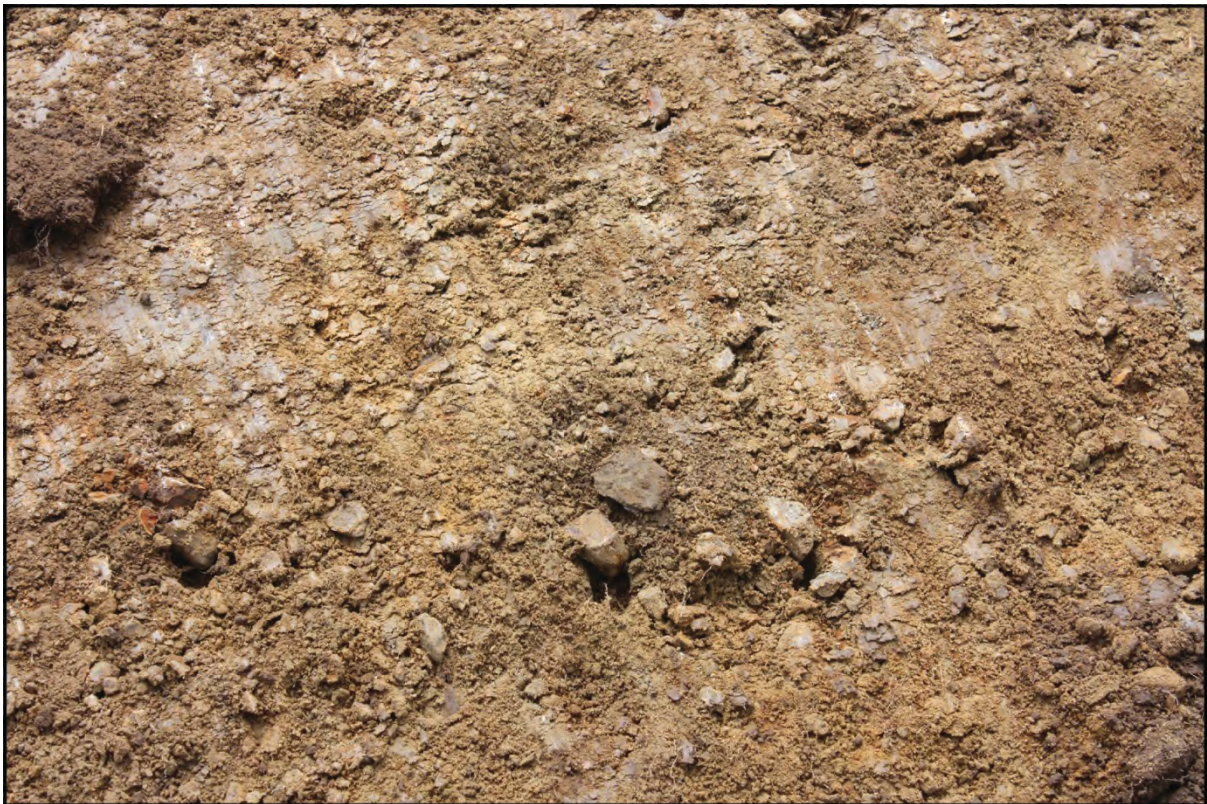
Stripping the house base area indicated an undifferentiated plough-soil ranging in depth from 38 cm to 60 cm. This unusually deep top-soil lay directly over a reddish brown gravelly till (photo 7) that sloped slightly towards the southwest. The till, which contained occasional large stones, became less gritty, with a higher percentage of clay minerals in the southwest corner of the stripped area. An apparent 'arrangement' of stones, one set on edge, was also noted in the south west corner (Drawings 1 and 2; Photos 8, 9, 10). Two distinct deposits, one black the other light grey, also appeared, at first sight, to be associated with the stones (Drawing 2; Photos 8, 9, 10, 11).

Photo 6 Typical gritty clay till

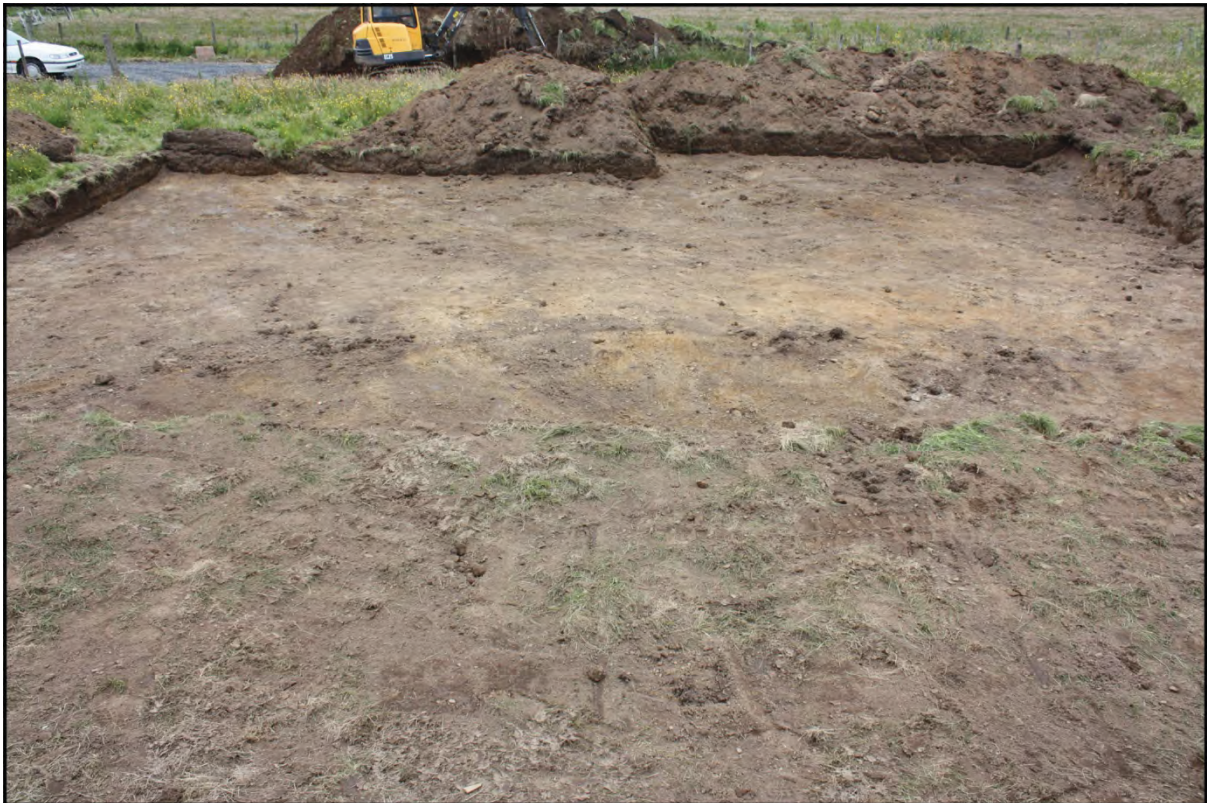
Photo 7 Stripped house-base looking east

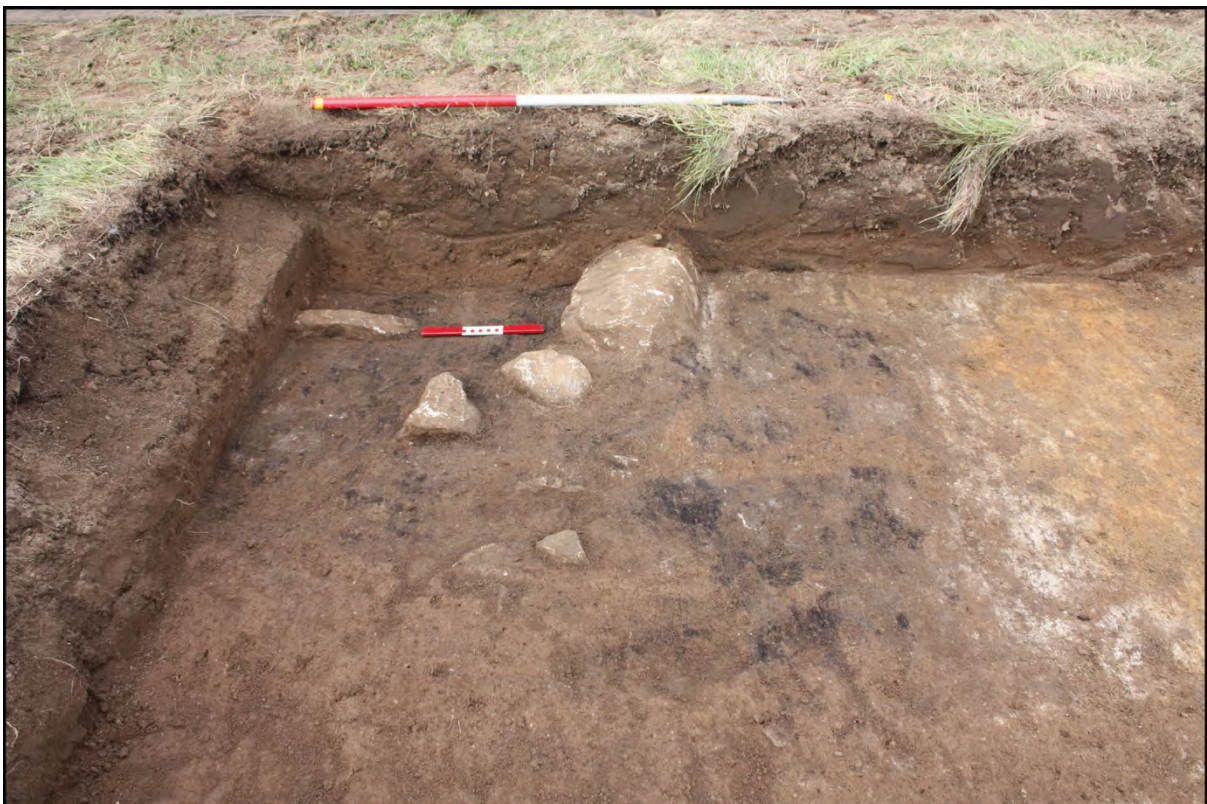
The stones and deposits together were designated Feature 1. At first sight this appeared to be a hearth-like structure, although there was no evidence of heating. The black and grey deposits were sampled to aid interpretation. The pale grey deposit proved to be clay; no large fragments of charcoal

Photo 8 Feature 1 - looking west

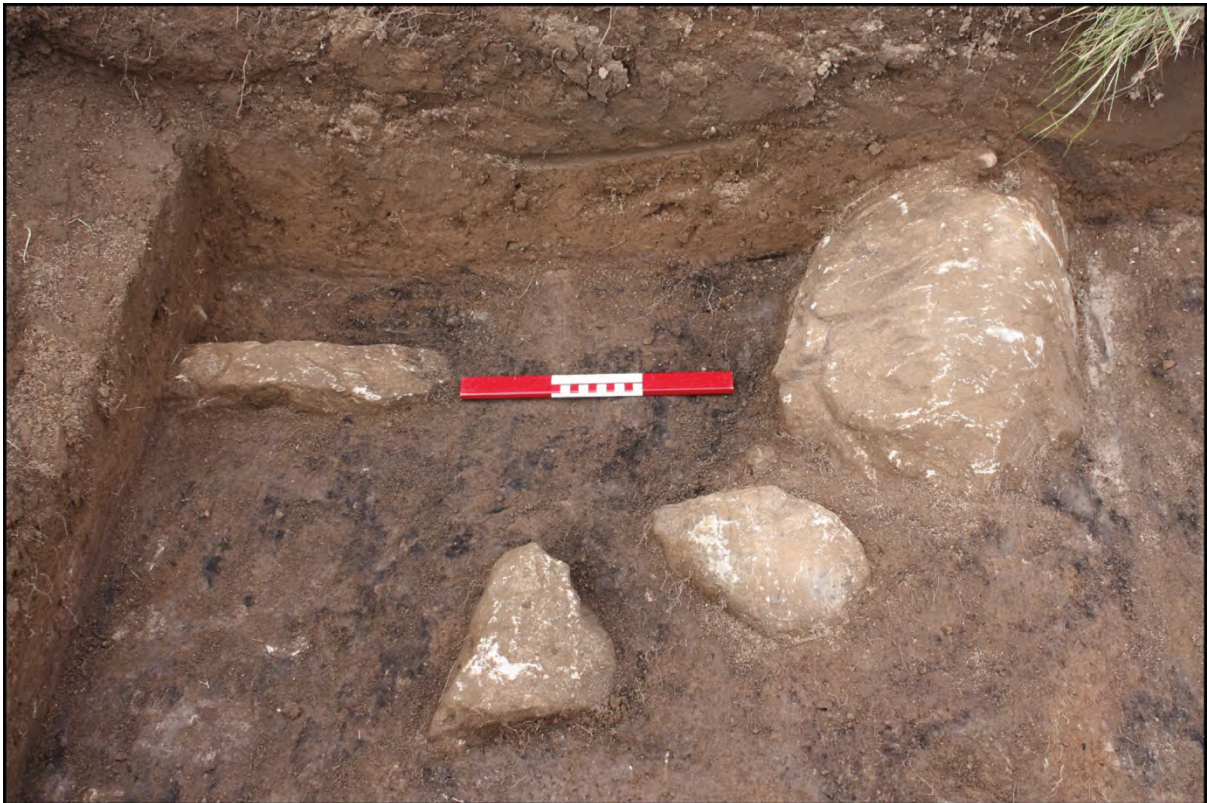
were found in the dry sample of the black deposit, however the addition of water floated-off small fragments of charcoal although the majority of the black material proved to be mineral, most probably a soft pan of manganese common in Caithness soils.

Photo 9 Feature 1 - close-up looking west (30 cm scale)

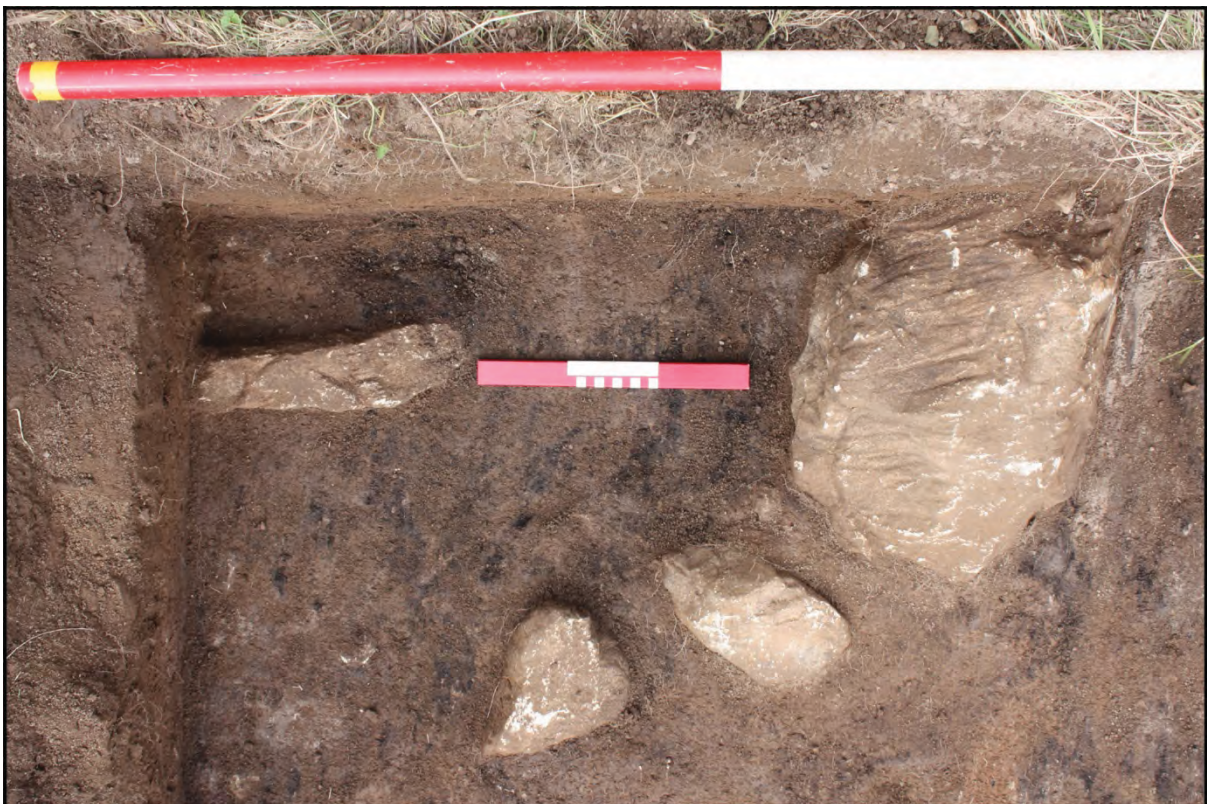
The largest of the stones within Feature 1 exhibited frequent striations (photos 10 and 12). These were interpreted as ploughshare marks. The marks were predominantly on the down-slope side of the stone consistent with ploughing up-slope. This was the preferred direction of ploughing before the introduction of the Ferguson hydraulic hitch, as it helped prevent the ploughs tendency to ride-up out of the soil.

Photo 10 Feature 1 - plan view (30 cm scale)

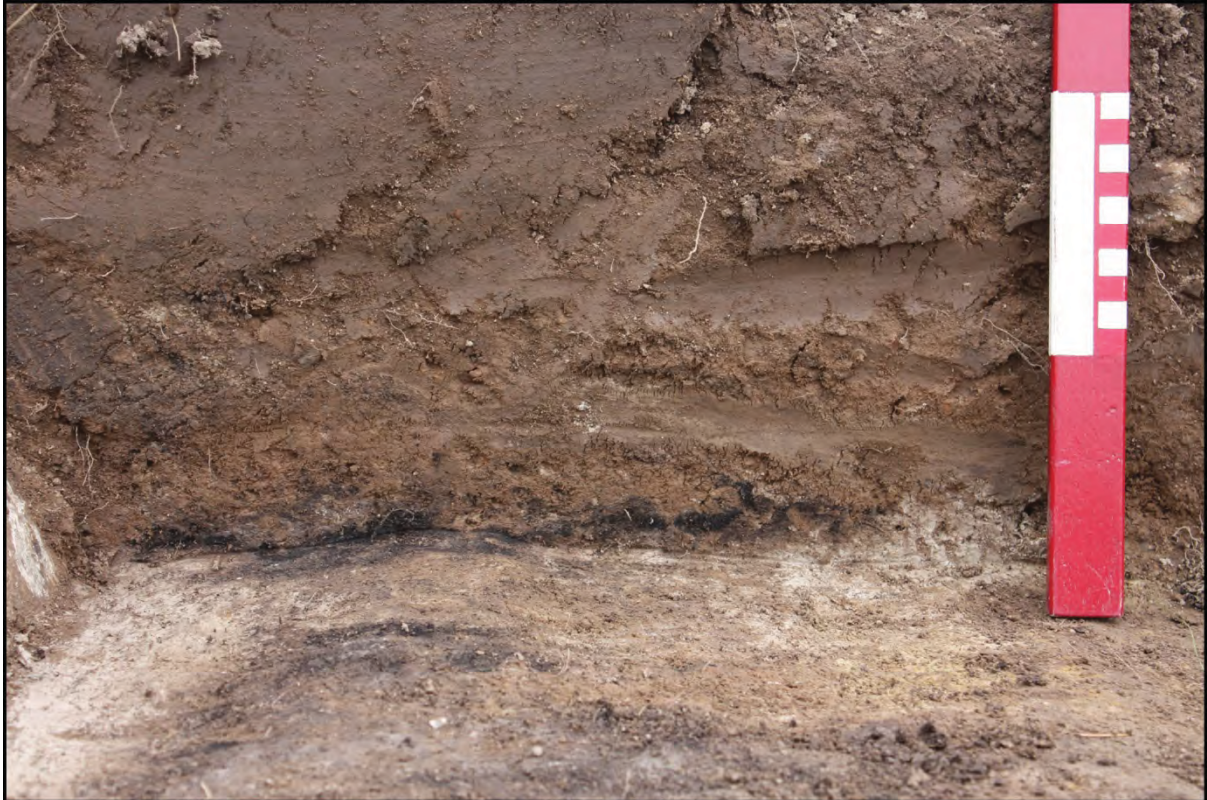
On balance Feature 1 is best interpreted as a natural feature with the pattern of deposits arising from localised soil chemistry. The edge-set stone is interpreted as ploughing disturbance. The small quantities of charcoal could have arisen from land clearance during the time of the agricultural improvements or possibly from later stubble burning.

Photo 11 Feature 1 - dark deposit profile looking west (30 cm scale)

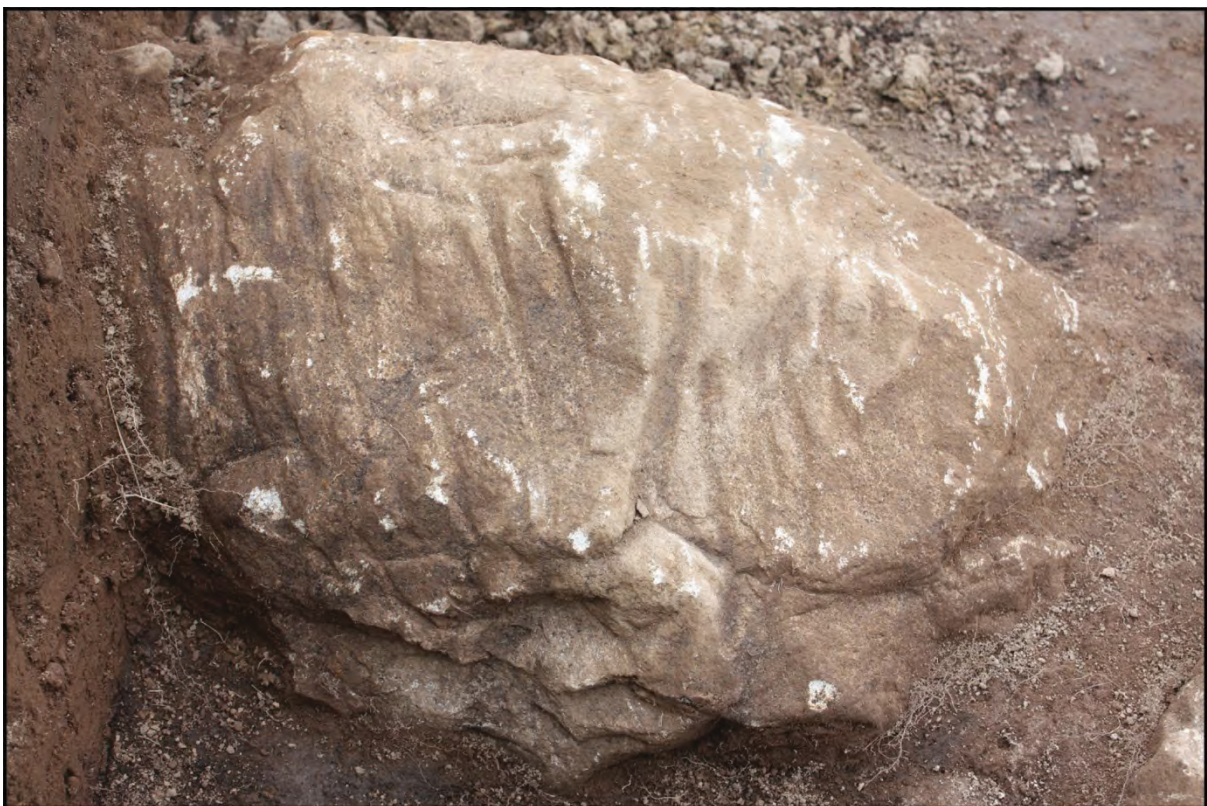
Photo 12 Feature 1 - detail showing ploughshare marks looking north

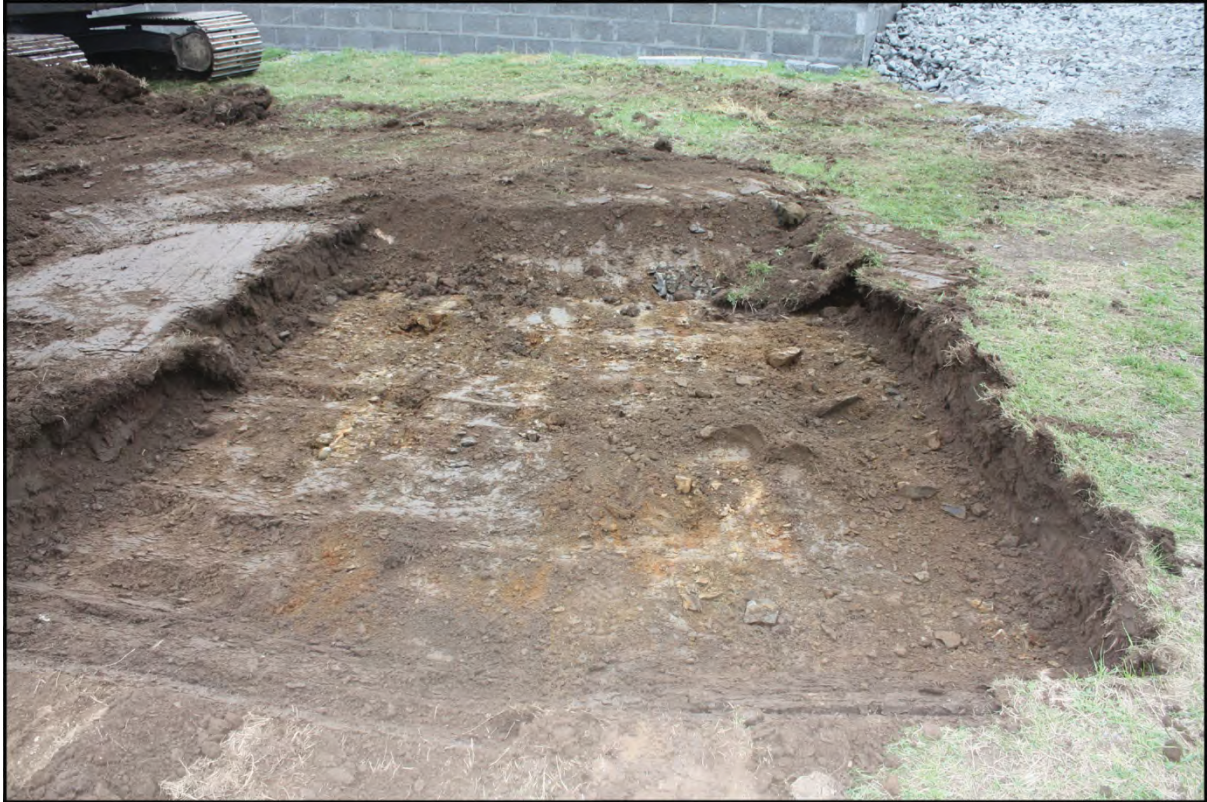
The 3 m square stripped area for the septic tank yielded nothing of archaeological significance (Photo 13).

Photo 13 Stripped septic tank location looking northwest
