Auchtertipper

Archaeological Survey

Report No.	HAS101007
Project Code	HAS-ACT10
Client	Cawdor Estate
Planning Ref	N/A
NGR (approx centre)	NH 9238 2785
OASIS	highland4-85666
Date/ revision	03/11/2020
Authors	John Wombell and John Wood

A rapid walk-over survey was carried out ahead of a tree-planting scheme at Auchtertipper, Cawdor. A large number of archaeological sites and features was recorded: these were all of medieval or post-medieval date.

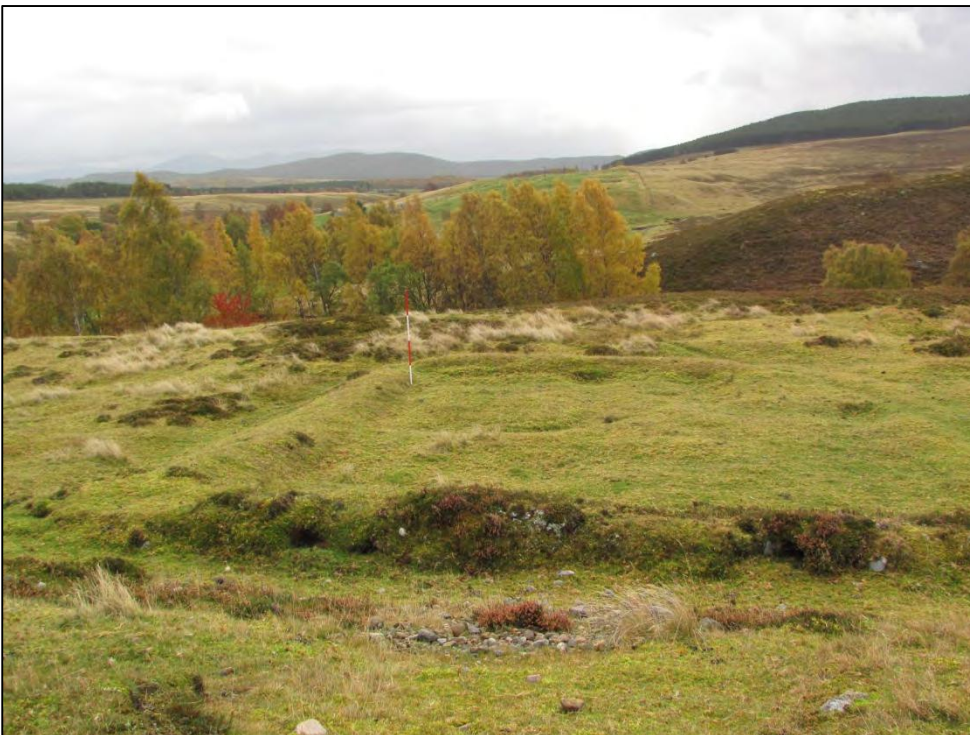
Plate 2 Auchterteang: Enclosure (Site LM15)

LM15 A substantial but ruined enclosure c17m E/W x 12m internally, at NH 92318 26581, walls of stone and turf, spread to c2m, stand to 1.3m on the N side, entrance on the S side. Several compartments within the enclosure, interpretation unclear. May have been an enclosure with wooden huts inside, may also have been a kail yard at some time as there are 2 large storage pits just outwith the enclosure on the S side. See scale drawing (Fig 16) and photos PL2 and PL3.

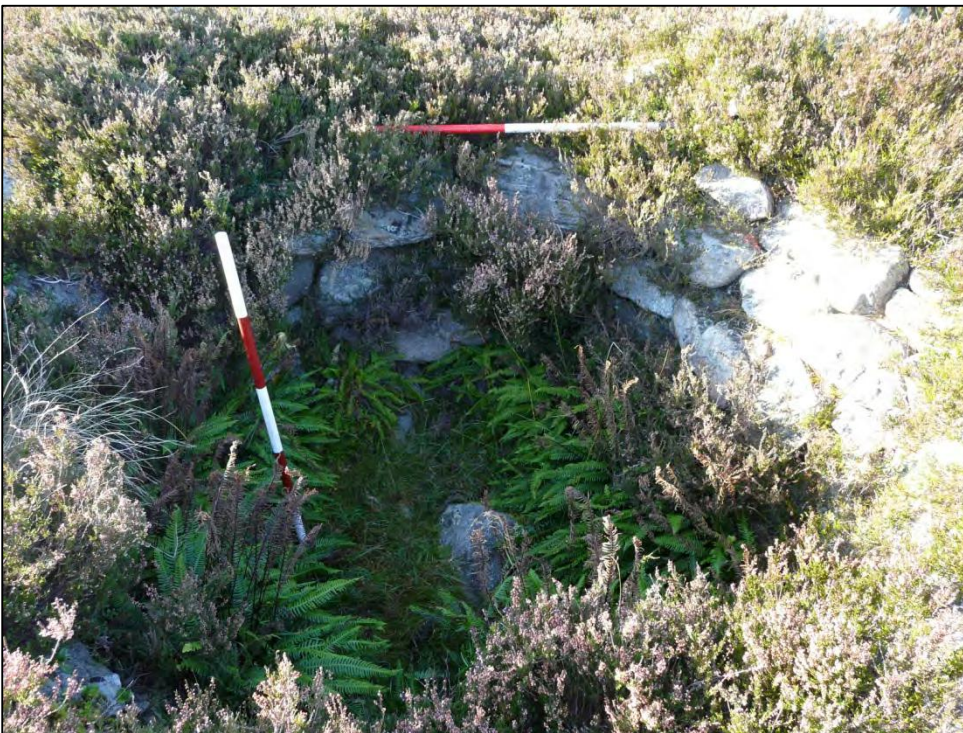
Plate 4 Corn-drying kiln (Site JW3)

Of particular interest is the corn drying kiln at Auchtertipper which lies c. 1 km away from the farmstead and fields out on the rough heather moorland. It survives in an exceptional state of preservation, complete with kiln barn attached and hints of a possible structure over the fire and flue. Approx 50m above the kiln there

risers a strong spring of clean water, whilst below the site is a small lochan. A well defined track leads to this kiln and continues c100m beyond it to a hollow with 4 small saucer shaped 'winter' ponds around it, all with smooth turf bottoms. The only reason which comes to mind for this elaborate isolated set-up is illicit whisky production. No whisky bothy could be found beside any of the burns at Auchtertipper and it appears that all the whisky production processes were taking place at this one location. The ponds and their banks would have been used for steeping and germinating, the kiln for drying the malt, the spring was the water supply and the whisky was distilled in the attached barn. The site can be seen from the farmstead through a gap in a low moraine ridge, but not from anywhere else.

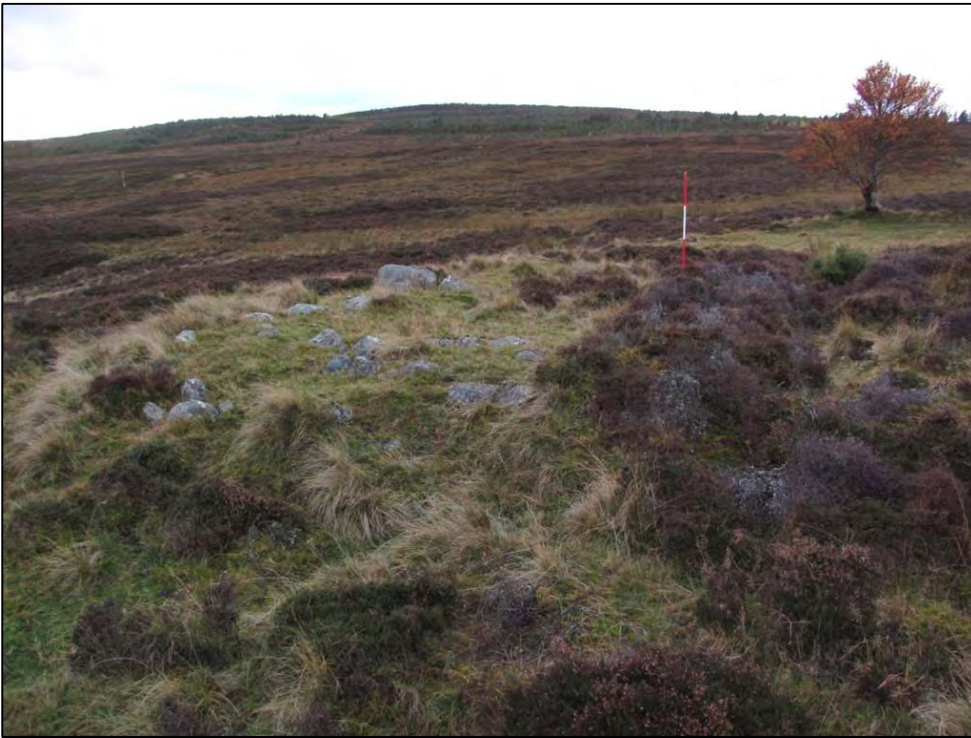
Plate 5 Badenargit longhouse Site LM31

Of note is the great length the inhabitants of Badenargit went to, to enclose some very poor ground with ditches and turf walls. They also enhanced by deeper digging a number of natural water courses in order to dry up and improve small areas of ground. The improved areas of ground as shown on the 1st Ed OS still stand out today as more fertile islands in a sea of rank heather.

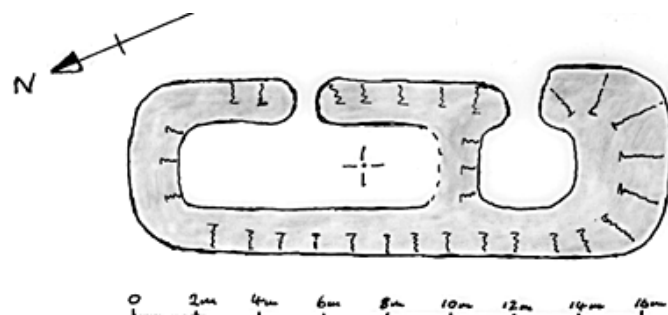
Figure 5 Auchtertipper sites LM2, JW5, JW6

SITE LM2 CENTRED ON: 292976 828941

PROBABLE TURF WALLED LONG HOUSE

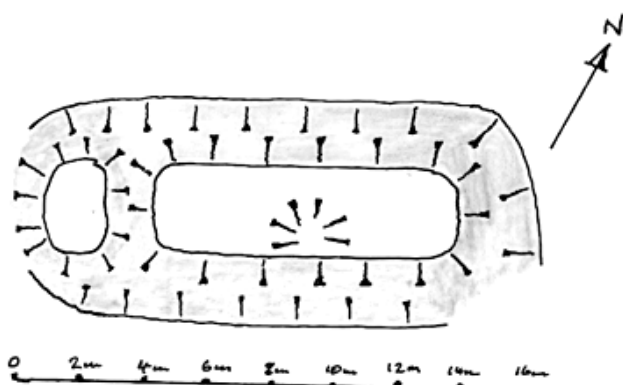
SITE JW6 CENTRED ON: 293084 828980

PROBABLE TURF WALLED LONG HOUSE

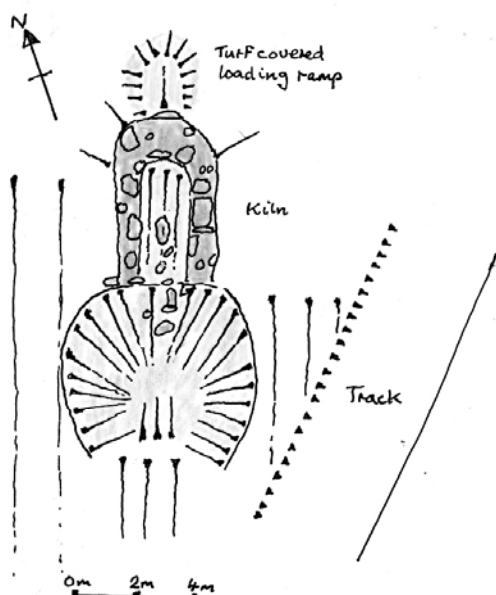
The lime kiln at Auchtertipper is reasonably well preserved, the best in the survey area, but all of the lintels and most of the front wall have been robbed out.

AUCHTERTIPPER FARMSTEAD
 SITE LM5
 LIME KILN
 DATE 11/10/2010
 Drawn at 1:200 By h.m.
 CENTRED ON: 293352 828878

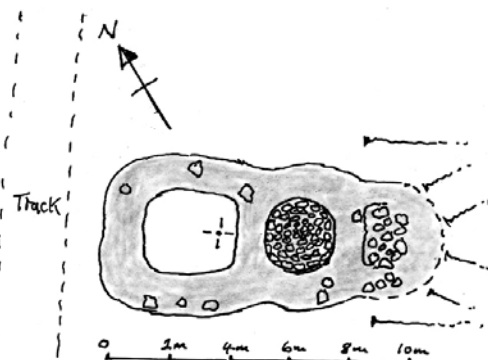
AUCHTERTIPPER - MOOR
 SITE JW3 CENTRED ON: 292653 828567
 CORN/MALT KILN & BARN
 Date 11/10/2010
 Drawn at 1:200 By JLD

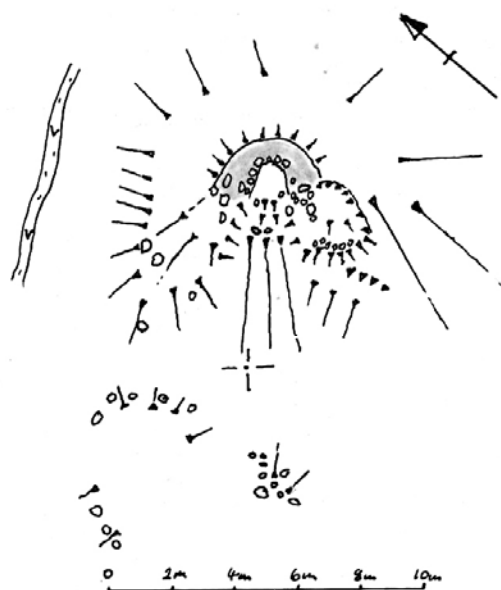
LM13 A ruined lime kiln at NH 92544 26507, much robbed and eroded by livestock, cut into the S side of a moraine bank, has a large work area below and the possible remains of an oval stance a few m away to the W. See scale drawing (Fig 11) and photo PJ49.

AUCHTERTEANG FARMSTEAD
SITE: LM 13
LIME KILN
CENTRED ON: 292 544 826507
DATE: 15/10/2010 Drawn by L.G.J. At 1:200

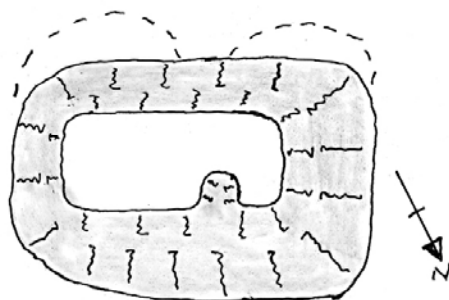
JW12 The low turf covered footings of a probable turf walled building at NH 92410 26463, truncated by a modern fence, measures c7m E/w x 3m internal, wall spreads up to 3m, c0.4m high, no obvious entrance. See scale drawing (Fig 11) and photo PJ50.

Auchterteang Farmstead
SITE JW 12
TURF WALLED BUILDING
CENTRED ON: 292410 826463
Date 15/10/2010 Drawn by JLO. at 1:200

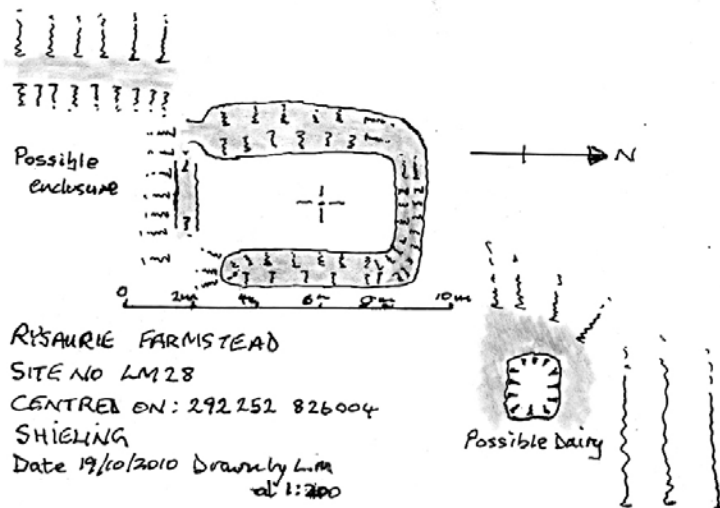
LM28 The scant heather covered footings of a shieling hut, at NH 92252 26004, 7m N/S x 2.5m internally. Possible pen attached to the S with a separate dairy c 2m x 1m internally, to the N, close a small un-named burn. A few stones show through the heather and turf. See scale drawing (Fig 13) and photo PL22.

SHIELING

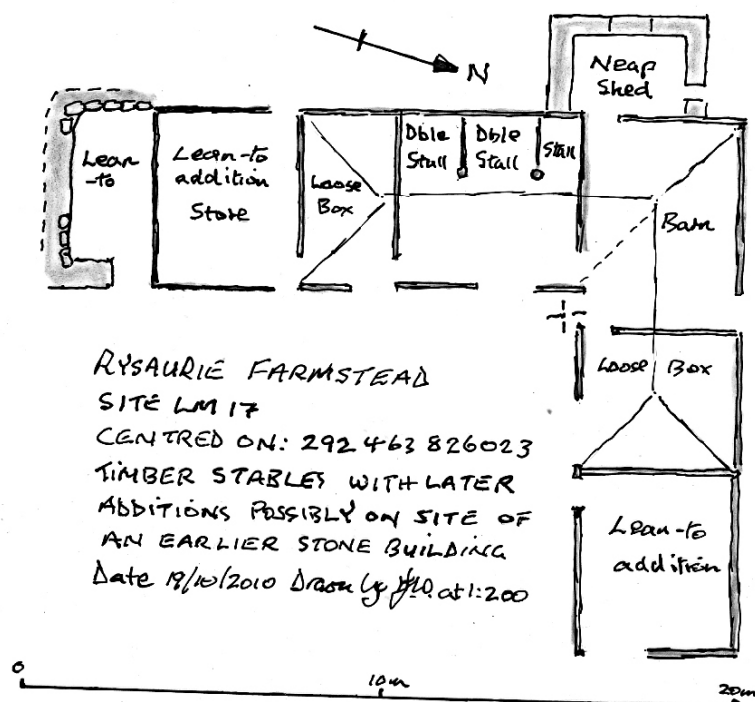
LM17 A substantial high quality timber built range, 'L' shaped in plan with stalls for 5 horses, 2 loose boxes and a barn with neap store attached, at NH 92463 26023. A date inscribed on one internal door is 1903. Two later lean-to poor quality timber additions added, one now dilapidated and the second also poor. The building sits on a dwarf wall c300mm wide and 300mm deep of lime mortared stones. The frame of the main and older building almost entirely of 150mm x 62mm Scots pine, apart from the main corner posts which are 150mm square. Vertical studs at 800mm centres. Dwangs 95mm x 35mm at 750mm vertically. Roof clad with corrugated iron, hip ends, galvanised iron gutters, 5 CI skylights. Outer cladding - vertical boards with weather overlap. See scale drawing (Fig 14) and photos PL13, PL14, PL17, PL28, PL29.

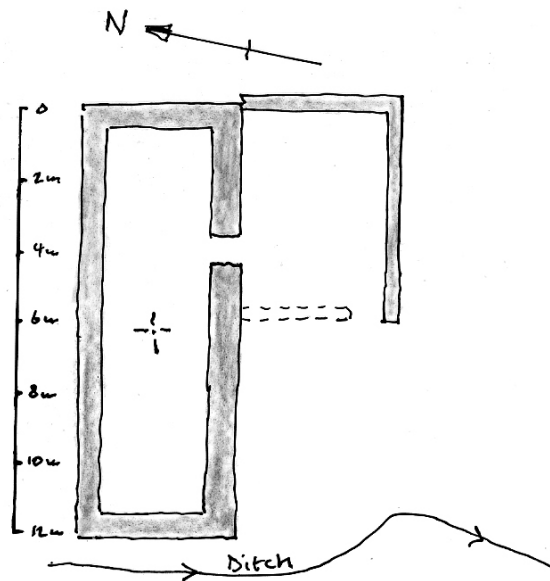
BADENARGIT FARMSTEAD (EAST)
 SITE: JW15 CENTRED ON: 292183 826260
 STONE FOOTINGS OF A BUILDING
 Date 18/10/2010 Drawn by J.F.O. at 1:200

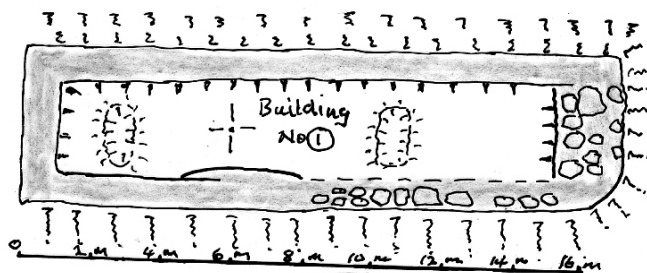
Figure 16 Badenargit sites LM31, JW15

BADENARGIT FARMSTEAD (WEST)
 SITE LM31 CENTRES:
 No. 1 291938 826324 No. 2 291958 826334
 Date 18/10/2010 Drawn by L.M. at 1:200
 2, possibly 3 FOOTINGS IN STONE
 OF BUILDINGS SHOWN ROOFED
 ON 1st Ed OS.

LM31a	Building	Fig 17	PL26-27	Building No1, possible long house, shown roofed on the 1st Ed OS, at 291938 826324, measures 16m E/W x 3m internally. Stone footings, spread to 2m in places, remain to c0.3m in ht. All covered in deep heather or turf. See scale drawing and photo PL26.	NH 9193 2632
LM31b	Longhouses	Fig 17	PL26-27	Possible long house. Building 2, smaller than Building 1 but of a similar nature, at 291958 826334, measures 5m N/S x 3m internally. Walls spread to c1m, remain to c0.4m high.	NH 9195 2633
