Furrows End, Watten Caithness

Watching Brief

| Report No. | HAS101107 |
| Date / revision | 16/12/2010 |

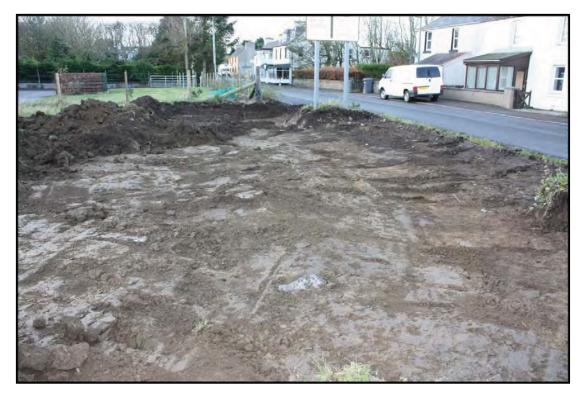
Plate 2: Concrete indicating main sewer line (Photos 5-6)

Nothing of archaeological significance was noted. On opening the site a cut was noted which proved, on enquiry, to be a main sewer. A wider spread of concrete on the top-soil / till interface indicated that the area had previously been stripped, presumably for the sewer construction (Plate 2 above).

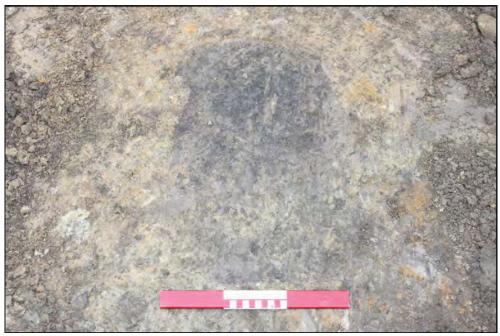
Plate 3 Feature 1 (Photo 8)

Feature 1 (Plate 3 below) was investigated and found to be an imprint caused by compaction of the surface. It was roughly rectangular with rounded corners and measured approximately 40cm x 30cm. It is interpreted as an impression made by the stabilising foot of a JCB.

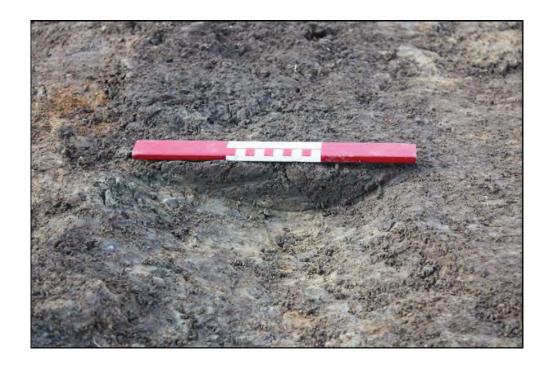
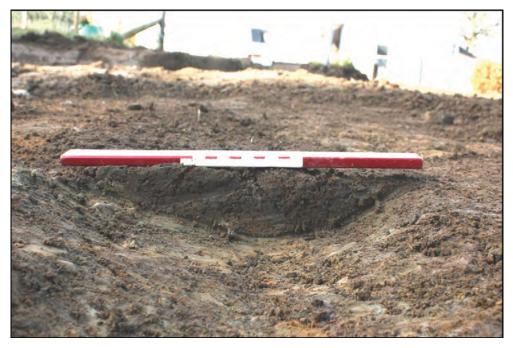
Plate 4 Sections through Feature 2 – above: Section A; below: Section B

Feature 2 (Plate 4 below) consisted of two shallow lines of compaction containing topsoil, 1.8m apart. Each track is about 30cm wide at the cleaned surface and about 10cm deep at the centre (See Plate 4).

This is interpreted as the tyre tracks of a construction machine. The extent of this feature suggest that approximately ³/₄ of the stripped area was stripped for the sewer construction. Both features were sectioned and photographed to confirm the interpretation (plate 6)
