Arrowdale

Leacnasaide, Gairloch

Archaeological Survey

Report No.	HAS101203
Site Code	HAS- AWD10
Grid Ref	NG 7987 7315
Client	Rupert + Clare Lumsden
Planning Ref	N/A
OASIS	highland4-91251
Date/ revision	22/01/2011
Author	J Wood

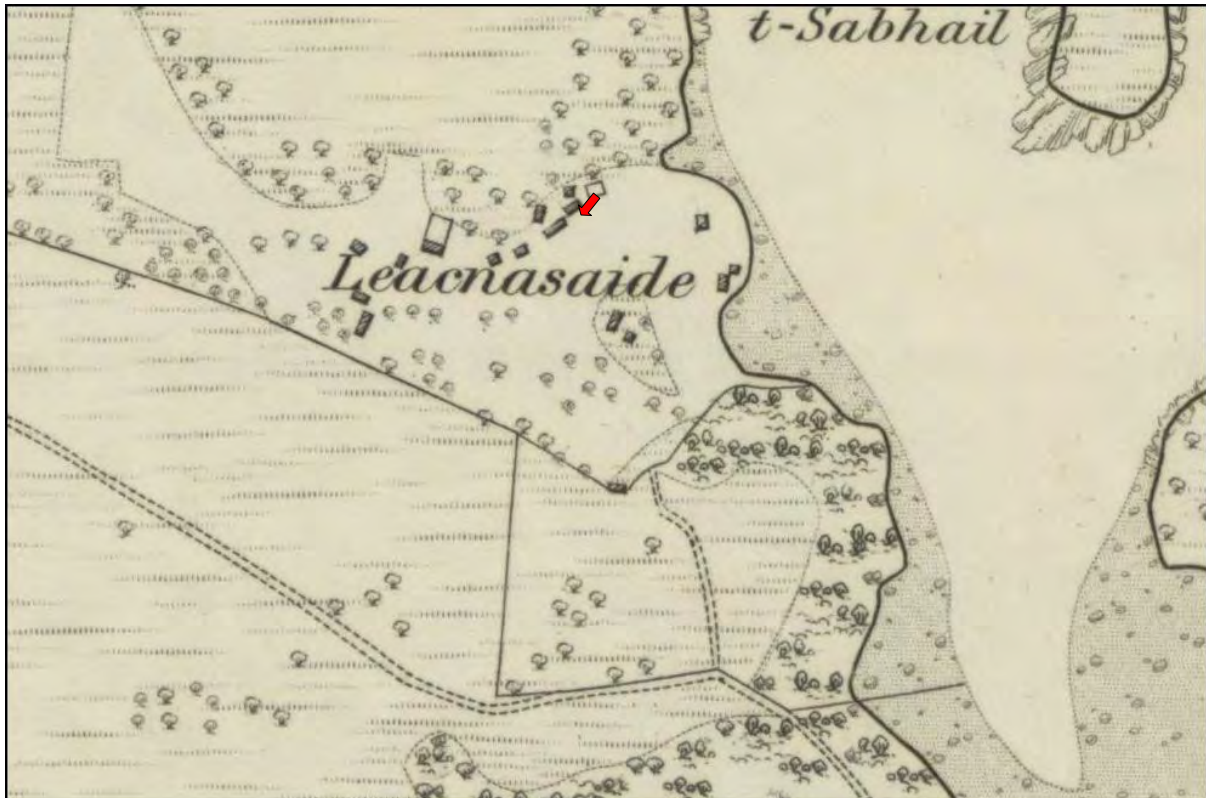
Figure 2 Extract from Ordnance Survey 1st Edition 6 inch map, surveyed 1875.

Ross-shire & Cromartyshire (Mainland) - 1:10,560 Sheet LVI. Not reproduced to scale. Courtesy of National Library of Scotland. Red arrow shows approximate location of present house.

The First Edition OS 6 inch map (Figure 2 above) shows that the township of Leacnasaide was still roofed and occupied in 1878. The houses are aligned around the edges of the cultivated ground, with the two noted in 2008 standing in an island of pasture.

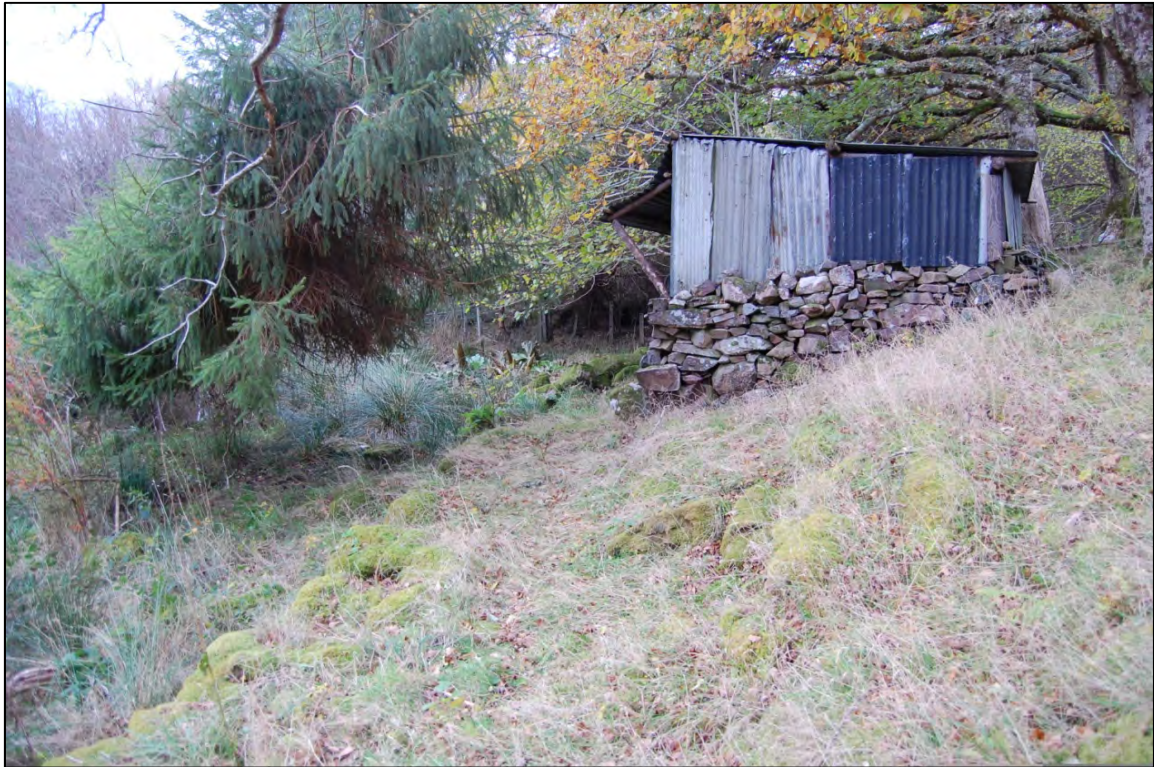
Photo 1 Corrugated shed (F7) to R of path; revetment wall (F1) to L.

Feature No.	Type	Location	Dimensions (Approx)	Notes
F7	Building	NG 79824 73139	5.65m x 2.65m	Rough stone footings with a wood framed, corrugated iron superstructure. See Photo DSC_001
F8	Wall	NG 79789 73157	11.9m x 21m	Rectangular enclosure, noted during survey and shown on 1st and 2nd edition OS 6 inch maps.
F9	Building	NG 79796 73139	5.55m x 11.85m	A rectangular building within F8 shown on 1st edition OS 6 inch map (apparently roofed) and 2nd edition OS 6 inch map edition (unroofed). The footings of a building noted during survey and shown on the current OS mapping (F21) do not seem to coincide with that shown on the 1st and 2nd edition maps.
F10	Building	NG 79866 73163	9.5m x 4.7m	Rectangular building shown (apparently roofed) on 2nd edition OS 6 inch map but not on the first edition, or on later maps. This lies partly beneath the present Arrowdale house and no evidence was visible on the surface.

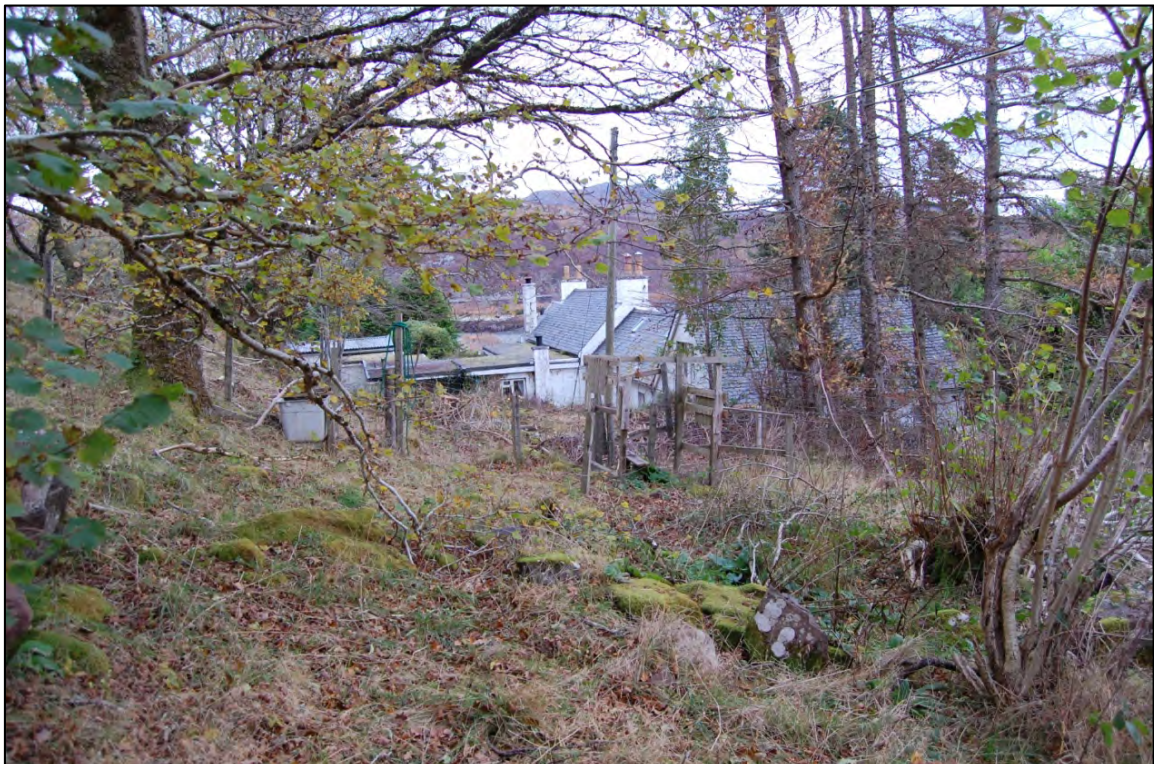
Photo 2 Footings of building F6; fence and current Arrowdale house

F6	Building	NG 79835 73141	11.46m x 4m	Rectangular building footings noted during fieldwork. Shown on current OS mapping, but a shorter building on the same N and S wall lines is shown on the 1st and 2nd edition 6 inch OS maps (F43)

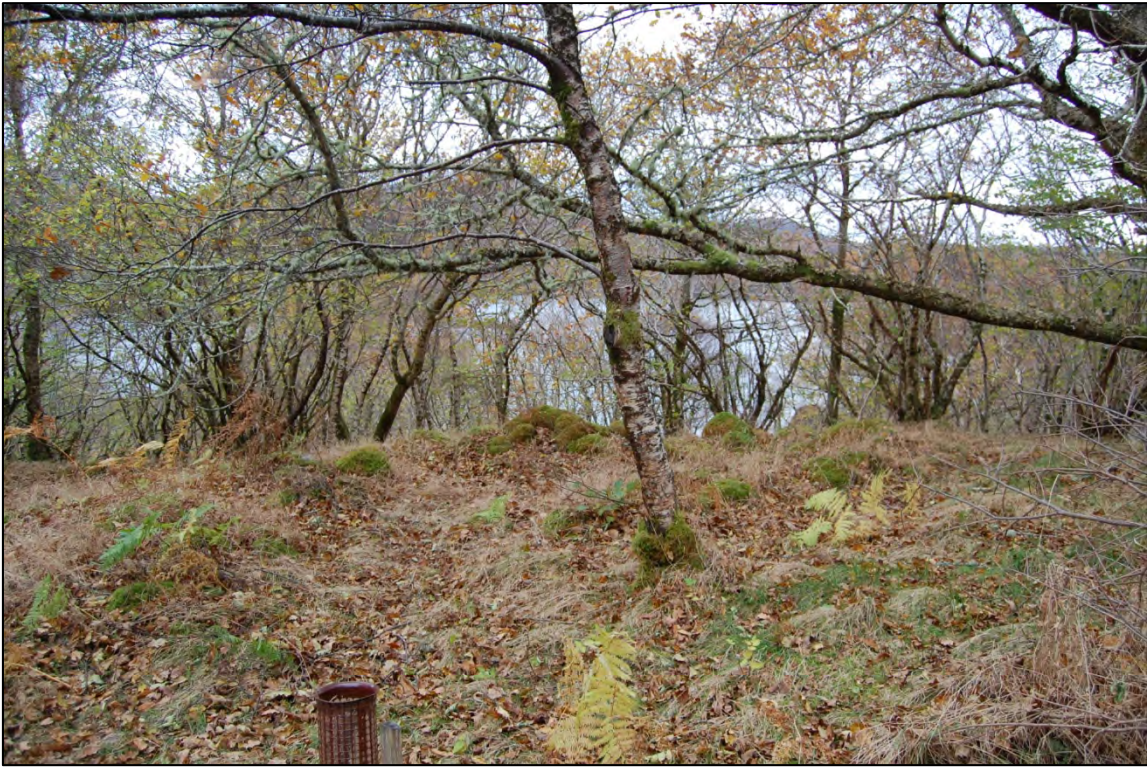
Photo 3 Footings of building F3

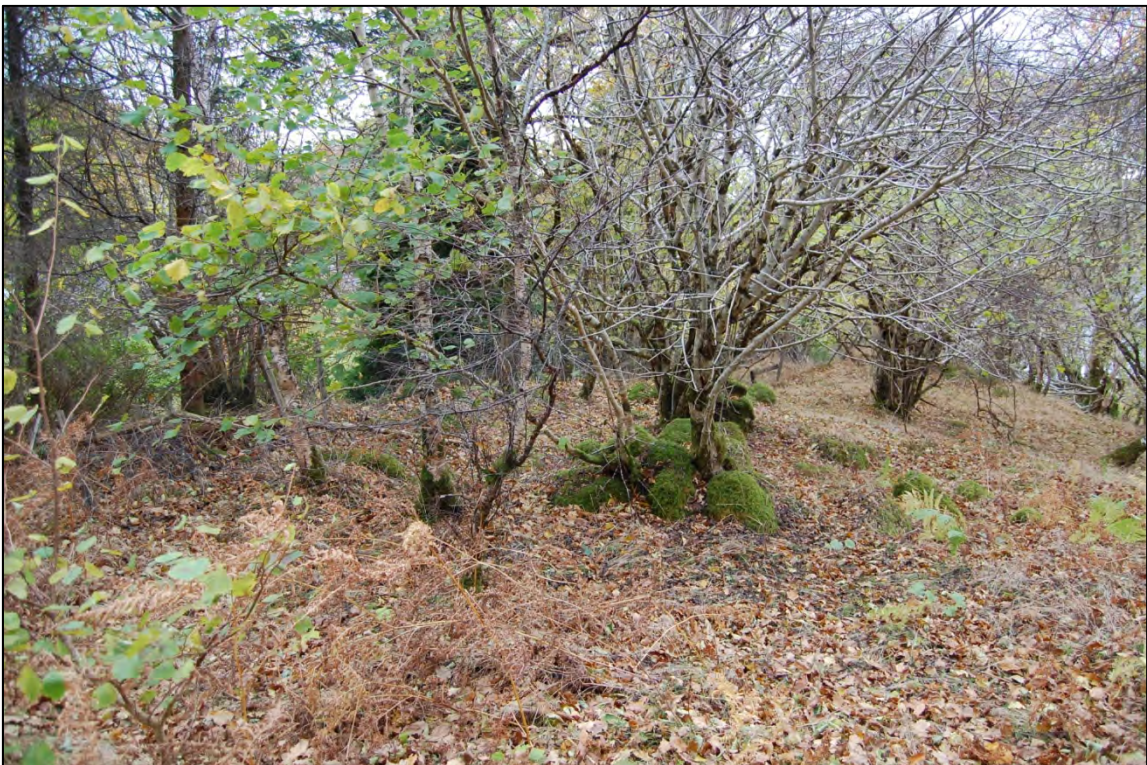
Photo 4 Footings of building F2

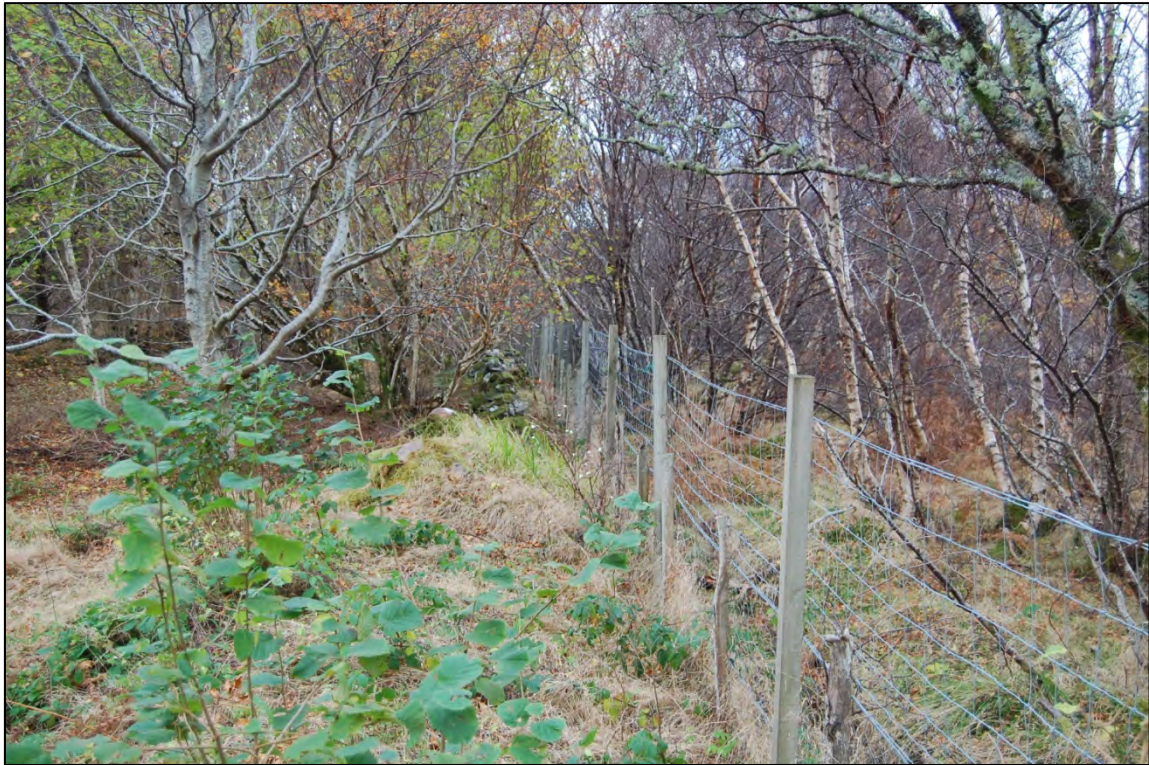
Photo 5 Township boundary dyke and modern fence line

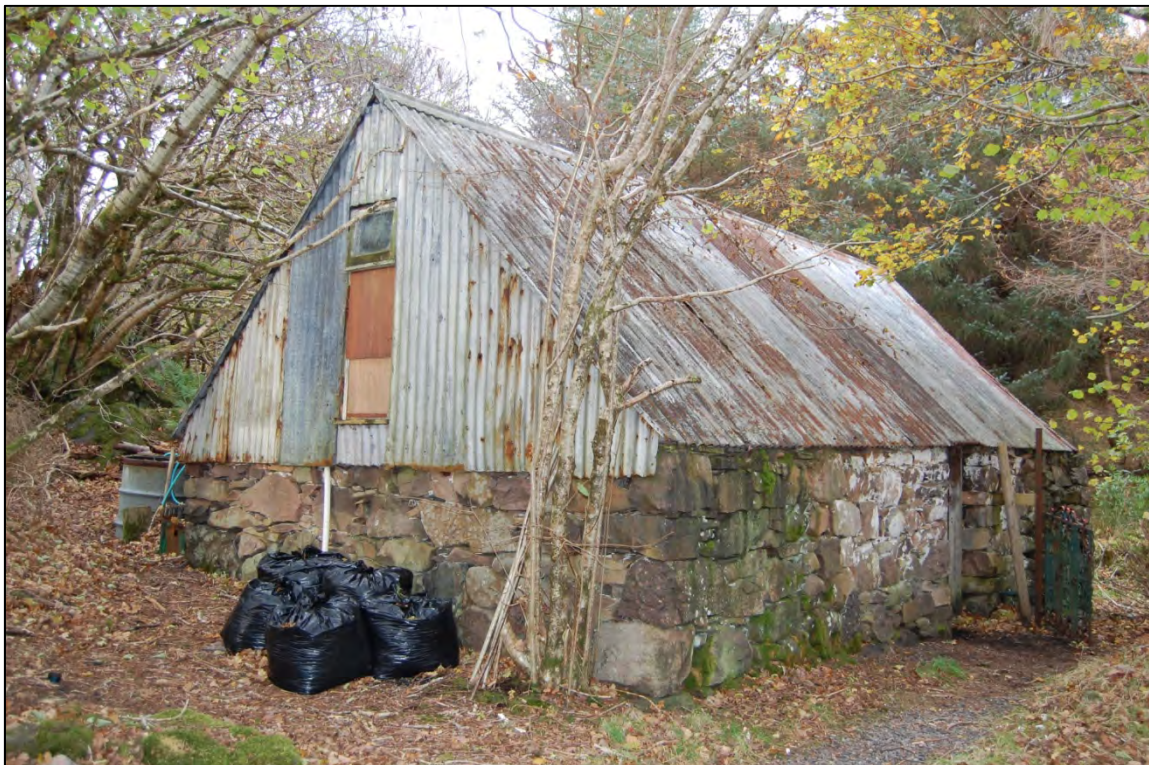
Photo 6 Roofed building F29

Feature No.	Type	Location	Dimensions (Approx)	Notes
F28	Building	NG 79847 73157	9m x 3.8m	Rectangular building shown on the 2nd edition OS 6 inch map, apparently replacing F11. No building remains were noted here during the survey but this area is strewn with rocks.
F29	Building	NG 79776 73119	7.8m x 3.4m	Rectangular building - roofed in corrugated iron. See photo DSC_006. This building does not seem to be shown on either the 1st or 2nd edition OS maps.
F30	Building	NG 79828 73136	4m x 5.3m	A rectangular building is shown here on the 1st and 2nd edition OS 6 inch maps but not on the current map, which shows a building apparently close by but on a different alignment. See F7 and Photo DSC_001
F31	Building	NG 79891 73083	6.3m x 2.8m	Rectangular building shown on current OS mapping. Not recorded during fieldwork.
F32	Building	NG 79770 873113	3.3m x 3.5m	Rectangular building shown on current OS mapping. Not recorded during fieldwork.

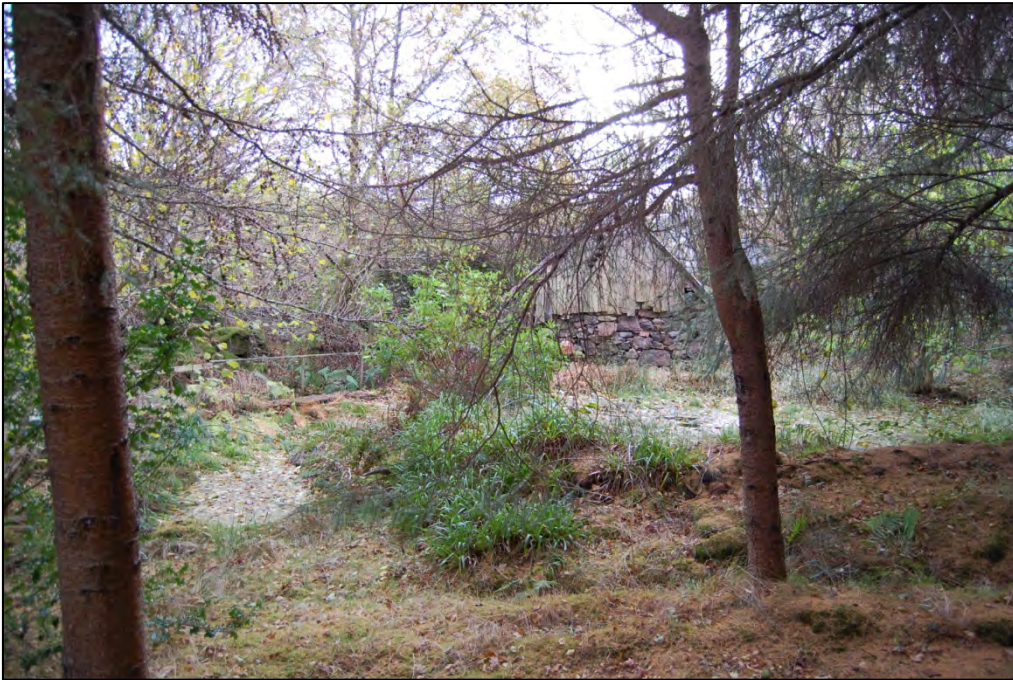
Photo 7 View to roofed building F29 across garden pond

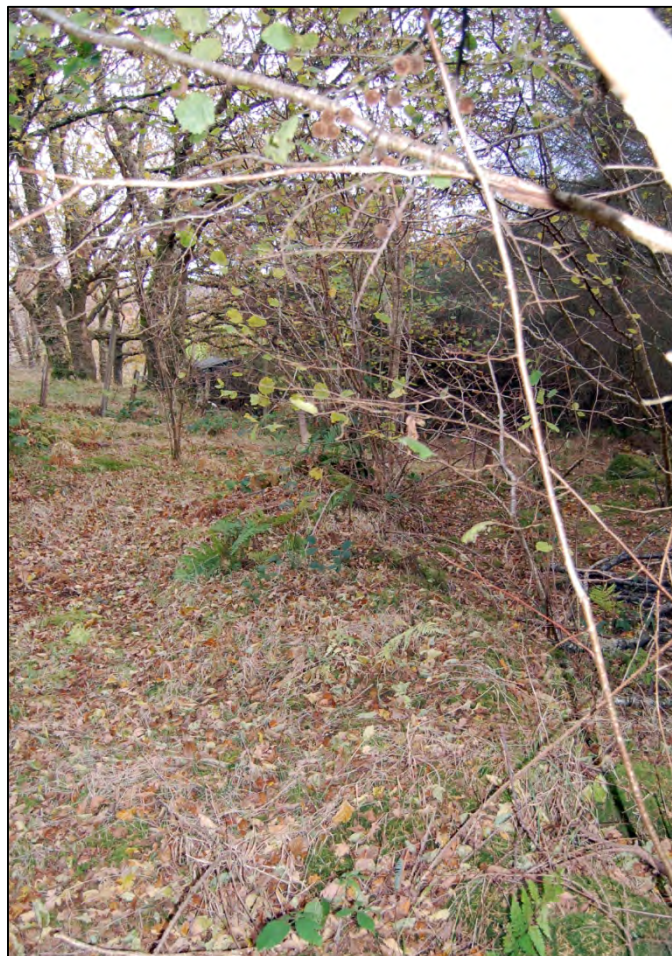
Photo 8 View along line of enclosure F8 to shed F33

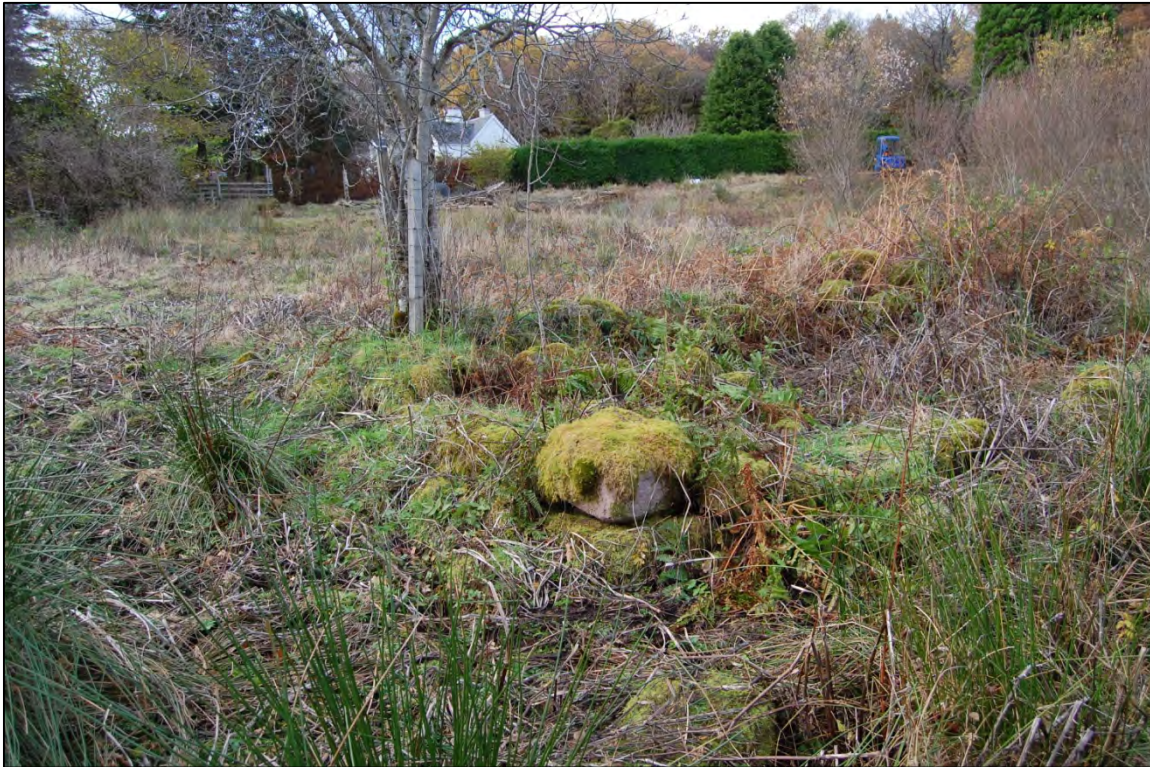
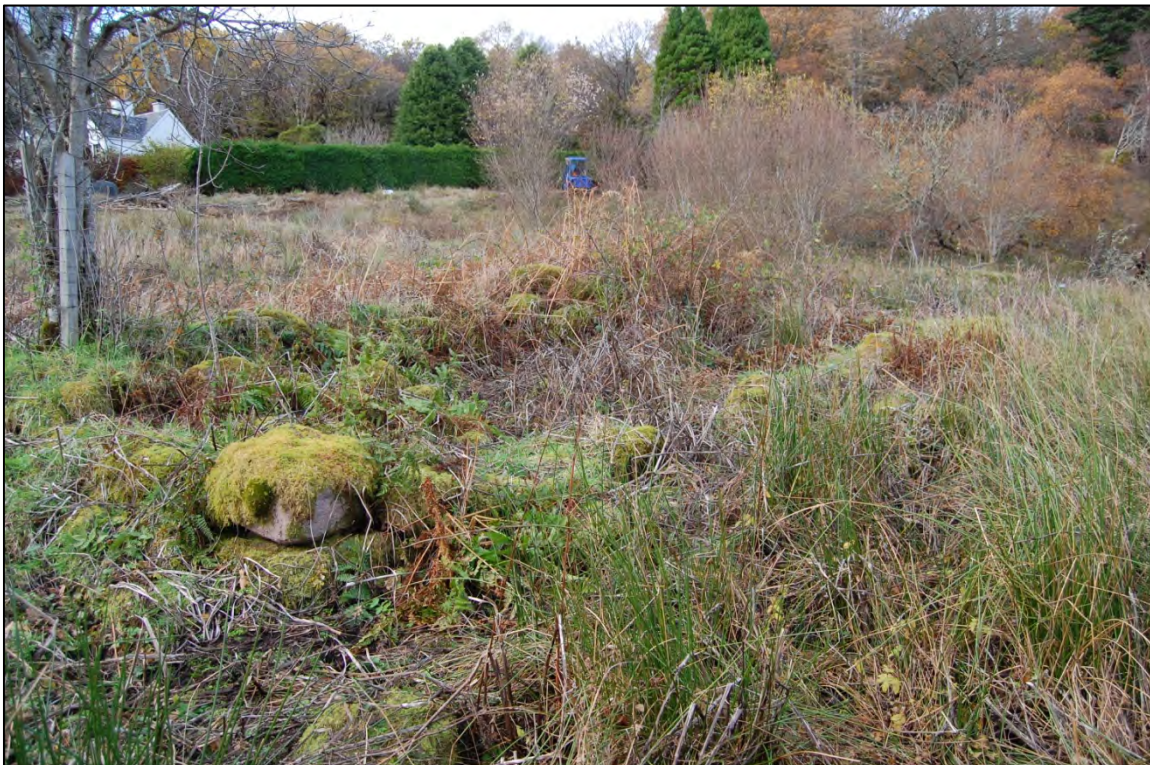
Photo 10 Footings of building F4

Photo 11 Footings of building F4

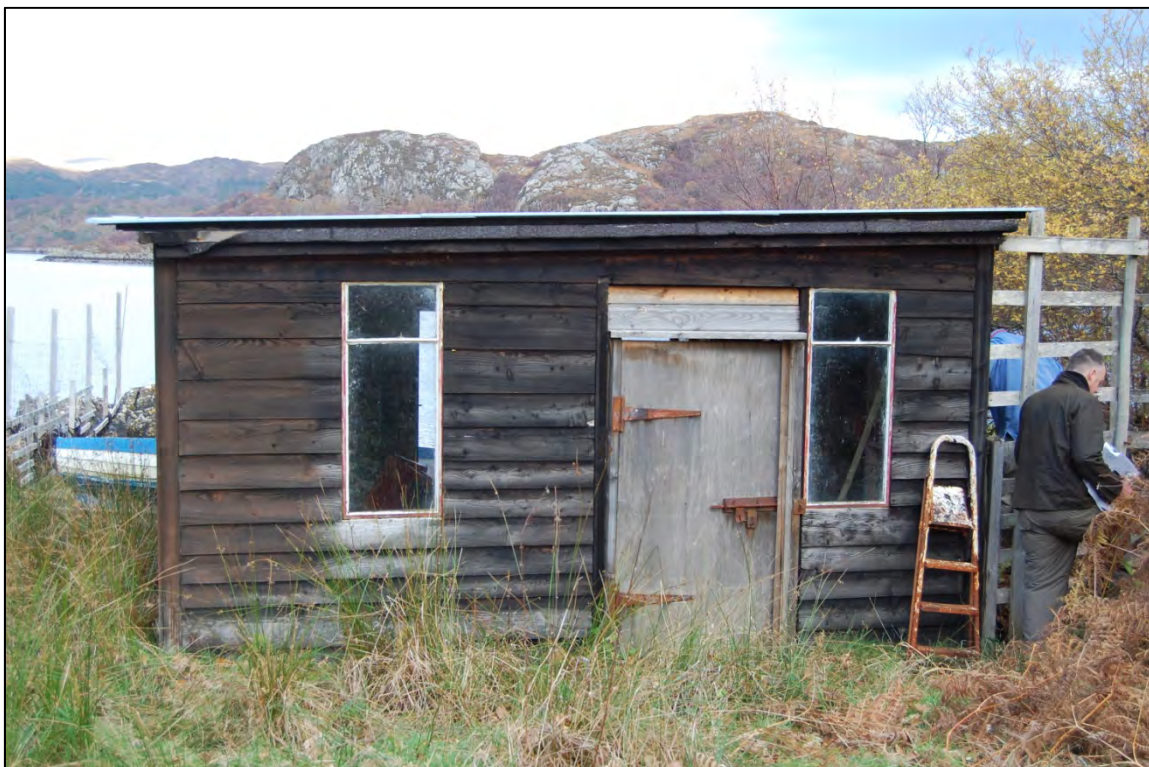
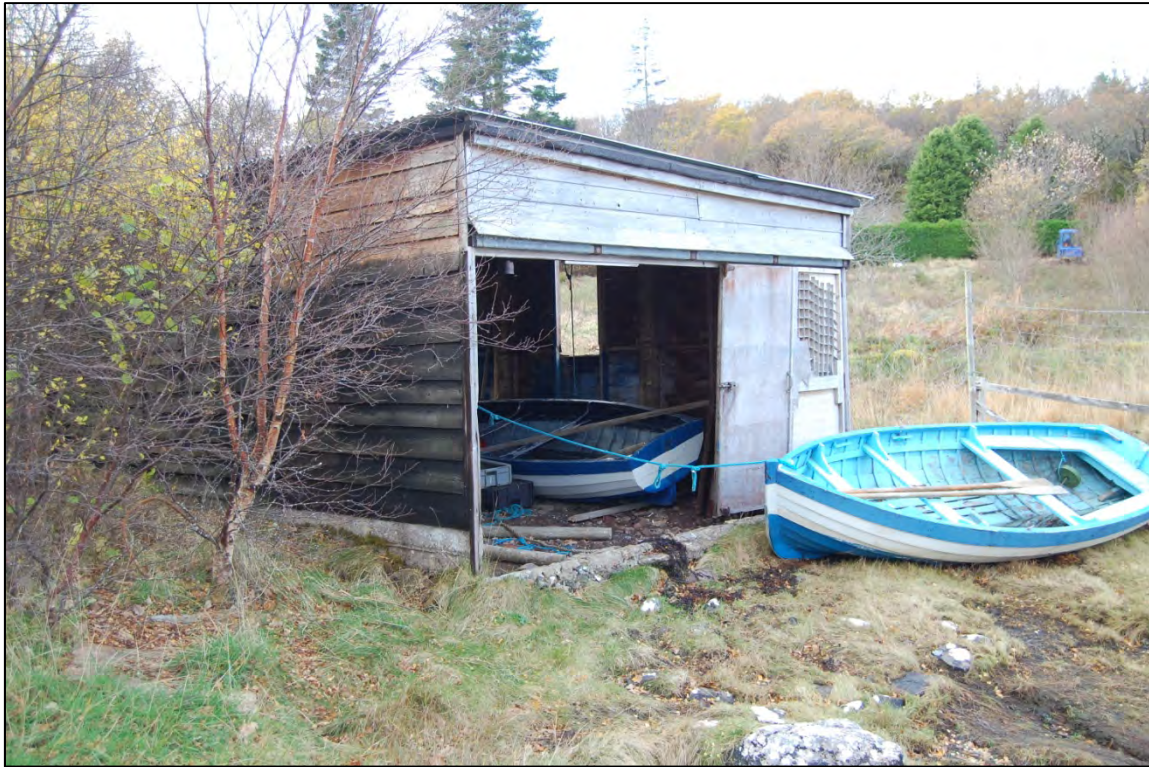
F33	Building	NG 79791 73147	2m x 2.4m	Shed (standing building) noted during the survey and shown on current OS mapping. Not shown on 1st or 2nd edition 6 inch maps.
F34	Building	NG 79963 73141	6.4m x 4.5m	Boathouse (standing building) noted during the survey and shown on current OS mapping. Not shown on 1st or 2nd edition 6 inch maps. See photos DSC-0013; DSC-0014
F35	Building	NG 79956 73131	6.3m x 3.6m	Rectangular building shown on 2nd edition 6 inch OS mapping. Building footings noted during fieldwork (F24) do not coincide with the outline of this building.
F36	Building	NG 79949 73118	6m x 5.5m	Rectangular building shown on 2nd edition 6 inch OS mapping. Building footings noted during fieldwork (F25) do not coincide with the outline of this building.
F37	Building	NG 79940 73152	7m x 6m	Rectangular building shown on 1st and 2nd edition 6 inch OS mapping. Rectangular building footings noted during fieldwork (F4) and shown on current OS mapping, do not coincide with the outline of this building.

Photo 13 Boathouse F34

Photo 14 Boathouse F34

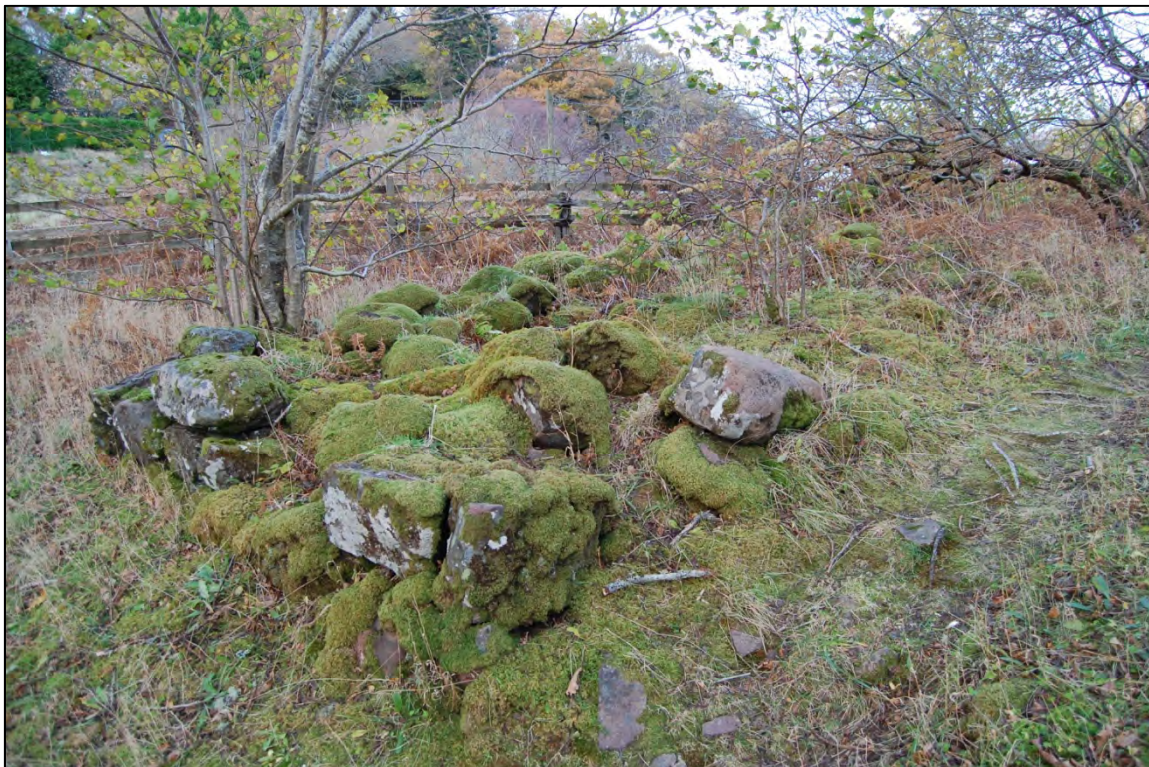
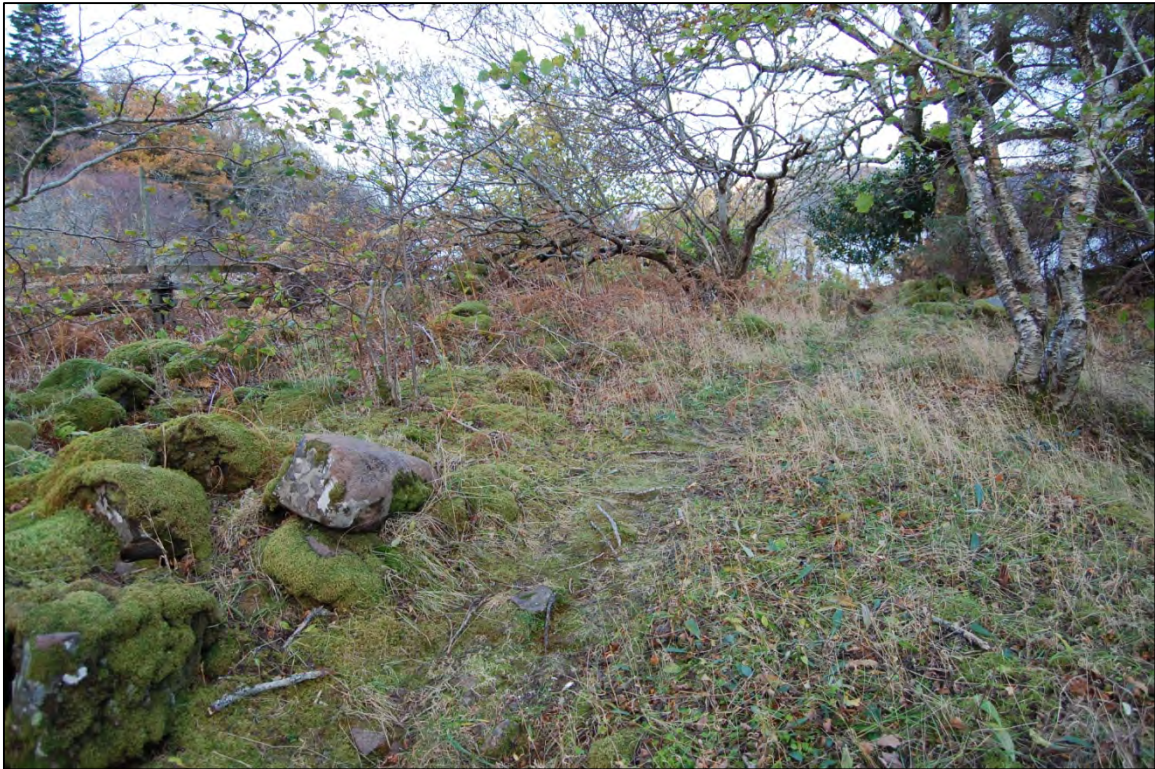
Photo 15 Wall forming part of F25 / F36

Photo 16 Wall forming part of F25 / F36

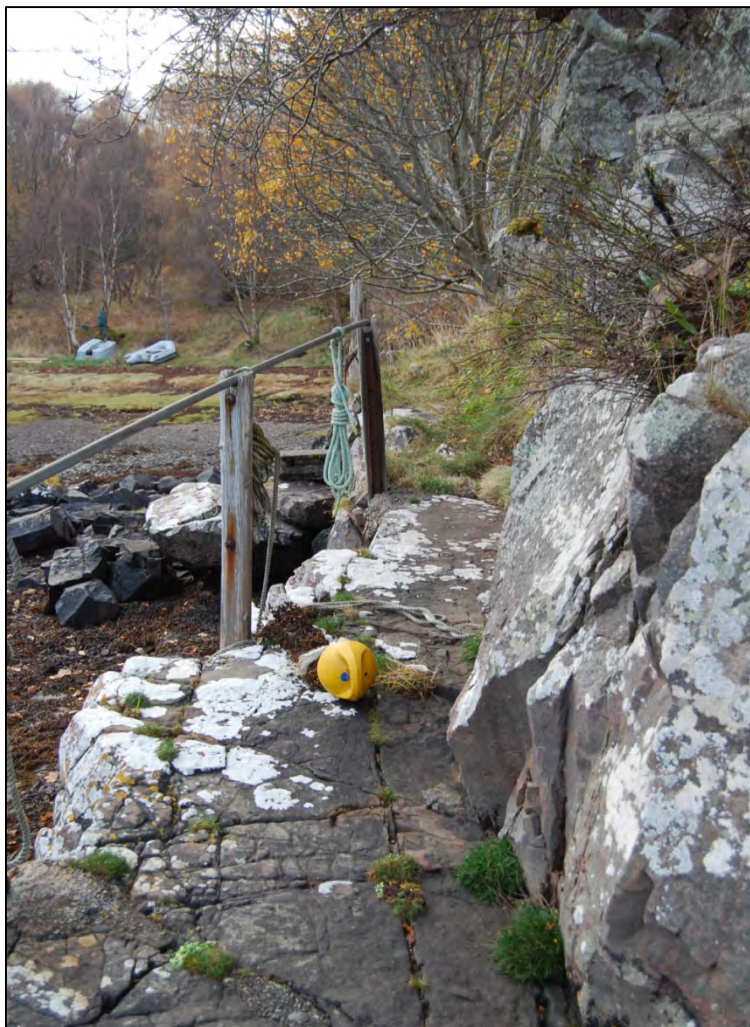
Photo 20 Rock-cut ledge / quay

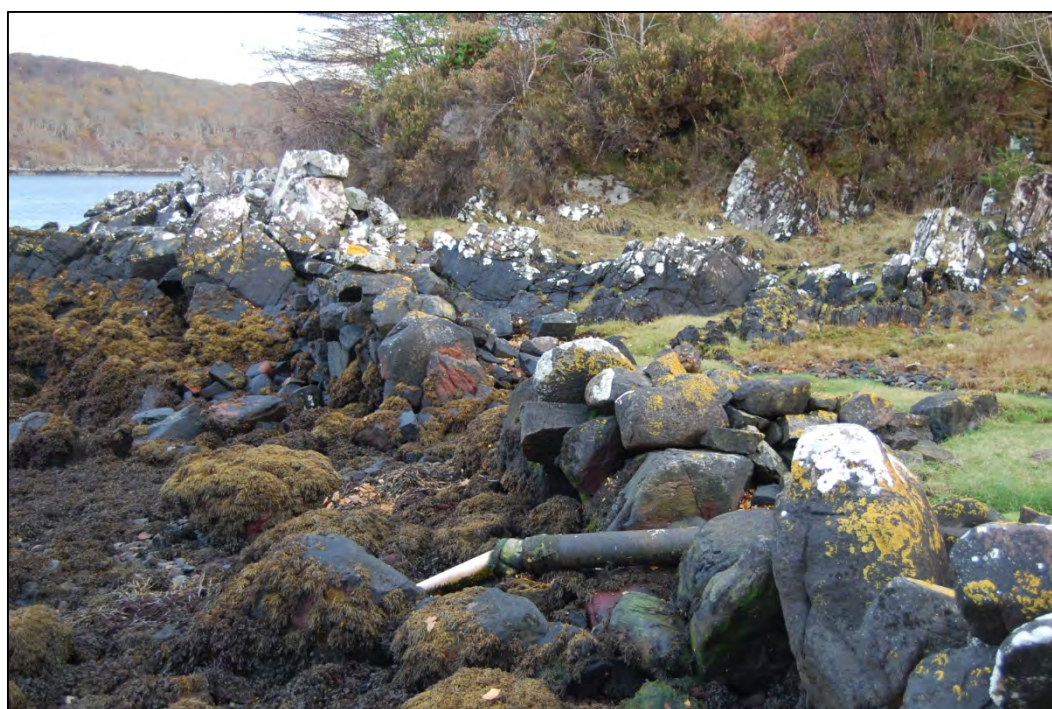
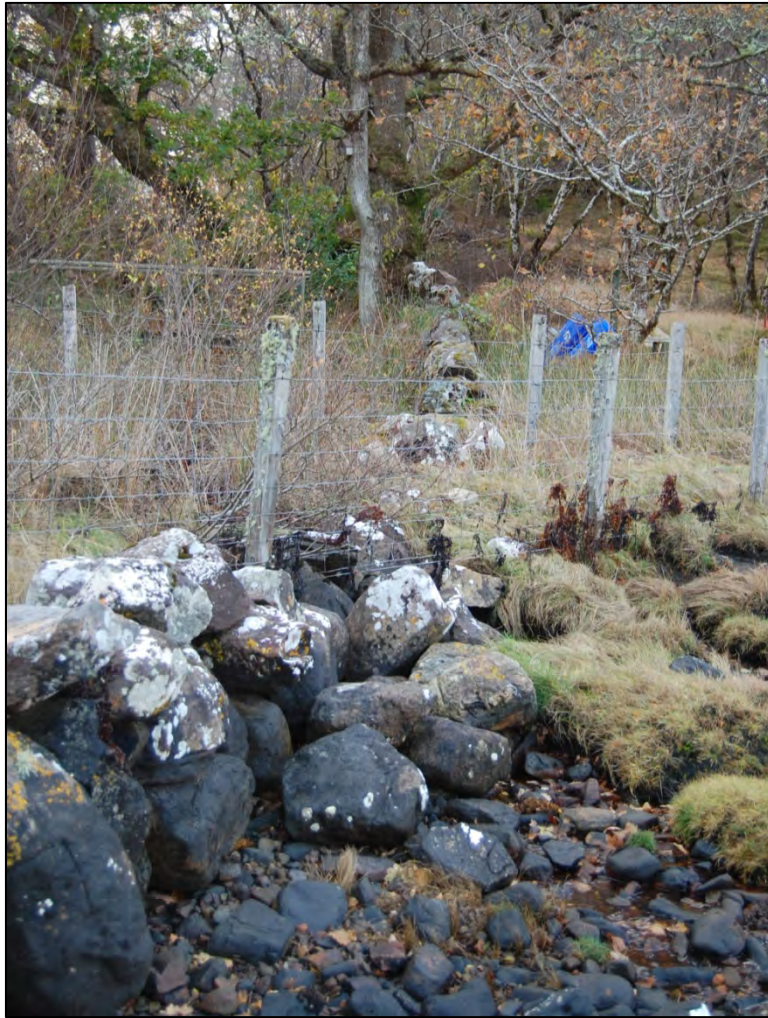
F38	Building	NG 79893 73104	10.4m x 3.9m	Rectangular building shown on 1st and 2nd edition 6 inch OS mapping. Rectangular building footings noted during fieldwork (F2) and shown on current OS mapping, do not coincide with the outline of this building.
F39	Building	NG 79900 73092	5m x 4.2m	Rectangular building shown on 1st and 2nd edition 6 inch OS mapping. Rectangular building footings noted during fieldwork (F3) and shown on current OS mapping, do not coincide with the outline of this building.
F40	Building	NG 79782 73107	4m x 3.9m	Rectangular building shown on current OS mapping. Not recorded during fieldwork.
F41	Wall	NG 79970 73061	0.75m - 1.2m across	Dyke forming part of the township boundary where it meets the sea - noted during fieldwork

Photo 21 Township dyke F41

Photo 22 Township dyke F41

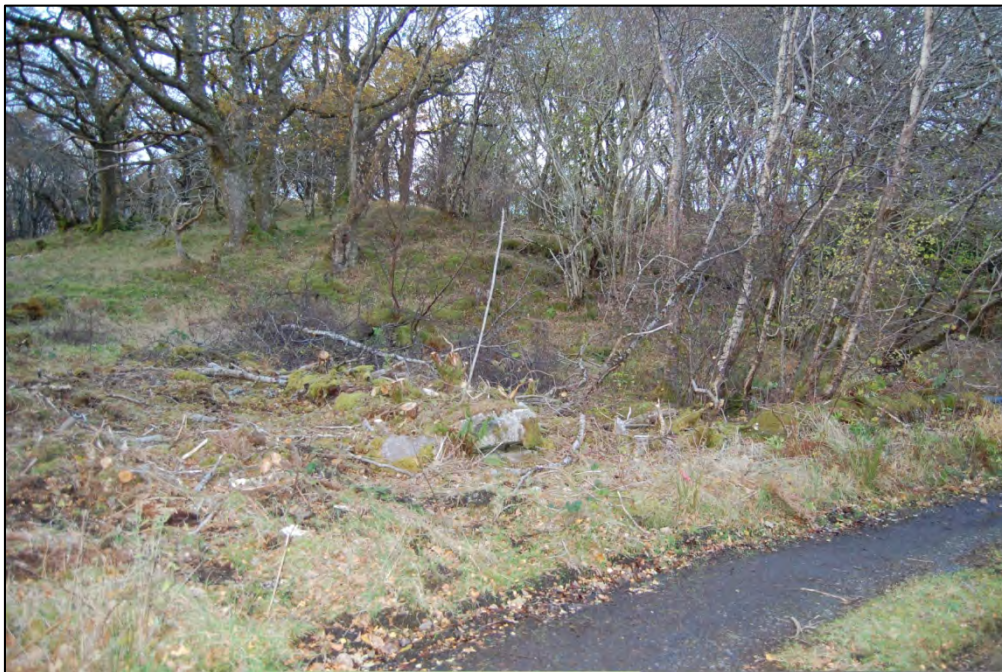
Feature No.	Type	Location	Dimensions (Approx)	Notes
F42	Wall	NG 79812 73064	8.8m x 11.3m	Oval enclosure - garden feature noted during survey
F43	Building	NG 79839 73138	4m x 6.6m	Rectangular building shown on the 1st and 2nd edition 6 inch OS maps. A longer building on the same N and S wall lines (F6) was noted during fieldwork and is shown on current OS mapping.
F44	Building	NG 79899 73030	8.65m x 3.75m	Concrete foundations of a rectangular building partly recorded on the current OS mapping but not shown on the 1st or 2nd edition maps. This has the appearance of a military building, possibly from the 2nd World War.

Photo 23 Building F44
