Craig Wood, Dingwall Phase 1

Archaeological Trial Trenching Evaluation

Report No.	HAS110101
Project Code	HAS-DNC11
Client	OER2006
Planning /HCAU Ref	10/00053/FULRC
NGR	NH 5559 6029
Date/ revision	26/01/2011
OASIS	highland4-92037
Author	John Wood

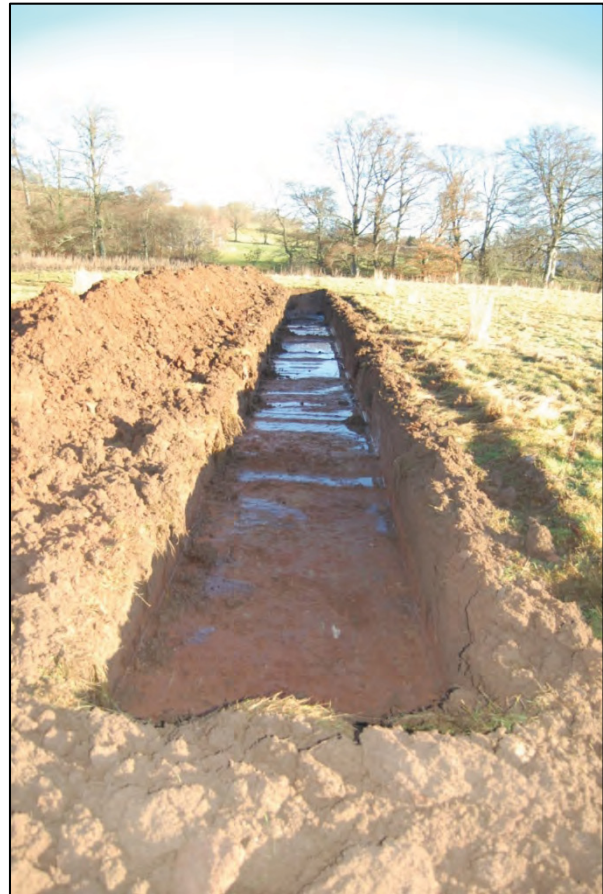
Photo 1 Trench 1 from SW

Smooth mid-brown sandy clay topsoil merged into clean, uniform red/brown clay with occasional rounded stones c.40-150mm across and larger rounded rocks c.30cm across. Topsoil depth varied from c. 0.5m to 1m. Lower levels of topsoil had occasional unstratified scattered charcoal flecks. No artefacts or archaeological features were found (Photo 1).

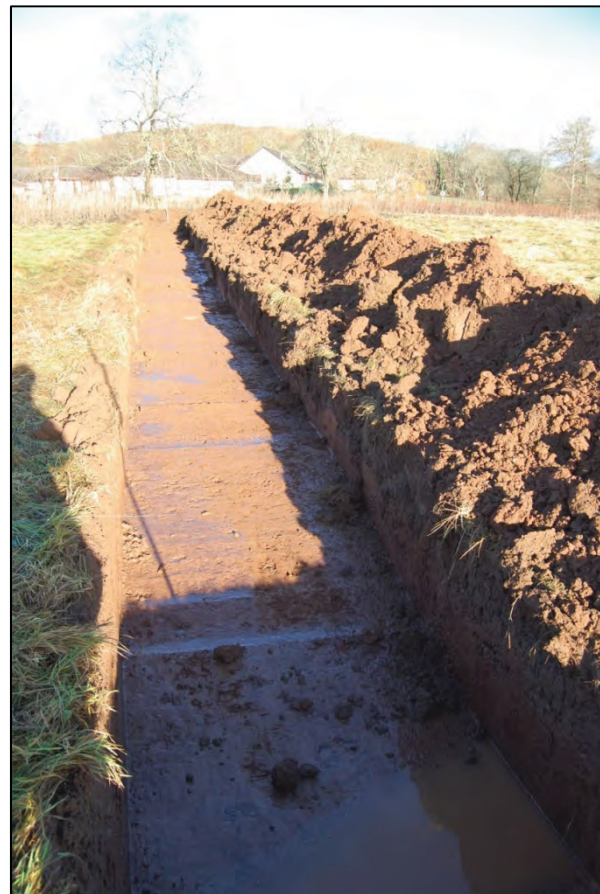
Photo 2 Trench 2 from S

Topsoil was removed onto clean, uniform red/brown clay with occasional grey patches in the N half, and angular stones c.100 -200mm across, lying at between 0.6m and 0.85m depth. No artefacts or archaeological features were found (Photo 2). It was not possible to photograph this trench from the northern end as this was direct into the low winter sun.

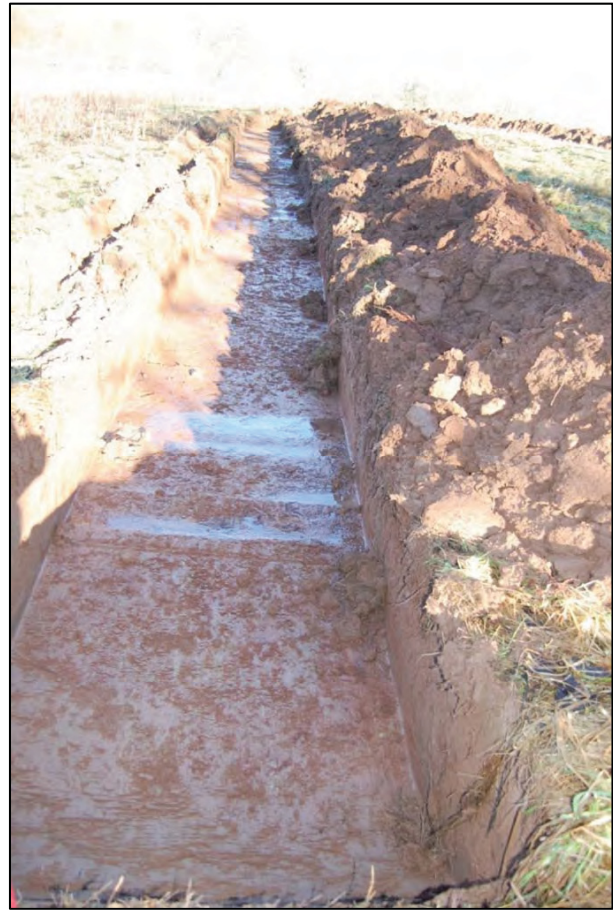
Photo 3 Trench 3 from N

Topsoil was removed onto clean, uniform red/brown clay with occasional angular stones c.30-60mm across, lying at between 0.6m and 0.75m depth. There was no clear horizon where the topsoil and subsoil merged. This trench cut into a raised bank at its west end which comprised upcast topsoil – apparently from clearance of the deep gully containing the burn along the western side of the field. No artefacts or archaeological features were found (Photo 3).

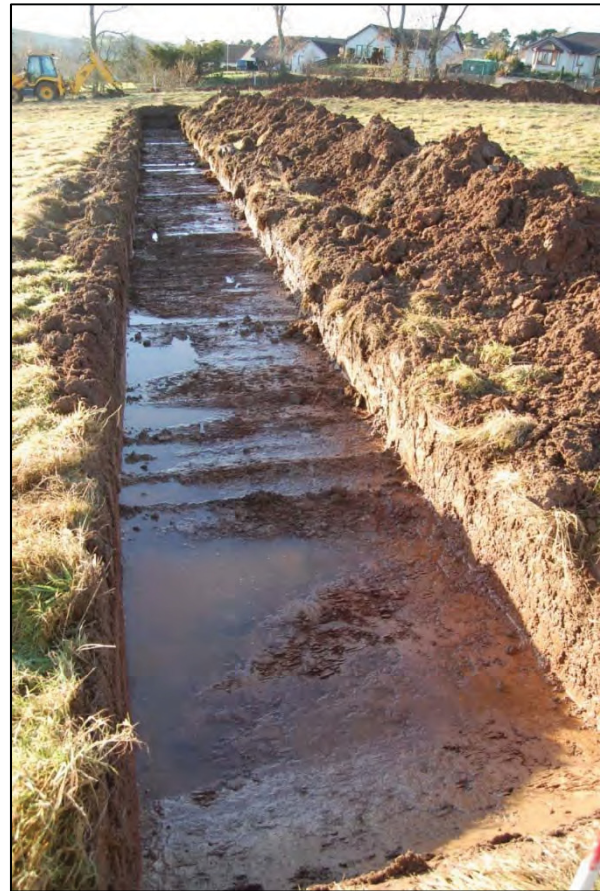
Photo 4 Trench 4 from E end

Topsoil was removed onto clean, uniform red/brown clay with occasional angular stones c.30-60mm across, lying at between 0.5m and 0.6m depth. There was no clear horizon where the topsoil and subsoil merged. No artefacts or archaeological features were found (Photo 4).

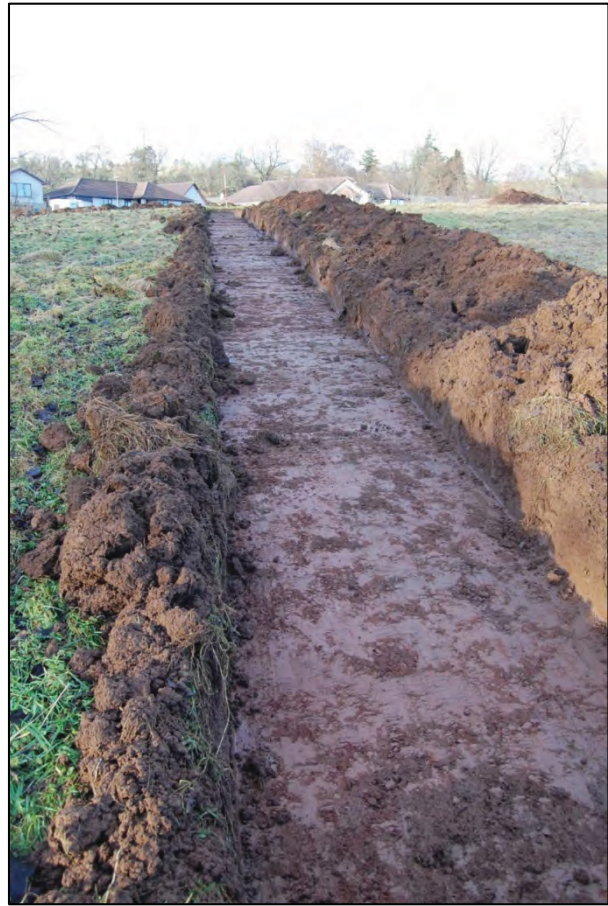
Photo 5 Trench 5 from S

Topsoil was removed onto clean, uniform red/brown clay with occasional angular angular stones c.30-60mm across, lying at between 0.4m and 0.5m depth. There was no clear horizon where the topsoil and subsoil merged. No artefacts or archaeological features were found (Photo 5).

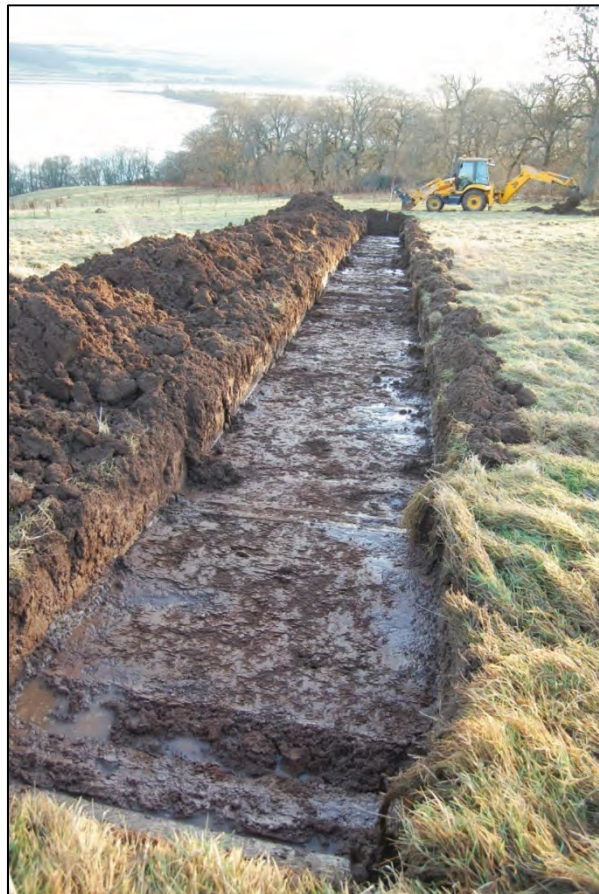
Photo 6 Trench 6 from N

Topsoil was removed onto clean, uniform red/brown clay with occasional angular stones c.100 -200mm across, lying at 0.6m depth (Photo 6). There has been considerable soil movement down the slope and material was very mixed. The southernmost 5m of this trench were therefore deepened to 1.1m to check (Photo 7 on p.13 below). This revealed a band of organic material at the base of the topsoil – apparently the result of root action. No artefacts or archaeological features were found.

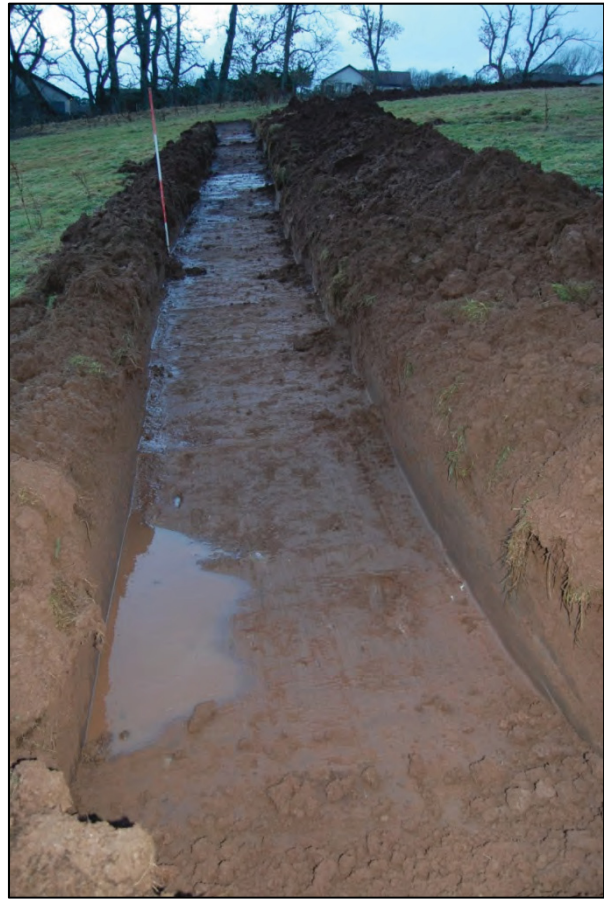
Photo 7 Trench 7, from E

Topsoil was removed onto clean, uniform red/brown clay with occasional angular angular stones c.30-60mm across, lying at between 0.5m and 0.6m depth. There was no clear horizon where the topsoil and subsoil merged. No artefacts or archaeological features were found (Photo 8).
