Archaeological Desk-Based and Walkover Survey

Proposed Alness and Cambusmore Electricity Substations

Report No.	HAS110301
Site Code	HAS-ACS11
Client	SSE
Planning Ref	N/A
OASIS	highland4-95730
Date/ revision	16/05/2011
Author	John Wood

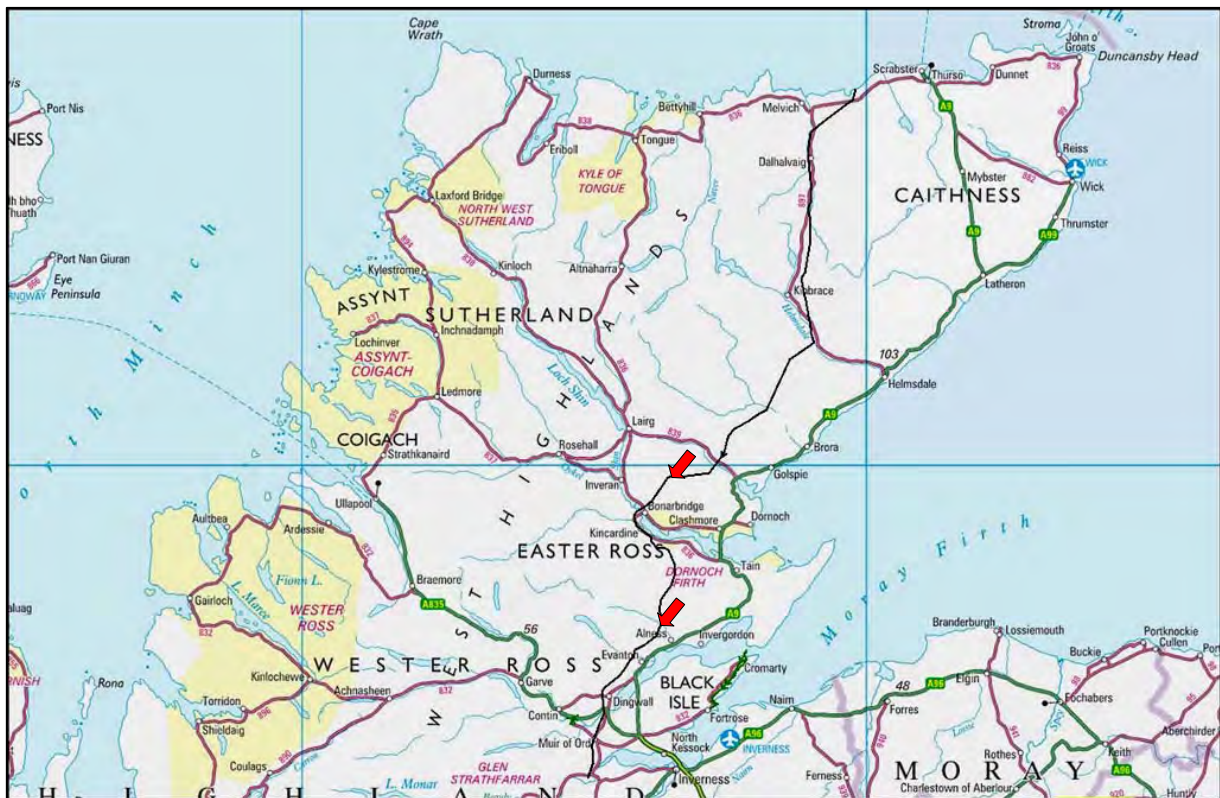
Figure 1 Site locations.

Black line shows approx. route of 275kv Dounreay – Beaulieu Transmission line.

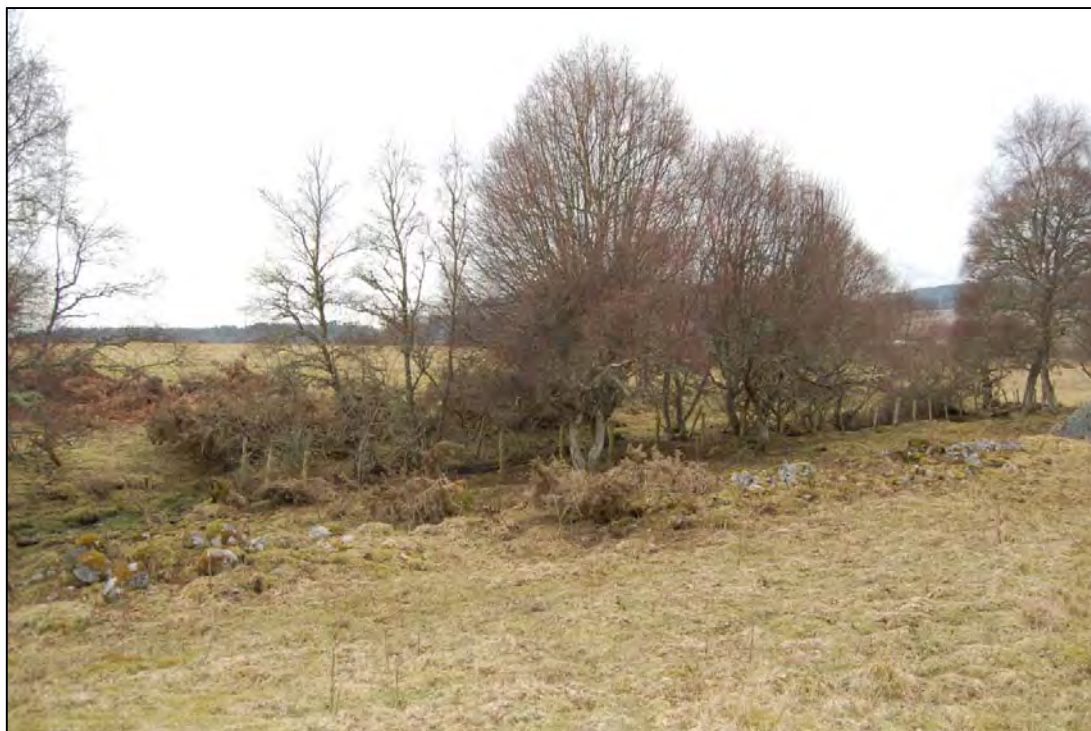
A fenced-off spring, apparently a private water supply, is sited in the field and to its south is a buried 20th c. reservoir. Beside this on both sides are considerable field clearance heaps which appear modern, but some might conceal footings of former buildings (See plate 2).

Plate 1 Feature 1, Area F (Field clearance)

There would appear to be few archaeological concerns with these sites. There are no recorded sites within them apart from the possible burnt mound in Area F (HHER MHG 8008), which should be safeguarded as a precaution. The field clearance heaps to the north of the spring might possibly conceal footings of buildings so if these are to be affected this possibility should be investigated. Any of them could contain buried evidence which cannot be detected by a walk-over survey, so it would be advisable that a further check be made when the chosen site is stripped.

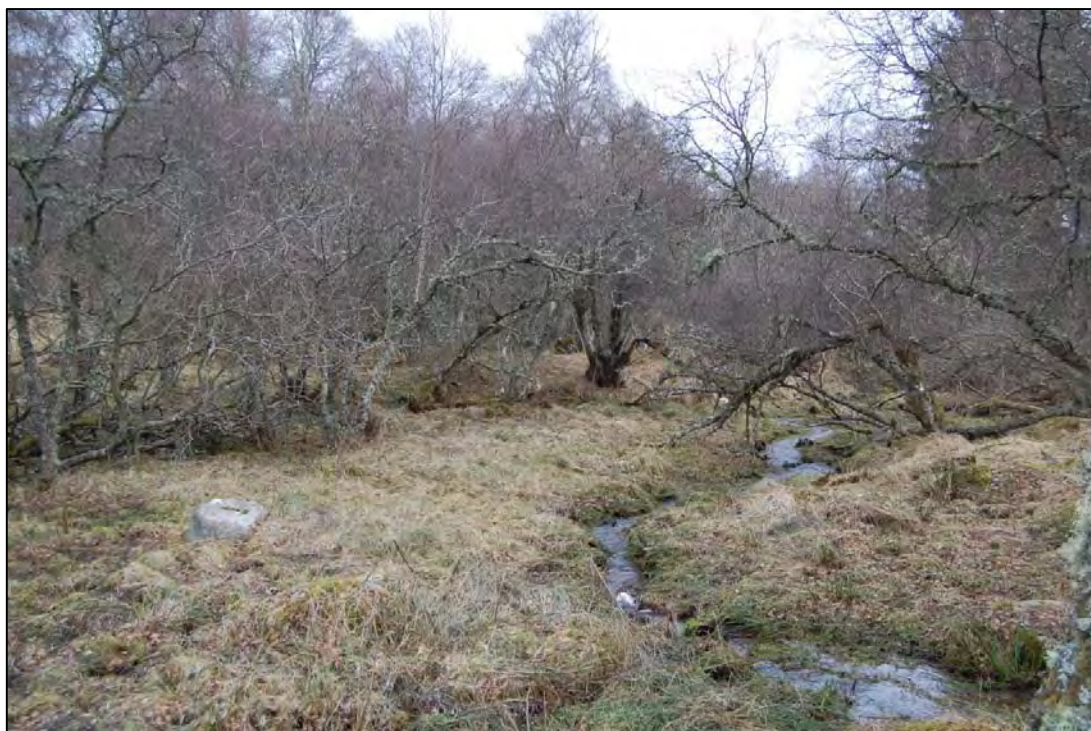
A Bronze Age Burnt Mound has been recorded by the stream near the southern edge of this site. This was located, but found to be covered by trees, grass and other vegetation. No burned material could be seen (See plate 2).

Plate 2 Feature 2, Area F: Possible burnt mound (HHER MHG8008)

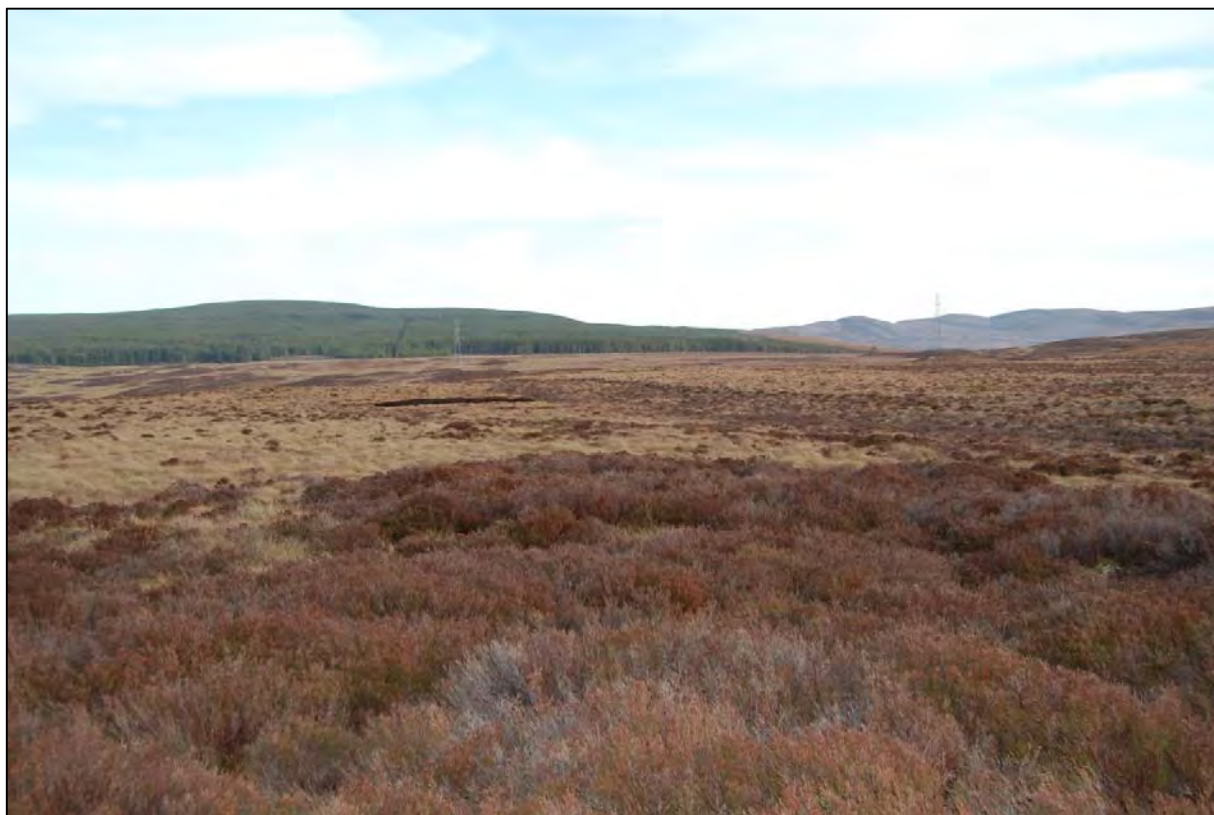
Plate 3 View (E) across Cambusmore Areas B, C, D, showing peat cutting in centre. Areas A and D are within the forest.

This is an area of open heather moorland which has been cut for peat over many years and one currently active peat cutting was noted. Outcrops of bedrock are visible. No archaeological features were recorded.
