## North Leigh Roman Villa

### Archaeological Watching Brief Report

April 2014

Client: English Heritage

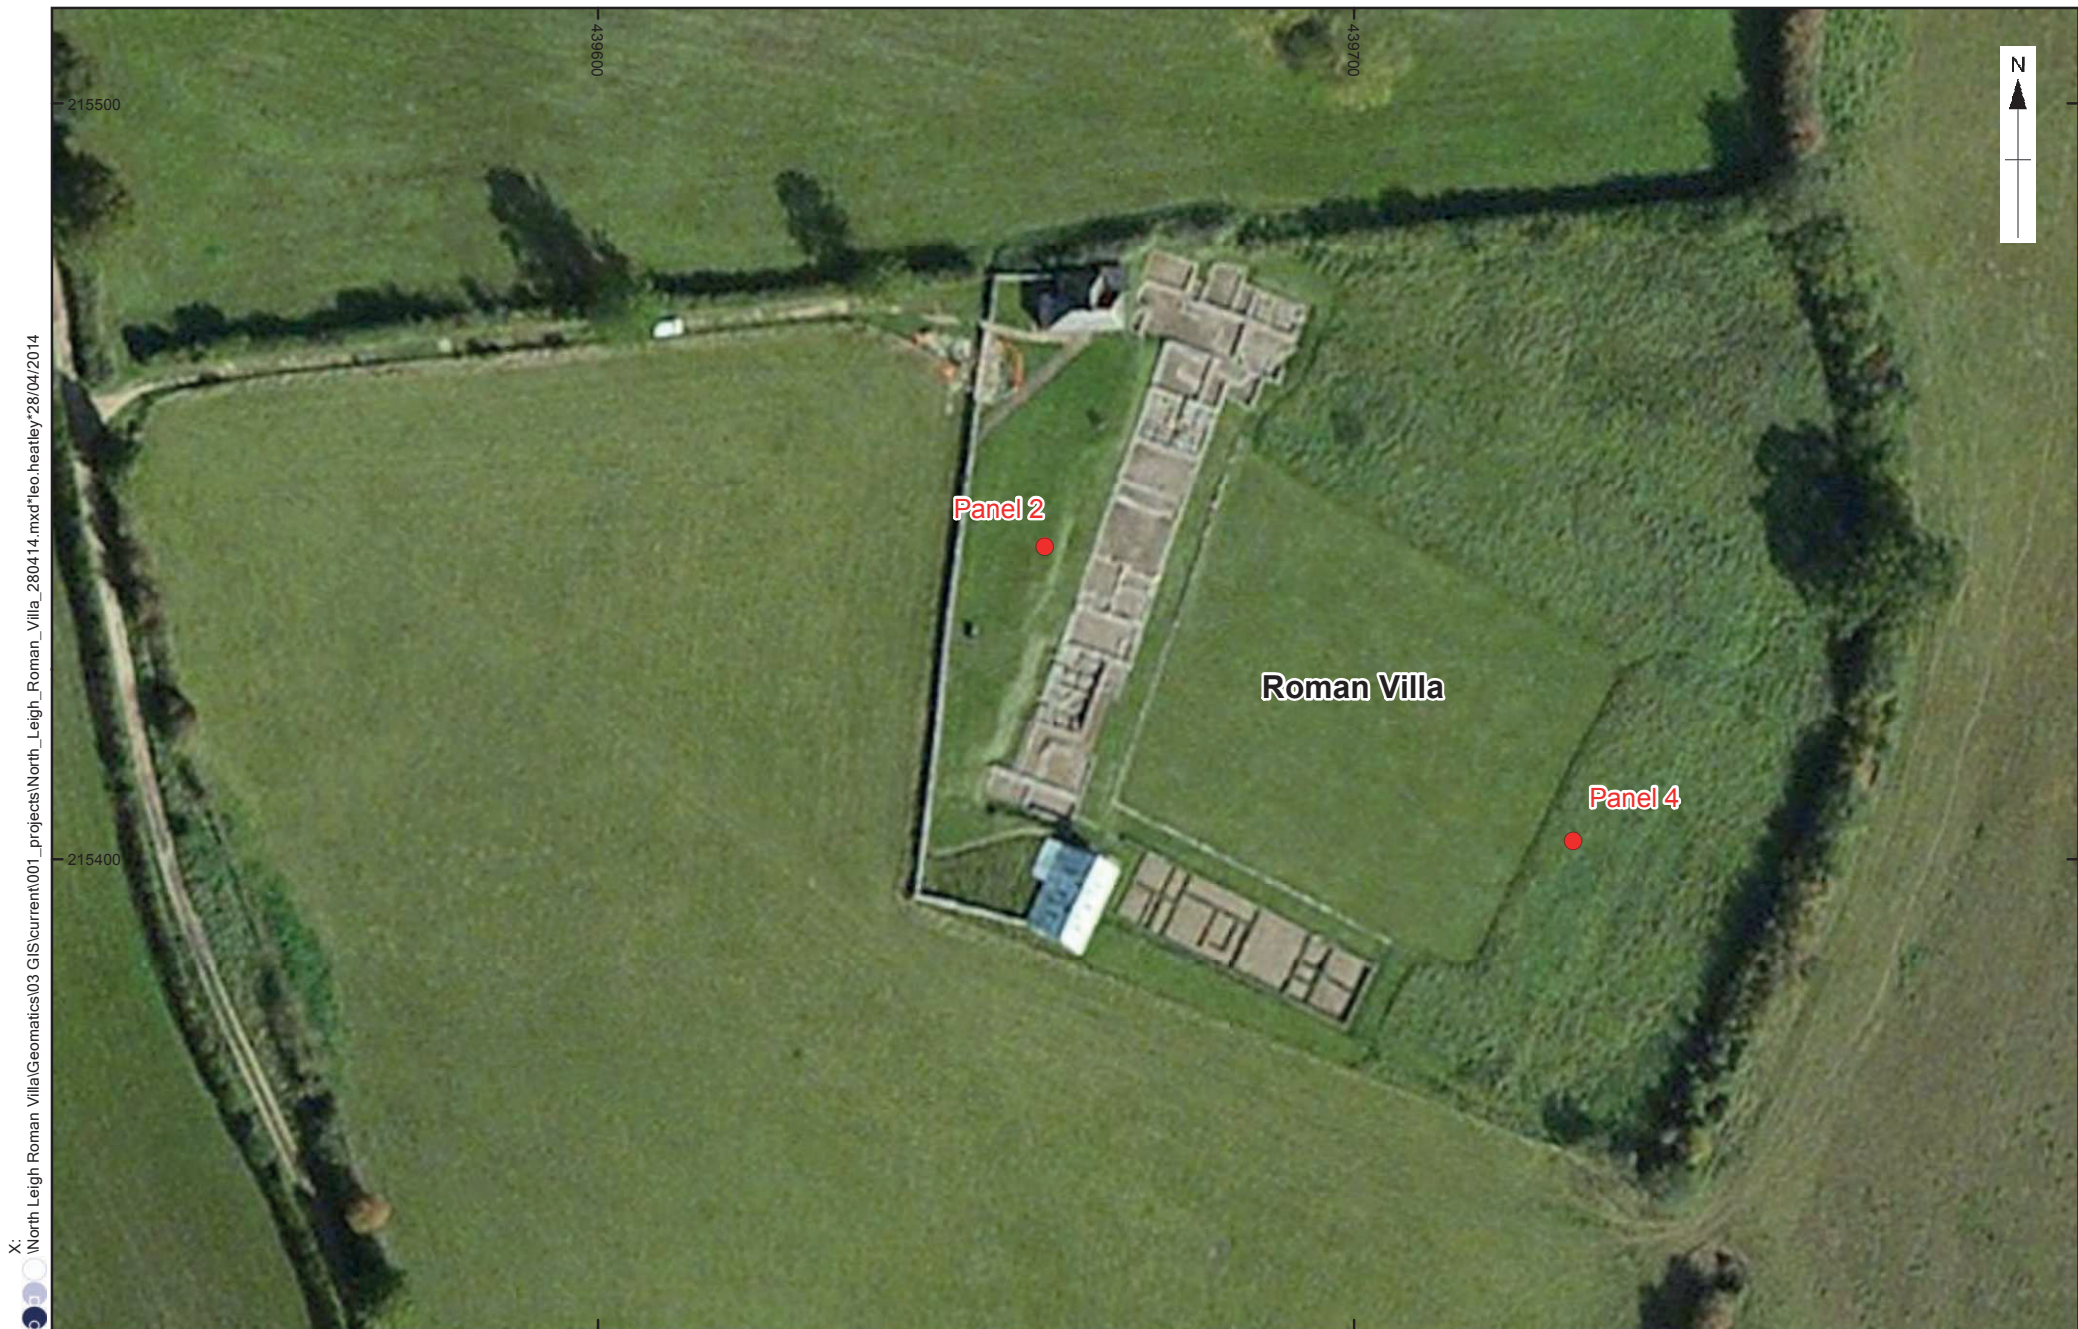
Figure 2: Location of new signs

- 3.1.1 Sign 2 was located to the north-west of the central range of the Villa, on a slightly raised, level grassed area (Fig. 2).
- 3.1.2 The excavation of the post holes was monitored until a pre-determined depth of 550mm was established in both the north-east and south-west locations.

- 3.2.1 Sign 4 was located at the centre of the south-east extent of the maintained, level, grassed area representing the edge of the courtyard of North Leigh Roman Villa (Fig. 2).
- 3.2.2 The excavation of the Sign 4 footing holes was monitored until the pre-determined depth of 800mm in the north-east footing hole. In the south-western hole excavation ceased at an archaeologically determined depth of 530mm when possible structural remains were encountered.
