Goodhart Building, University College, Oxford

Archaeological Watching Brief on engineering test pits (May 2013)

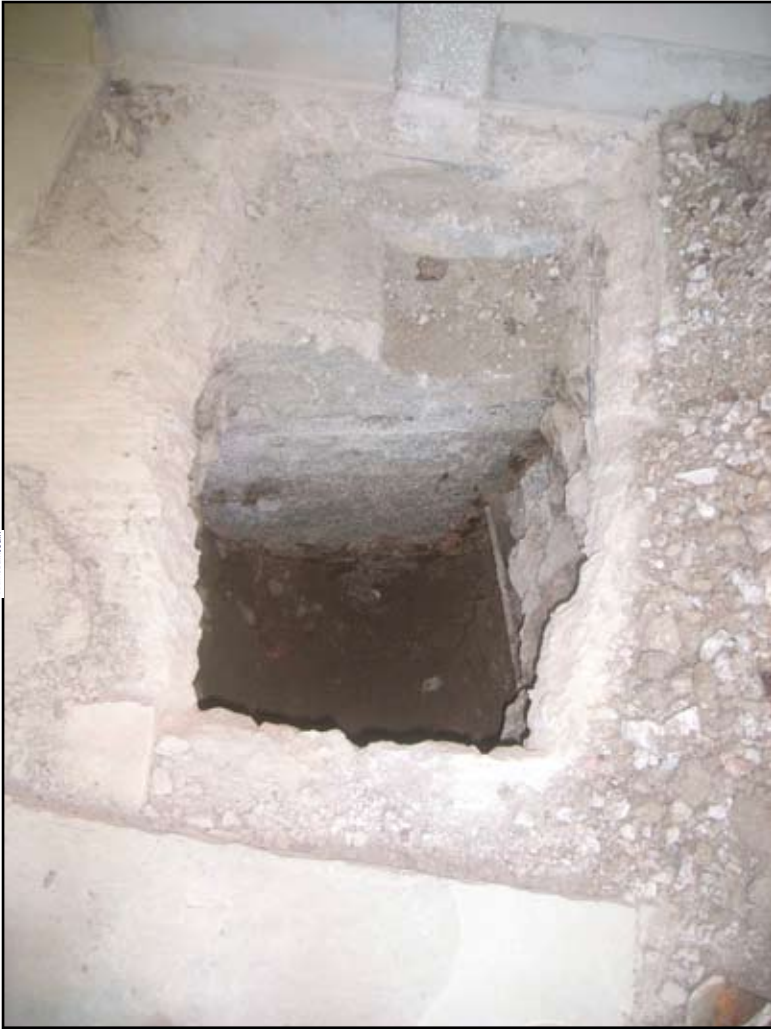
Plate 1: Test Pit 1 looking north

Test Pit 1 (Fig. 1 and Plate 1)

TP1 was excavated against a pillar in the south wall of the south-east corner of the Goodhart Building (Fig. 1). The Test Pit extended 1.5m to the south of the wall and was a maximum of 0.9m wide. The southern edge of the exposed pillar base was not parallel with the wall of the Goodhart Building, being offset by 0.6m at the western edge of the trench and 0.45m at the eastern edge.

The southern half of the pit was excavated to 1.25m below the existing flagstone paving (bgl) to facilitate the deeper excavation of the northern half of the pit to expose the depth of the concrete base of the pillar. The southern edge of the deeper excavation was battered to a general depth of 1.65m bgl, and a c 0.2m² sondage excavated up against the foundation to a maximum depth of 1.9m bgl.

The remnant of the timber shuttering against which the concrete had been poured was evident, and had presumably been placed against the edge of a trench for the foundation which had been excavated through the material to the south. This material comprised 0.9m⁺ of predominantly mid brown clayey silt which had modern finds throughout - although infrequent - and was in turn overlain by 0.8m of mixed construction debris (concrete fragments/stone/brick rubble/aggregate etc). The latter was overlain by a 0.2m re-enforced concrete slab, which was in turn overlain by the 0.08m thick flagstone paving.

The remnants of timber shuttering used to form the foundations during construction was revealed against the face of the concrete foundation in TP1, and was present from immediately below the existing concrete slab (c 0.25m bgl). This could be the result of a number of different scenarios;

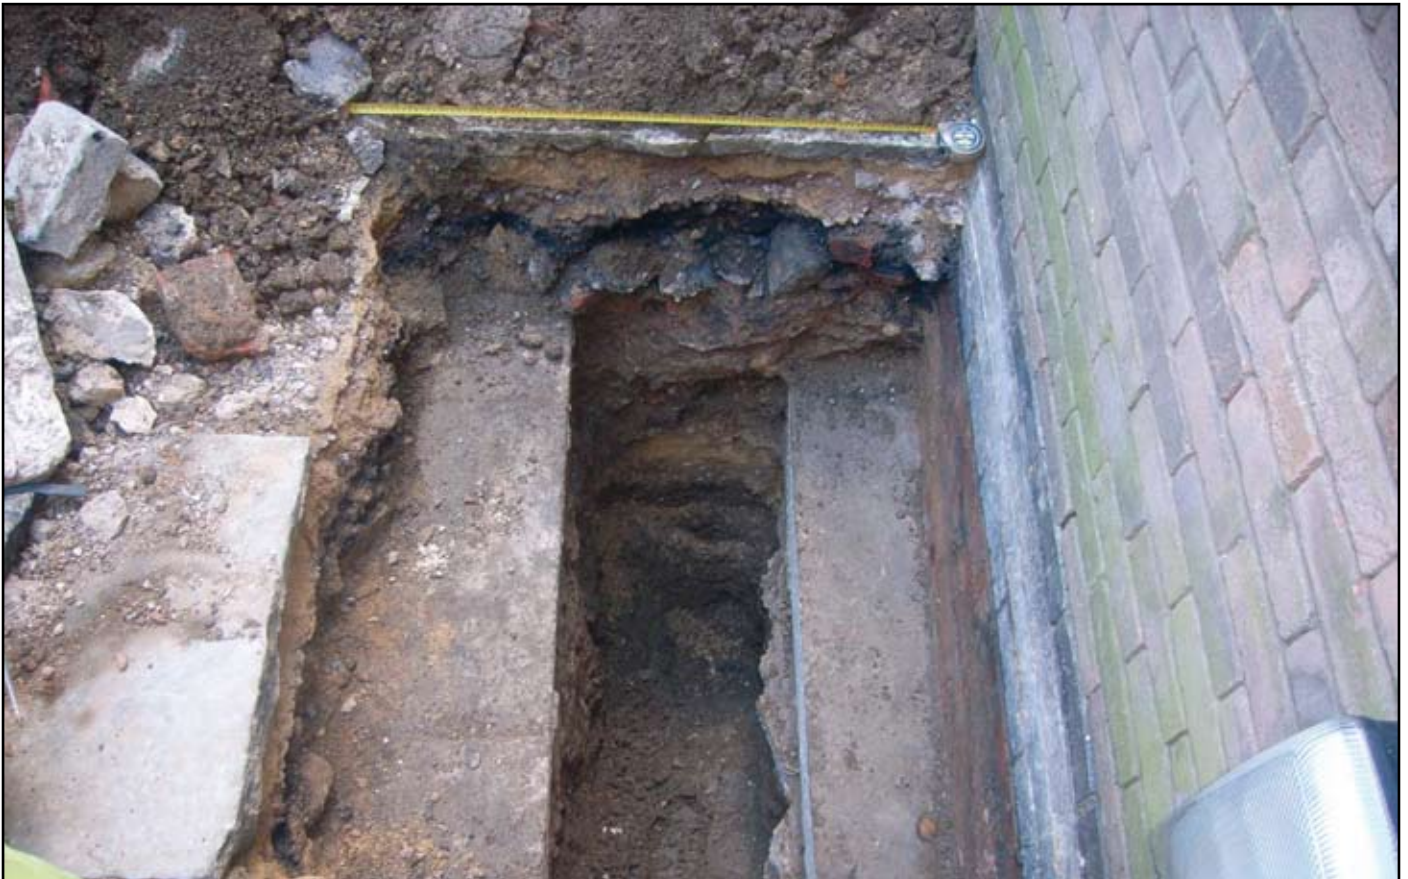
Plate 2: Test Pit 2 looking north (subsequently extended north)

Test Pit 2 (Fig. 1 and Plate 2)

TP2 was excavated on the north-west corner of an ancillary building to the north-west of the Goodhart Building (Fig. 1). The trench measured a maximum of 1.9m from north to south and extended 1m from the western wall of the building. The earliest deposit encountered was a 0.2m-0.55m⁺ thick deposit of mid brownish grey clay silt, which was overlain by up to 0.9m of mixed construction debris (brick/concrete fragments/tarmac/sand etc). The interface between these deposits corresponded to the base of the concrete footing for the standing building (at 1.4m bgl) and the base of a brick, concrete capped structure on the same alignment (at 1.05m bgl). The mixed deposit; concrete foundation and concrete cap of the brick structure were overlain by c 0.5m of bedding deposits for the existing 0.08m thick flagstone paving.

Characterisation of the clayey silt deposit was problematic given the restricted confines of the Test Pits. In Test Pit 2 it contained post-medieval finds (sherds of a late 19th century marmalade jar and some glass fragments – not retained), and in Test Pit 1 it yielded modern finds including fragments of concrete and broken ceramic service pipe. This would suggest that even if it does represent an archaeological horizon – it had been disturbed during the construction of the Goodhart Building (or that it is a re-deposition of material excavated from elsewhere).
