Danesfield House Hotel Medmenham

Archaeological Evaluation Report

June 2016

Client: Danesfield House Hotel

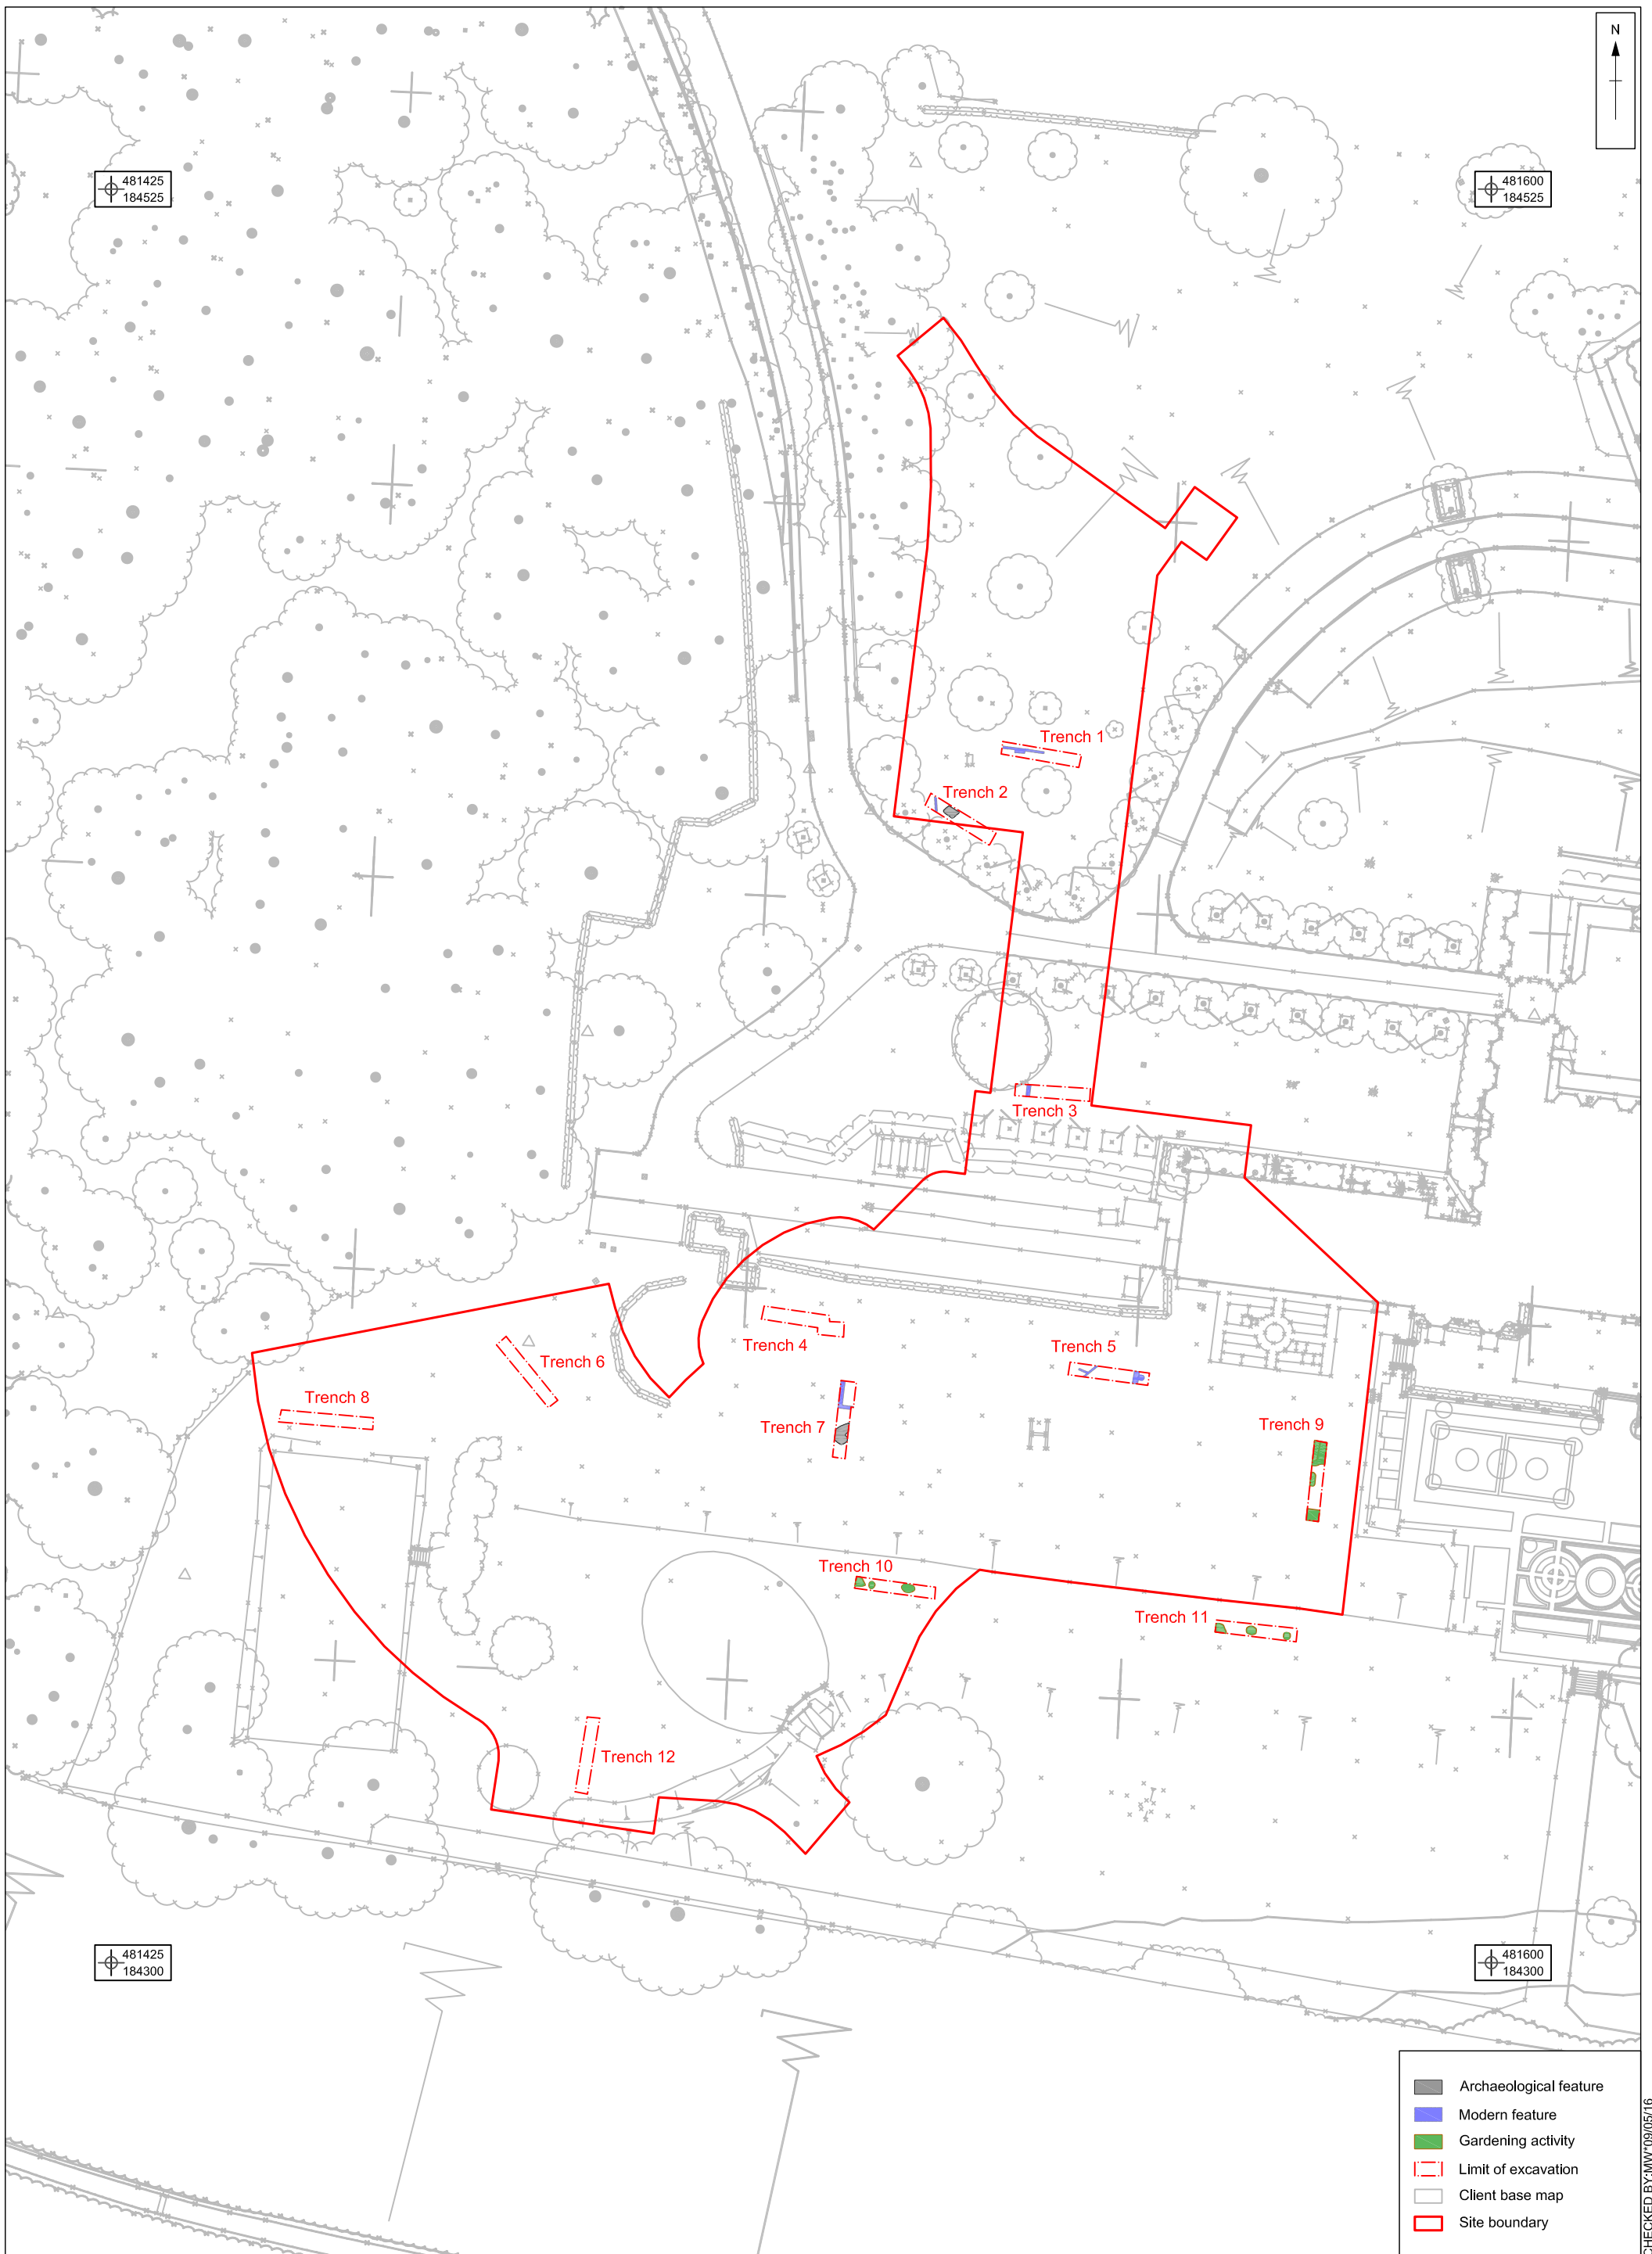
Figure 2: Trench location plan

- 2.2.1 The evaluation comprised 12 trenches each measuring 10m by 1.5m. The trenches were located to provide an even coverage of the site (Fig. 2). The location of all trenches, except Trench 12, was altered slightly from those specified within the WSI due to the presence of garden features or previously unknown services.
- 2.2.2 All trenches were located using a GPS system with a sub 50mm accuracy.
- 2.2.3 Trenches were CAT scanned prior to and during excavation to avoid any unknown service pipes and cables. Trenches were opened under constant archaeological supervision, using a mechanical excavator fitted with a toothless ditching bucket.
- 2.2.4 Revealed features were hand cleaned and a sample were excavated and recorded. Finds were recovered and bagged by unique context number.

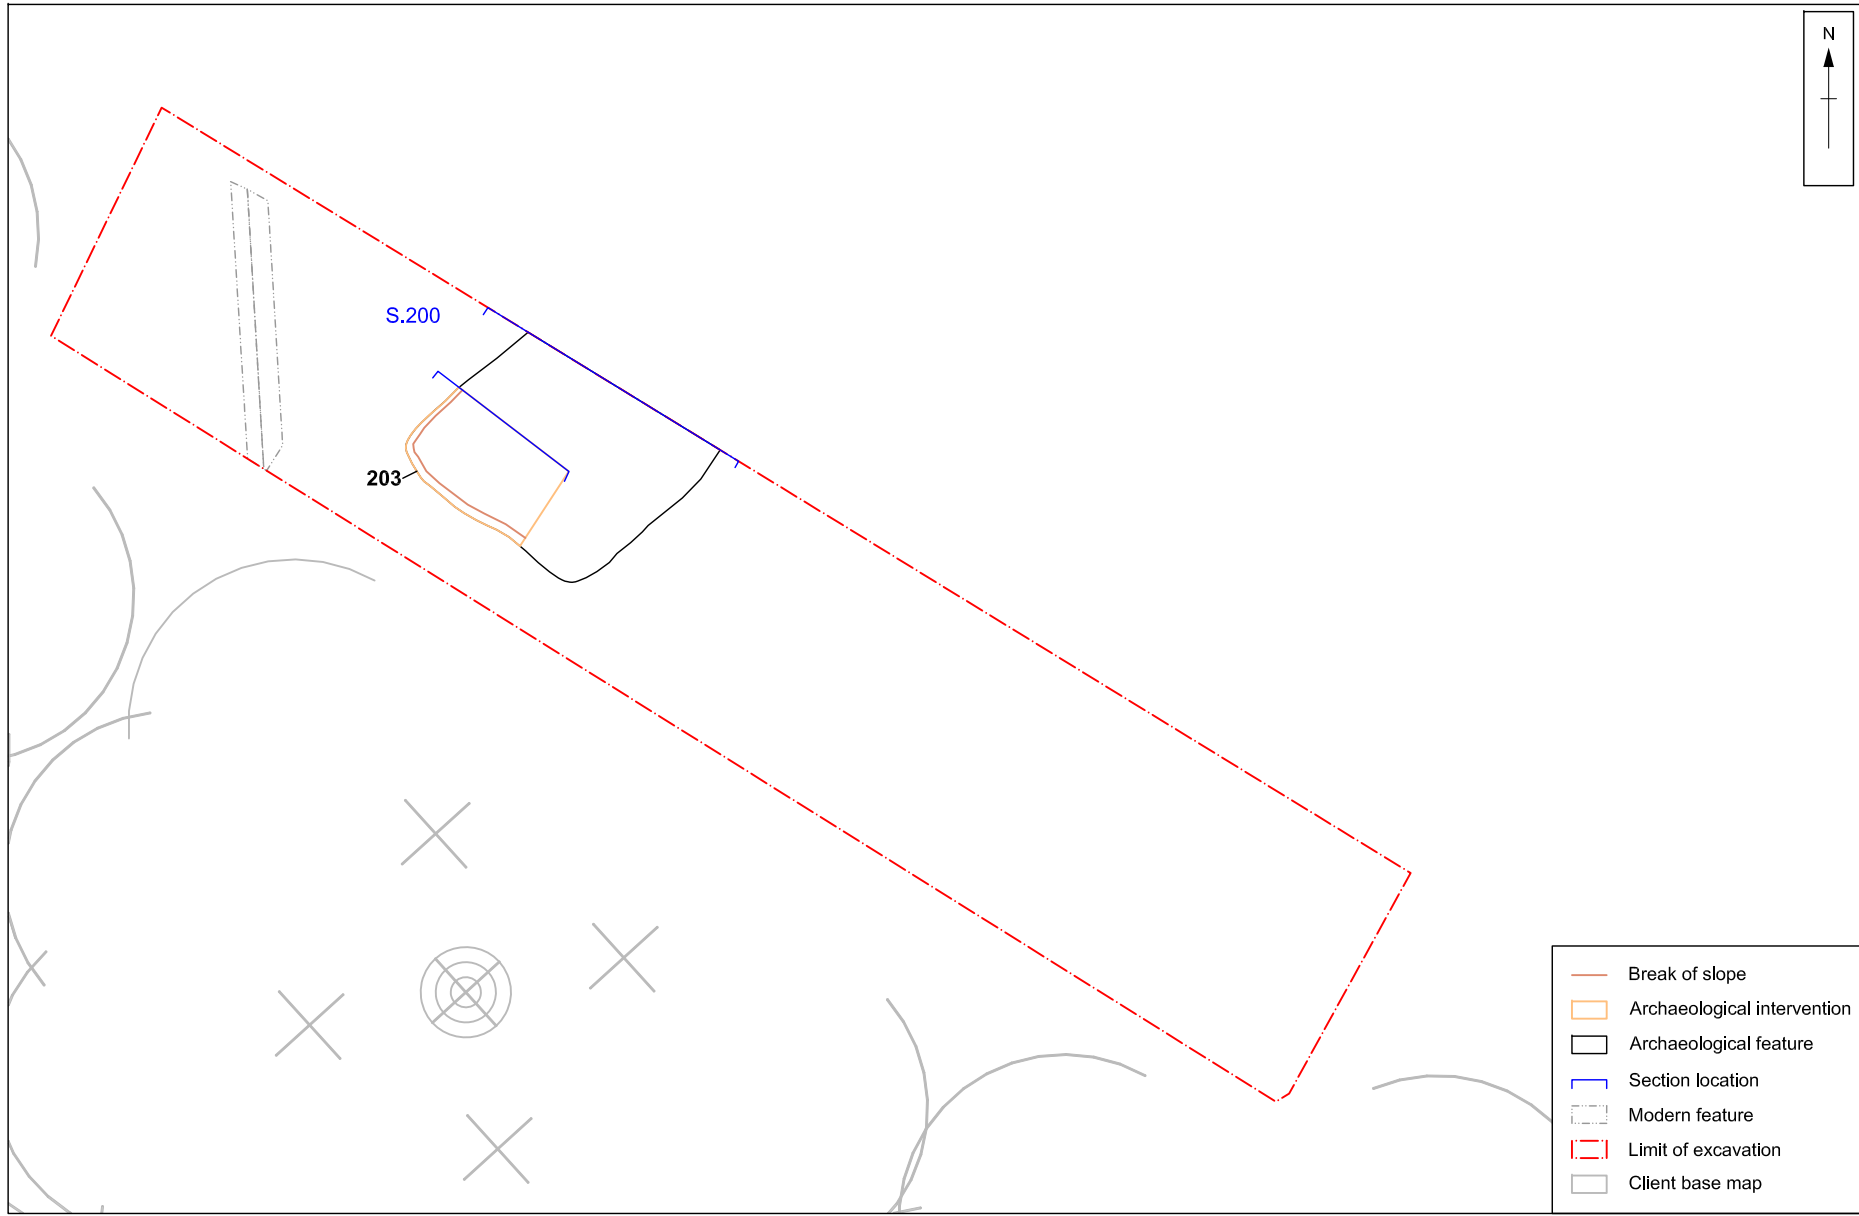
Figure 3: Trench 2

3.5.1 Aligned NW-SE, the western end of Trench 2 (Fig. 3 and Plate 3) had been disturbed by the former road alignment surviving within the trench as a kerb stone and its associated construction cut.

3.5.2 A single feature, 203 (Plate. 4), was observed within the centre of the trench continuing beyond its northern limits. The feature, rectangular in plan and measuring 1.2m by 1.6m within the trench, was 0.74m deep with near vertical sides and flattish base. No artefacts were recovered from the mid greenish brown silty clay which filled the feature.

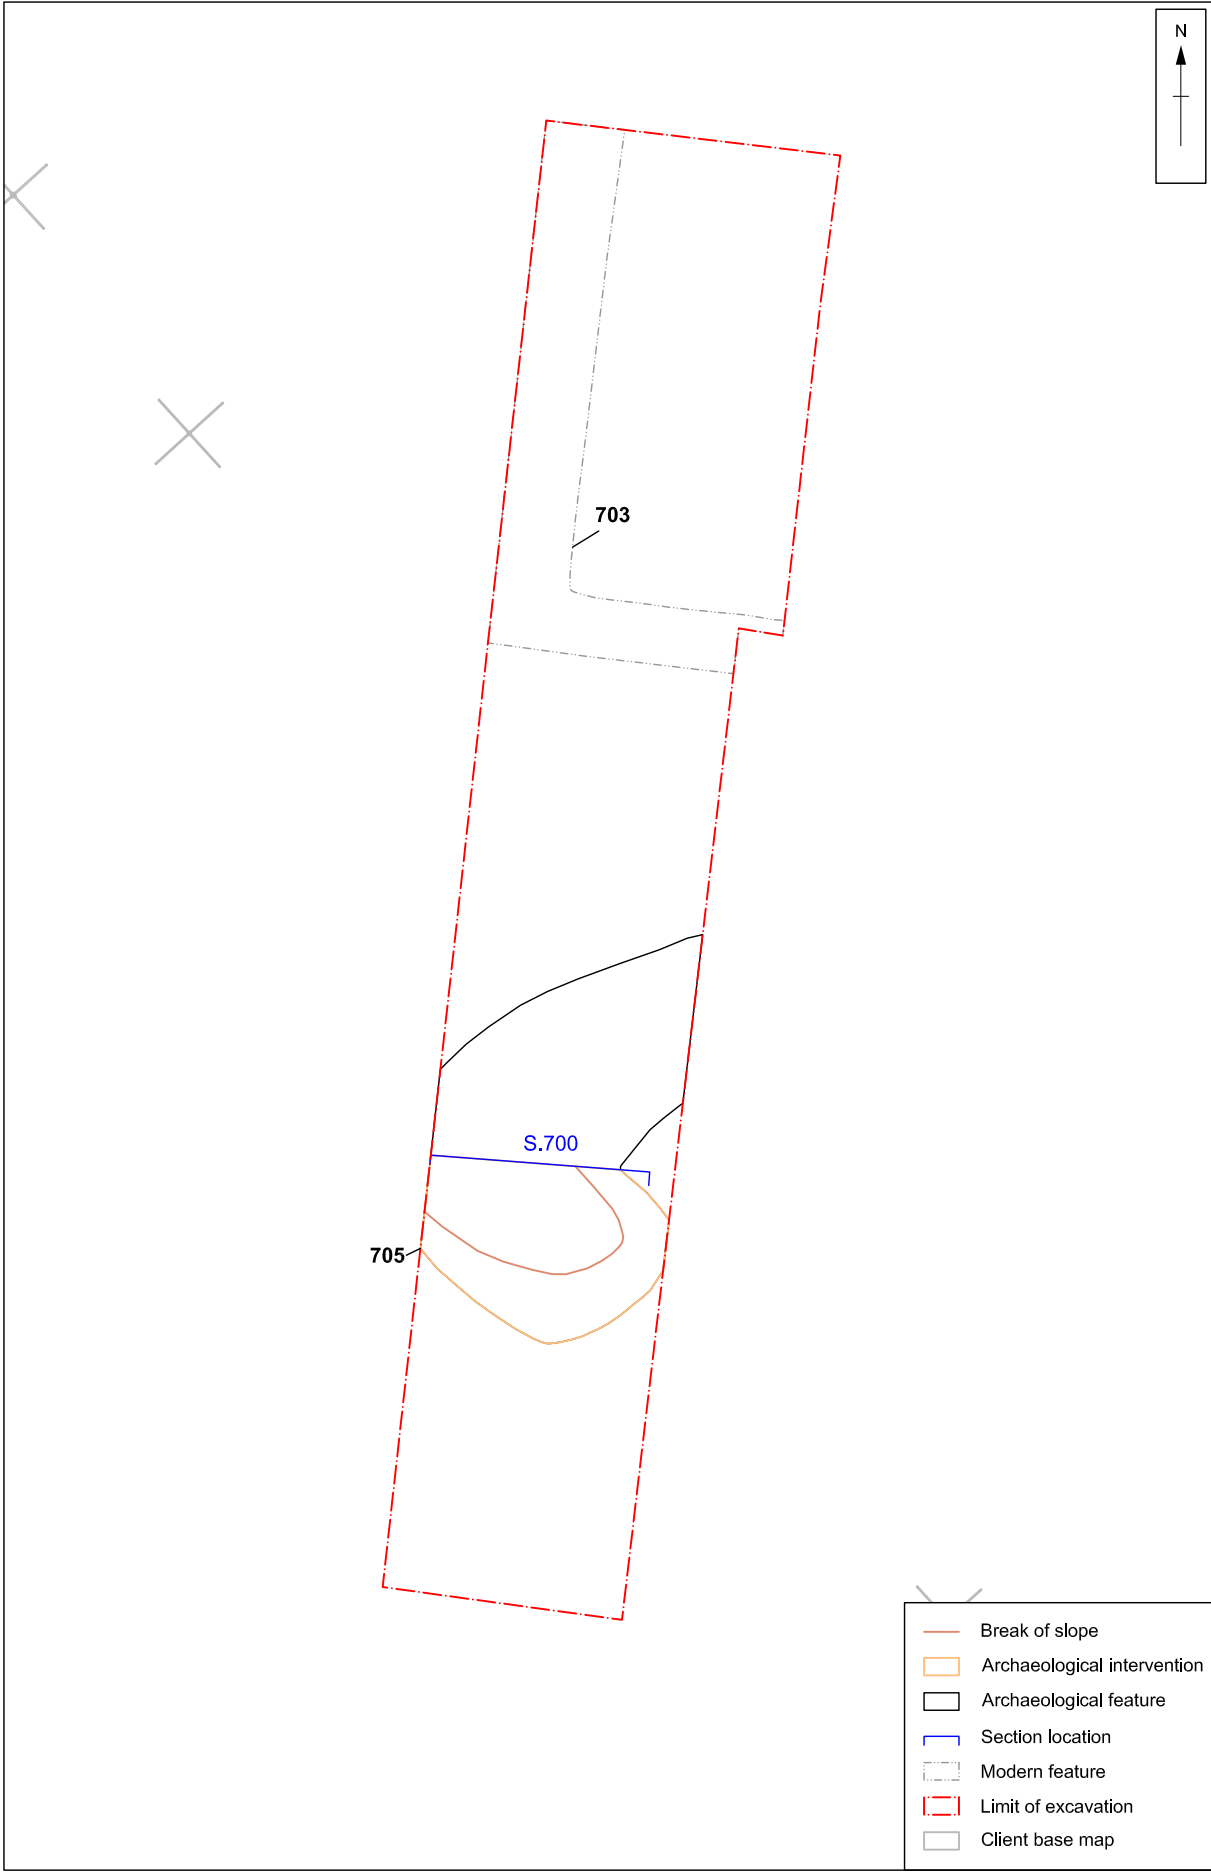
Figure 4: Trench 7

- 3.10.1 Aligned N-S, Trench 7 contained a single pit or ditch terminus, 705, towards the southern end (Figs. 4 and 6, Section 700). Observed to be at least 2.44m by 1.6m the feature continued beyond the eastern limits of the trench. The profile of the feature, moderate concave sides tapering to a rounded base, suggest it to be a pit rather than a terminus.

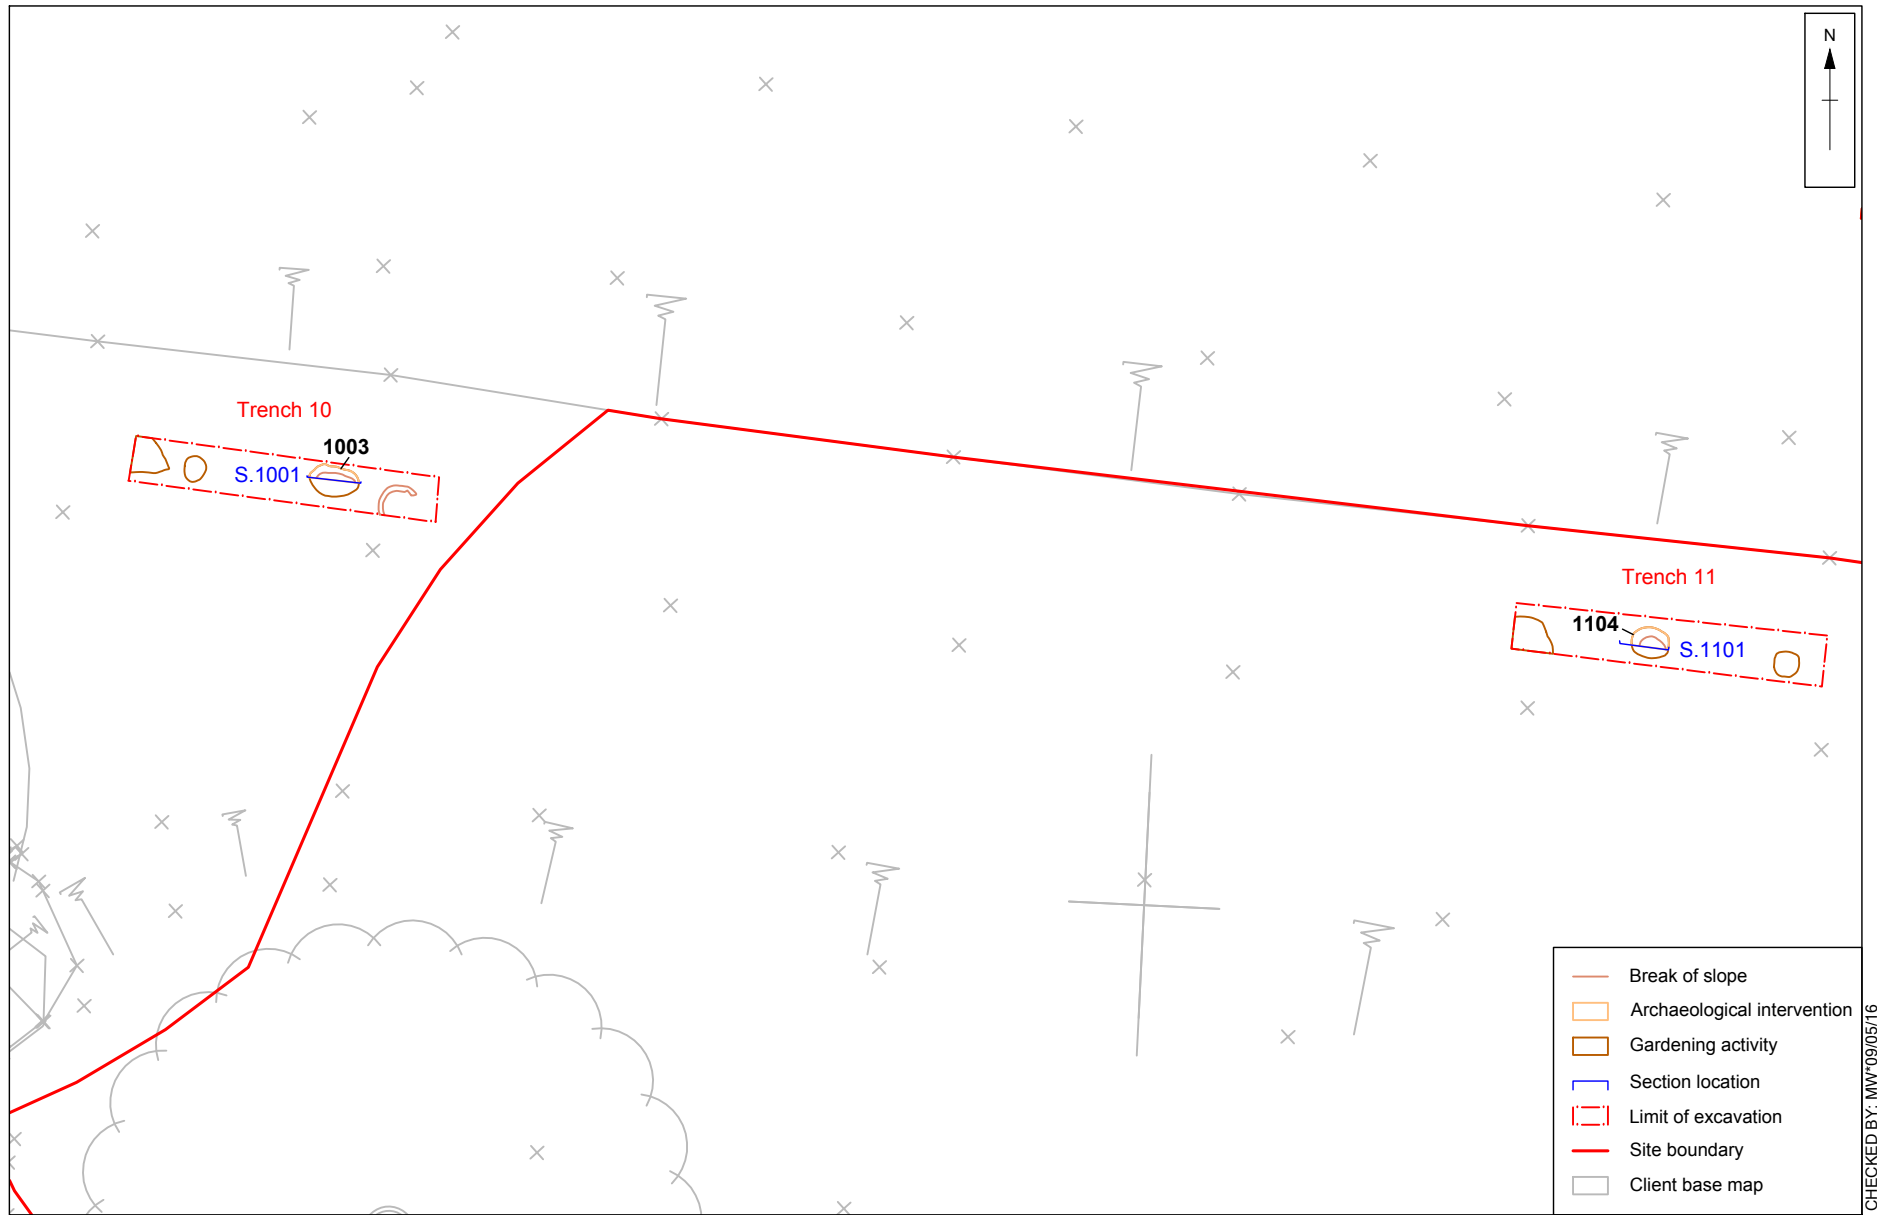
Figure 5: Trenches 10 and 11

- 3.13.1 A pit, 1003, (Figs. 5 and 7, Section 1001 and Plate 15) excavated at the eastern end of the trench was observed to be cut through subsoil, 1002, and underlying natural gravels, 1005. The pit, measuring 1.66m by 1m, was observed to be 0.2m deep and filled with a dark greyish brown silty sand. From the fill a small quantity of 19th - 20th century pottery along with, clinker, coal, CBM, glass and an Iron nail was retrieved.
- 3.13.2 A second similar unexcavated pit was located at the eastern end of the trench (Plate 14).

- 3.14.1 Aligned with those within Trench 10, Trench 11 contained a further three pits.
- 3.14.2 Distributed evenly along the length of the trench the pits were observed to be cutting the subsoil, 1102, and underlying natural gravels, 1105. Pit 1104 was the only one of the three excavated. From the fill, a mid greyish brown sandy silt, a piece of swan animal bone was recovered (Figs 5 and Plates 16 and 17). Pit 1104 was similar in profile to pit 1003 from Trench 10.

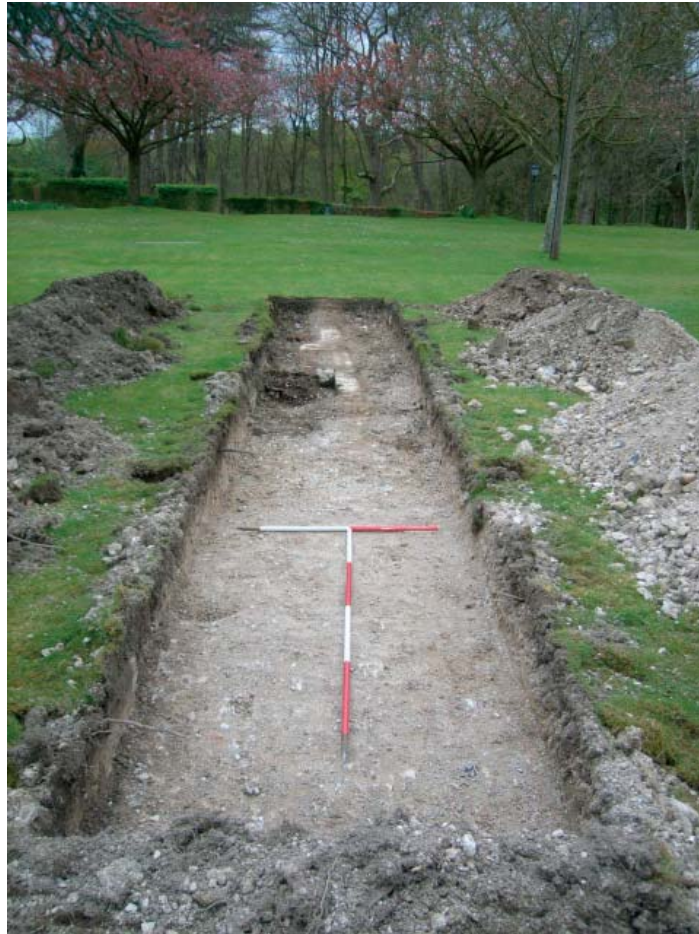
3.4.1 Within Trench 1 (Plate. 1) natural gravels were sealed by a mid grey brown sandy gravel subsoil, 105. Extending from the western end of the trench an east west aligned wall, 103 (Plate 2), was observed to truncate the subsoil. Constructed upon a concrete footing, 104, only two courses of bricks survived. The wall was sealed by a dark grey silty sand with frequent mixed CBM and concrete inclusions, 102. From this deposit a sherd of pottery stamped RAF was recovered. This deposit was sealed by a compacted chalk layer containing occasional brick fragments, 101 (Fig. 6, Section 100).

Plate 1: Trench 1, view to west

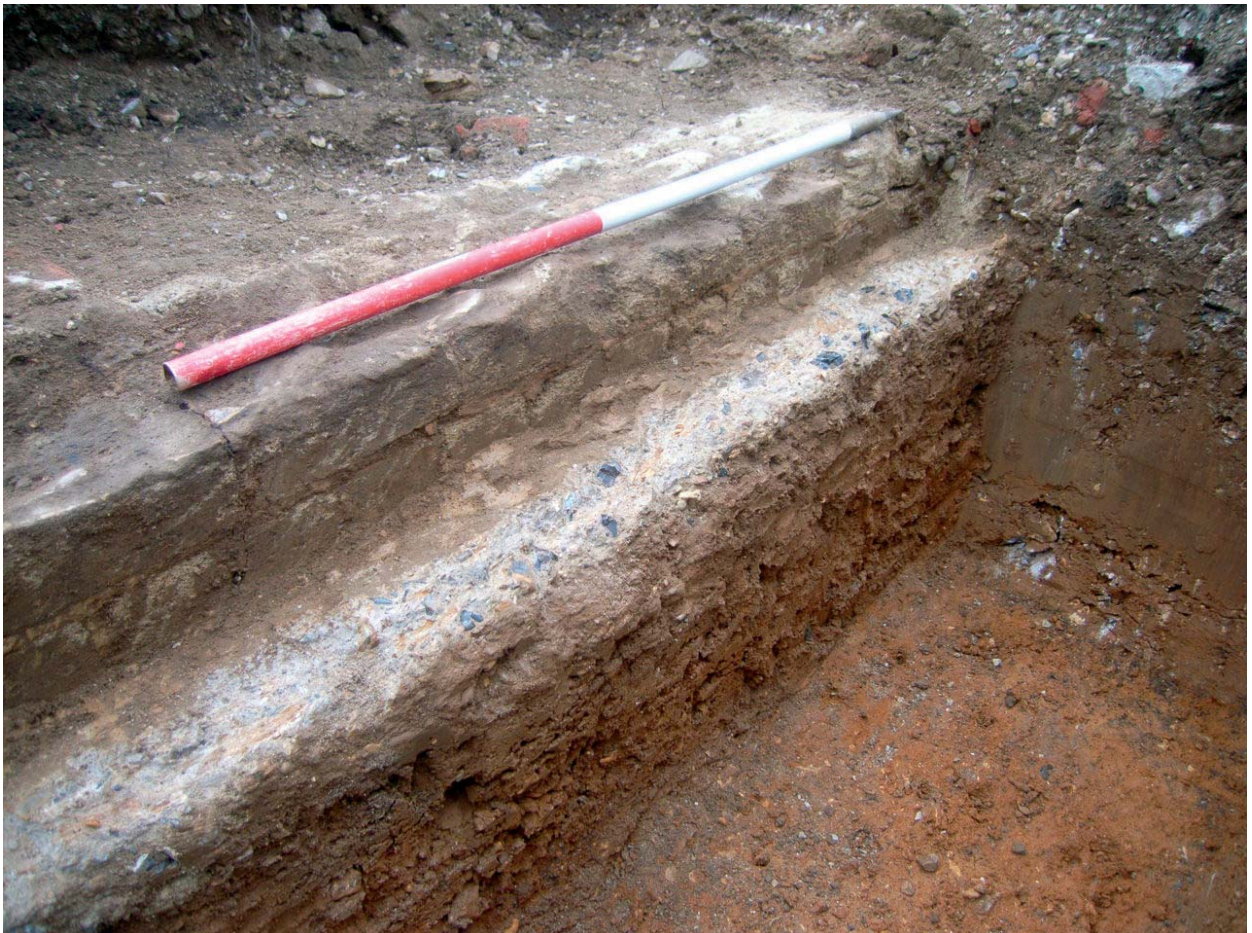
Plate 2: Trench 1, wall 103 and foundation 104

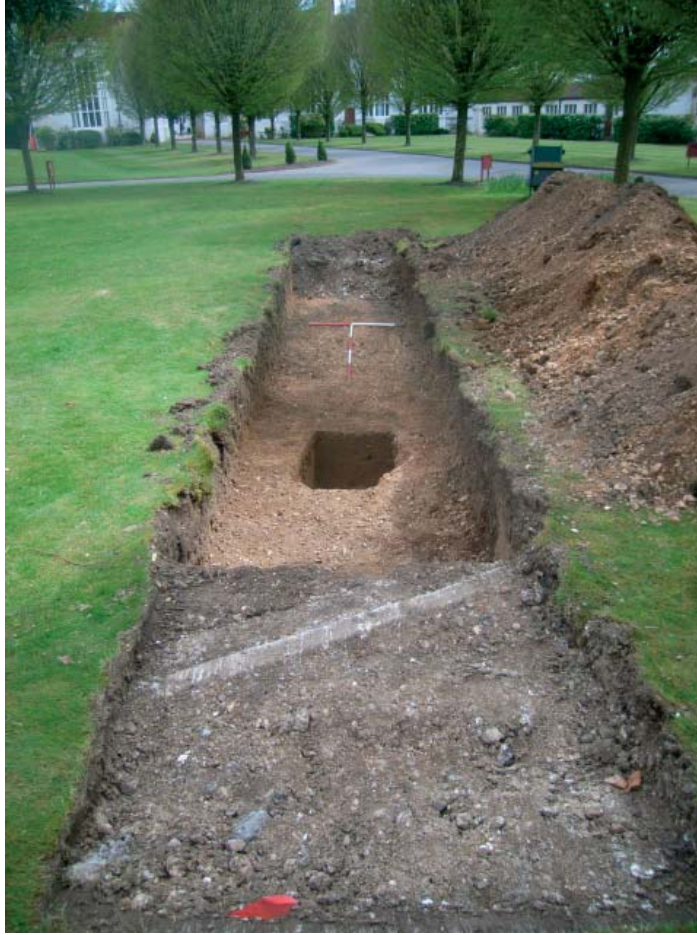
Plate 3: Trench 2, view to south-east

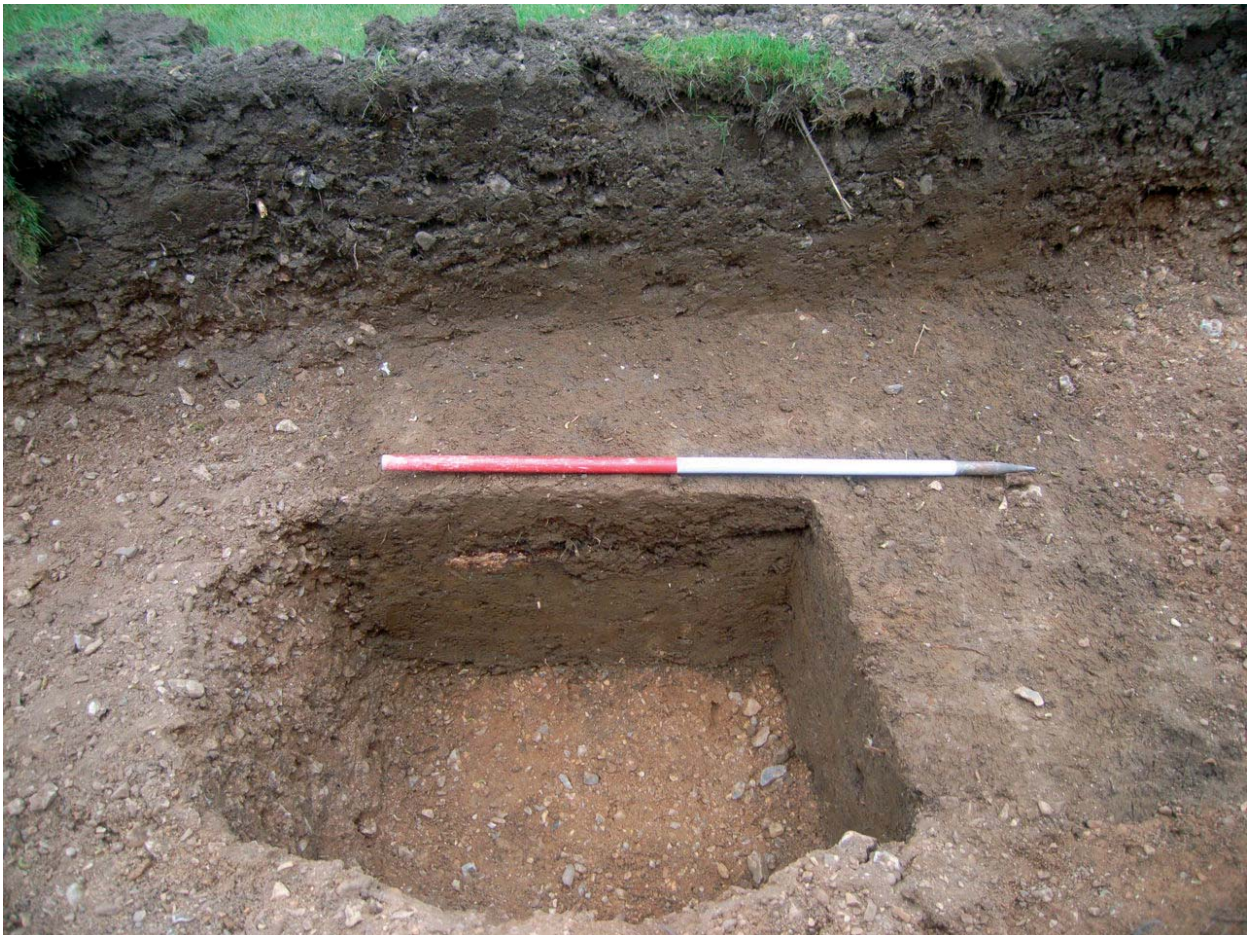
3.5.3 The feature cut both the natural gravels, 202, and the subsoil, 201. Overlying the subsoil and sealing feature, 203, was levelling deposit, 205, a dark greyish brown silty sand which in turn was sealed by topsoil (Fig. 6, Section 200).

Plate 4: Trench 2, pit 203

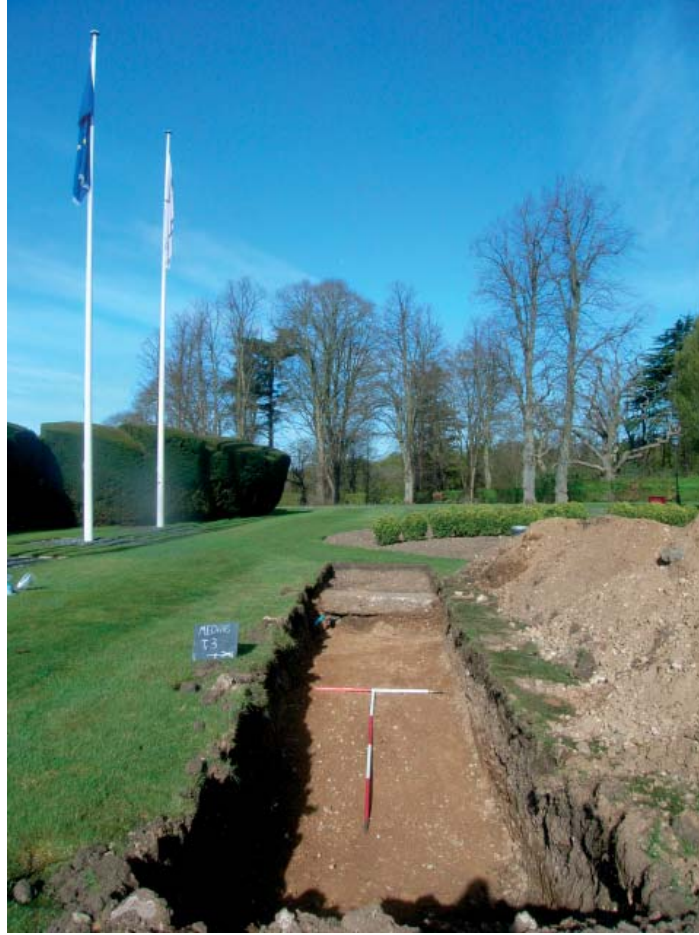
- 3.6.1 A concrete foundation pad was observed at the western end of Trench 3 (Plate. 5) and had been covered by levelling deposit, 305.
- 3.6.2 The levelling deposit was observed to run the length of the trench and sealed a subsoil deposit, 301, which was only present at the eastern end. Removal of the subsoil exposed the natural gravels.

Plate 5: Trench 3, view to west

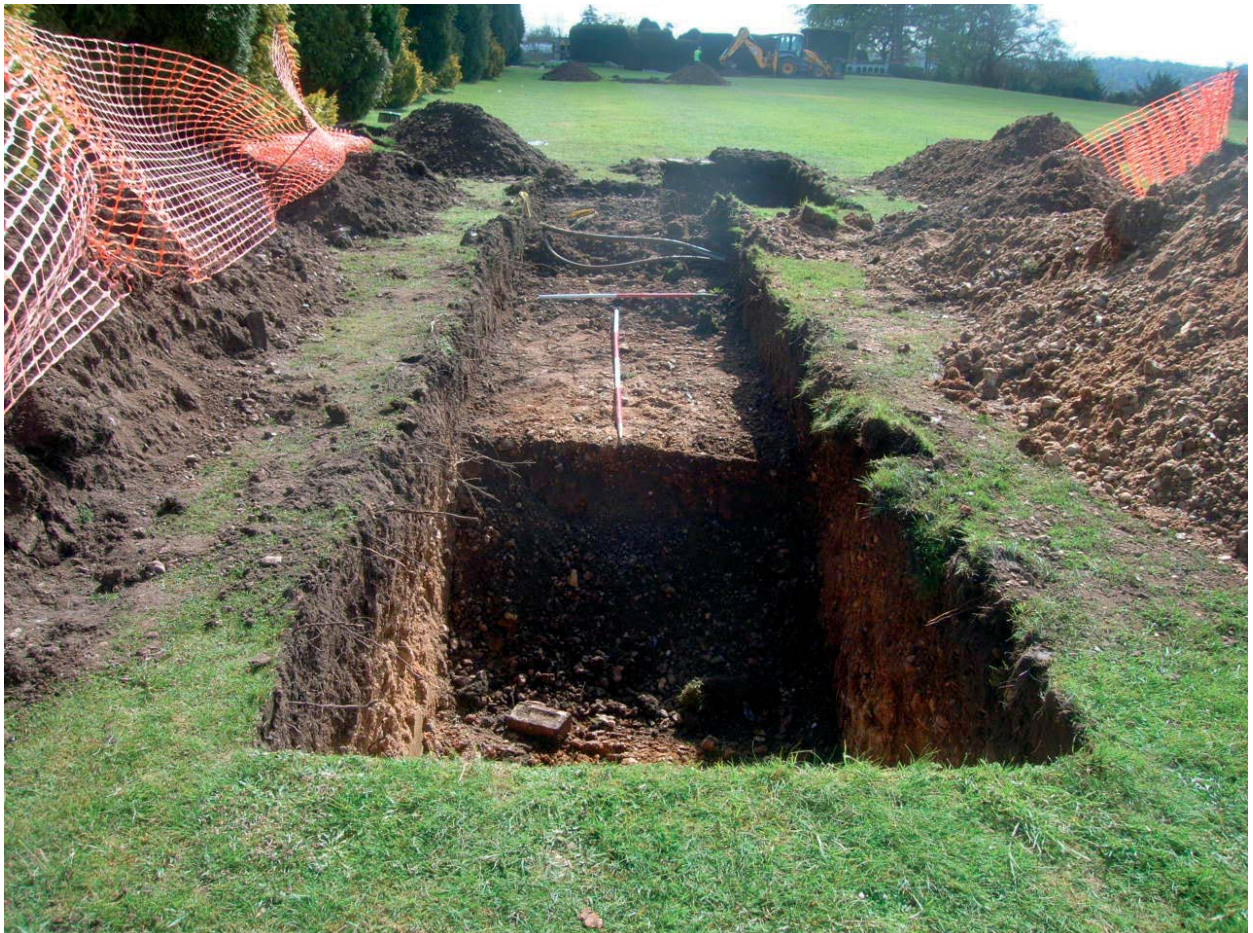
- 3.7.1 Trench 4 (Plate. 6) was devoid of archaeology. Natural gravels were overlain by a mid yellowish brown sandy gravel subsoil, 401, and subsequently a dark greyish brown silty loam topsoil, 402.

Plate 6: Trench 4, view to east

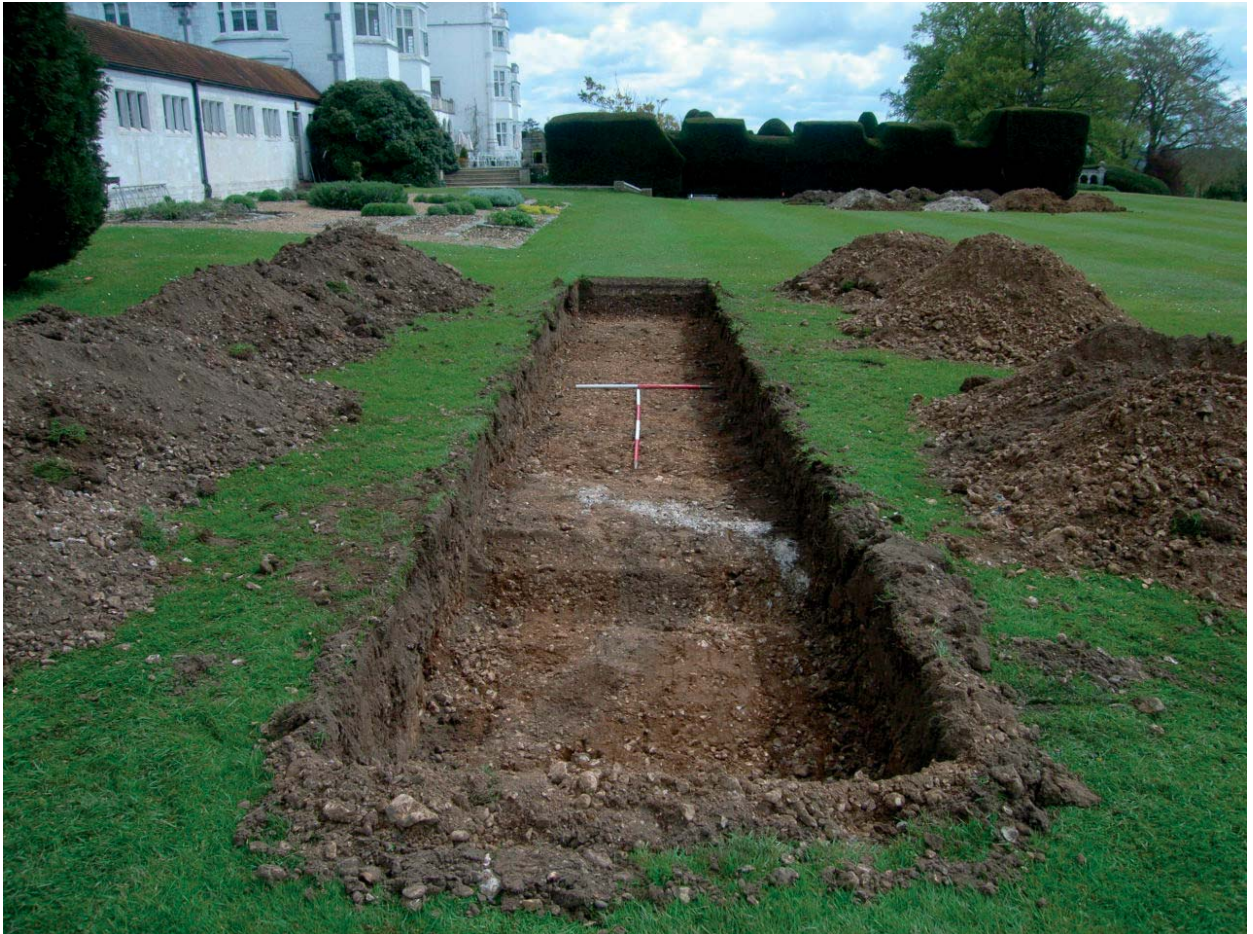
- 3.8.1 At the western end of Trench 5 (Plate. 7) a concrete footing aligned NE-SW was observed cutting the subsoil, 502, and natural gravels, 503.
- 3.8.2 A second footing, 504, aligned N-S, was observed at the eastern end of the trench and associated with a small pit 504. Circular in plan the pit appeared to be later than the foundation and likely resulted from the partial removal of the structure.

Plate 7: Trench 5, view to east

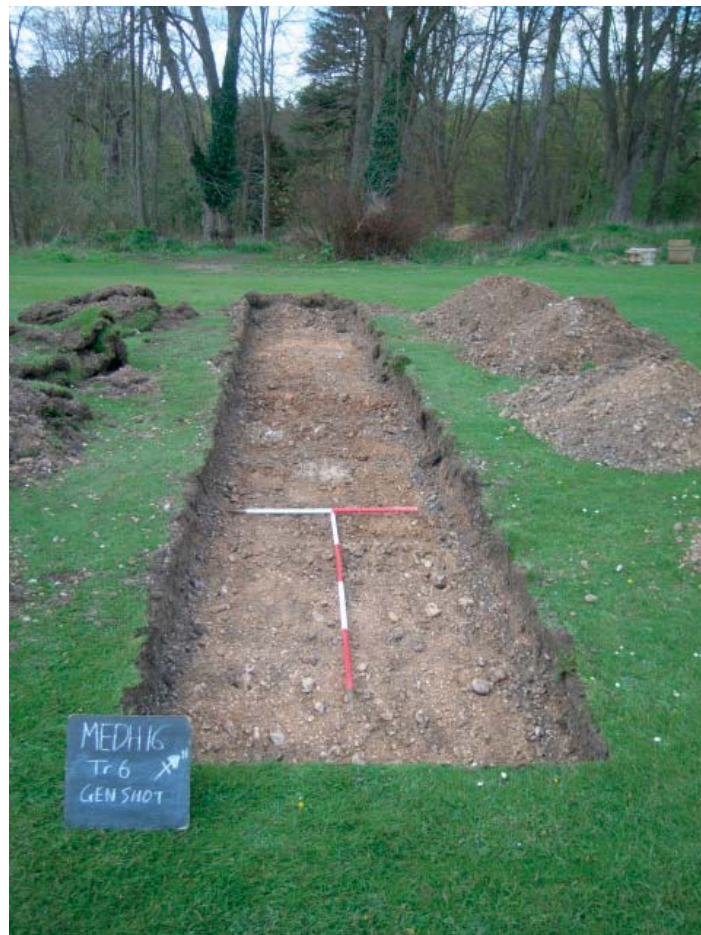
- 3.9.1 Trench 6 (Plate. 8) was devoid of archaeology. No subsoil was present within the trench, natural gravels were directly overlain by topsoil.

Plate 8: Trench 6, view to north-west

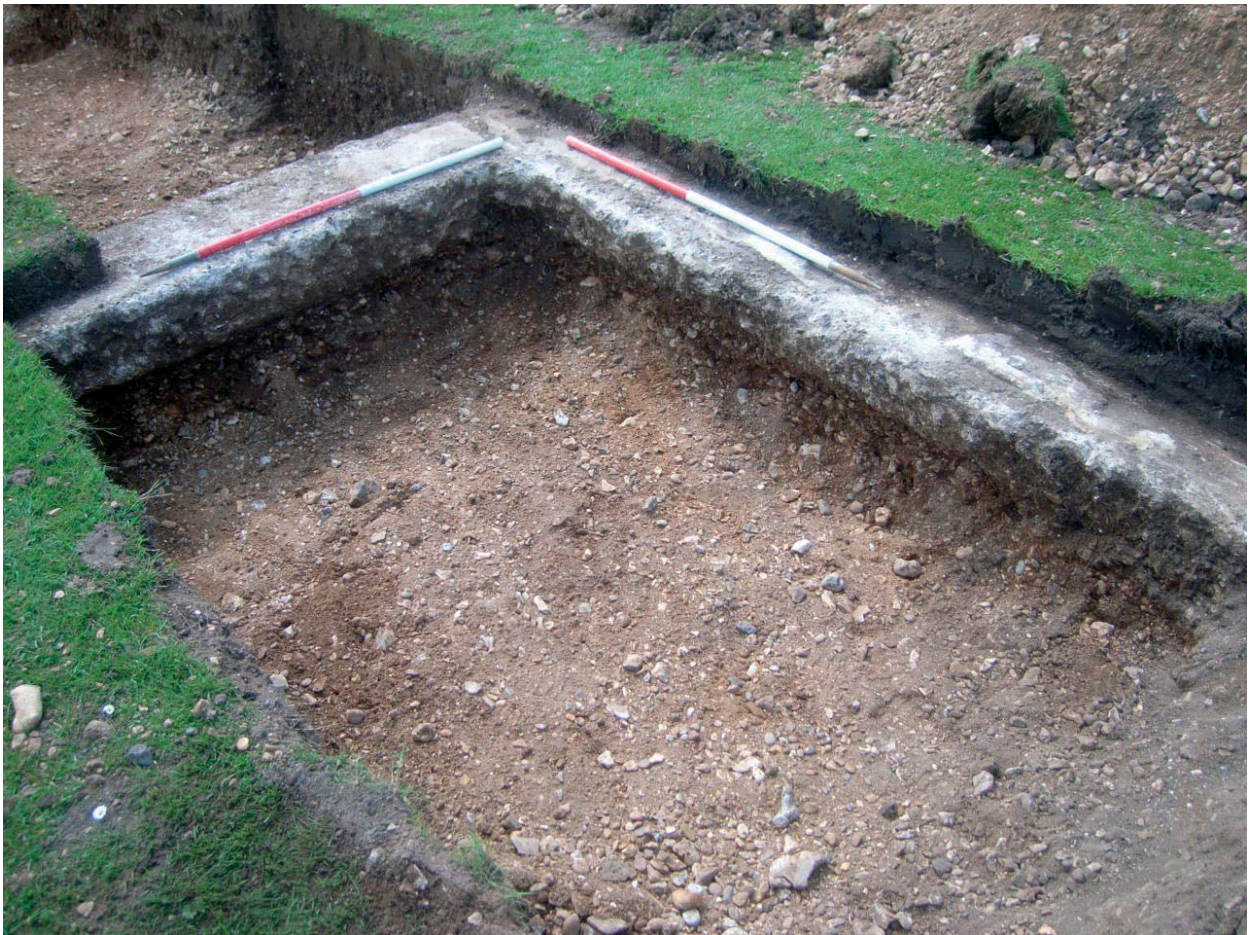
- 3.10.3 A concrete footing, 703 (Plate. 10), was observed at the northern end of the trench. Initially running east to west across the trench the footing turned to the north and continued beyond the limit of the trench.

Plate 10: Trench 7, foundation 703

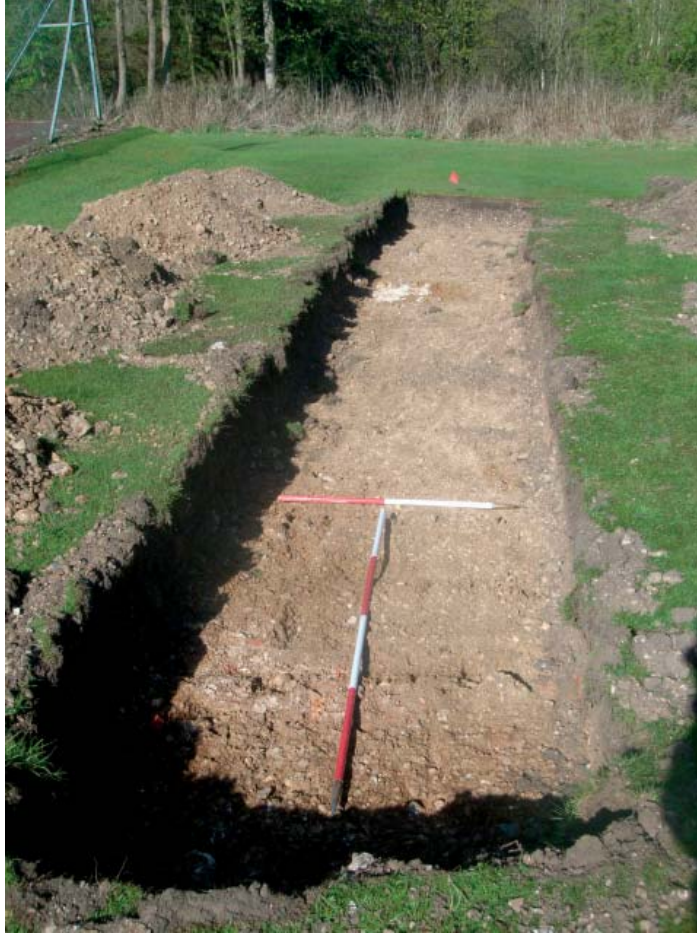
- 3.11.1 Trench 8 (Plate. 11) was devoid of archaeology. Natural gravels were overlain by a mid greyish brown sandy gravel subsoil, 801, and subsequently a dark greyish brown silty loam topsoil, 802.

Plate 11: Trench 8, view to west

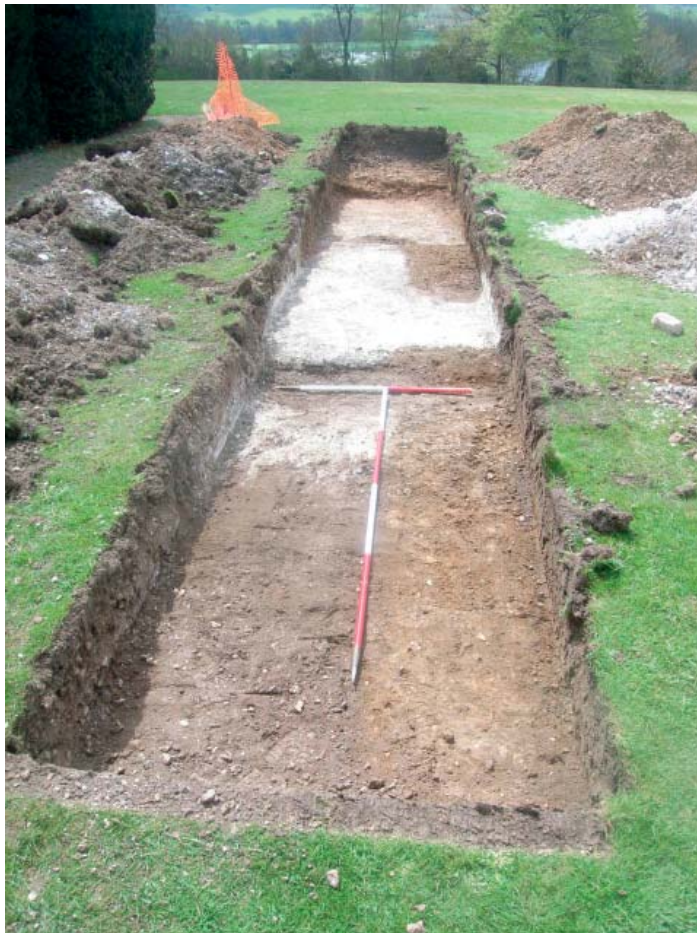
- 3.12.1 Underlying the topsoil within Trench 9 (Plate. 12) a redeposited sand gravel layer, 903, was observed to seal chalk footings, 904, associated with garden landscaping.

Plate 12: Trench 9, view to south

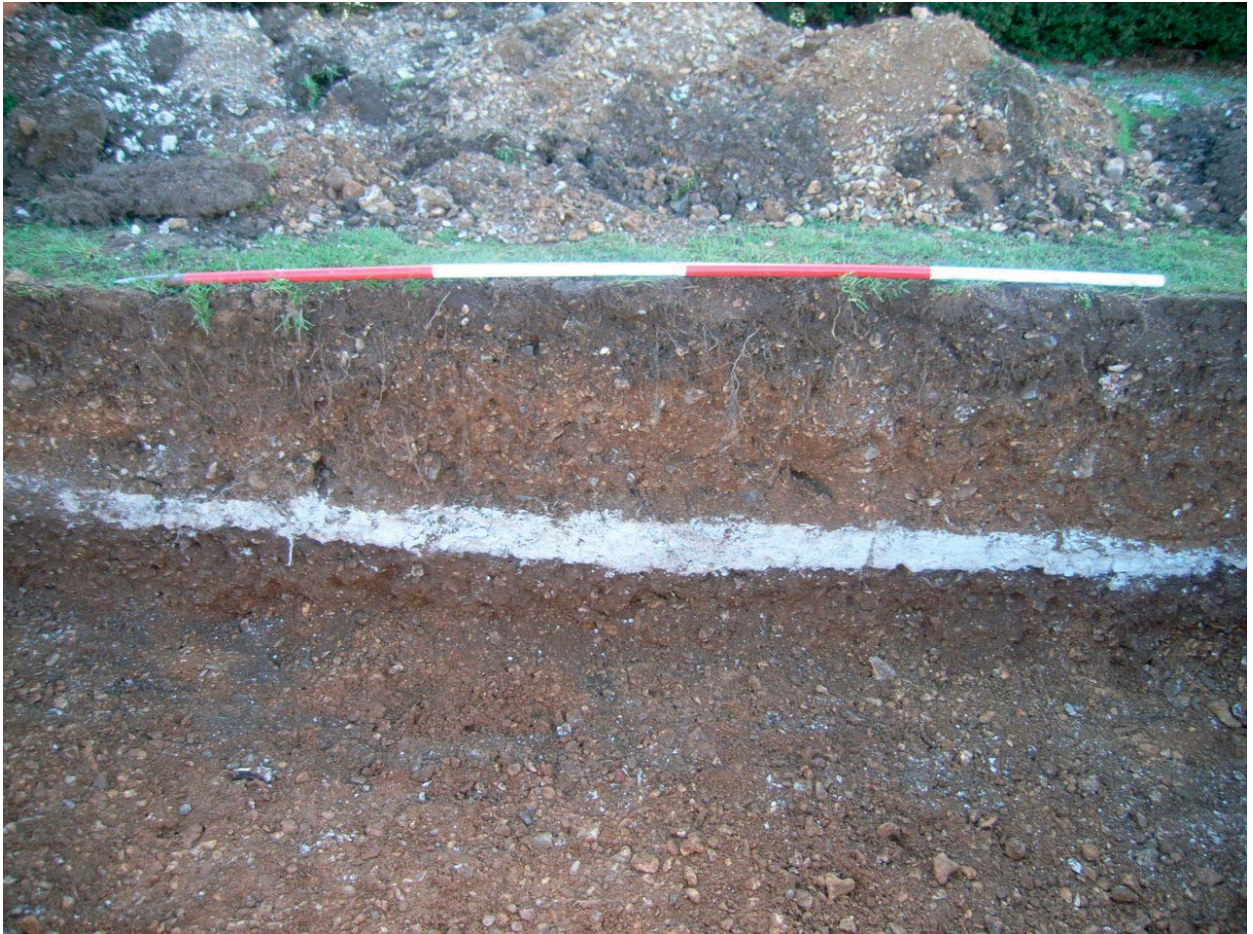
- 3.12.2 Evidence of suspected backfilled flower beds were present at the northern end of the trench.
- 3.12.3 The chalk footings were set on a dark grey brown subsoil deposit, 901, which in turn overlay natural gravels, 902 (Plate. 13).

Plate 13: Trench 9, deposit sequence
