Danesfield House Hotel Medmenham

Archaeological Evaluation Report

June 2016

Client: Danesfield House Hotel

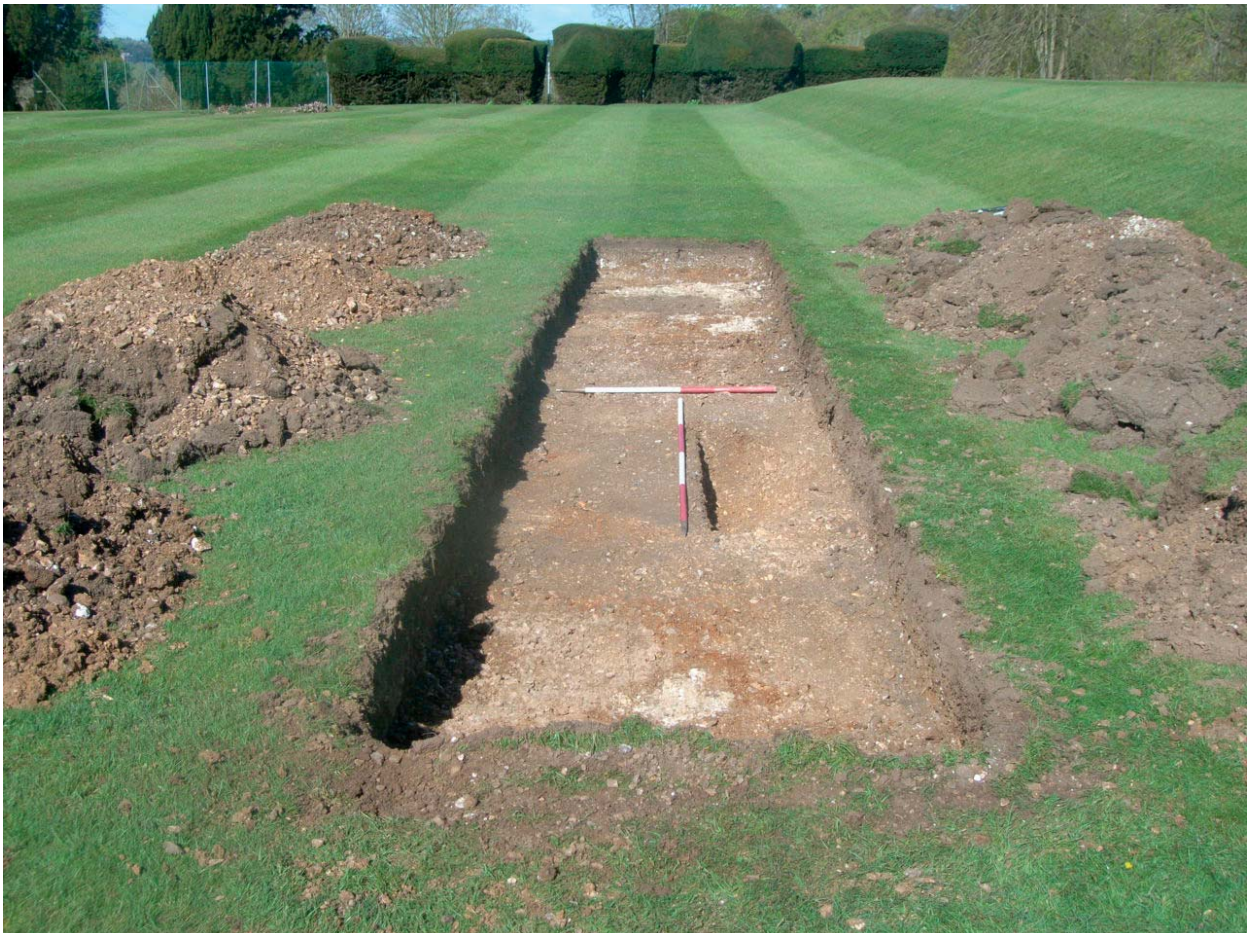
- 3.13.1 A pit, 1003, (Figs. 5 and 7, Section 1001 and Plate 15) excavated at the eastern end of the trench was observed to be cut through subsoil, 1002, and underlying natural gravels, 1005. The pit, measuring 1.66m by 1m, was observed to be 0.2m deep and filled with a dark greyish brown silty sand. From the fill a small quantity of 19th - 20th century pottery along with, clinker, coal, CBM, glass and an Iron nail was retrieved.
- 3.13.2 A second similar unexcavated pit was located at the eastern end of the trench (Plate 14).

Plate 14: Trench 10, view to west

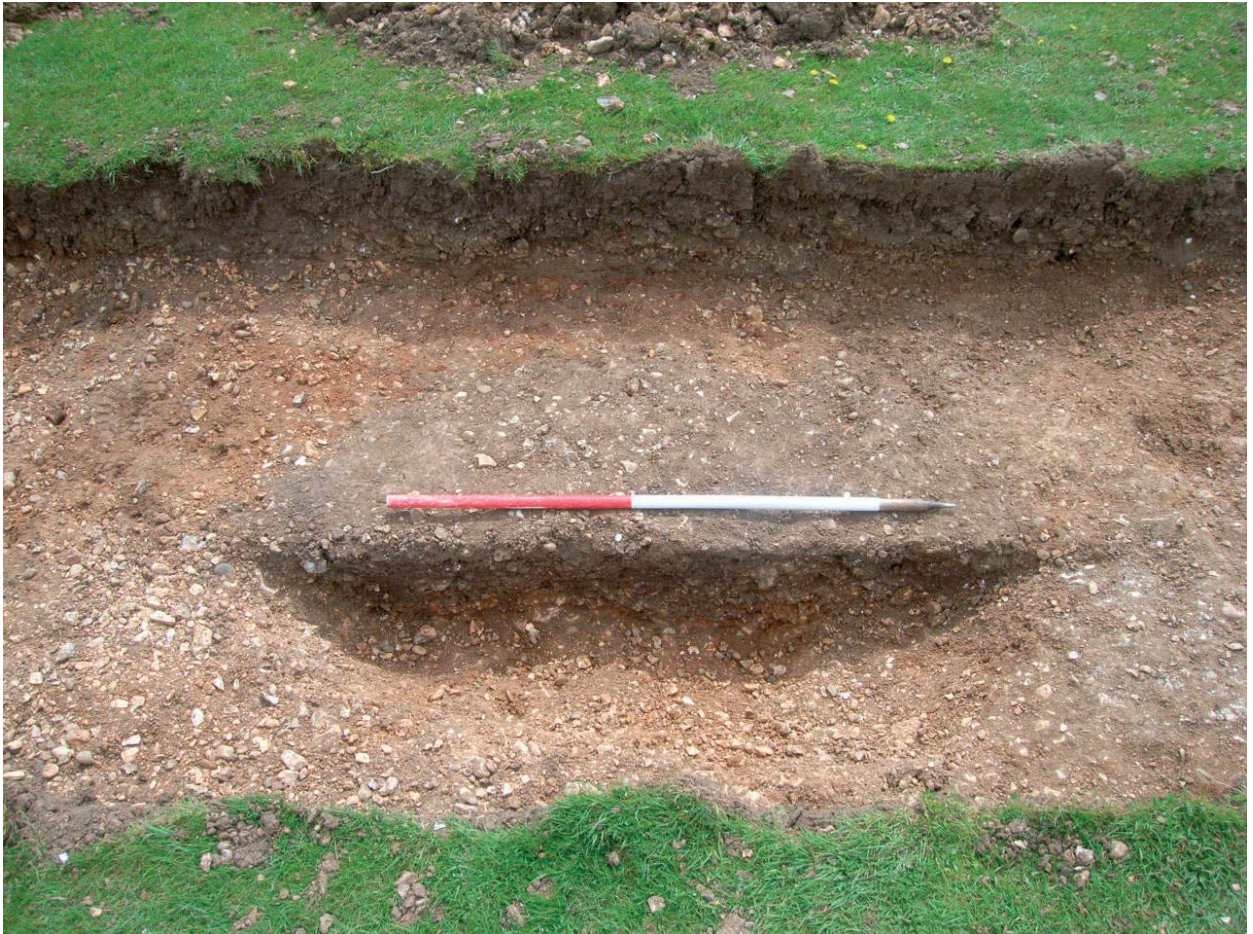
Plate 15: Trench 10, pit 1003

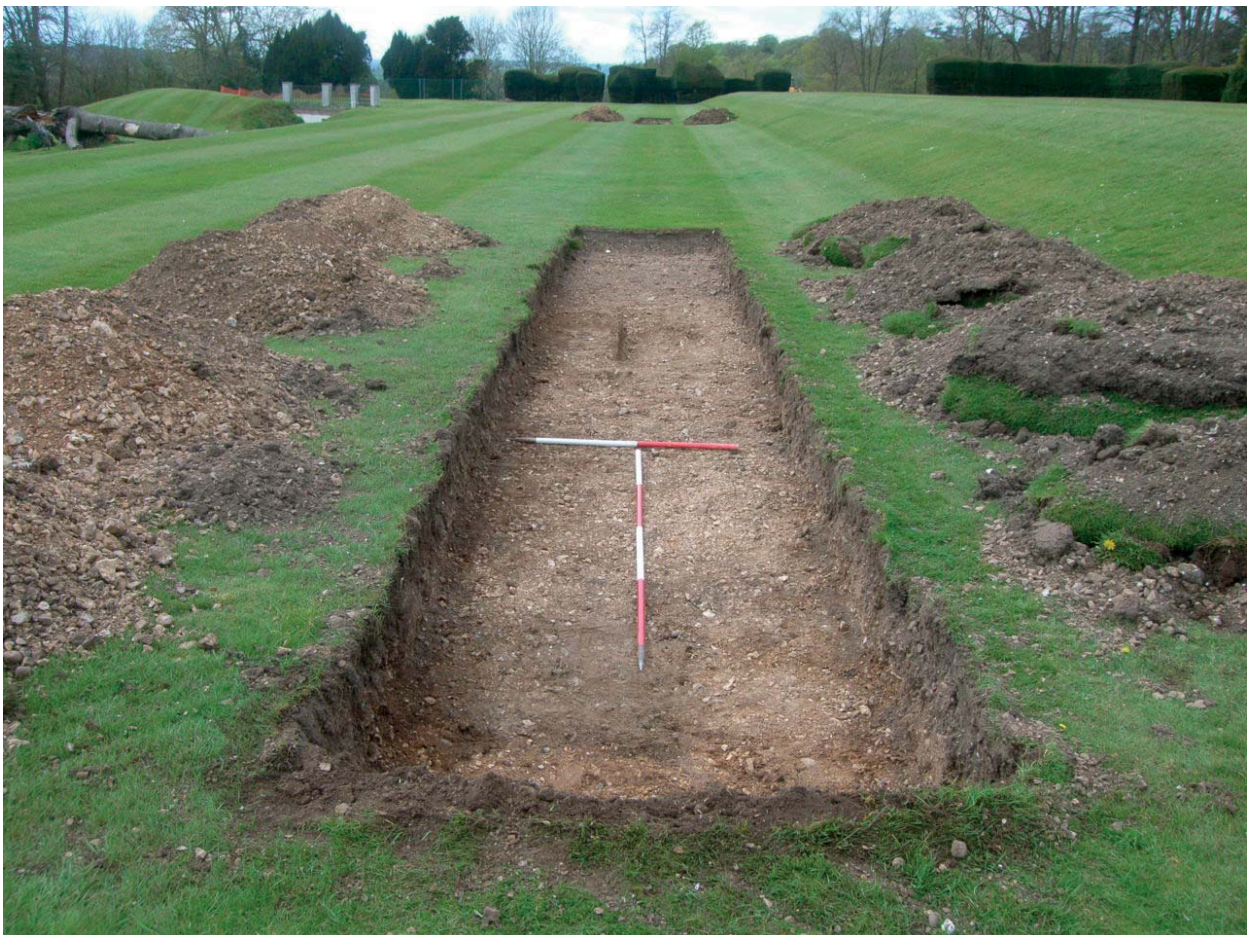
- 3.14.1 Aligned with those within Trench 10, Trench 11 contained a further three pits.
- 3.14.2 Distributed evenly along the length of the trench the pits were observed to be cutting the subsoil, 1102, and underlying natural gravels, 1105. Pit 1104 was the only one of the three excavated. From the fill, a mid greyish brown sandy silt, a piece of swan animal bone was recovered (Figs 5 and Plates 16 and 17). Pit 1104 was similar in profile to pit 1003 from Trench 10.

Plate 16: Trench 11, view to west

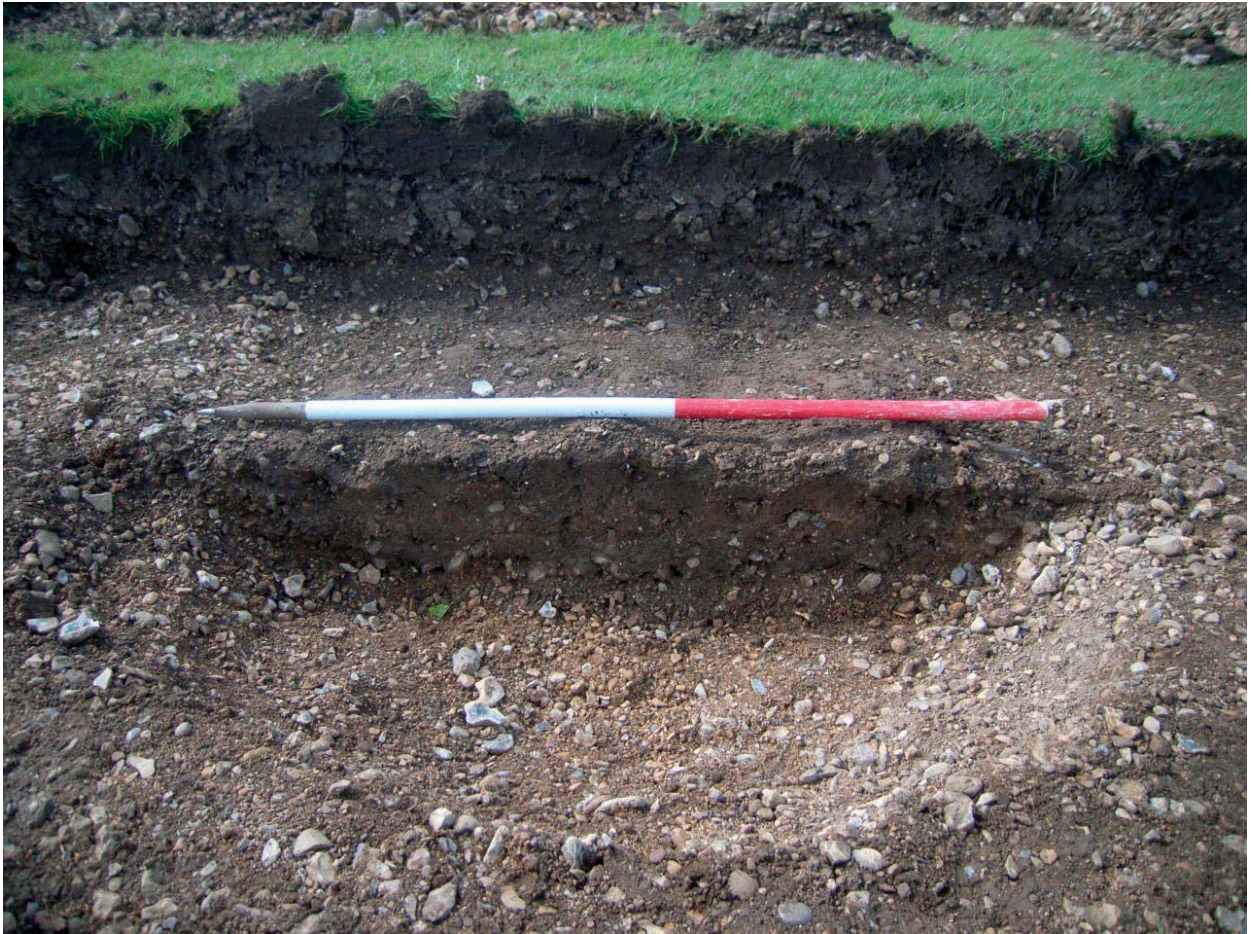
Plate 17: Trench 11, pit 1103

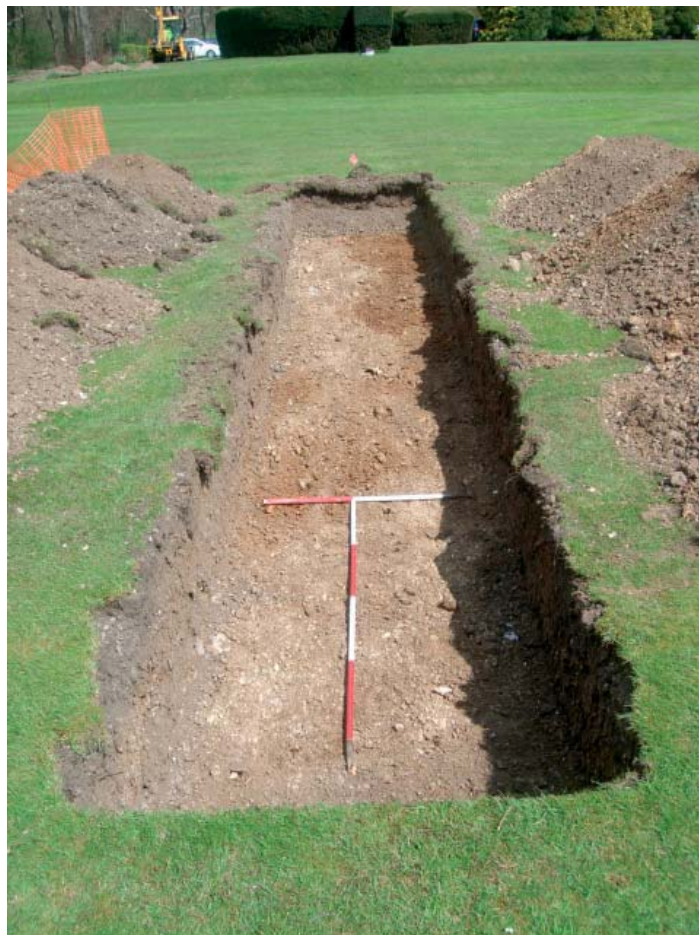
- 3.15.1 Natural gravels within Trench 12 (Plate. 18) were overlain by a mid greyish brown sandy gravel subsoil, 1201, which was sealed by a dark grey brown silty sand loam, 1200.
- 3.15.2 As these deposits were overlain by a second sequence of subsoil and topsoil, 1204 and 1203, it is suspected that these deposits represent the previous ground level within this area (Fig 7, Section 1200 and Plate 19).
- 3.15.3 No material was recovered from any of the deposits and therefore no date can be associated with the landscaping.

Plate 18: Trench 12, view to south

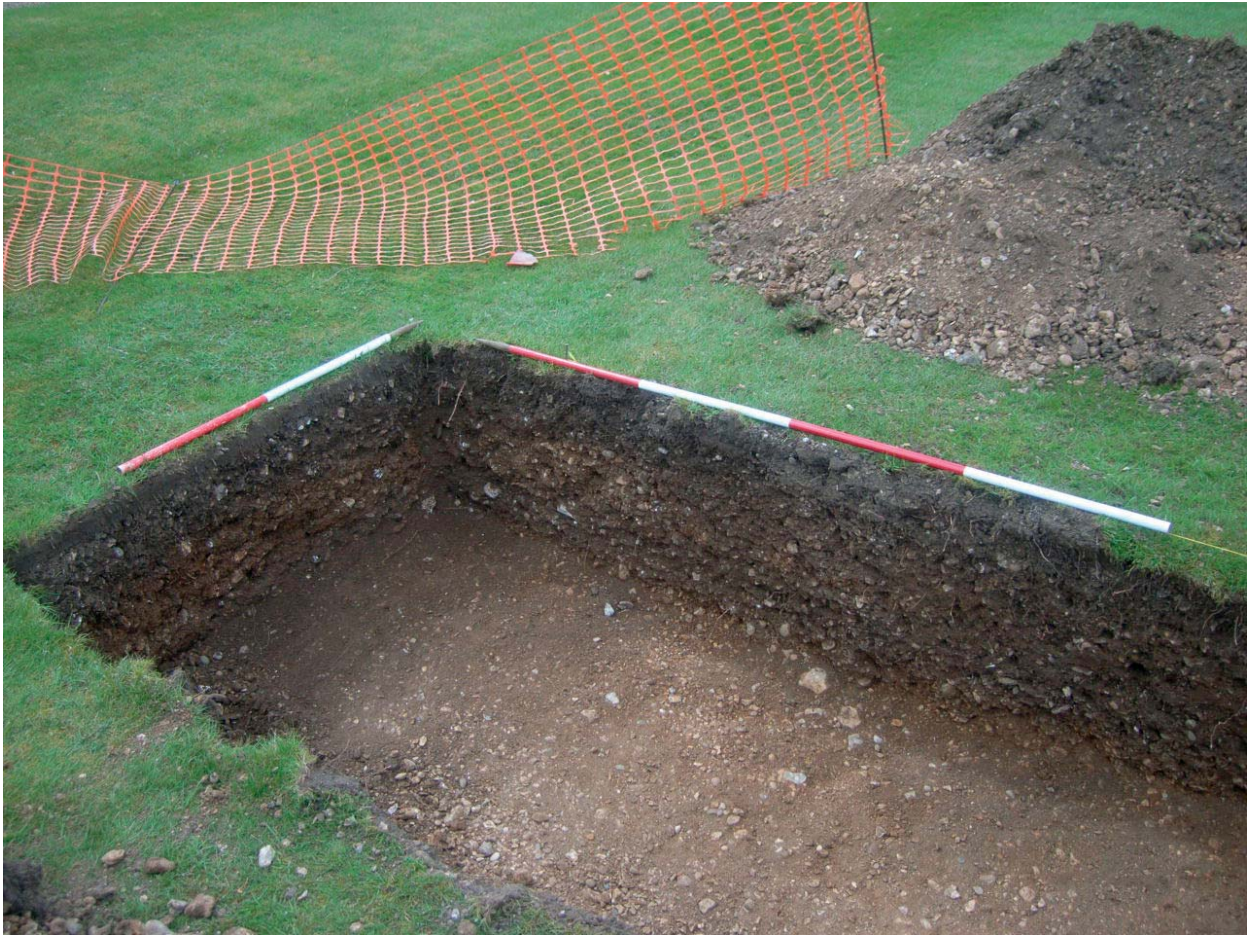
Plate 19: Trench 12, deposit sequence
