Aynhoe Park

Archaeological Observation, Investigation and Recording Report

August 2021

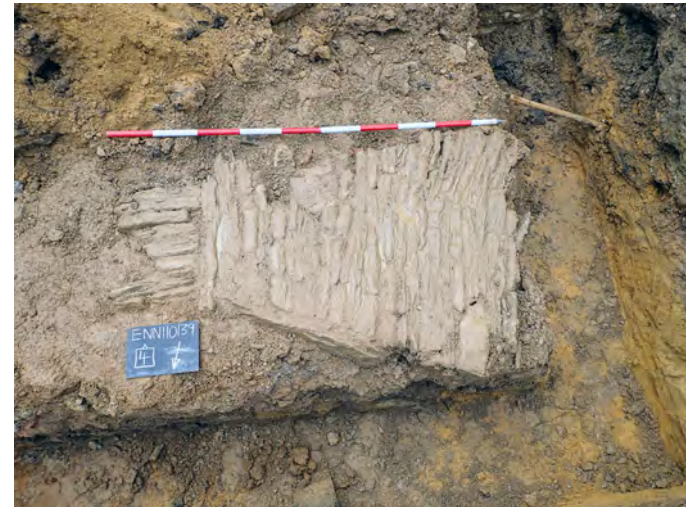
Figure 4: Plan of stone surface 4, group 57

3.4.11 Within Area A.3, the southern part of Area A.1 and the eastern part of Area A.2, several areas of *in situ* stone surface survived. The surface, group 57, comprised long, flat roughly pitched pieces of sandstone, laid on the long edge and packed tightly together. Changes to the direction of the surface coursing were marked by slightly raised runs of larger sandstone pieces used to create a division. Edging stones of the same shape were also identified in A.1 and A.3. Figure 4 presents a representative illustration of the stone surface as discovered within Area A.3. The sandstone pieces were set into a purplish brown silty sand, (group 58). Within Areas A.2 and A.3, the sandy bedding layer directly overlaid natural geology. However, in Area A.1 group 58 directly overlay demolition layer 20, pit fill 19, pipe trench fill 24, and layers 30 and 31 (Fig. 3). No finds were recovered from the surface or bedding layer.

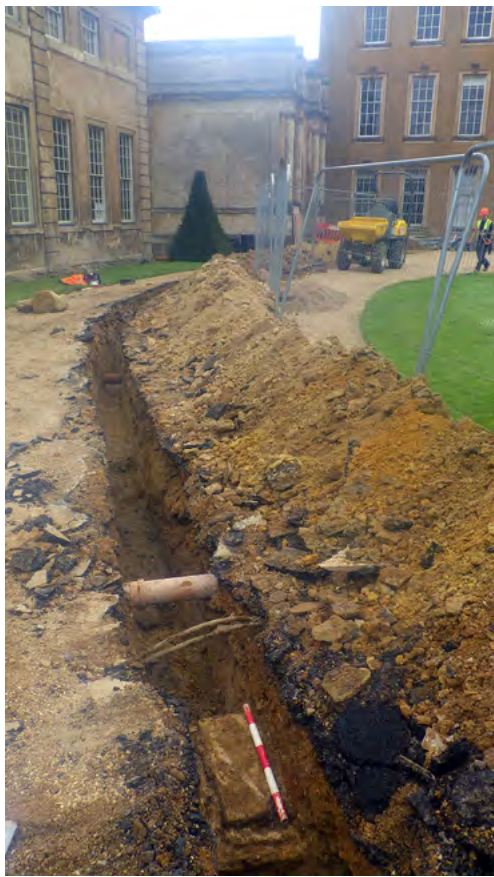
Plate 1: View south-east along area A.1

3.4.2 Area A.1 extended north along the curve of the driveway from the cellar light-well located to the east of the principal house entrance, up to the lawn edge north of the western courtyard wall. This part of the trench measured c 53m long by up to 0.5m wide and was excavated to between 0.9m to 1m bgl. The level of the natural geology varied in this area and the highest level was recorded at c 0.45m bgl.

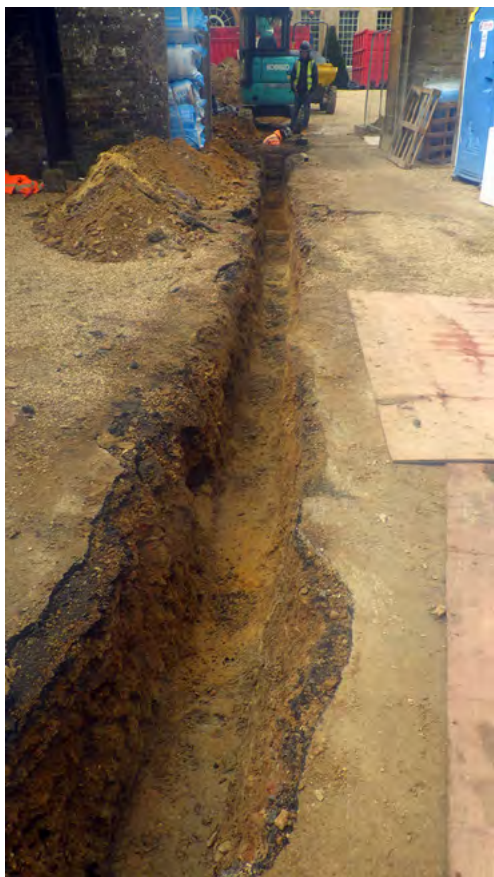
Plate 3: View east along area A.2

3.4.3 Area A.2, the kitchen connection trench, extended east beneath an archway from c 2.8m north of the light-well, to join the north-eastern corner of kitchen foundation trenches. This section measured 18m long by 0.5m wide and was excavated to between 0.7m to 0.85m bgl. The natural geology was identified at c 0.8m bgl in this area.

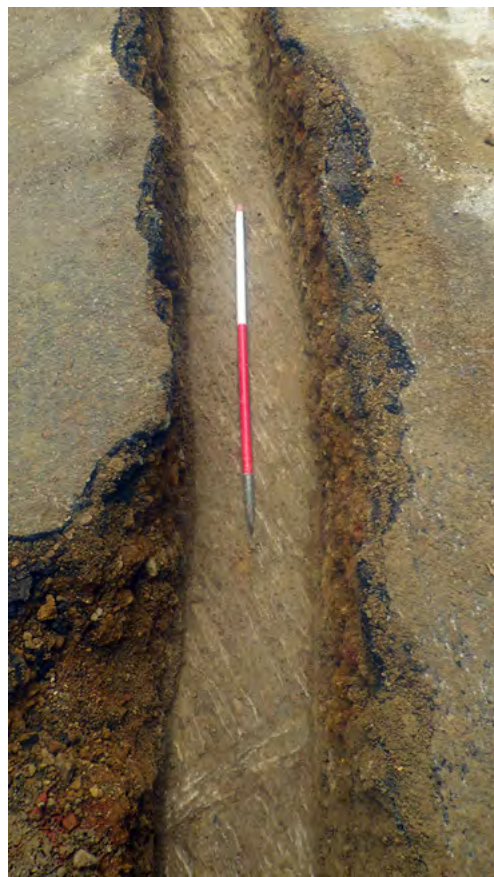
Plate 4: East-north-east plan view of surface 43

3.4.14 The stratigraphic relationship between surface 43 (of group 57) in the eastern part of A.2 with other features in the western extent of the area could not be established as a modern drainage service truncated the area where any such relationships may have existed.

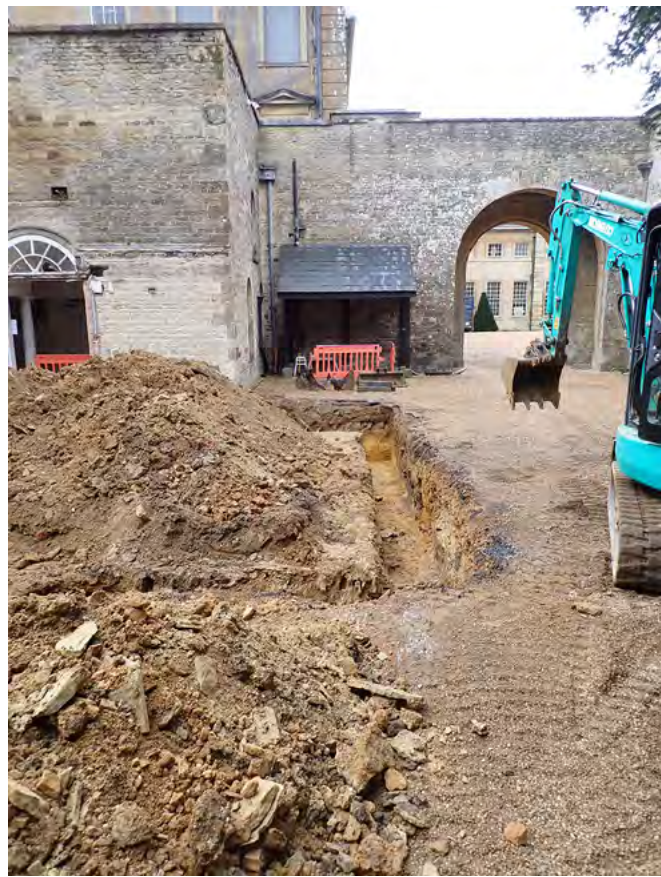
Plate 5: View east across area A.3

3.4.4 The kitchen foundation trenches, (Area A.3), covered an area measuring 9.5m by 9.5m and were excavated up to a maximum depth of 1.2m bgl. The kitchen extension comprised a 3m by 9.5m in the northern part of this area. The natural geology was identified at c 0.78m bgl in this area.

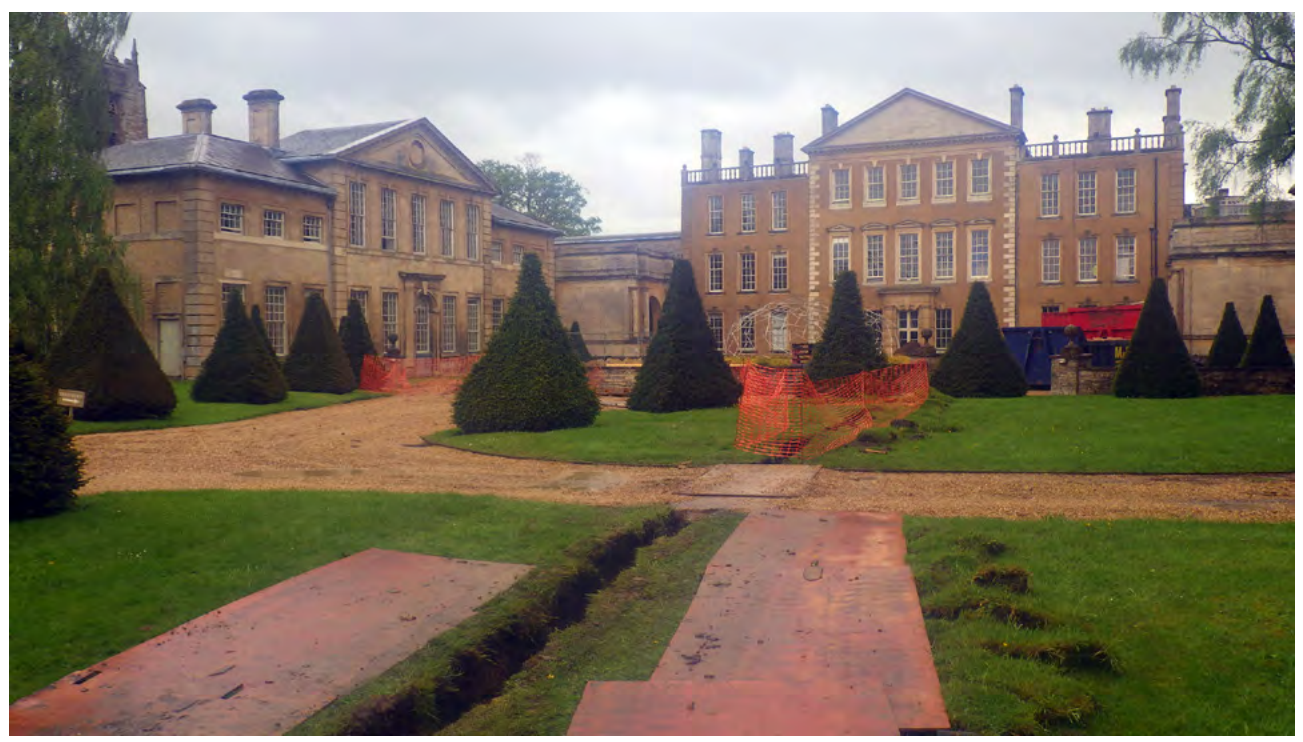
Plate 6: View south-east across area B

3.5.1 Area B was the continuation of the gas trench from Area A.1. The trench extended north across two lawns and an access road before continuing west along a row of shrubbery that marks the northern property boundary. The trench extended up to the garden wall where the gas meter housing will be installed adjacent to a wooden gate. This section of the trench measured approximately 50m in length by up to 0.45m in width. It was excavated to a depth between 1 and 1.3m bgl. The stratigraphy in the north-western part of the area had been heavily disturbed by dense rooting and a water service. The natural geology in this area undulated between c 0.75m to 0.95m blg.
