Dorchester Abbey Tower Dorchester on Thames Oxfordshire

**Building Recording and
Watching Brief**

Client: Martin Ashley Architects

Historic Building Investigation and Recording

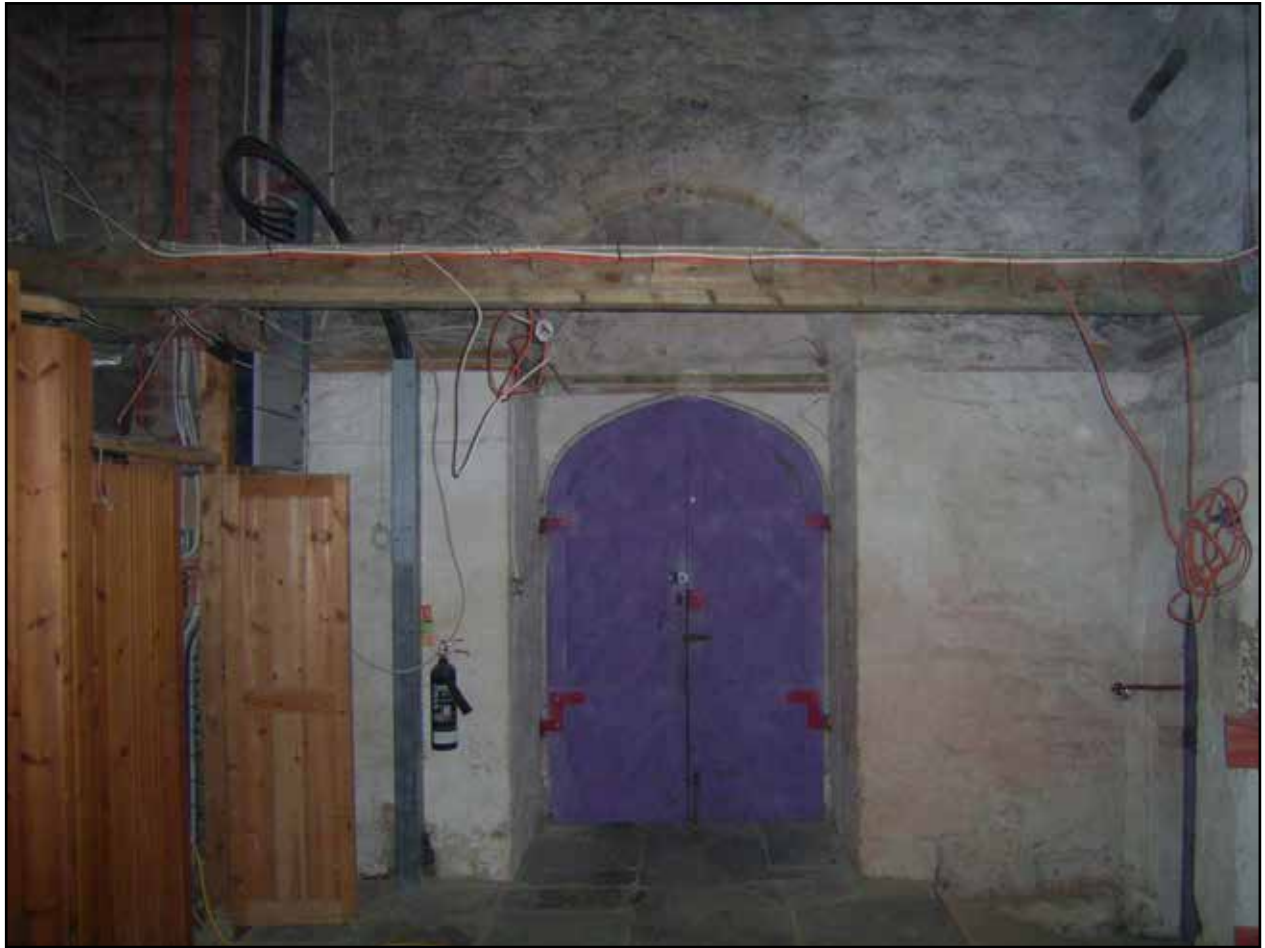
Plate 1. East Elevation of Tower

3.2.2 The east elevation has a double door just off centre to the north. It has a turret in the north-east corner, shared with the north elevation and abuts a spiral staircase in the south- east corner, which, also, abuts the south elevation. There is a door leading from the east elevation into the spiral staircase. The walls are constructed of stone.

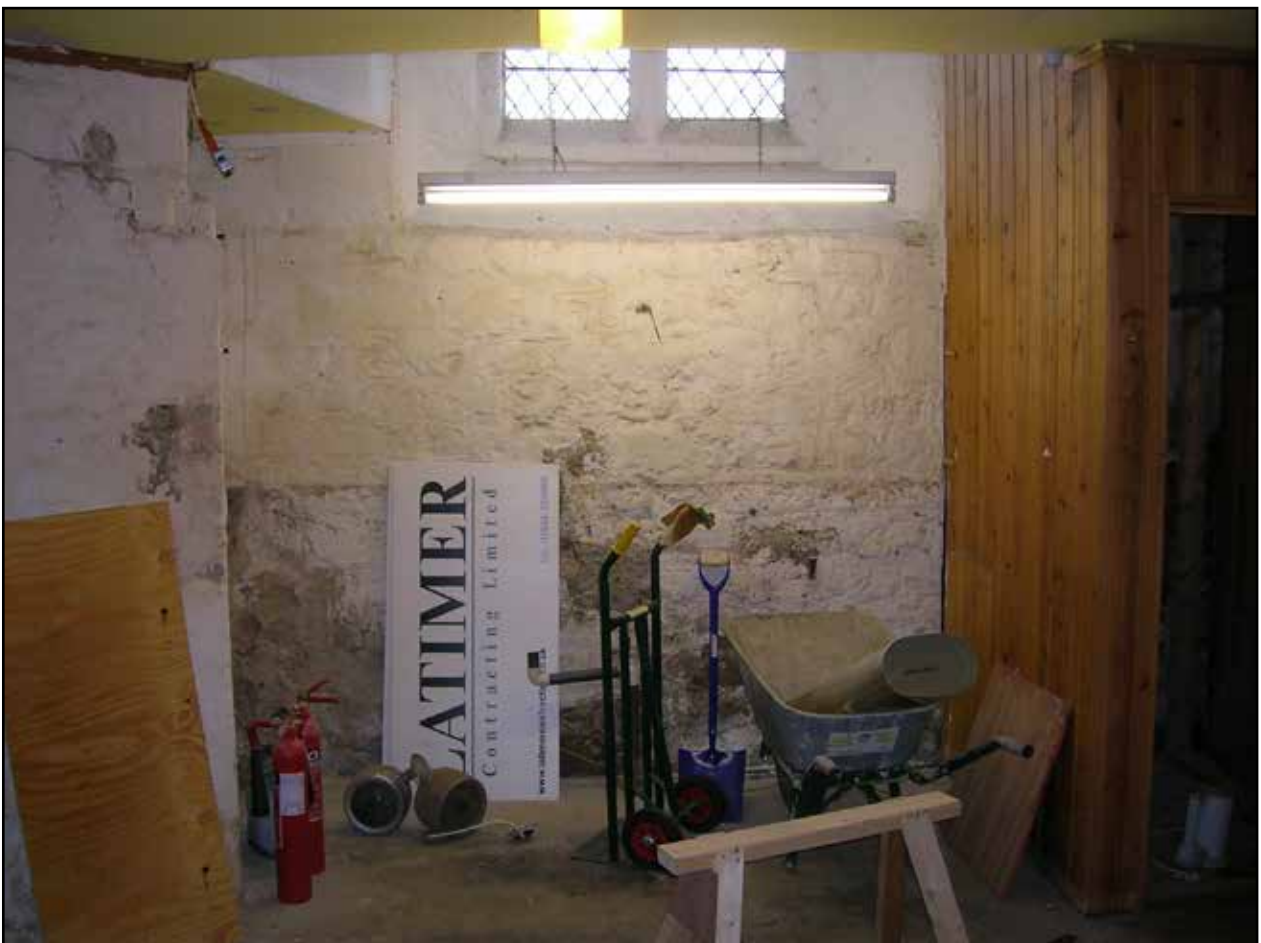
Plate 2. South Elevation of Tower

3.2.5 The south elevation has a turret in the south- west corner, shared with the west elevation and it abuts the spiral staircase in the south-east corner, which also abuts the east elevation. It has a window and the walls are constructed of stone.

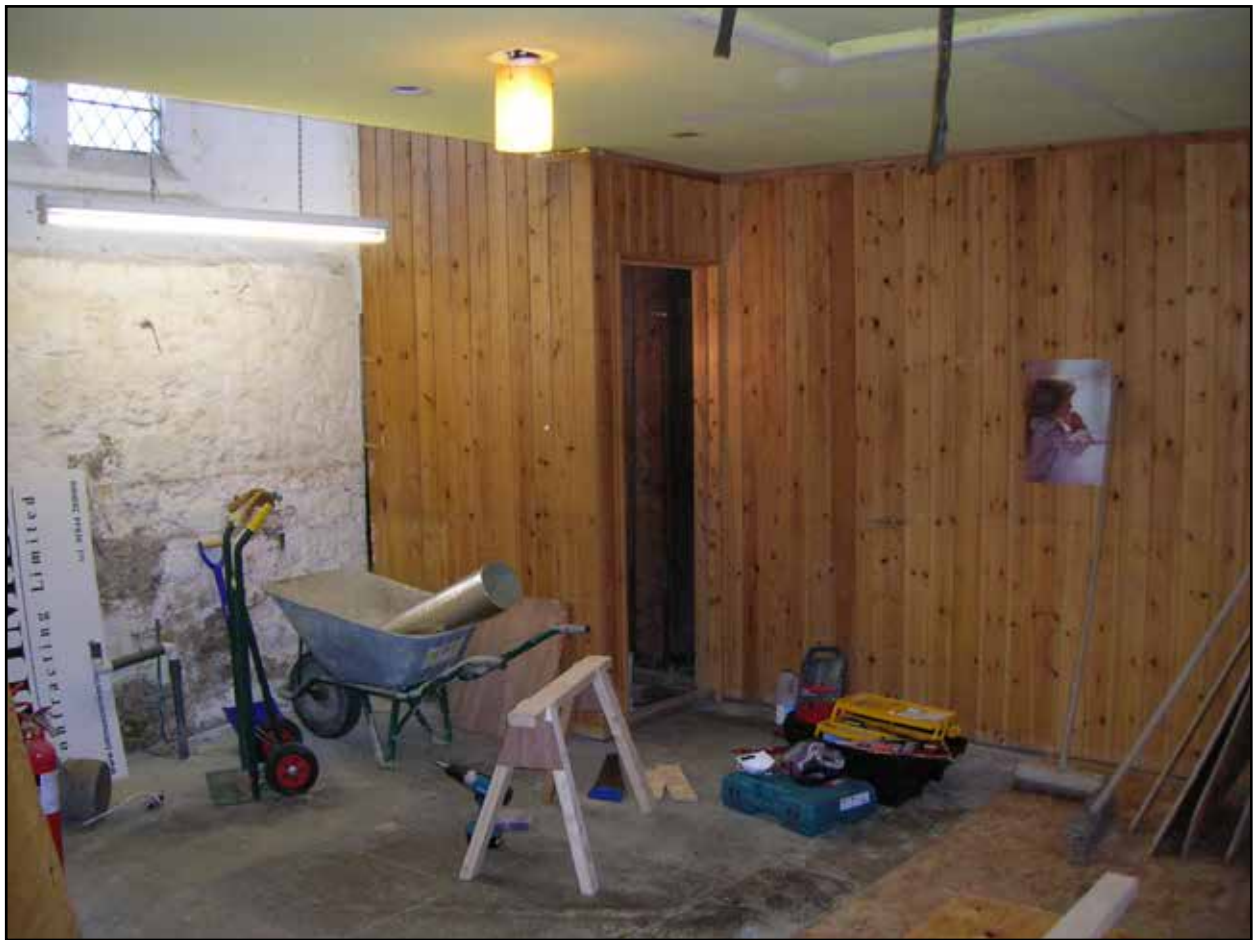
Plate 3. West Elevation of Tower

3.2.4 The west elevation has turrets in both the north-west corner, shared with the north elevation and the south-west corner. The north-west corner, also, abuts the entrance steps from the door in the north elevation. The walls are constructed of stone.

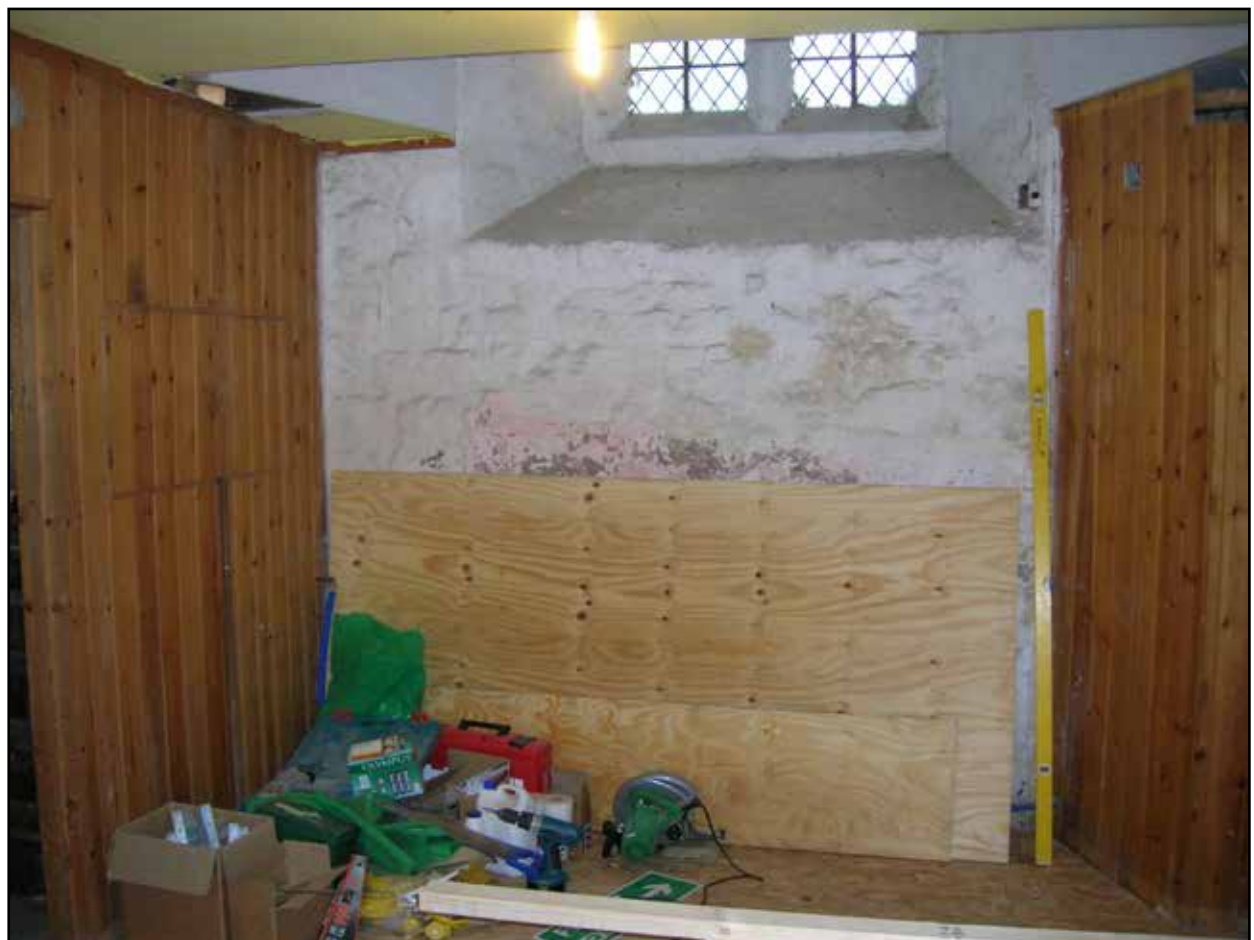
Plate 4. North Elevation of Tower

3.2.3 The north elevation has a turret in both the north-east and the north-west corner. It has a window in the centre of the elevation and a door to the west, inbetween the north-west turret and the windows. Before the watching brief began, there were also entrance steps, in front of the door, which abut the west elevation. The walls are constructed of stone.

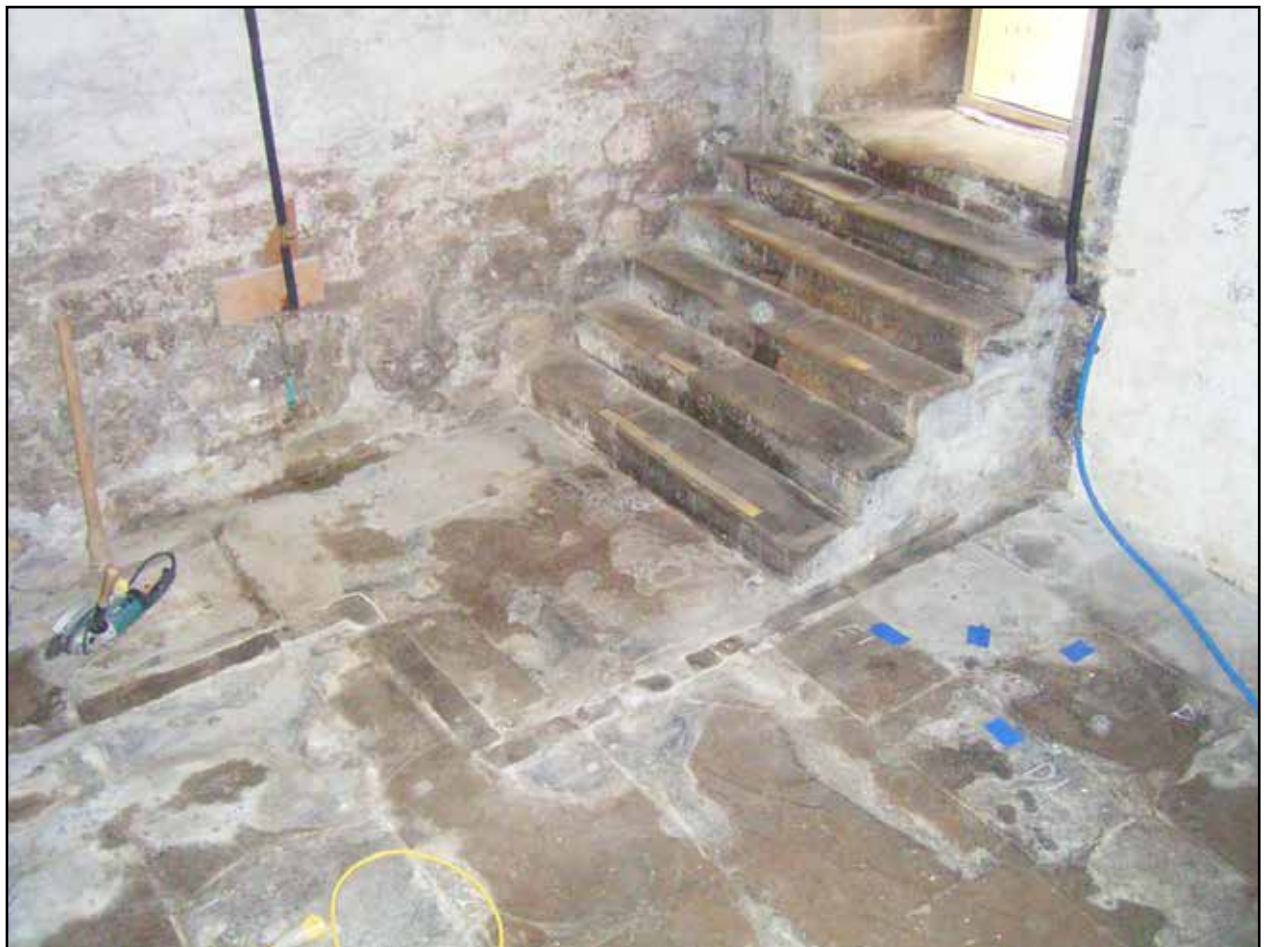
4.7.3 The erection of a new staircase to lead to the doorway on the north elevation and to provide access to the two new floors was, also, constructed and, subsequently, recorded using photography. The new staircase appears to go over the top of the already existing entrance steps. It is possible these are still intact beneath the new renovation work.

Plate 6. North entrance steps

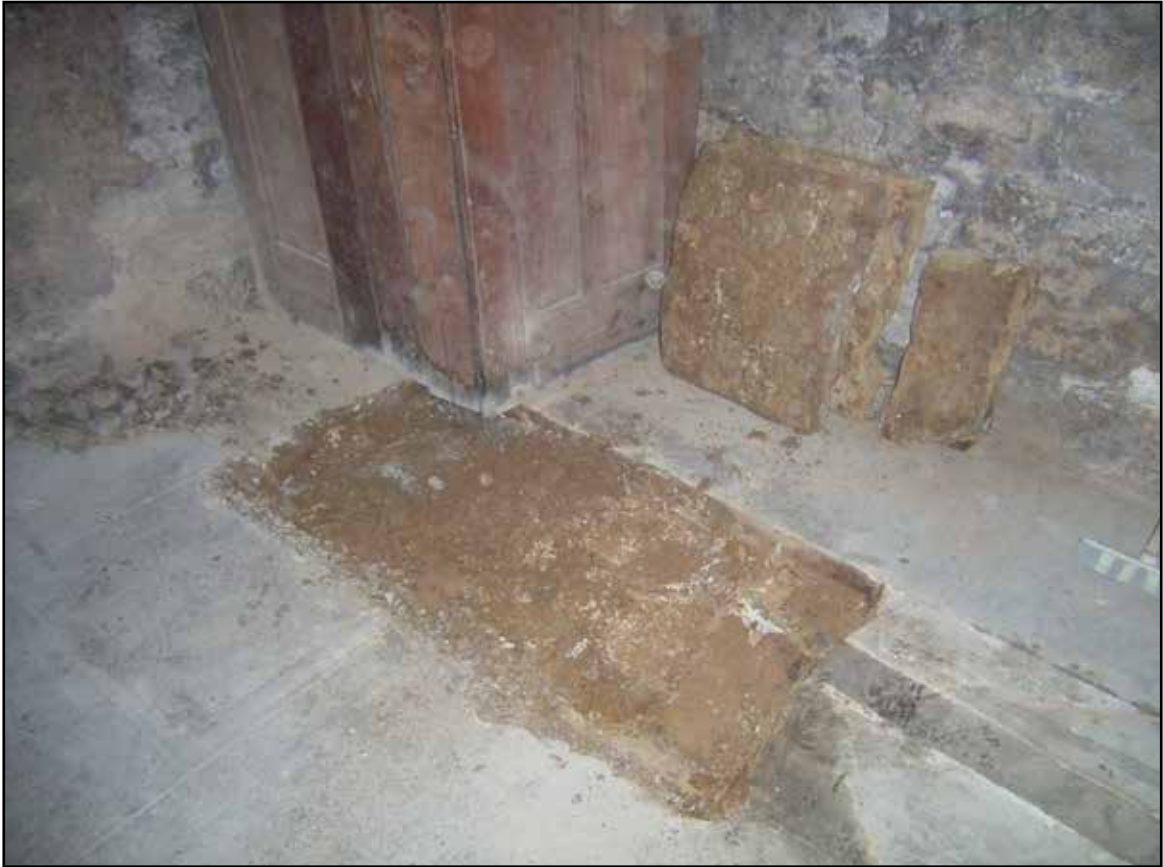
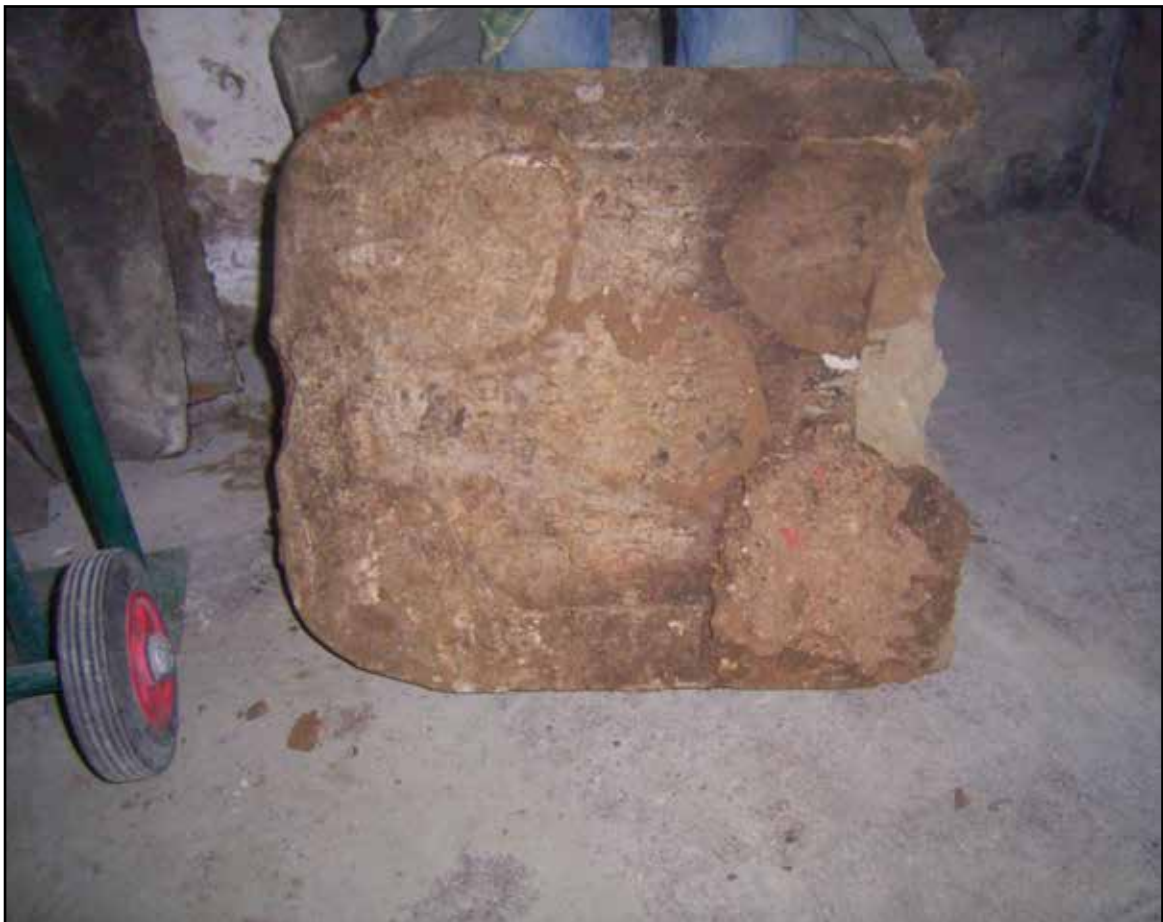
4.1.1 This is in the south-west corner of the tower. It was aligned north-south and measured approximately 0.7m by 0.8m. The stone flags (100) were uplifted, which measured 0.05m and then a further 0.85m of probable backfill or building debris (101) was excavated. It consisted of a mid to dark grey, brown, stone, mortar and flint rubble. A small amount of tile was, also, found. No significant archaeology was present.

Plate 9. Foundation Pad 1

Plate 10. Grave slab removed from Foundation Pad 1

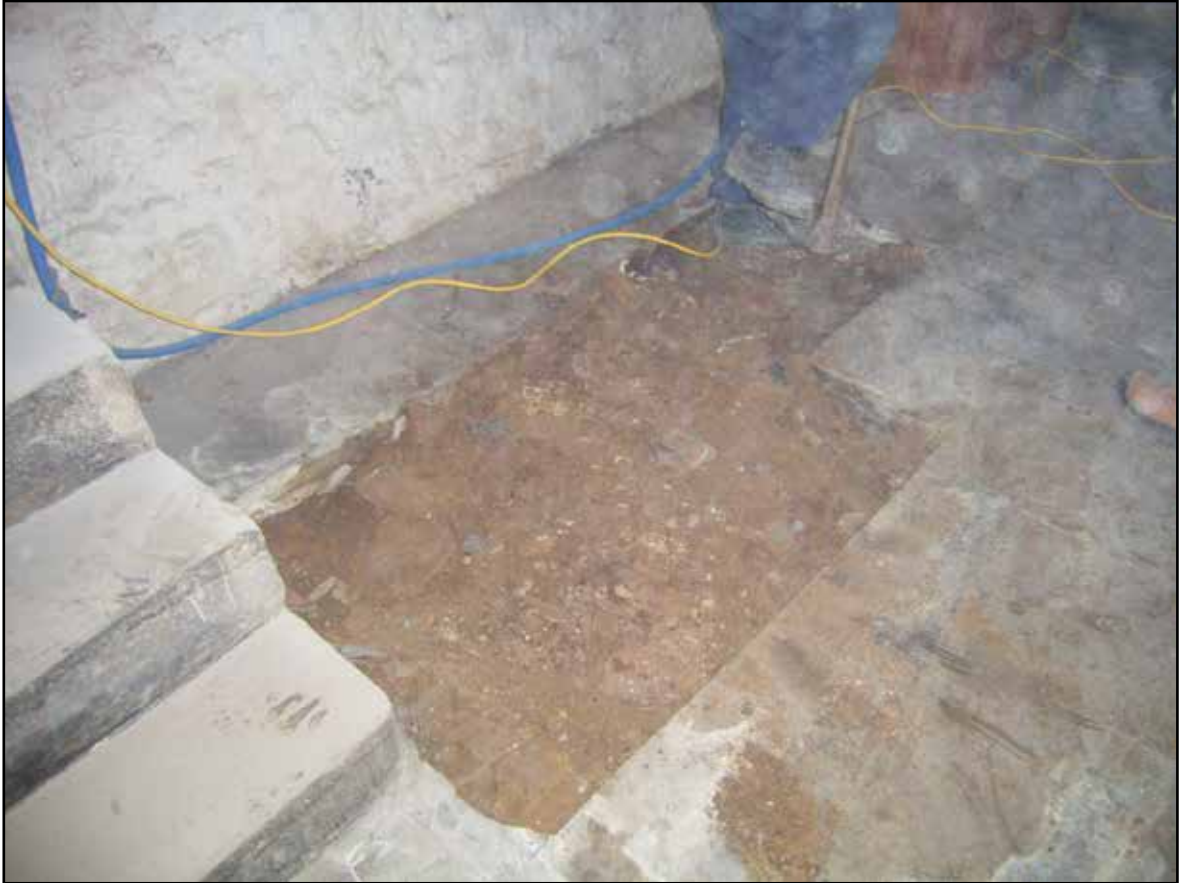
4.2.1 This is in the north-west corner of the tower, east of the steps for the entrance to the tower. The trench was orientated east- west and measured approximately 0.8m by 0.8m. The stone flag (200) was removed and measured 0.05m in depth. There was a stone, mortar and flint rubble backfill or building debris. This was 0.85m in depth (201). A decorated floor tile was uncovered, which is believed to have come from (201). Beneath the rubble layer, a dark grey to black organic silt was visible (202). This feature is possibly part of the edge of a pit of 0.05m visible width and 0.4m maximum visible depth. Animal bone and shell were recovered from within the fill. The possible edge of pit may be part of the same feature, as was located in Foundation Pad 4, which was to the west of the entrance steps to the tower. Not enough was uncovered to be certain.

Plate 11. Foundation Pad 2 during excavation

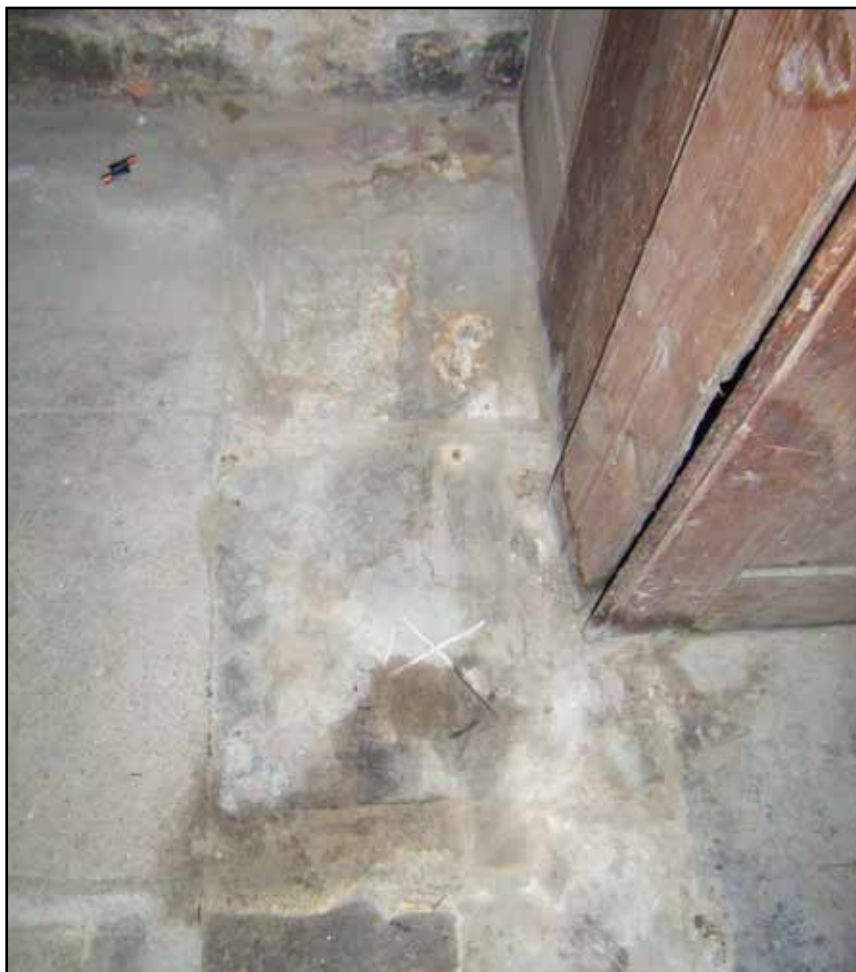
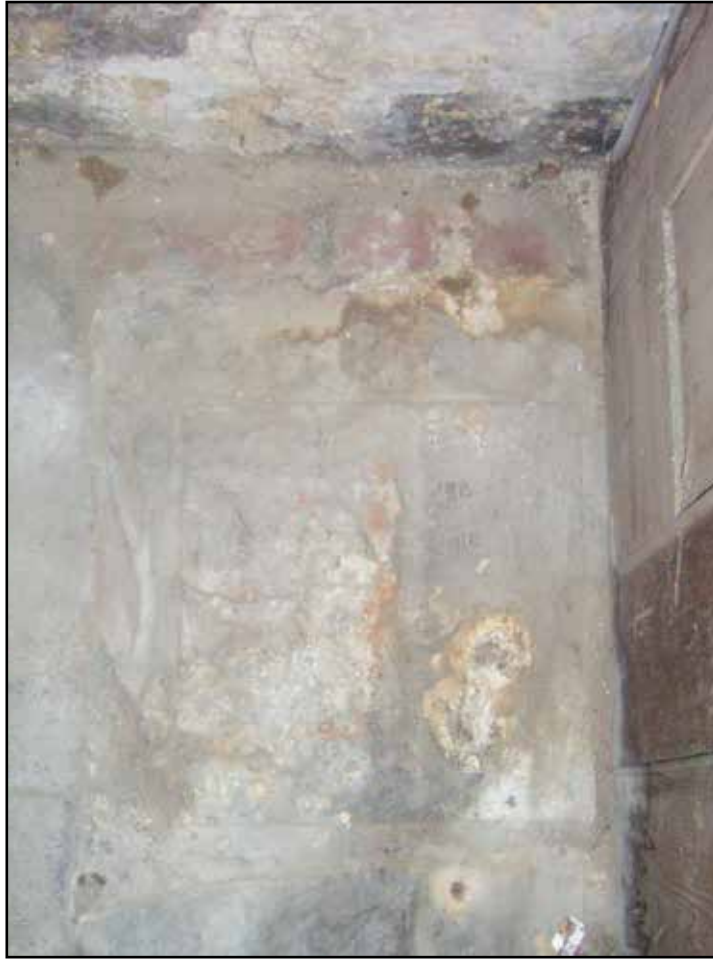
4.3.1 This is in the south-east corner of the tower and is to the west of the stairs. It was aligned north-south and measured 1.25m by 0.55m. A concrete flag of 0.5m depth was removed (300) to uncover an area of flint shingle (301) 0.7 x 0.55 x 0.4m maximum. This was only located in the southern three quarters of the trench. It appeared to be modern backfill, possibly due to previous drainage work. This theory is reinforced by the flagstone material being modern concrete. Beneath this, stone, mortar and flint rubble, to a depth of 0.04m, was uncovered (302). This, again, was probably building debris and, also, contained some bone and tile. At the base of the pad, original brick (303) and stone (304) foundations were uncovered. This stopped any further excavation from taking place.

Plate 12. Area of Foundation Pad 3

Plate 13. View of grave slab flagstones in Foundation Pad 3

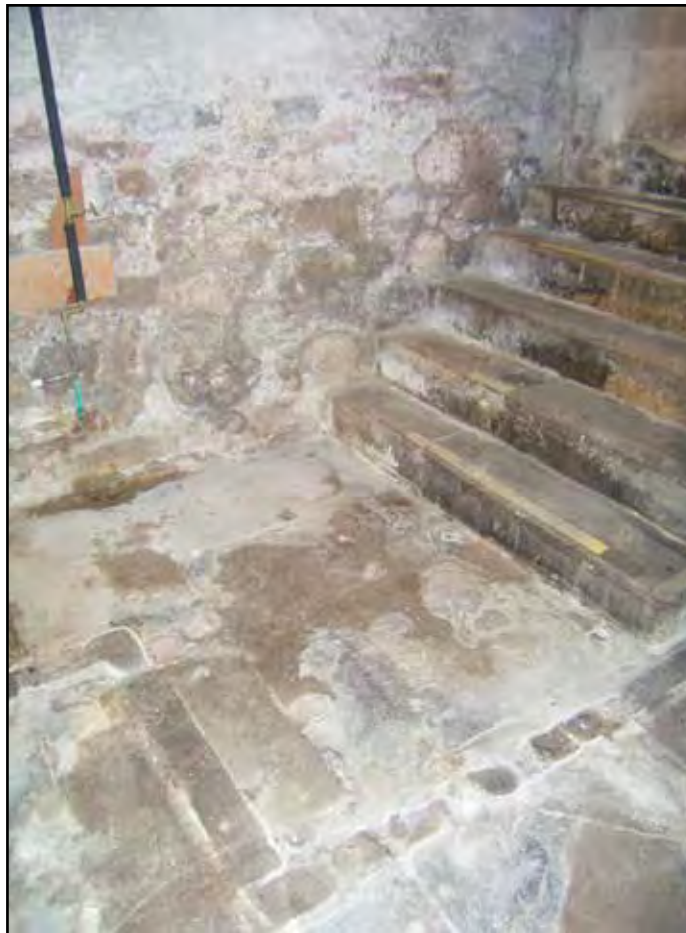
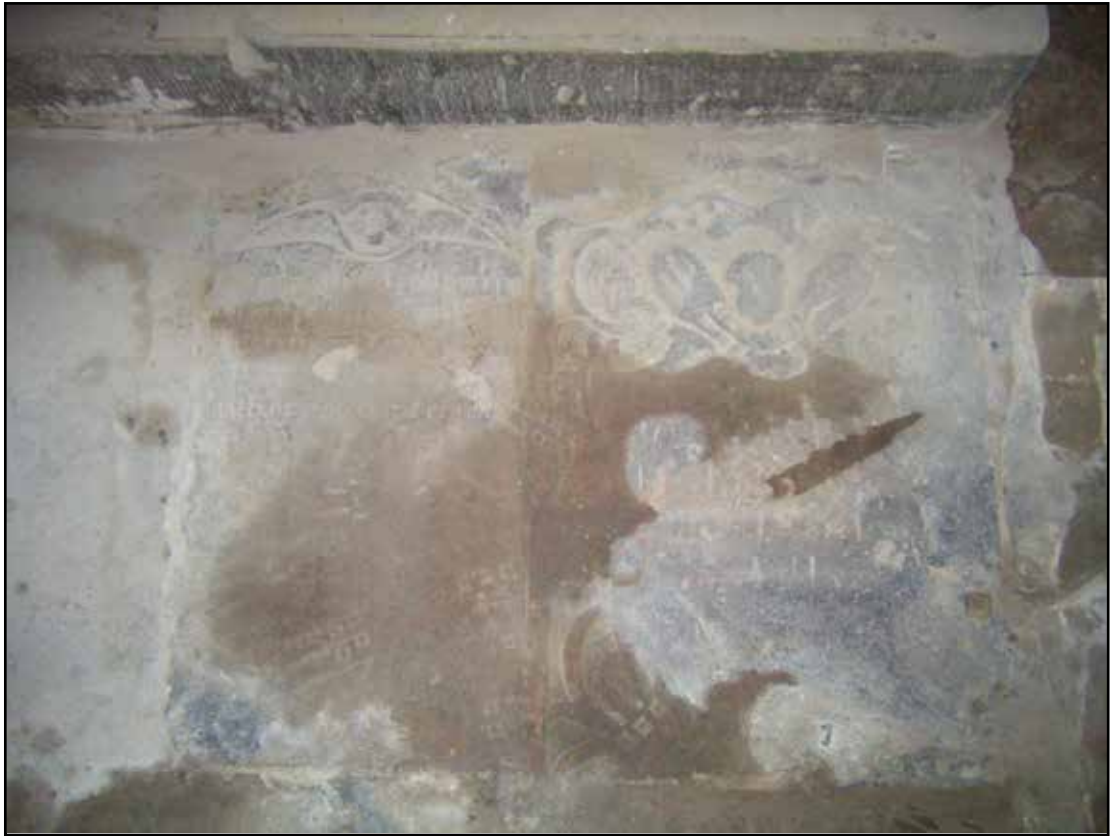
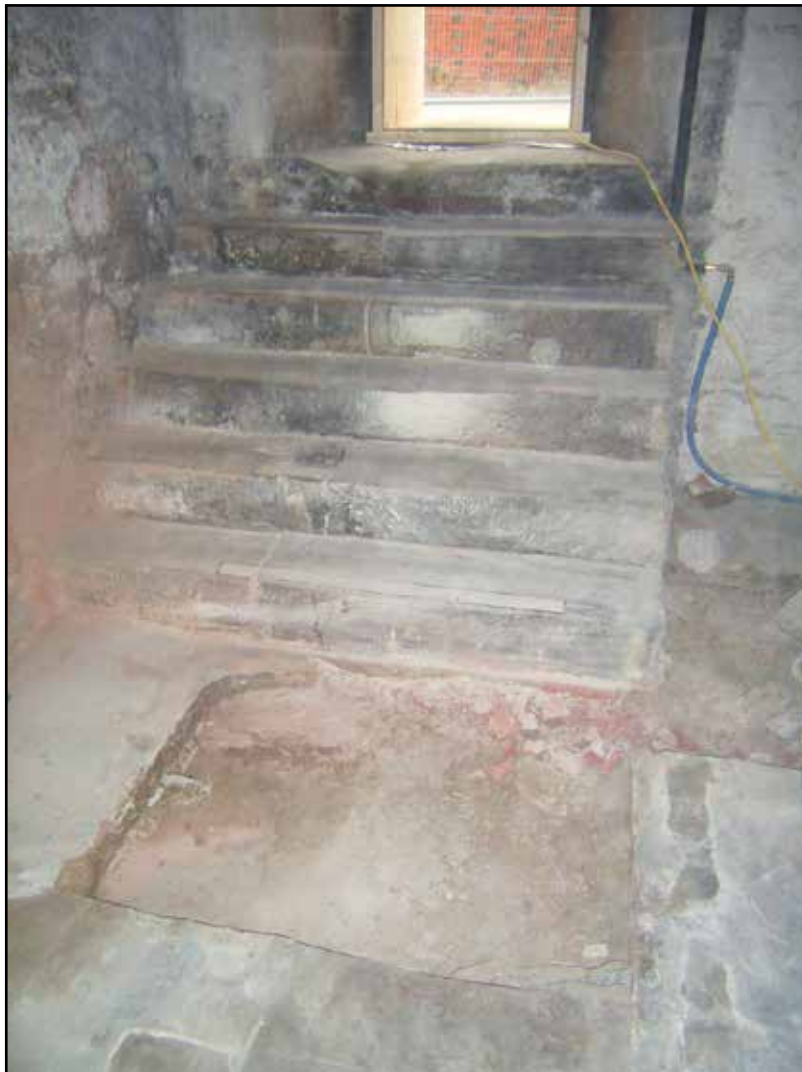
4.4.1 This is in the north- west corner of the tower, to the west of the entrance steps. It is orientated north-south and measures approximately 0.8m by 0.8m. Stone flags to the depth of 0.05m were removed (400). A stone, mortar and flint rubble layer was beneath this to 0.85m, this was probable building debris (401). Beneath this, a dark grey to black organic silt was uncovered to the eastern edge of the pad (402). Animal bone was recovered from (402). It is possible (402) represents the further edge of a pit, as was seen in Foundation Pad 2, but not enough was uncovered, to be certain.

Plate 14. Area of Foundation Pad 4

Plate 15. Grave slab flagstones in Foundation Pad 4

Plate 16. Foundation Pad 4 during excavation

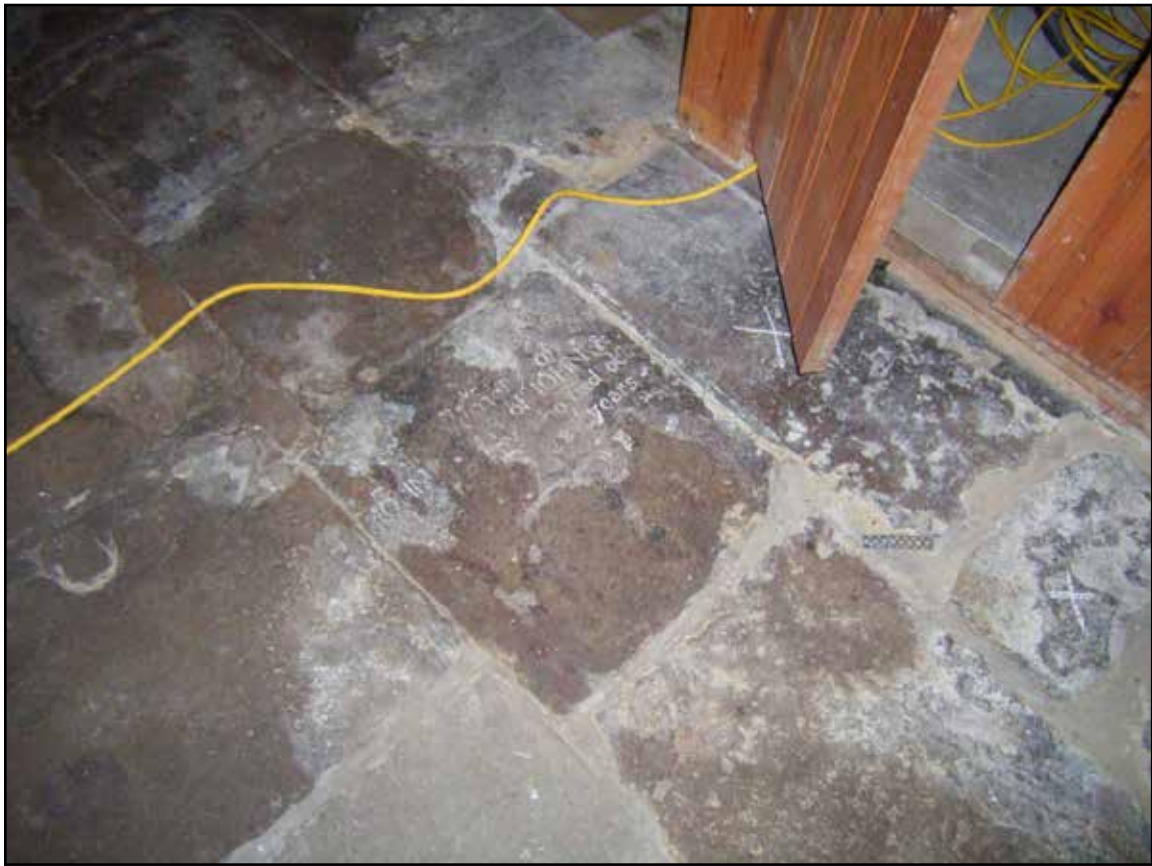
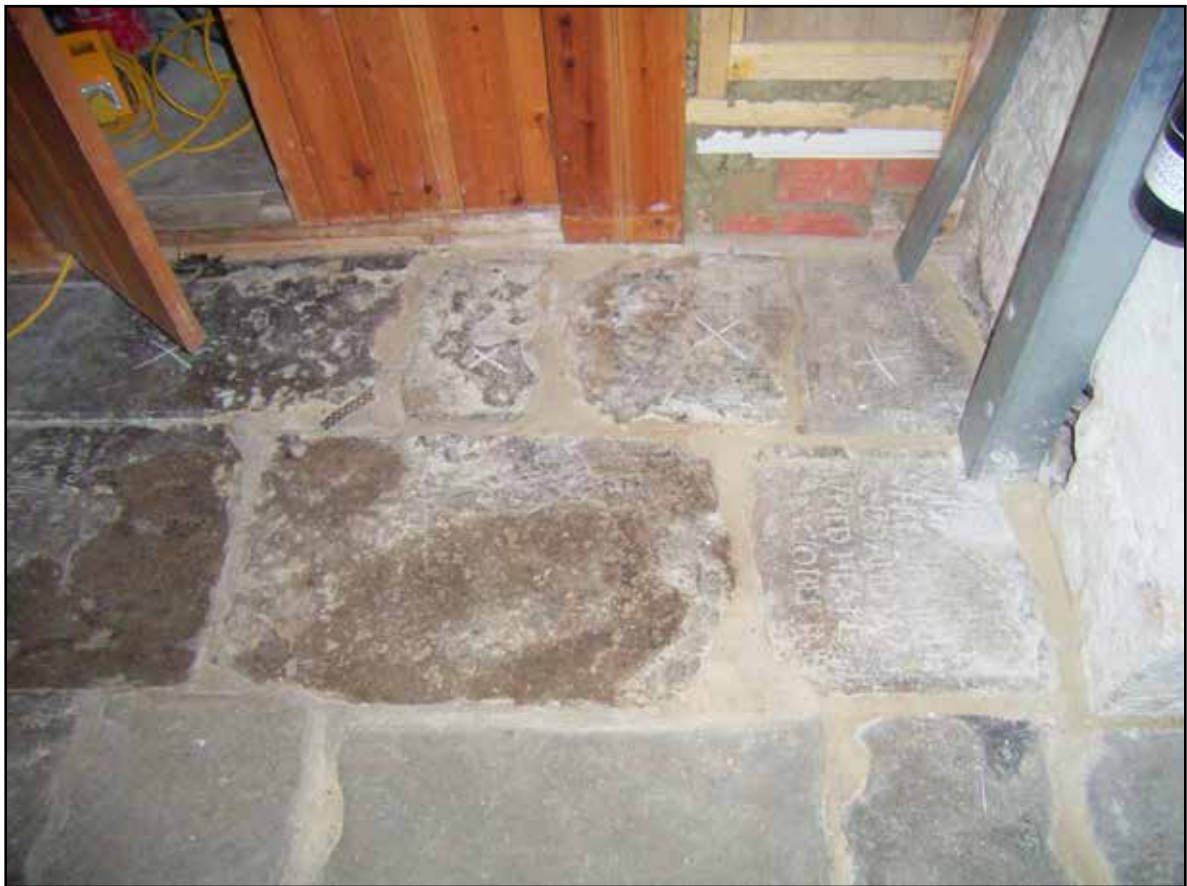
4.5.1 This is in the north-east corner of the tower. It measured 0.7 by 0.7m and was excavated to a depth of 0.6m through probable building debris (**501**). Flagstones were removed to a depth of 0.05m (**500**). Stone foundations (**502**) and brick foundations (**503**) for the chimney were uncovered from the original tower, which stopped further excavation.

Plate 17. Area of Foundation Pad 5

Plate 18. Grave slab flagstones in Foundation Pad 5

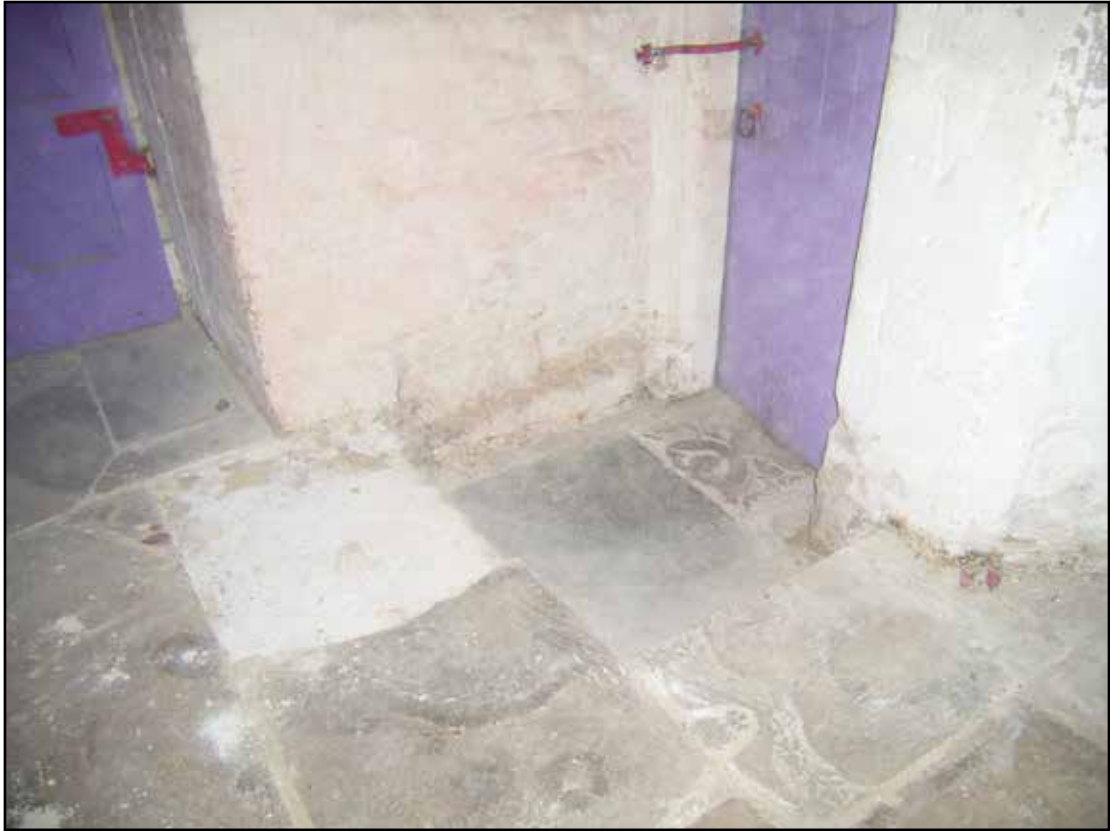
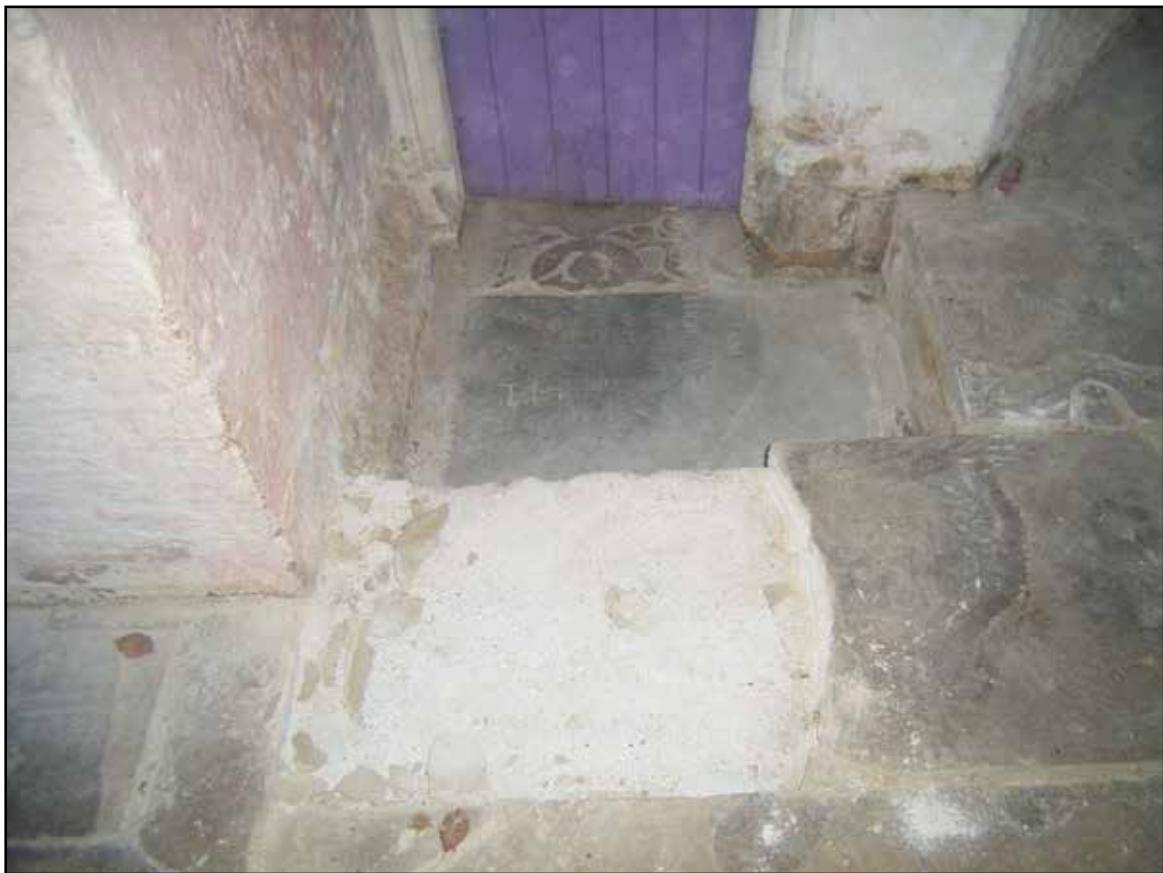
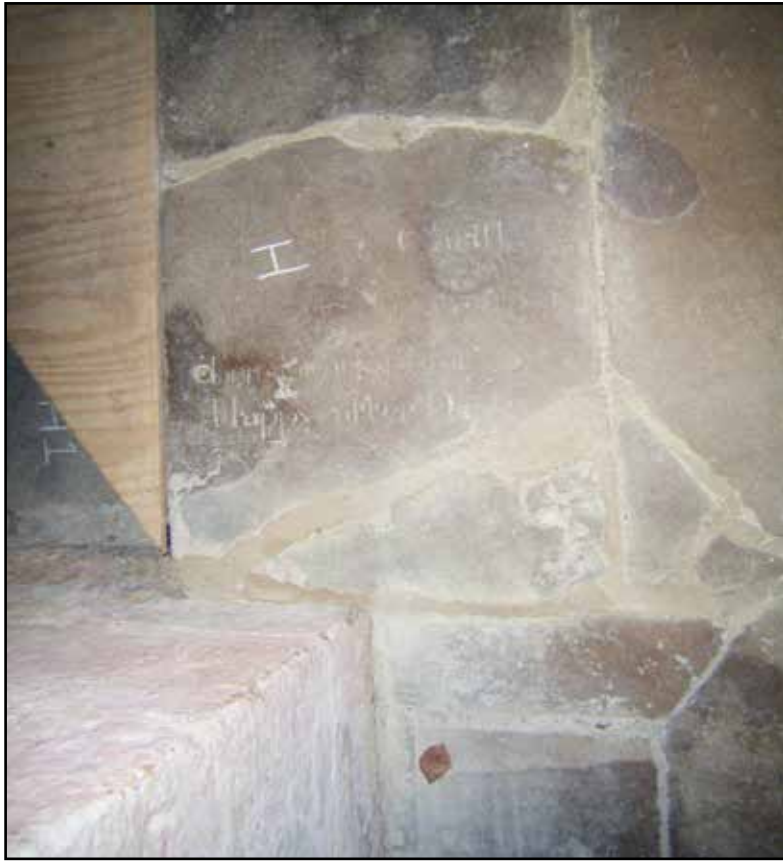
4.6.1 This is in the north-west corner, to the north of the entrance steps of the tower. The trench is aligned east- west and measured 0.6m by 0.4m. A stone flag (**600**) of 0.05m was removed and beneath this a stone, mortar, flint rubble, which was probably building debris, was located (**601**). This was to a depth of 0.35m. Once this was removed, the original stone foundations (**602**) of the tower were recovered, which prevented any further excavation. A grave stone, on an east-west alignment was also recovered. This restricted the extension of the Foundation Pad and extension to the north was disallowed.

Plate 19. Area of Foundation Pad 6

Plate 20. Foundation Pad 6 during excavation

Plate 21. Grave slab flagstone in Foundation Pad 6

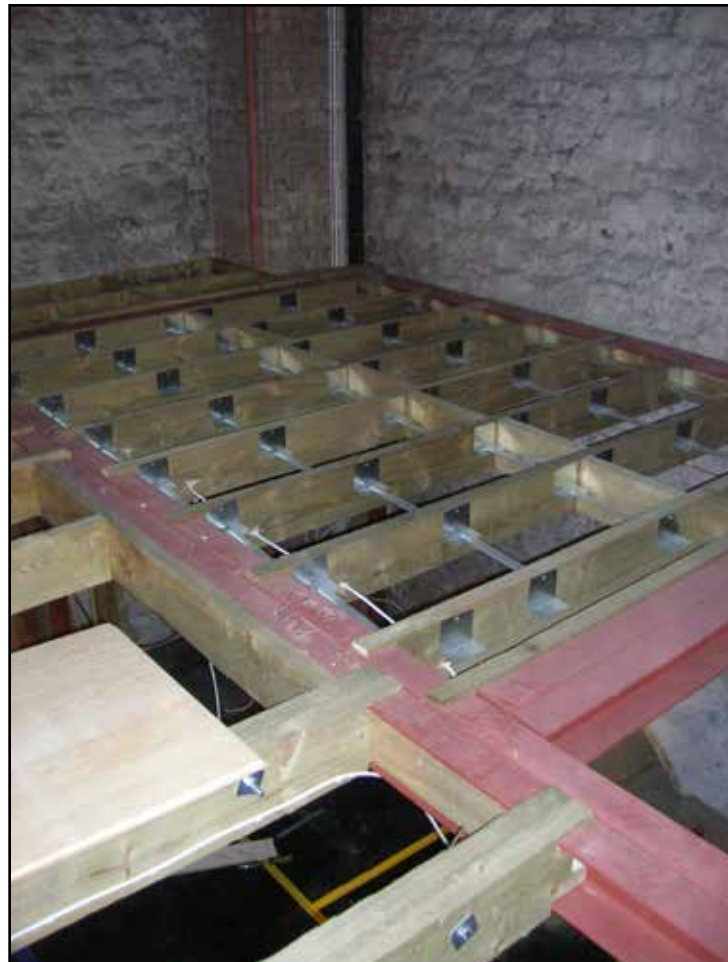
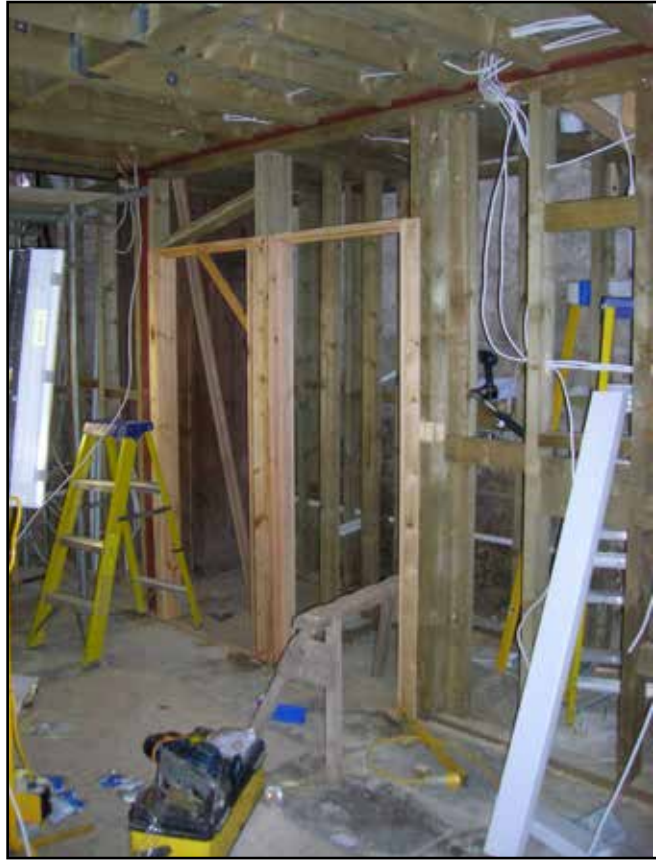
4.7.2 Two extra floors were inserted into the tower, providing an office and a store room. These were designed to have as limited an impact on the building as was possible. The groundworks of the tower were the only areas affected, due to extra support pillars being needed, in order for the new floors to be stable.

Plate 22. Erection of new floor

Plate 23. Erection of new interior

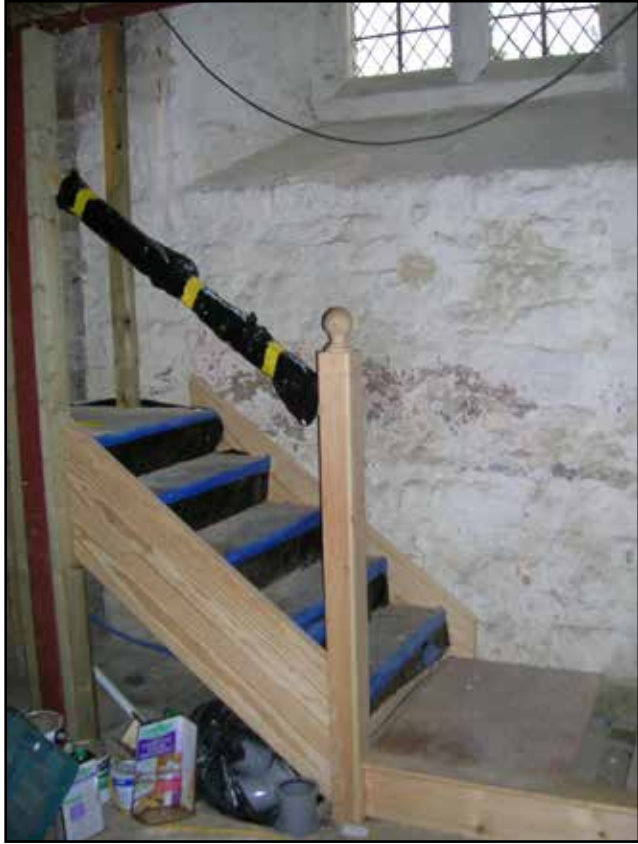
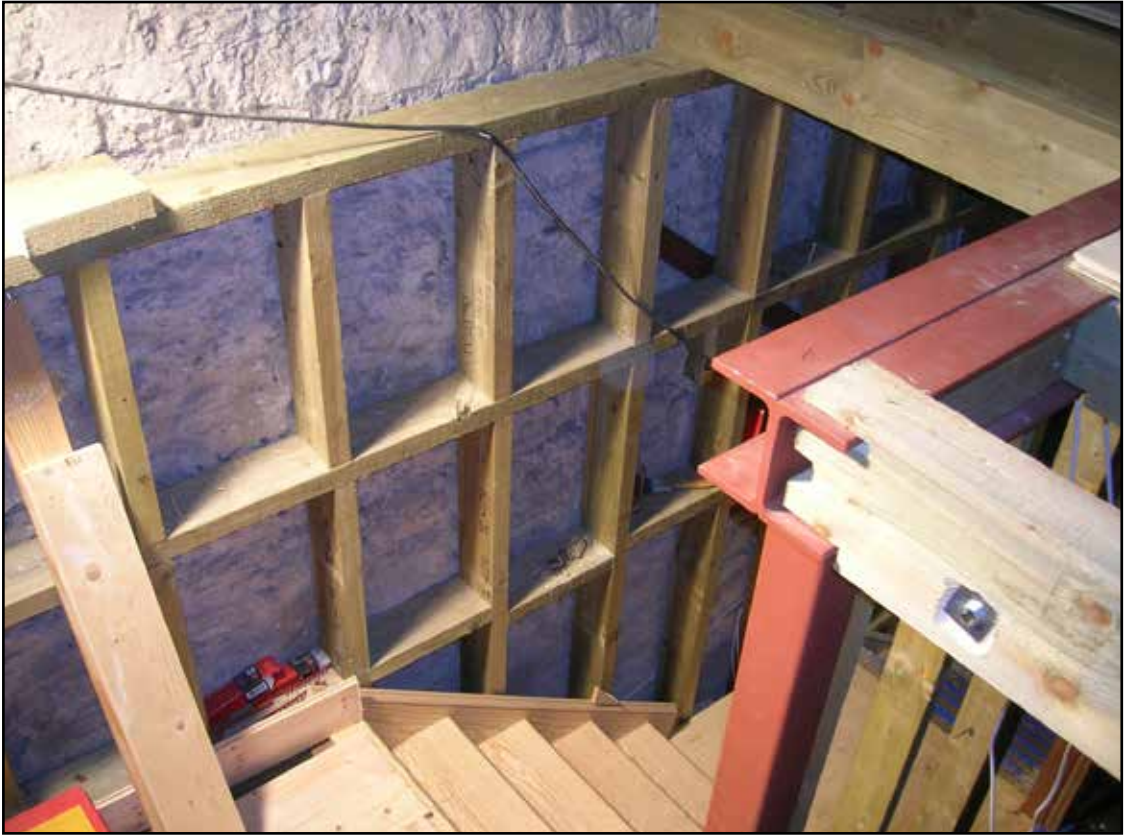
Plate 24. Erection of staircase

Plate 25. Staircase to new floors
