Dorchester Abbey Tower Dorchester on Thames Oxfordshire

**Building Recording and
Watching Brief**

Client: Martin Ashley Architects

Historic Building Investigation and Recording

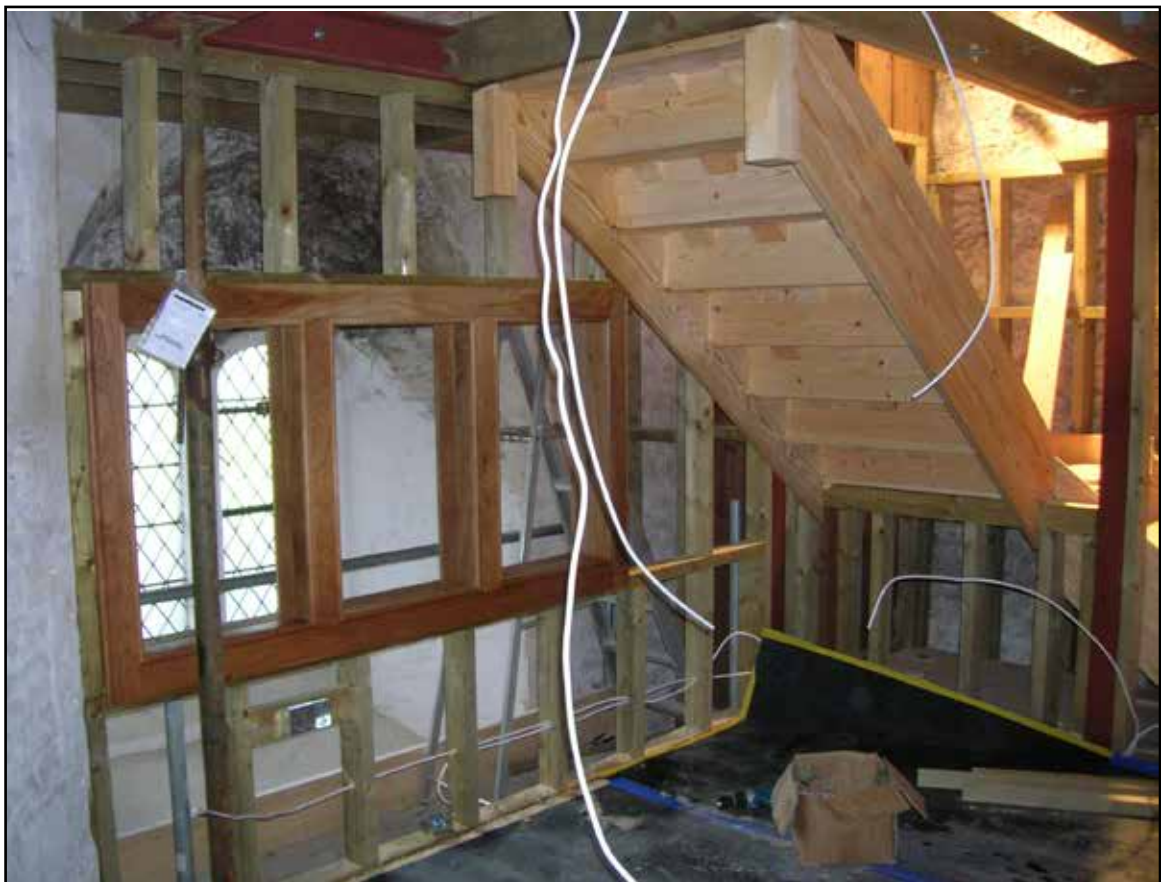
Plate 26. Office room, showing no damage caused to structure, especially to the window

5.1.2 The previous interior of the tower, including wooden cupboards, was all removed. Two new floors were inserted, providing more useable space, which were adapted into an office and a store room. On the ground floor, a new staircase was added and the area was updated to create both a kitchen and a toilet. The second floor was designed to have as little impact on the tower, as was possible, and is a wooden box
