All Saints Church High Wycombe

Archaeological Watching Brief Report

April 2011

OA Job No: 4857

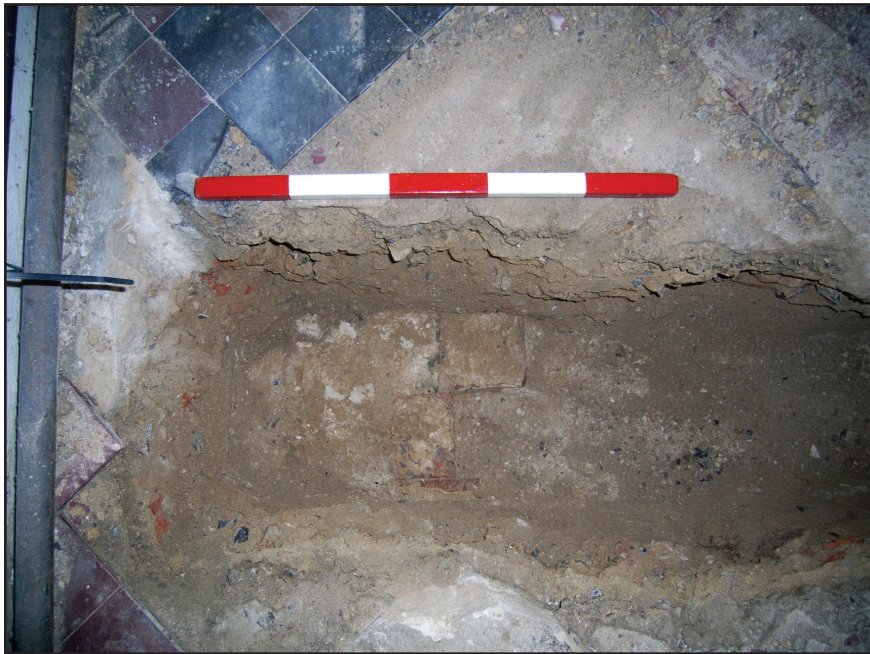
Plate 1: In situ medieval floor tiles in Trench 4

- 3.1.10 Four medieval floor tiles (context 1012) were observed at the western extremity of the internal part of Trench 4 next to the western wall (Figure 2, Plates 1 and 2). These were photographed and retained.

- 4.1.1 The relatively shallow depth of the groundworks meant that only limited evidence of the medieval church was observed. A small area of the original medieval floor (1012), comprising four tiles, was revealed at the western extent of Trench 4, adjacent to the west wall of the south aisle. A rubble levelling deposit (1001), measuring at least 0.70 m in thickness, was observed throughout the excavations which either obscured further medieval floors and walls or filled voids following the removal of medieval structures.

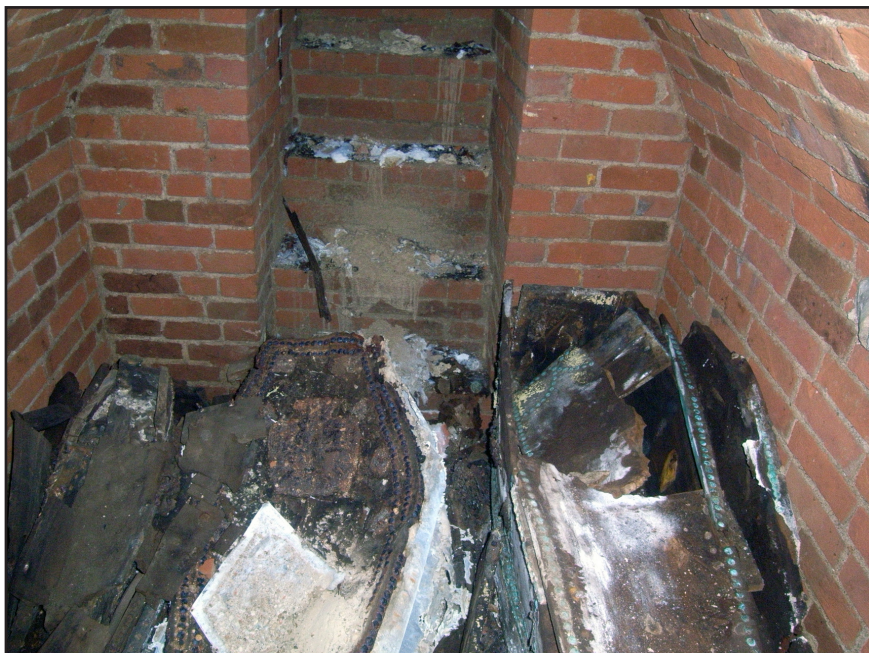
Plate 3: Coffins in vault 1002

- 3.1.7 Vault 1002 was revealed in Trench 3, within the nave immediately to the east of the baptismal font. The font had been constructed directly over the steps leading up from the west side vault. The vault measured approximately 2.70 m in length, 1.40 m in width and 2 m in depth. It was constructed from red bricks with a barrel-vaulted top. This had previously been breached, presumably during Victorian restoration work. Investigation of the breach in the vault roof revealed at least six, and possibly up to nine, triple-shelled, fabric-covered 19th century coffins (Plate 3). At least five of the coffins were adult sized and one was probably that of a child.
