Firs Field Lightshaft Combe Down Bath

Archaeological Evaluation Report

ARCHAEOLOGICAL EVALUATION

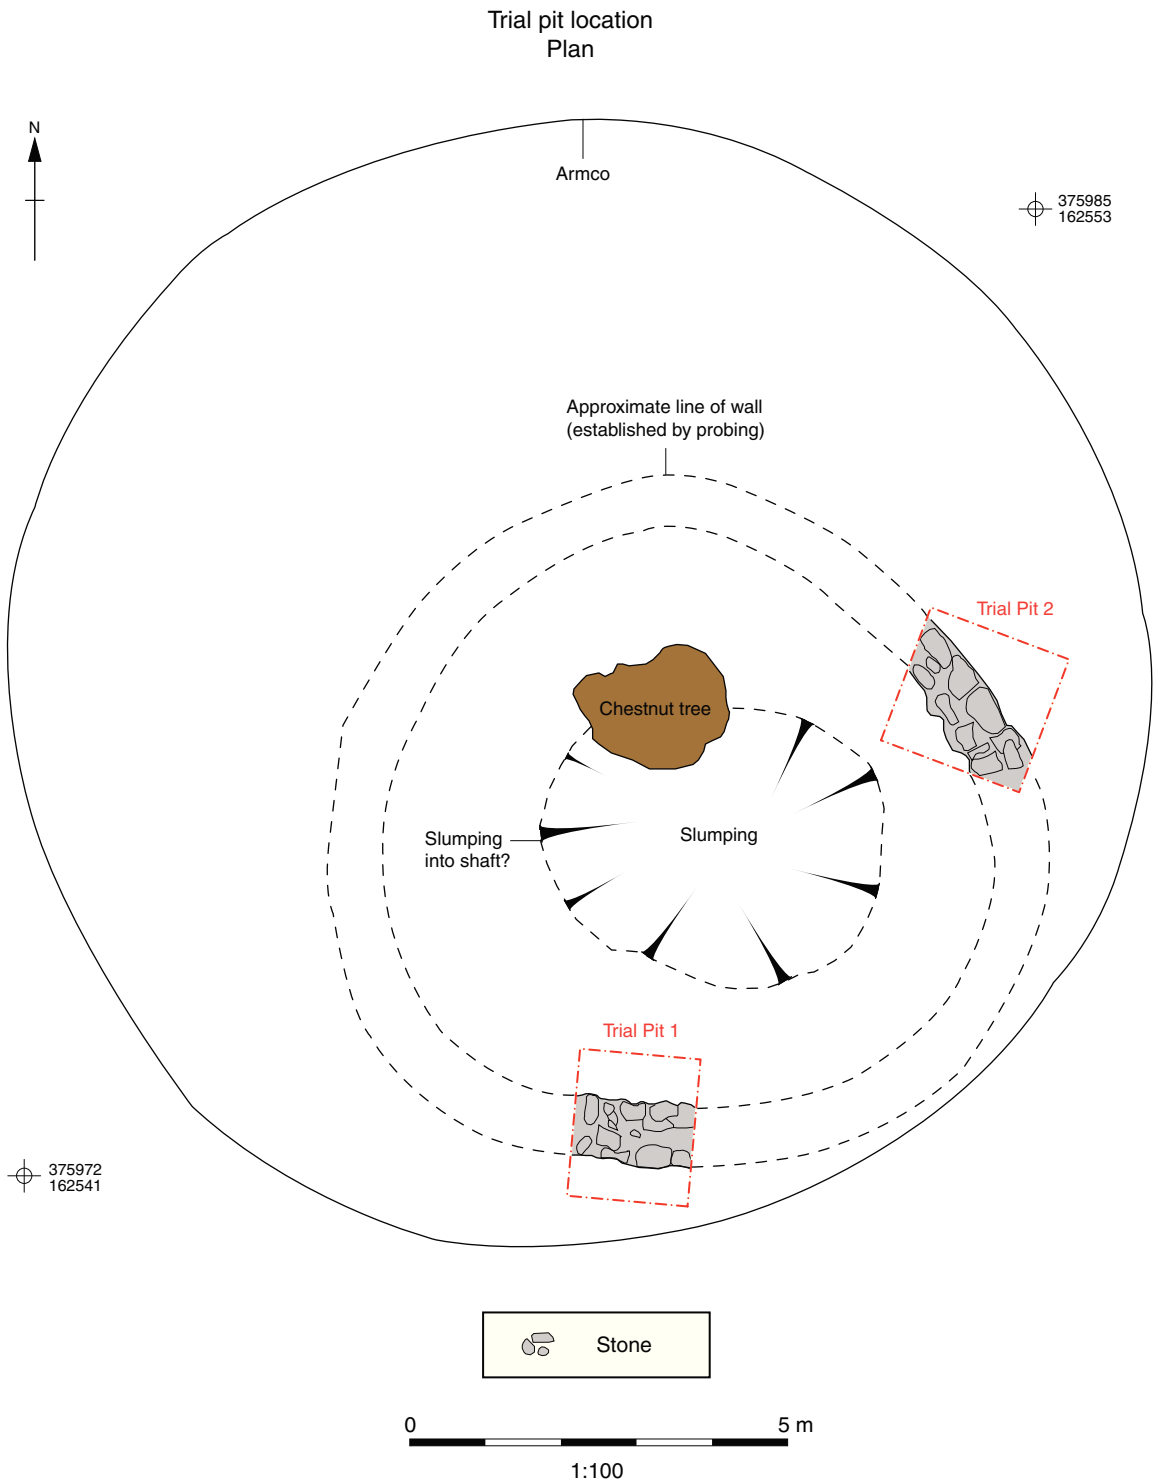
Figure 2: Trial pit location plan

- 3.1.1 The evaluation consisted of two trial pits each measuring approximately 1.8 m square located across opposite sides of any visible remains of the feature, while avoiding any potential damage to the root system of the standing horse chestnut tree (Fig. 2).

- 5.1.1 This was located on the southern side of the evaluation area, straddling a high point within the enclosed area (Fig. 2).
- 5.1.2 A layer of yellow-brown clay silt containing small fragments of sub-angular limestone (4) was encountered approximately 0.4 m below the current ground level (Fig. 3, Plan 10 and Fig. 4, Section 10). This was overlaid by a 0.15 m deep layer of dark grey-brown silt loam (3) which contained shards of transfer printed pottery and fragments of bottle glass.

- 5.1.5 This was situated on the north-eastern corner of the evaluation area (Fig. 2).
- 5.1.6 A continuation of the layer of yellow-brown clay silt (22) was encountered 0.3 m below the current ground level (Fig. 3, Plan 20 and Fig. 4, Section 21). This was overlaid by a layer of dark grey-brown silt loam, 0.15 m deep, (21) which produced fragments of transfer printed pottery and brick.

- 6.2.5 The truncated remnants of the wall had been sealed below layers of modern made ground, (layer 2), and covered by a landscaping layer of topsoil and turf (layers 1 and 20). This probably occurred during the post-war reclamation of the site.
- 6.2.6 The dimensions of the wall suggest that it had been built stepped back roughly 1 m from shaft itself, which would have typically have been 5 m to 6 m in diameter, and therefore the wall does not appear to have formed part of the shaft lining. No evidence for the shaft itself was encountered in either of the trial pits, although a depressed area, indicative of possible slumping, was visible within the centre of the evaluation area (Fig. 2).

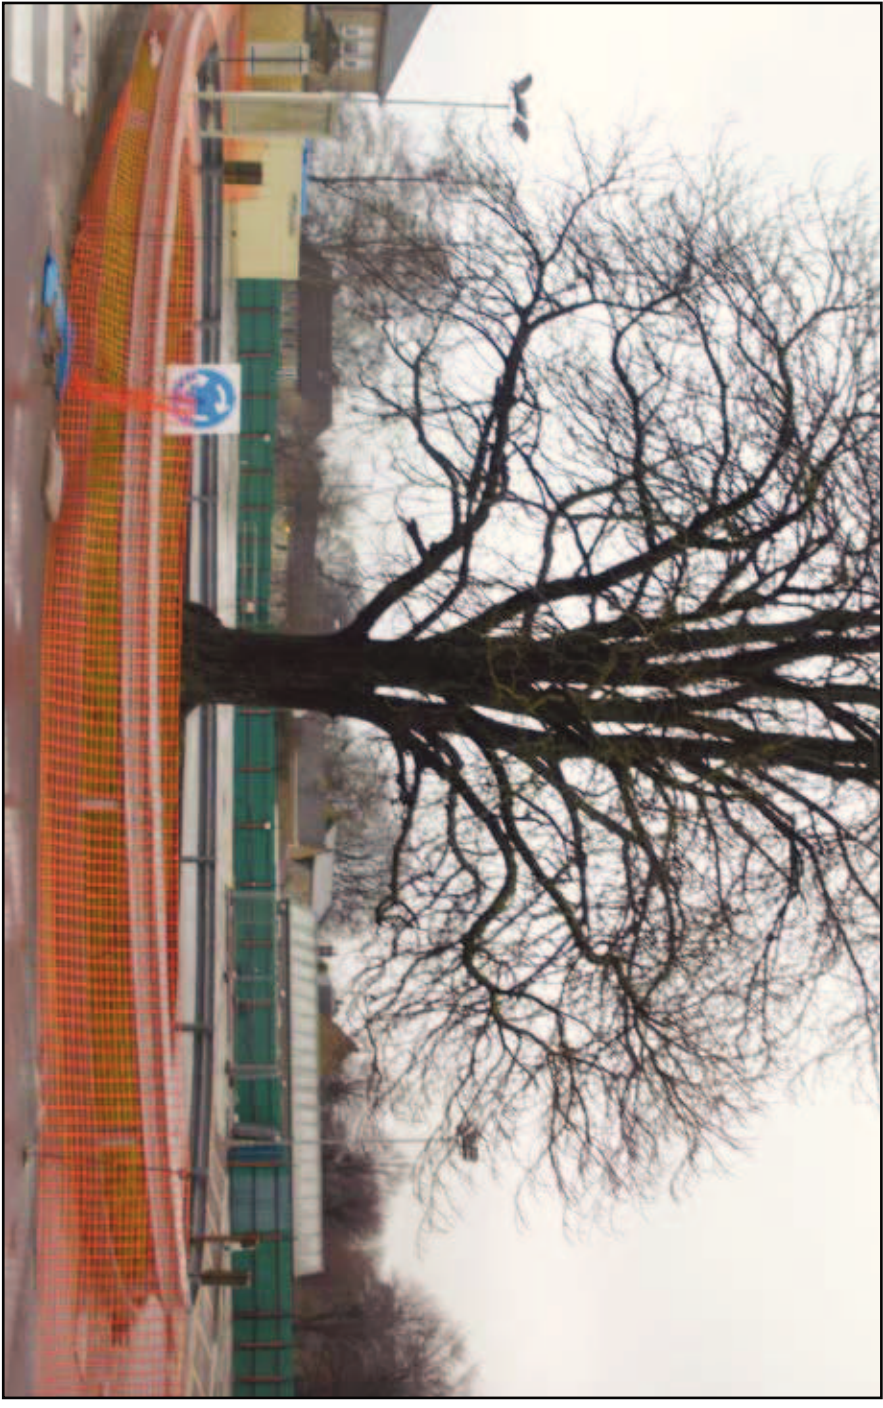
Plate 1 : Site location

- 1.2.4 At the time of the excavation works the shaft was located within the main compound of the Combe Down Mine Stabilisation scheme, lying at the centre of the main compound roundabout (Plate 1). This roundabout will henceforth be referred to as ‘the site’ as it contained both the shaft and the remains of the potential surrounding wall feature which was the focus of the excavation and of this report.

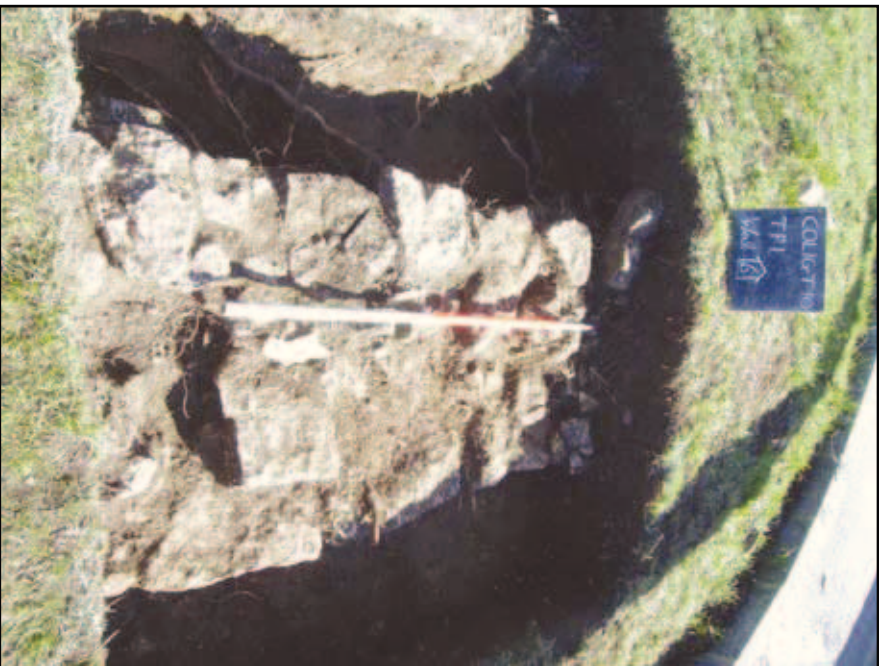
Plate 2: Trial pit 1. Details of the wall feature

Trial Pit 1 (Plate 2)

- 5.1.3 Cutting this layer to a depth of 0.2 m and a width of 0.85 m was a curvi-linear flat bottomed trench (5). Built within this trench was a drystone constructed wall 0.8 m wide (6). This was constructed using roughly dressed blocks of the local Bath stone laid in courses with a rubble core. Only two full courses of this wall survived in situ, with fragments of the core extending above these in places.

- 5.1.4 Sealing the truncated wall was a layer of grey-brown clay silt (2), up to 0.2 m in depth. This deposit contained fragments of earthenware, creamware and transfer printed pottery, together with fragments of brick, corroded tin cans and screw top bottle glass. This was sealed below a layer of dark grey-brown silt loam (1), the present day topsoil and turf.

- 6.2.7 The trial pits have shown that the base of the wall surrounding the lightshaft has survived in situ, allowing the line and extent of the wall to be established. The roots from the horse chestnut tree do not appear to have damaged or dislodged the wall within the two sections exposed within the trial pits.

- 6.2.9 The wall itself was of drystone construction which may prove problematic if exposed to the wear and tear of pedestrian traffic. It may be necessary to stabilise its structure (ie with mortar) in order to provide a more durable monument.

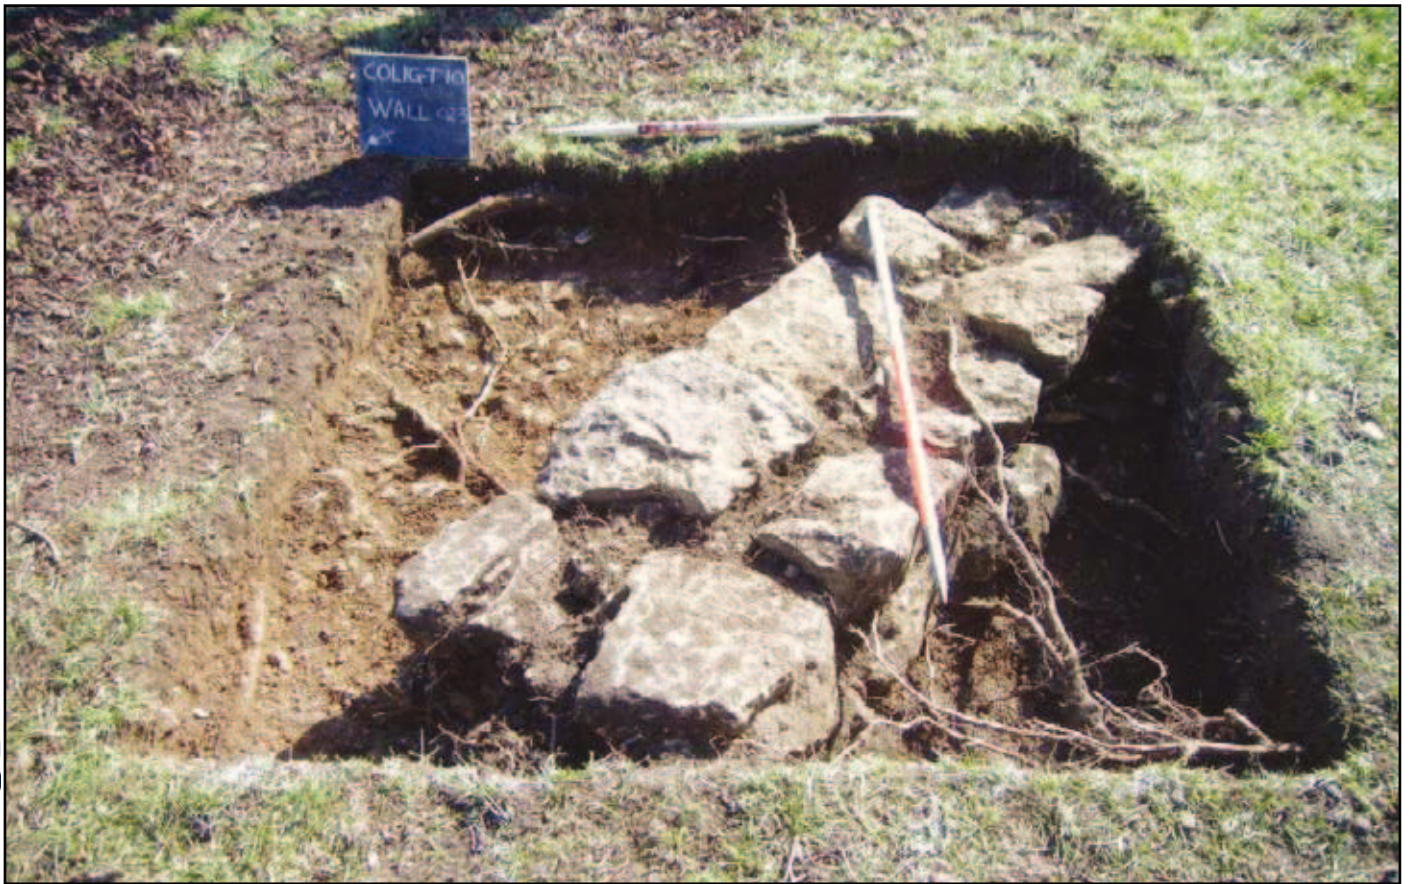
Plate 3: Trial pit 2. Details of the wall feature

Trial pit 2 (Plate 3).

- 5.1.7 Built directly upon this deposit was a curved 0.8 m wide wall (23). This was built using drystone construction with roughly dressed blocks of the local Bath stone laid in courses with a rubble core. Only two courses of this wall survived in situ, with evidence of robbing or truncation reducing this in places.

- 5.1.8 Butting up, and also sealing the truncated remains of the wall, was a layer of dark grey-brown silt loam (20), the present day topsoil and turf. This deposit produced fragments of transfer printed pottery, screw top bottle glass and corroded metal cans.

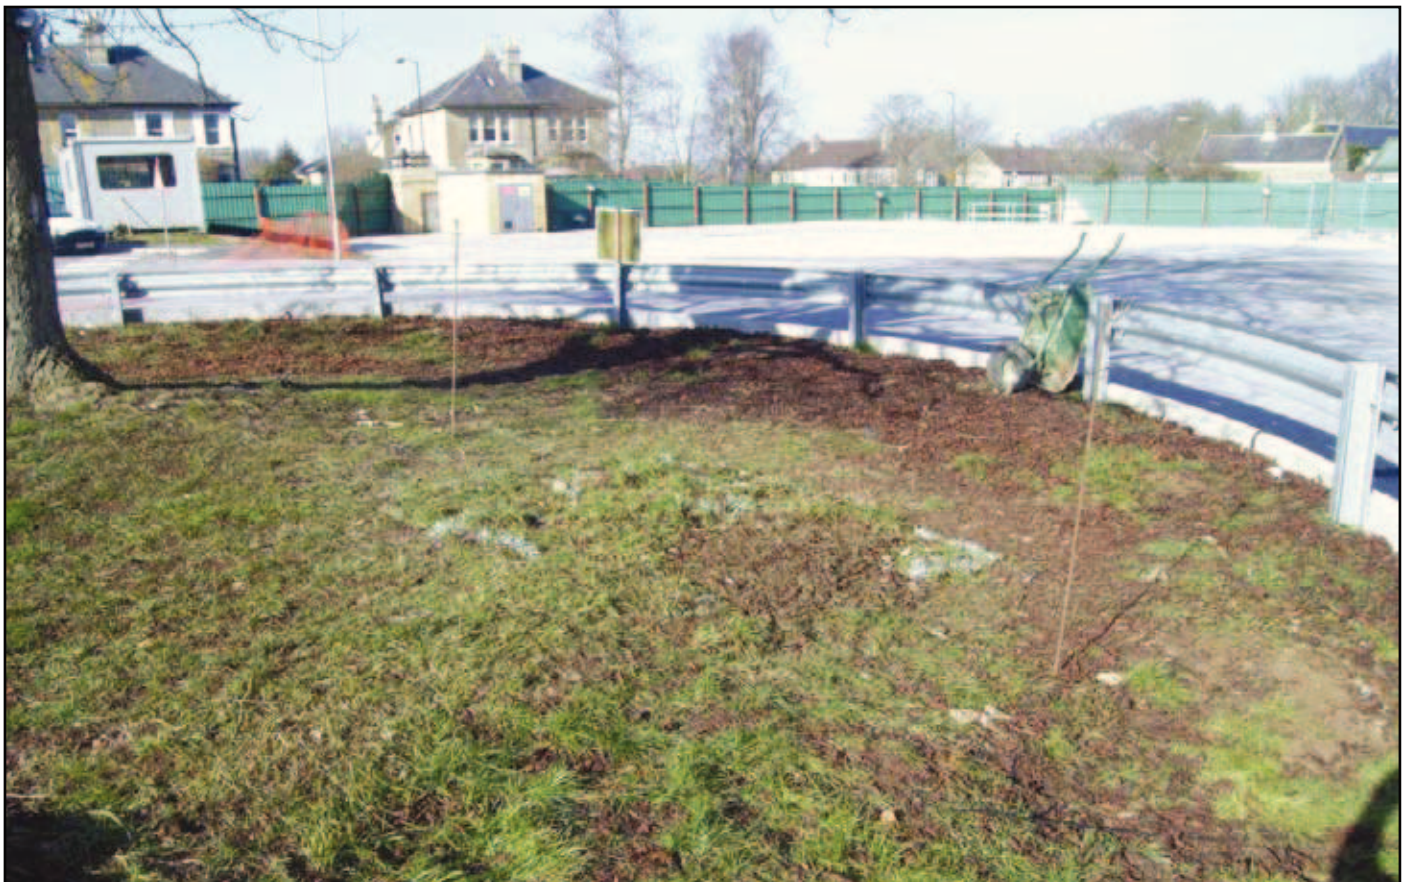
Plate 4: Trial pit 2. (After reinstatement) showing current disposition of the site

- 6.2.8 The top of this truncated wall was encountered directly below the turf in places and it may be possible to expose the wall simply by reducing the ground level locally (the existing ground level itself appears to rise within the area surrounding the horse chestnut tree). The disposition of the site at the time of the excavation can be seen on Plate 4.
