Fletching Mill

November 2008

OA Job No: 4225

Geoarchaeological Assessment Report

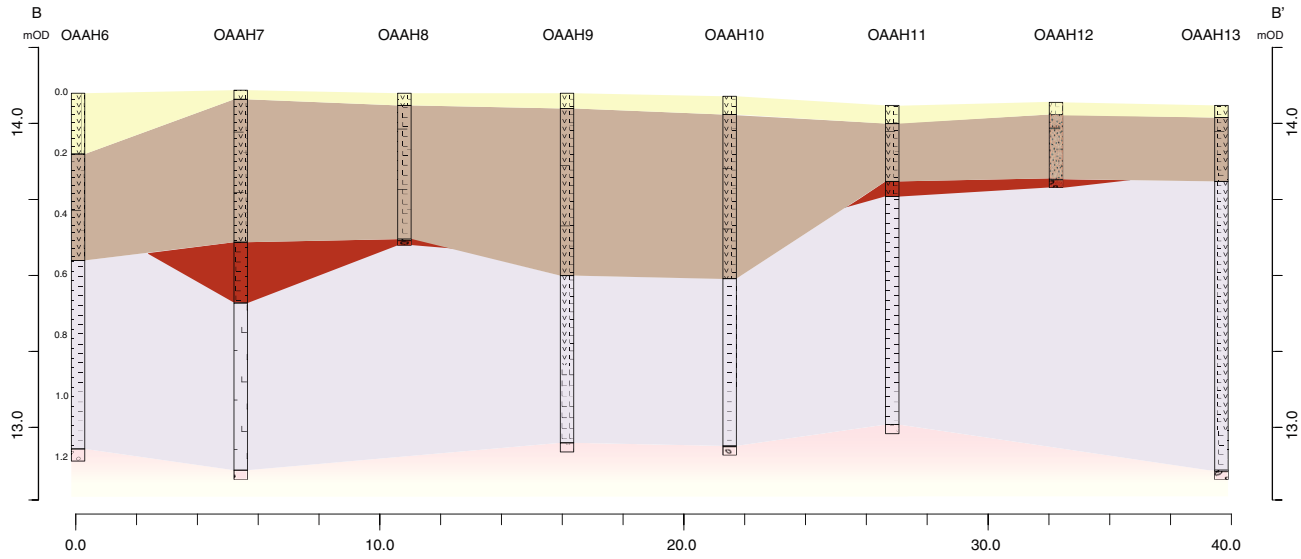
Figure 3: Cross-sections

4.2.1 Based on the result of the auger survey a stratigraphic sequence for the site has been developed to aid the assessment of the archaeological and palaeoenvironmental potential. The following sequence has been proposed:

- Bedrock
- Waterlogged clayey silts
- Archaeological deposits
- Upper ditch fill deposits
- Topsoil/leaf litter

4.3.1 **Bedrock:** The sandy bedrock was recovered within the majority of auger holes as a reddish brown sand deposit with occasional angular to sub-angular stone inclusions. The bedrock was encountered on average depth of 1.20m, ranging between +12.75m OD and +13.0m OD.

4.4.1 **Waterlogged silty clay:** Alluvial deposits were encountered in all auger holes apart from AH8 and AH12, where penetration of the auger was disrupted at approximately +13.65m and +13.80m OD due to an obstruction, and AH15 and AH16 which were situated at the edges of the ditch itself. When encountered, the clays were between 0.60m and 1.20m in depth (+12.80m OD and +13.80m OD). The alluvial deposits consisted of structureless silty clay with rare coarse inclusions, ranging from light grey to a dark grey. Organic matter was present and targeted for sampling. Within the southern ditch, towards the base of these deposits it gradually became more gravelly with increasing moderately sorted sub-angular to sub-rounded stones.

4.4.4 **Upper ditch fill deposits:** A sequence of ditch fill deposits was identified below the thin topsoil throughout the site, from +13.20m OD to +14.03m OD. These deposits ranged from silty clays to clayey silts and contained decayed organic matter, occasional to frequent modern rootlets and signs of oxidation.
