Compost Site Manor Farm Wall Lichfield Staffordshire

Archaeological
Watching Brief Report

Issue No: 1 OA Job No: 4922

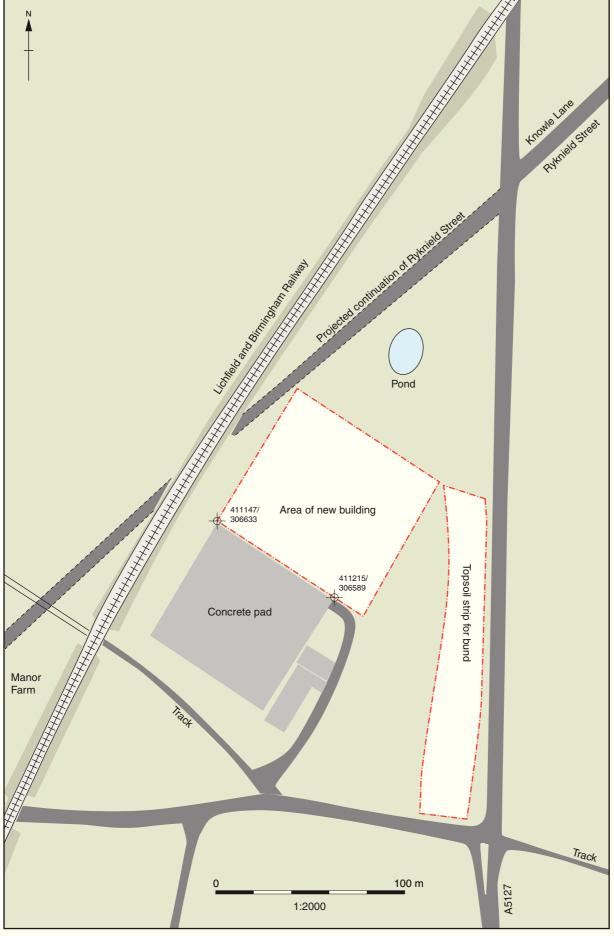
Figure 2: Site plan

- 3.1.1 The groundworks consisted of two areas of activity, the area of the proposed building and its surrounds and a separate bund to be constructed using the material removed during the construction (Fig. 2).

- 3.1.2 Prior to the start of the groundworks on the proposed building a roughly rectangular area of topsoil measuring approximately 30 m east-west and 170 m north-south, running along the eastern boundary of the site was stripped forming the footprint of the proposed bund.

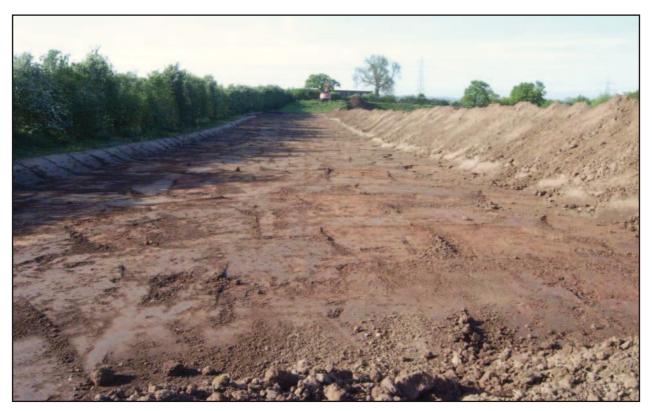
Plate 1: Topsoil strip for bund (looking south)

- 3.1.3 A overall layer of reddish brown clay sand (11) was exposed within the base of the stripped area (Plate 1). No features were observed within its surface. This was overlain by a 0.5 m deep layer of a mid orange-brown sandy silt (10) representing the present day ploughsoil.

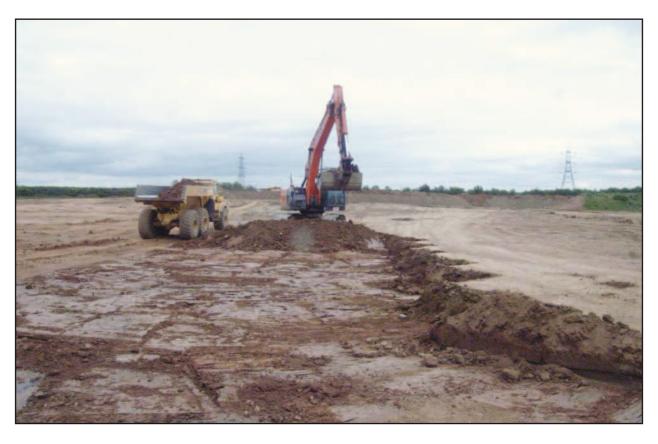
Plate 2: Subsoil strip for new building in progress (looking east)

- 3.1.4 Within the main development area adjacent to the current concrete yard a rectangle measuring 90 m by 80 m was stripped and levelled by a mechanical excavator fitted with a toothless grading bucket (Plate 2). The total depth of excavation was between 0.8 m and 1.3 m.

- 3.1.5 Exposed within the base of the stripped area was a layer of fragmented sandstone within a clay-sand matrix (22). There was no evidence of activity visible within the surface of this deposit. Overlying this was a reddish brown clayey sand (21), averaging 0.5 m in depth, but in excess of 0.8 m in places. This is a probable continuation of the subsoil (11) observed during the topsoil strip for the bund. No activity was discernable at this level.
