Reading GreenPark Village Clembins geotechnical works monitoring

Archaeological Watching Brief Report

Document Title: Reading GreenPark Village - Clembins geotechnical works monitoring

Document Type: Watching Brief

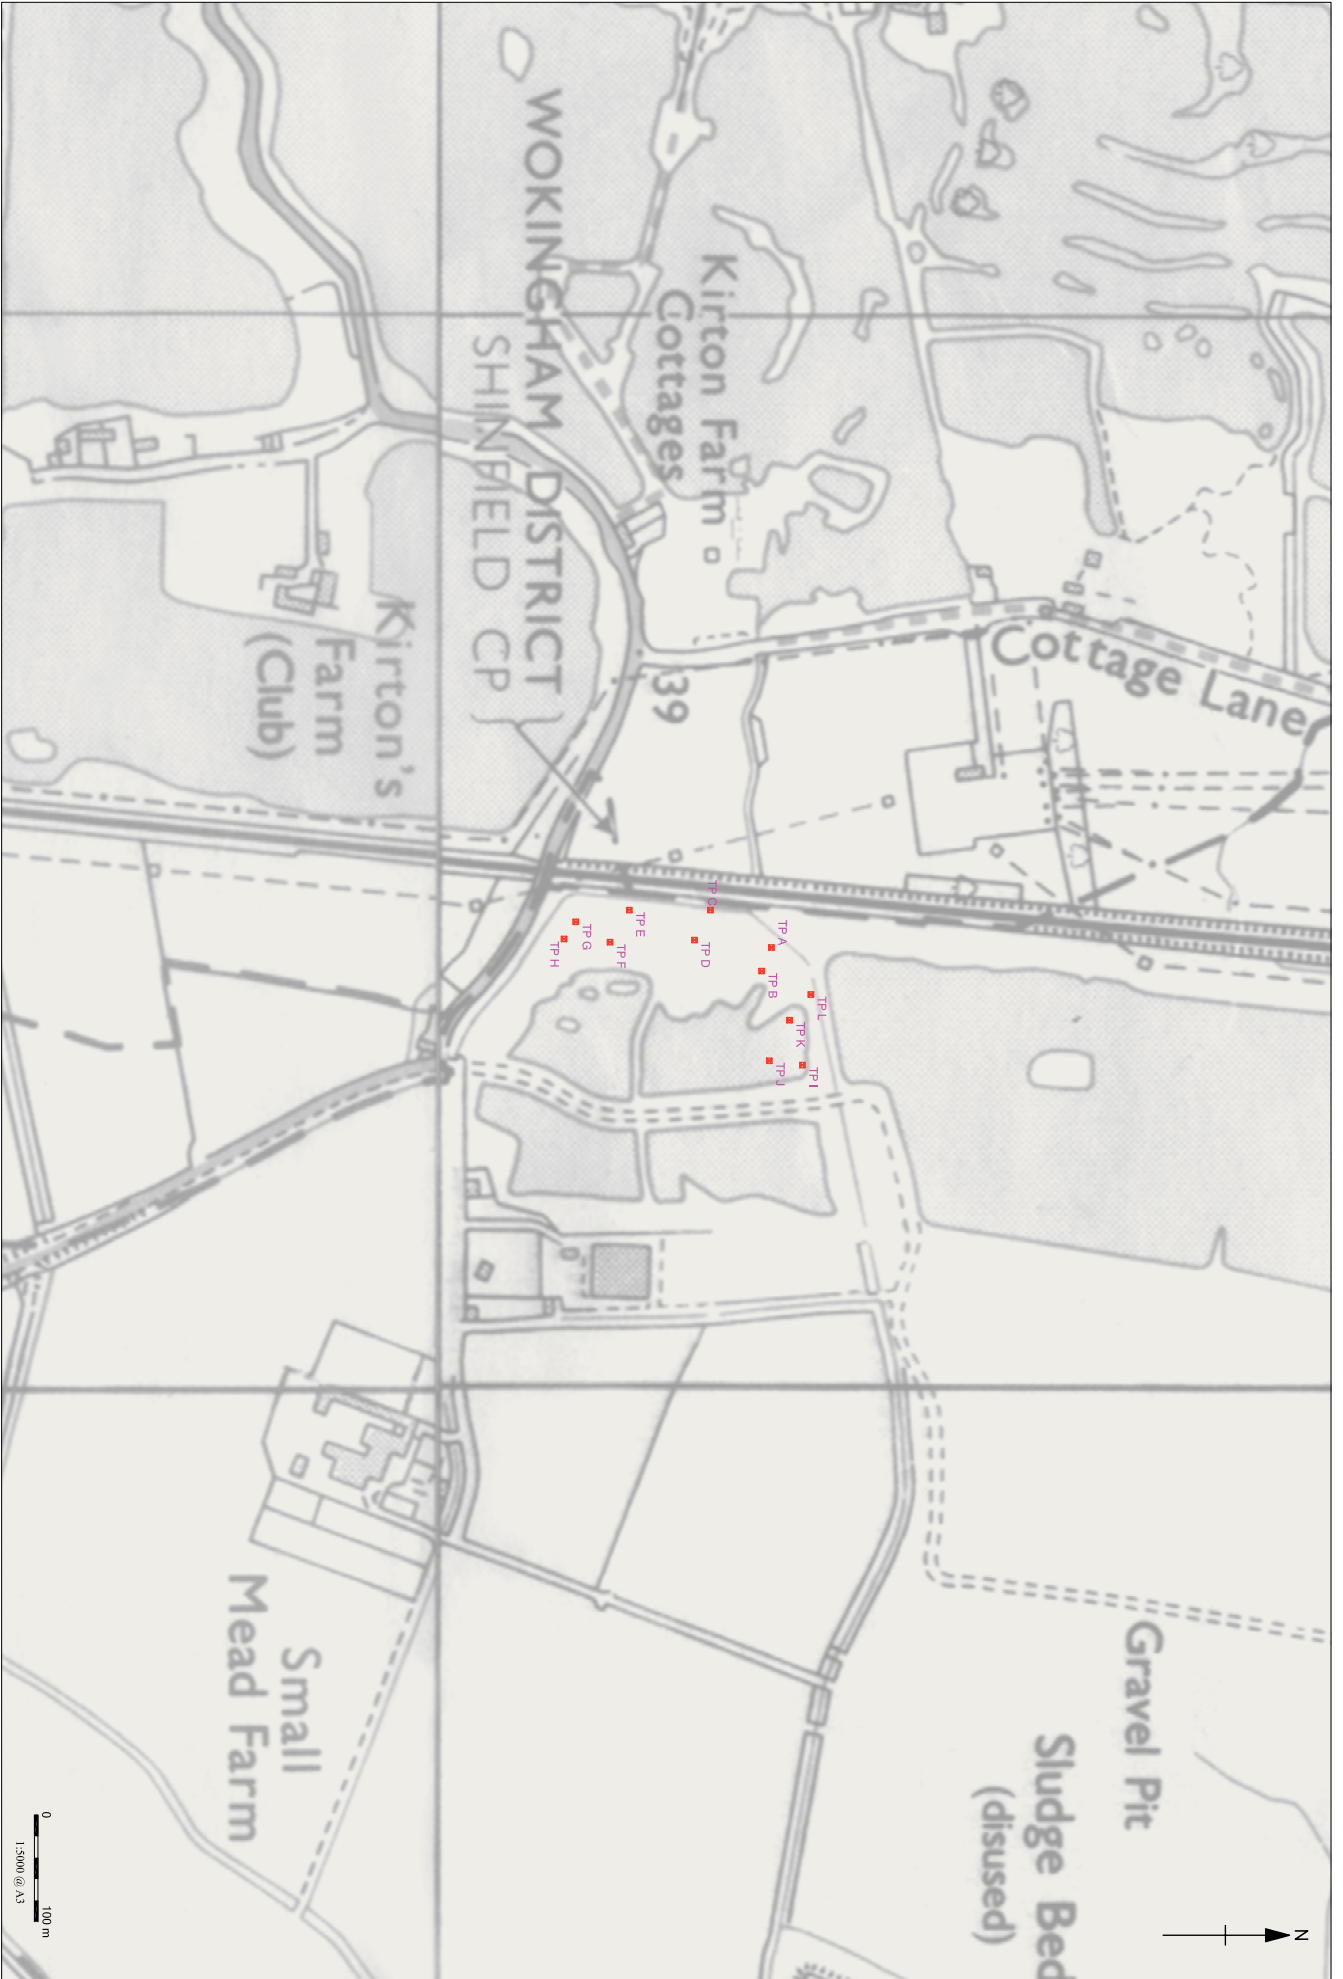
Fig 1: Test Pit Location Plan

2.1.1 The monitoring consisted of observing and recording twelve geotechnical test pits across the site. Test pit locations are shown on Fig.1.

Table showing deposits present in Test pits (locations shown on Fig.1)
